The Angel Hotel, Chippenham SN15 3HD  
ROOF BALUSTRADE: STRUCTURAL REPORT

[1121GE]

February 2022

| Document name | Roof Balustrade: Structural Report |

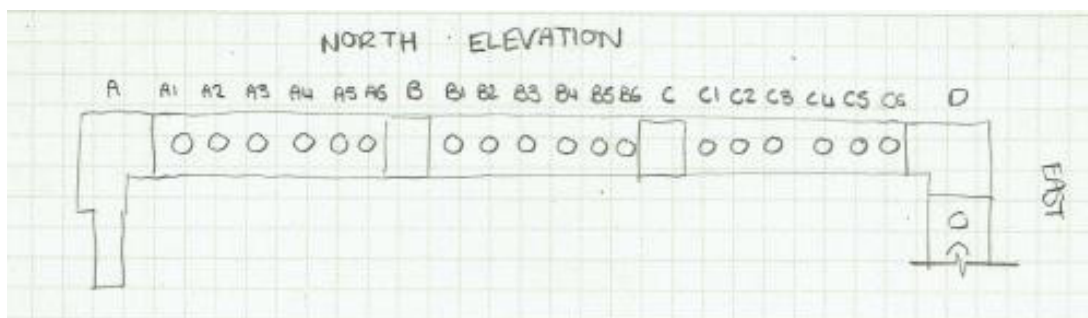
Figure 3: Diagram to label balusters and newel posts on north elevation.

The level of damage to each baluster and newel post has been categorised as follows:

| 1 | No significant spalling of stonework. |
| 2 | Some local spalling of stonework requiring patch repair. |
| 3 | Major cracking requiring replacement. |

Balusters and newels posts labelled as above and severity of damage is scheduled below:

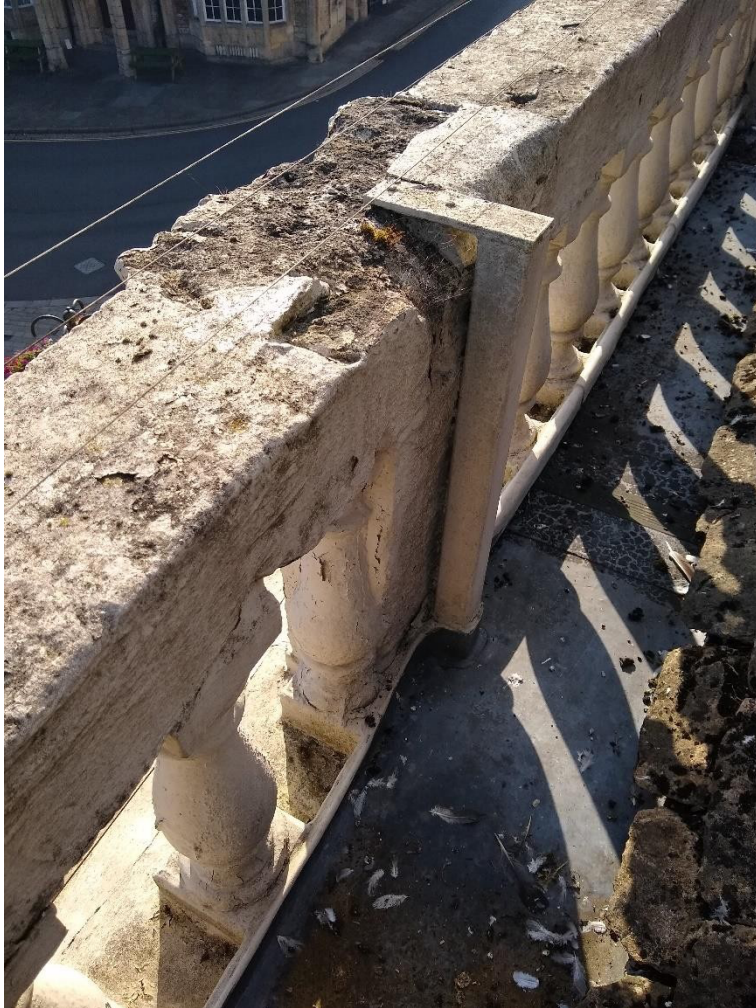
| Ref | Location | Description | Figure | Action |
|---|---|---|---|---|
| 1 | Balustrade east elevation | Some wearing of stone top course, not requiring repair | Figure 4 | N/A |

*Figure 4: East elevation showing top rail and steel strengthening.*

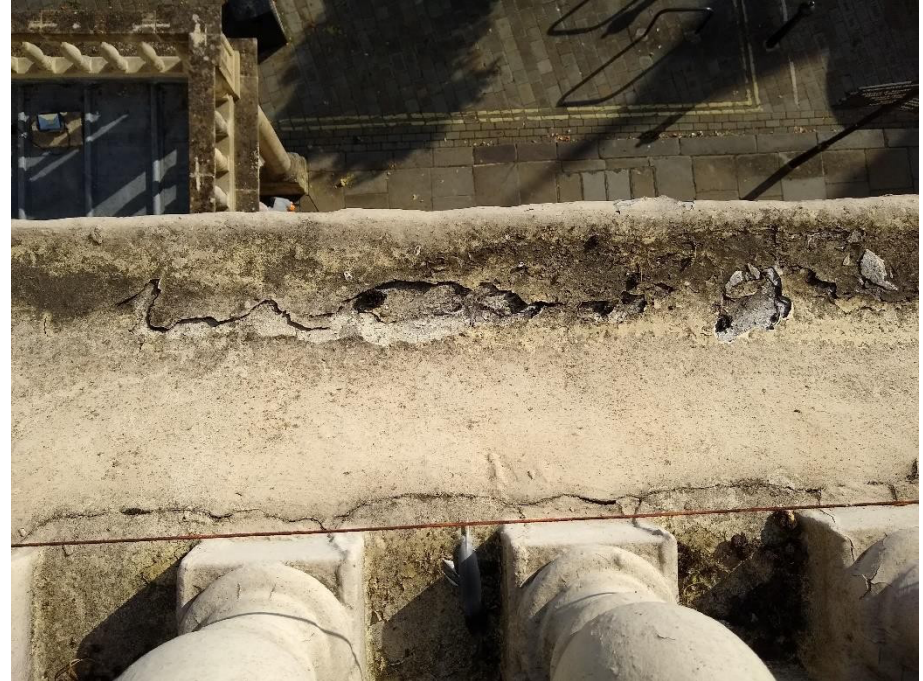
| Ref | Location | Description | Figure | Action |
|---|---|---|---|---|
| 2 | Balustrade east elevation | Entire balustrade is coated with impermeable paint, which is spalling in many locations. | Figure 5 | 1 |

*Figure 5: East elevation top of external wall showing paint spalling.*

| Ref | Description | Timeframe to be completed |
|---|---|---|
| 1 | To full extent of balustrade on north and east elevations: Remove impermeable paint to reveal the stone below and allow the stone to breathe. Ideally clean the stone and leave exposed, or recoat with a permeable paint e.g. Earthborn Eco Pro Silicate Masonry Paint <a href="https://earthbornpaints.co.uk/product/ecopro-silicate-masonry-system/">https://earthbornpaints.co.uk/product/ecopro-silicate-masonry-system/</a> | Medium term |

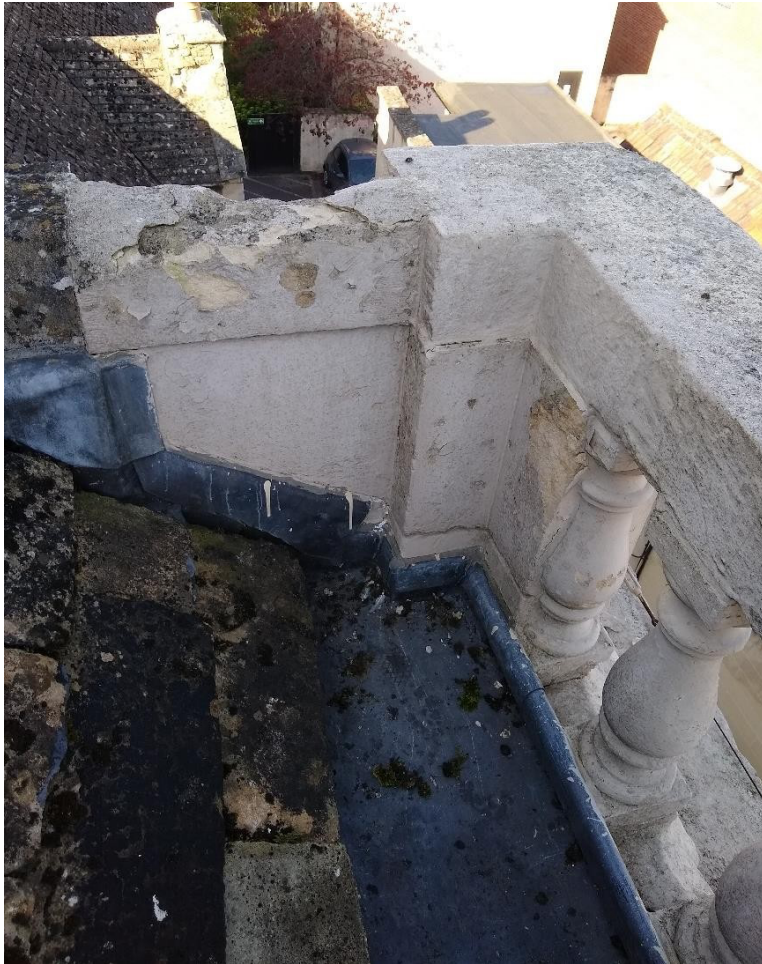
The condition of the balustrade on the north elevation is significantly worse than that on the east elevation. The damage is thought to have been caused by repeated freeze/thaw action over a number of years in the more shaded north facing position.

| Ref | Location | Description | Figure | Action |
|---|---|---|---|---|
| 3 | Balustrade north elevation | Some damage/spalling/cracking of balusters and newels posts. See section 2.1 for itemised observations. | Figure 6,<br>Figure 7,<br>Figure 8,<br>Figure 9,<br>Figure 10,<br>Figure 11 | 1, 2, 3 |

*Figure 6: West end of north elevation.*

| Ref | Description | Timeframe to be completed |
|---|---|---|
| 2 | For balusters on north elevation with category of damage 2: Clean stone, patch small areas of spalling stone with lime mortar and repoint with lime mortar. Use a natural hydraulic lime NHL2. | Short term |
| 3 | For balusters on north elevation with category of damage 3: Remove the damaged stone and replace with new to match existing. Dismantle top rail as required to replace balusters. New balusters to have stainless steel pin at each end to provide connection into top and bottom rails. Where top rail is reinstated, replace existing stainless steel connector pins with new. | Short term |
| 4 | For entirety of balustrade on north elevation: Wrap entire balustrade in mesh/fabric to provide protection from falling debris. | Immediate |

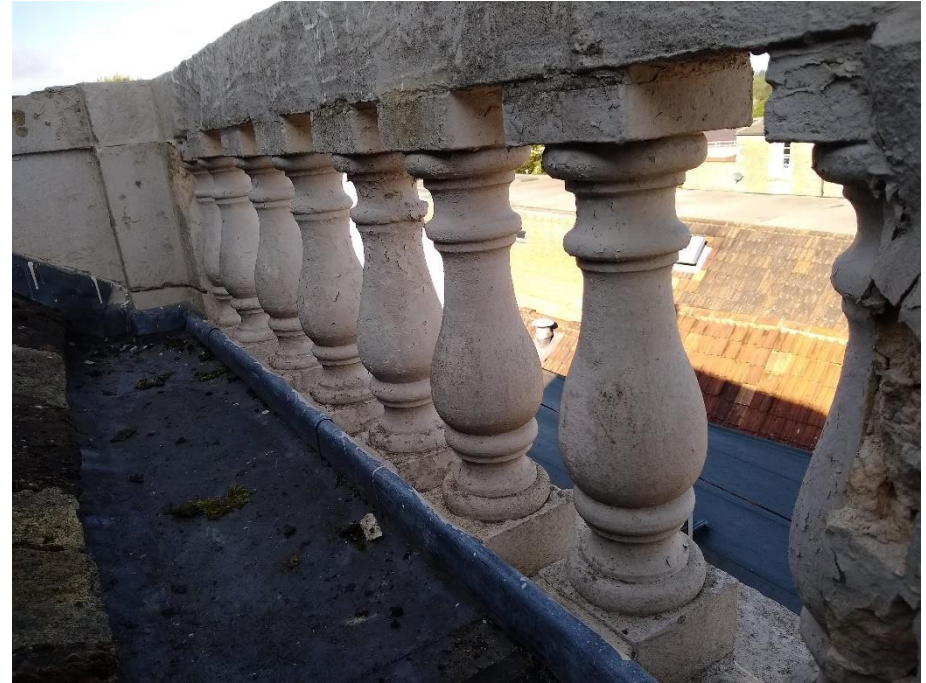
| A1: 1 | B1: 1 | C1: 3 |
| A2: 1 | B2: 1 | C2: 3 |
| A3: 1 | B3: 1 | C3: 3 |
| A4: 2 | B4: 2 | C4: 3 |
| A5: 1 | B5: 1 | C5: 3 |
| A6: 1 | B6: 3 | C6: 3 |

*Figure 7: Balusters A1-A6*

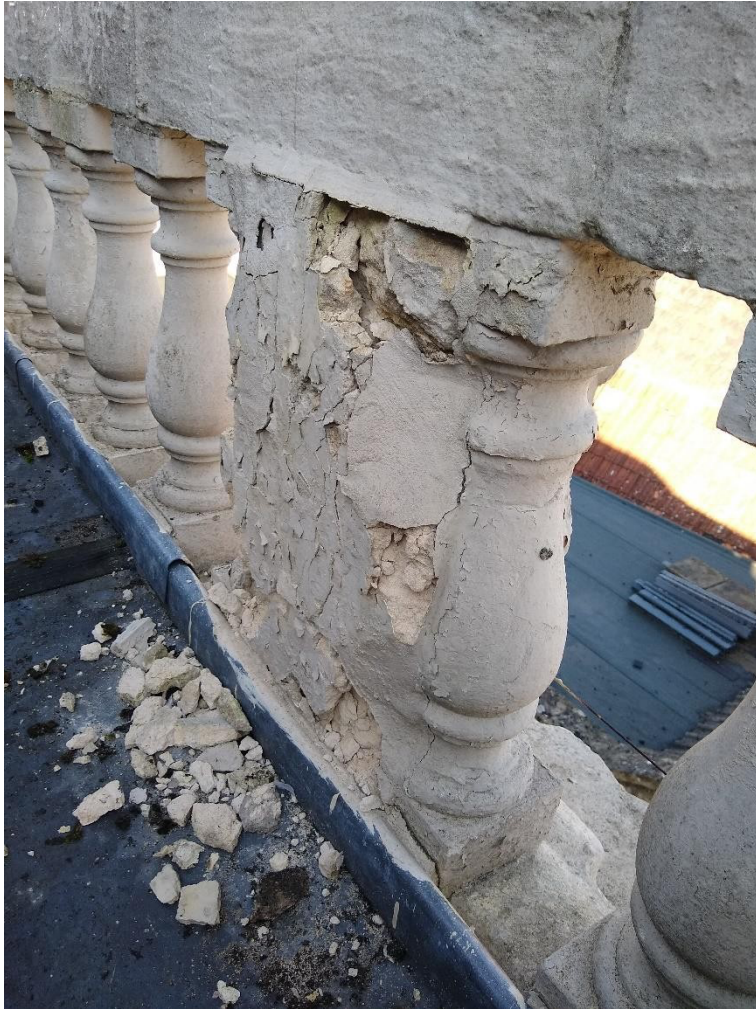
| A: 2 | B: 3 | C: 3 |

*Figure 8: Newel post B.*

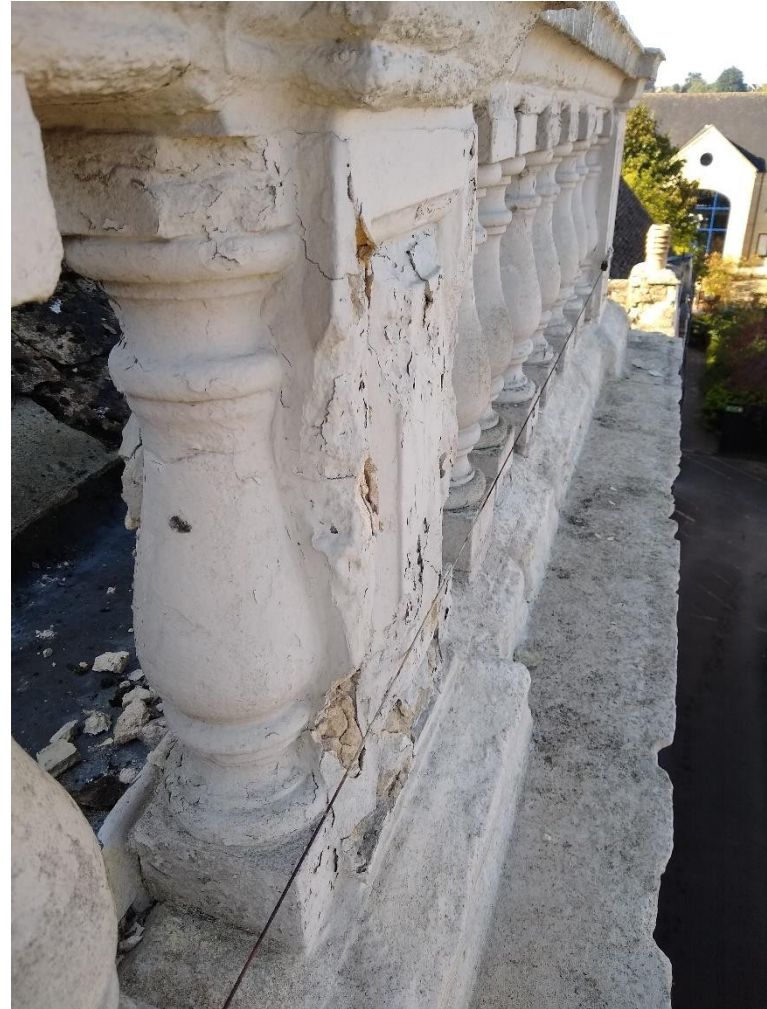
*Figure 9: Newel post B, outside face.*

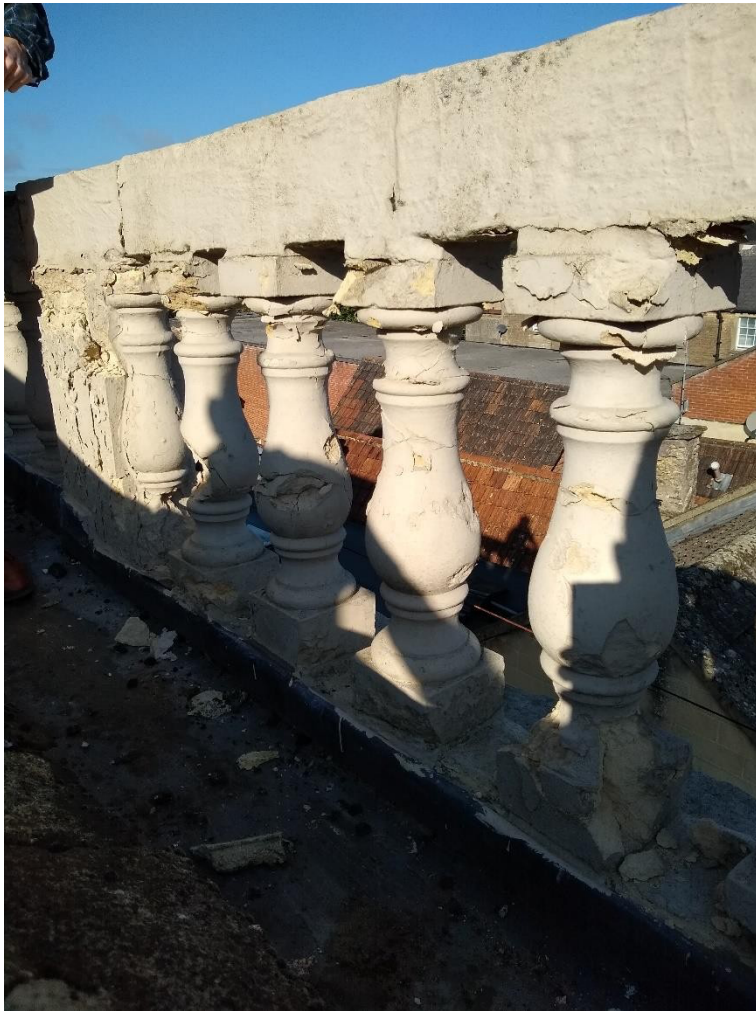
Figure 10: Balusters C1-C4.

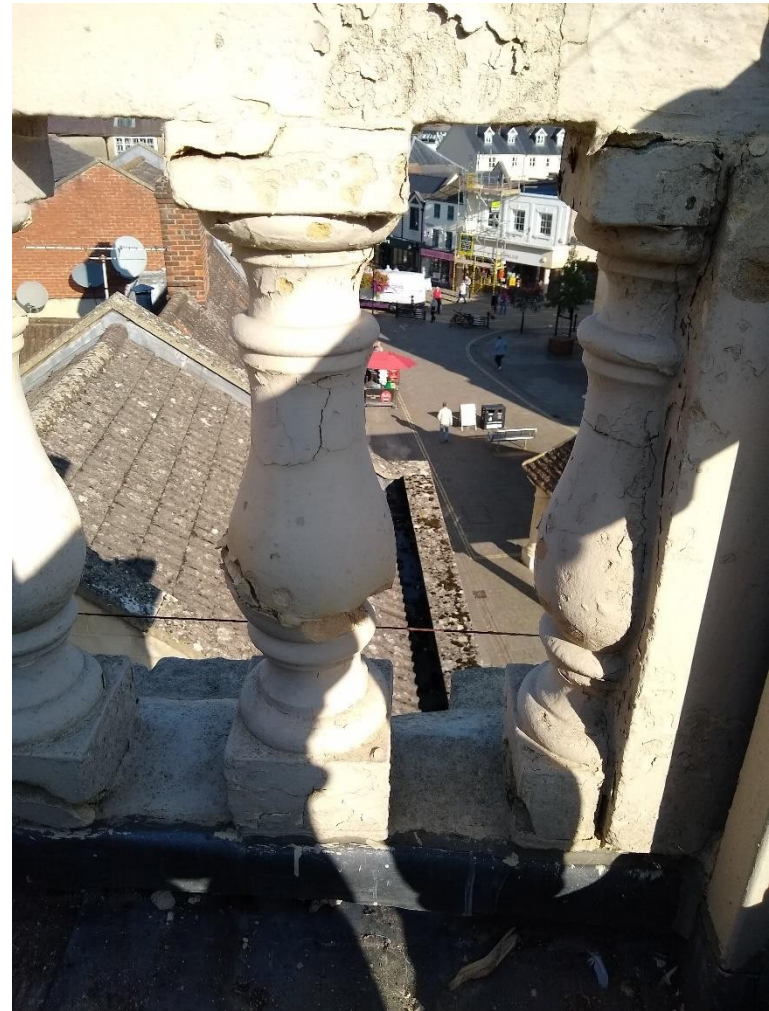
Figure 11: Baluster C6.
