Project P0969: 1 Manor Farm House  
63 High Street  
Worton  
SN10 5RU

Report: STRUCTURAL REPORT  
Purpose: Structural Report and drawings as supplementary information for planning submission to repair and Outbuilding and Garage in curtilage of a Grade 2 listed house.  
Prepared for: Mr & Mrs Foster  
Prepared By: Darrell Morcom  
Date: 02nd July 2026 Issue 1

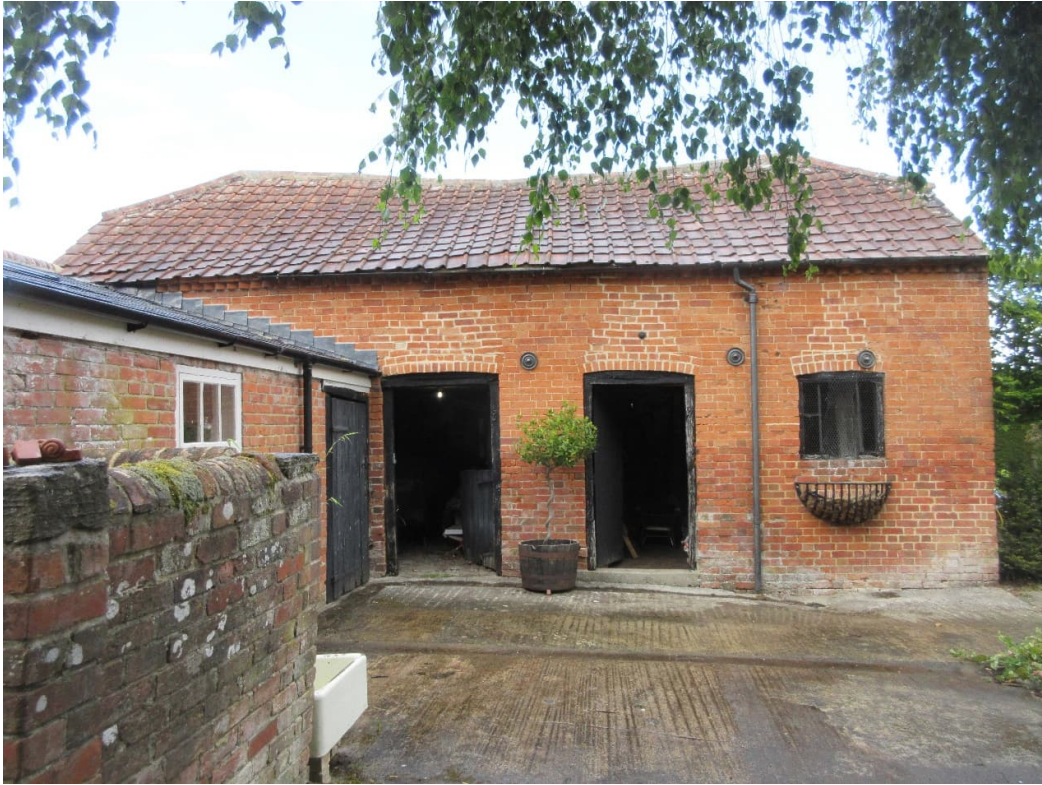
- There are 2 doors and one window on the south elevation and each with a brick arch above. The outward movement of the wall has resulted in damage to the arches which have bowed out. There are signs of multiple repairs and pointing repairs in non matching lime material.

South Elevation Barn- note 3 brick arches and movement/ repairs

- BF- Helifix bed joint reinforcement and repointing to brick above arches

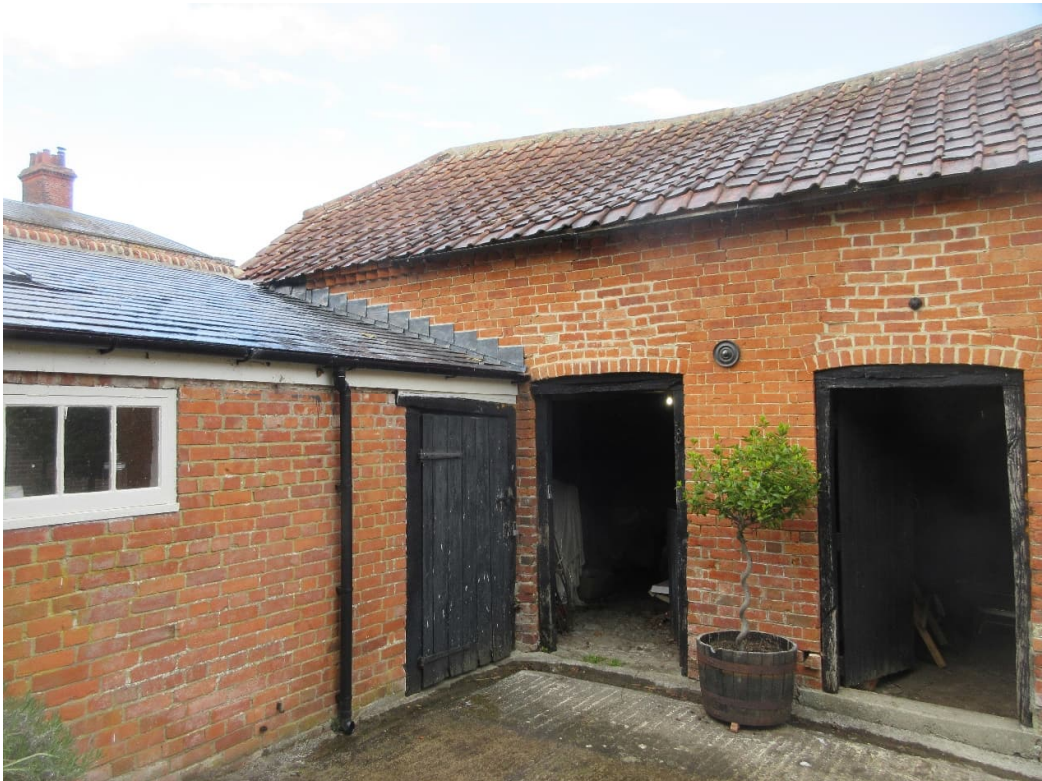
The addition of the small utility building effectively “buttressed” one side of the barn but both exaggerating the wall movement above the first floor on that side but also increasing the effective lateral movement on the garage side.

Junction of the utility wall and roof providing “buttressing” to the barn

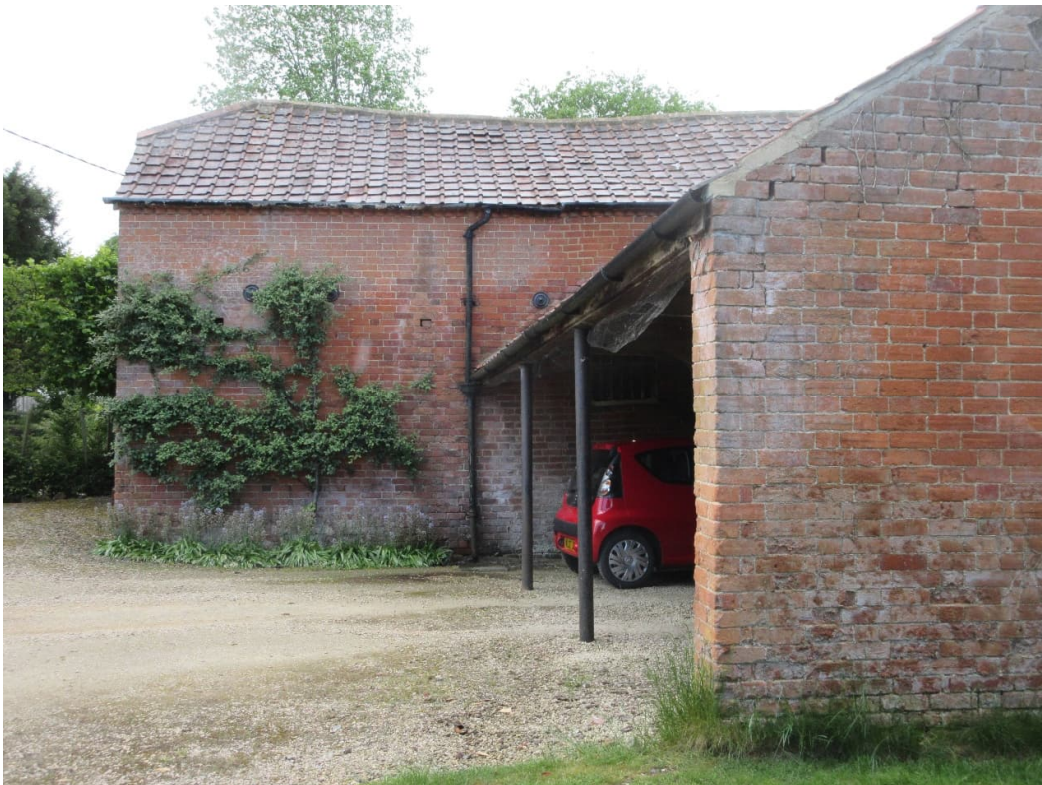
North elevation with high ridge deflection- note garage relies on main barn for stability

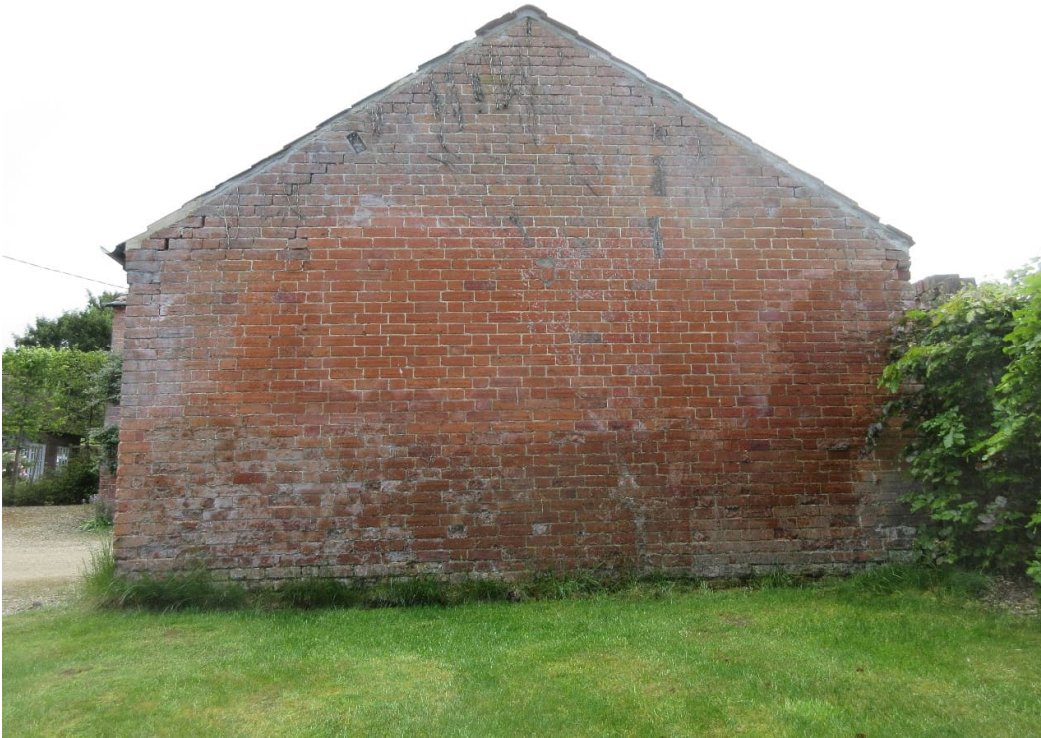
- 2no trussed rafters set on lateral timber eaves beams and 2 sets of 2no. hollow steel posts.
- The large lateral eaves movement of the main barn roof on north elevation has pushed one of the garage eaves out by a similar extent (8 to 10 cm) with corresponding warping damage to the end brick gable wall.
- The trussed rafters arrangement is poor resulting in a higher proportion of the roof load being supported in beam action on the tie beam. Resulting in significant sag.
- The overall movement has also resulted in the trussed rafters slewing over sideways which increases the general movement.

The garage structure lacking in lateral stiffness and relying on the main barn for lateral stability has followed the outward movement leading to significant warping of the garage end gable.

Garage end gable- high left hand side deflection and damage due to main barn movement

- GA- Add additional rafters (4x1no.) to make a pair with the single truss rafters such that a stiffer triangle is formed. The rafter to tie beam with will be bolted to strengthen this connection.
- GB-Place timber fillet blocks behind the bottom of the purlin at the diagonal prop position to enhance the robustness in a traditional way.
- GC- Pack and bolt the last timber rafter to the main barn to give added lateral stability to the garage roof structure and end brick gable which relies on this effect.
- GD- Mechanically tie the purlins to the end brick gable to enhance the lateral stability.

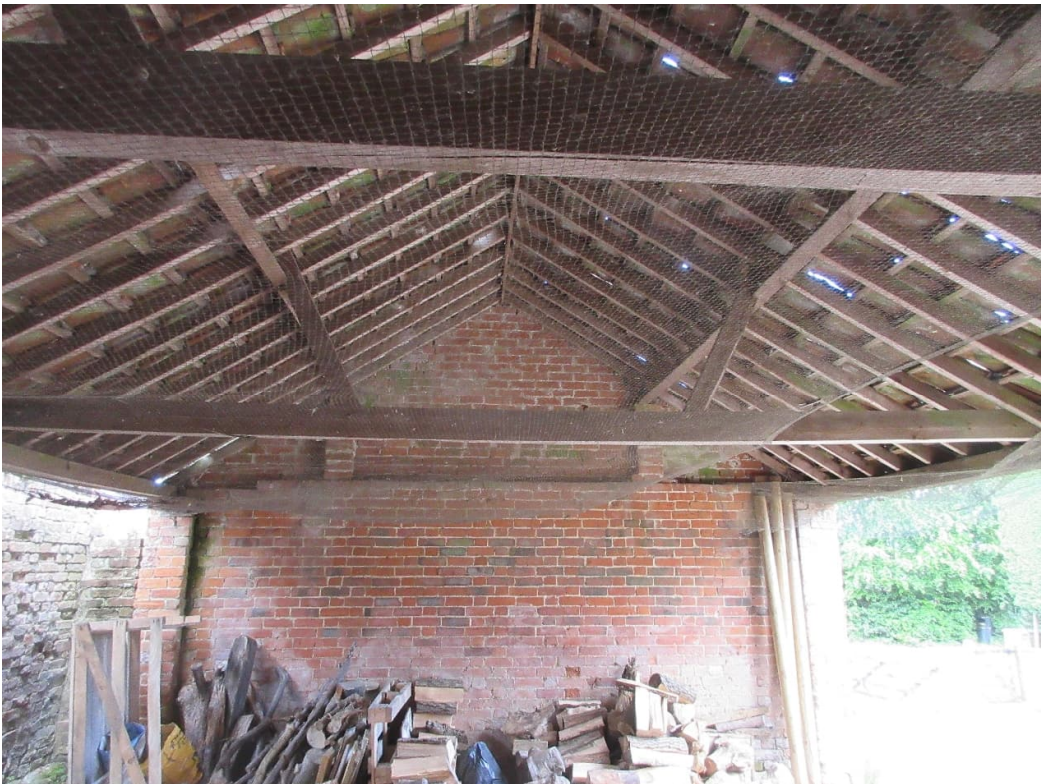
Internal garage roof tied rafters- note sag in tie beam due to inefficient connections

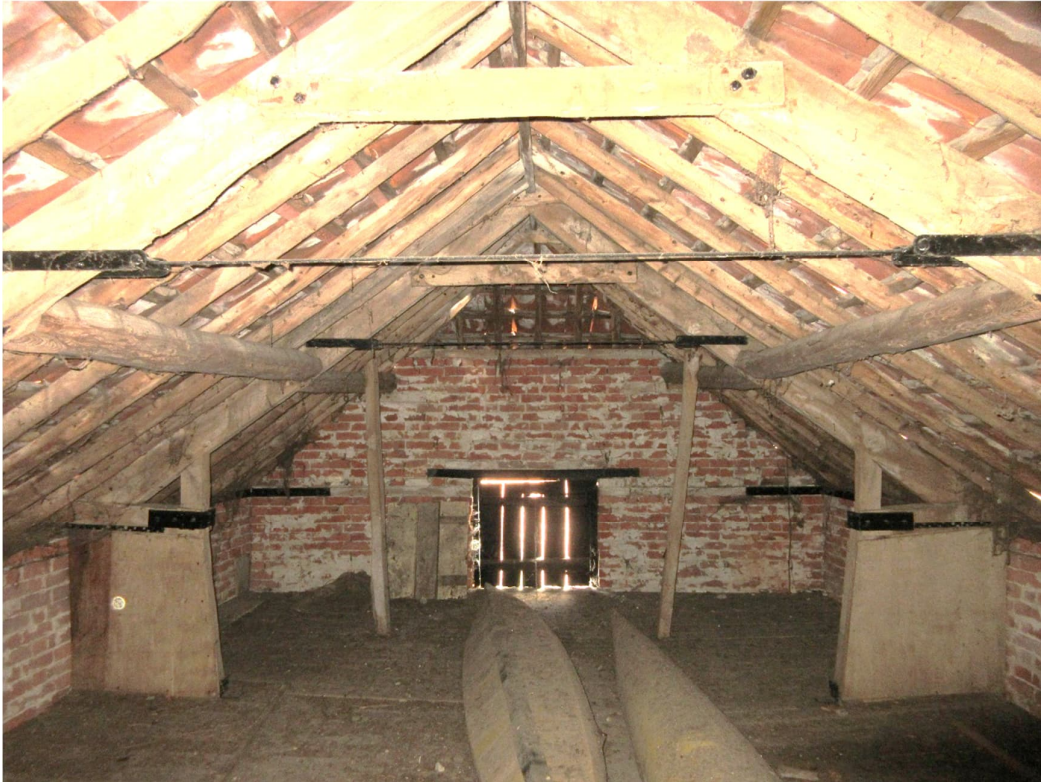
Internal view main barn first floor looking towards the east- note two hip end props and metal ties

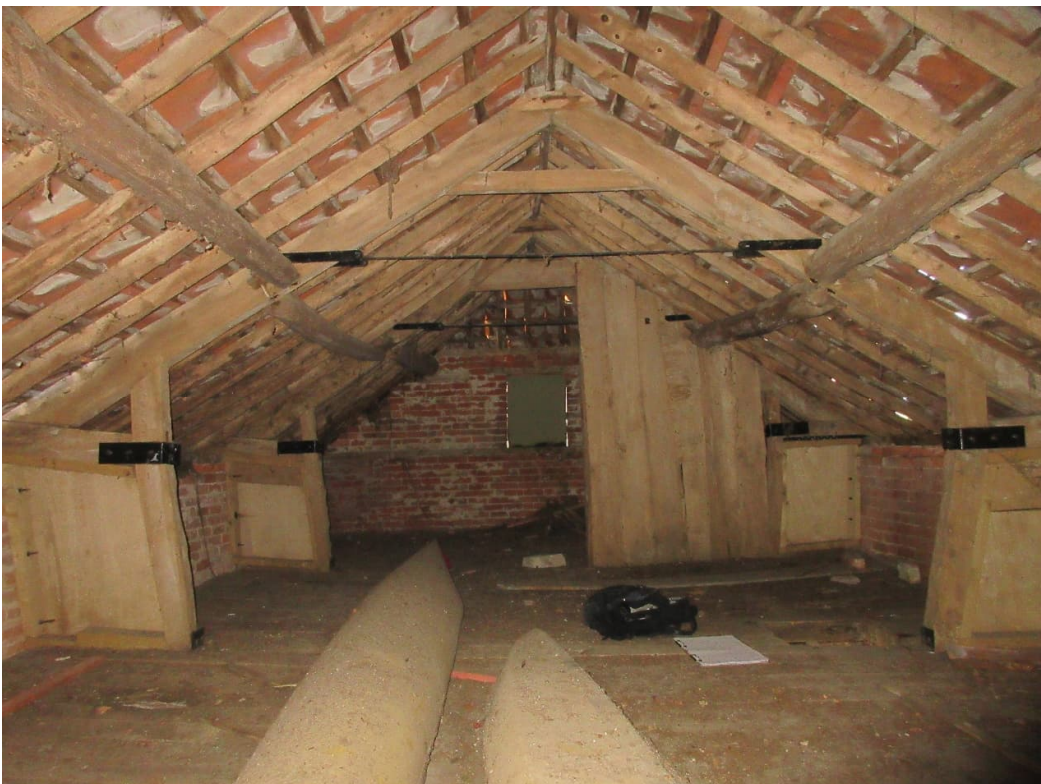
Internal view main barn first floor looking towards the west- note steel elements and ply wood diaphragms

- BA- Remove the lower sets of screw fixings of the steel angle and replace with long bolts fully through the supporting timber beams
- BB- Remove the plywood and inserted softwood block diaphragms to eaves bays and replace with small steel angle strut screwed to the timbers at each end.

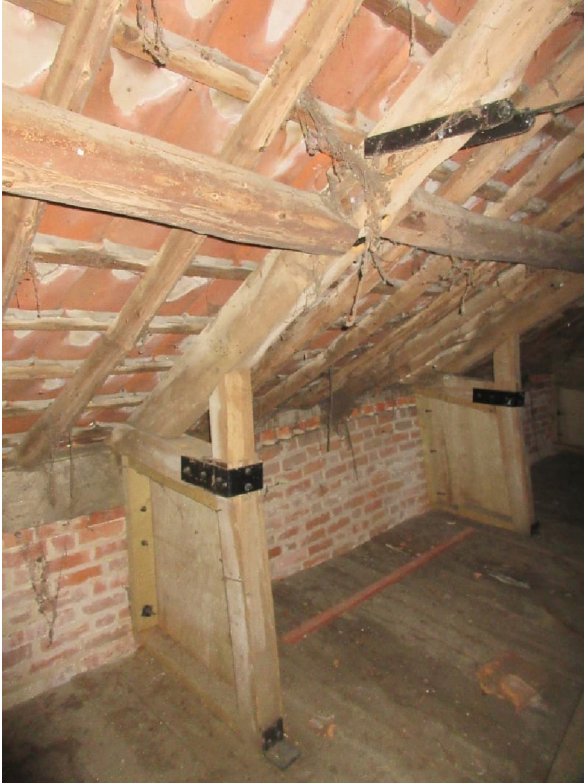
Eaves detail with original post and ledger and added ply wood and soft wood diaphragm and brackets

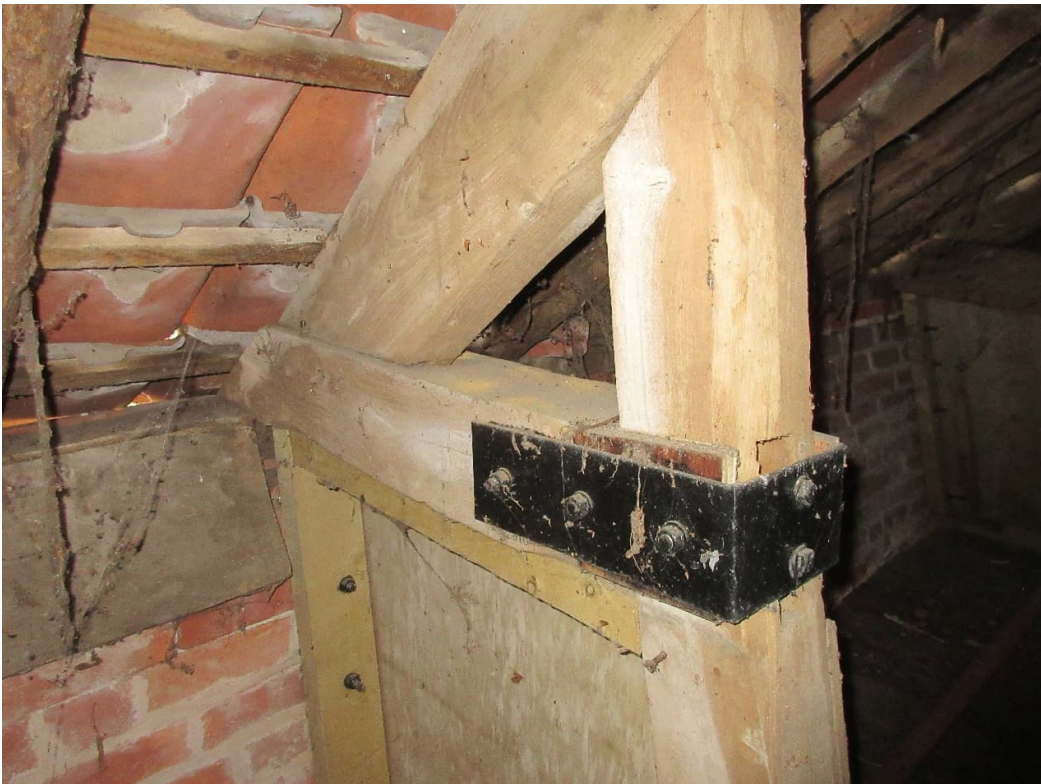
Close up eaves detail with original post and ledger and added ply wood and soft wood diaphragm and brackets

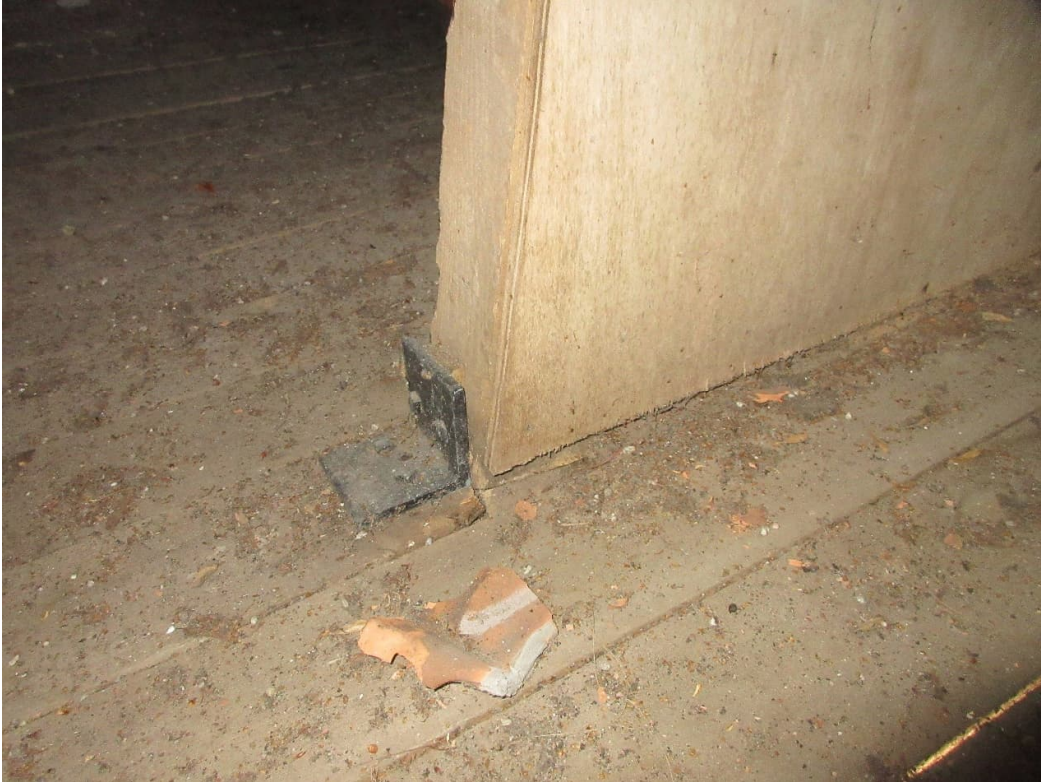
- This movement would have been gradual since the original construction but would have accelerated when the pegged eaves support joints failed.
- Small Steel angle brackets have been added which tie the eaves timber post assembly to the first floor beams. These are very important to the structural stability and fixings should be improved.

Tie down steel angle to main beams

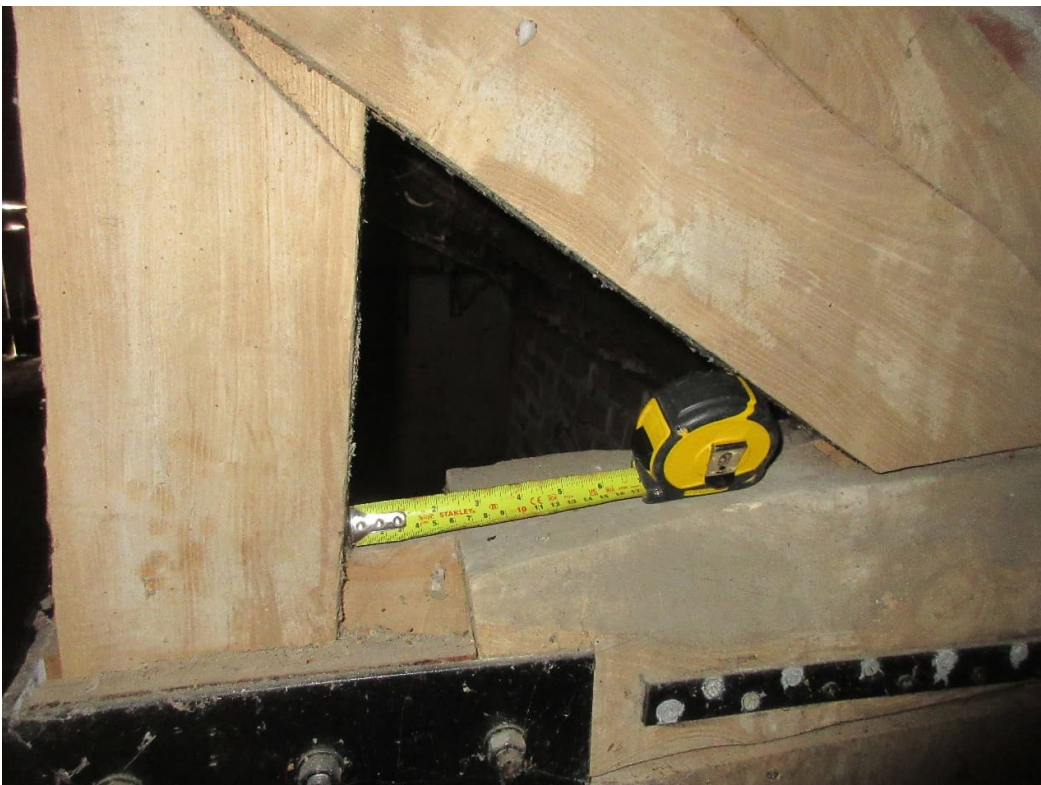
Detail showing 6cm tenon failure

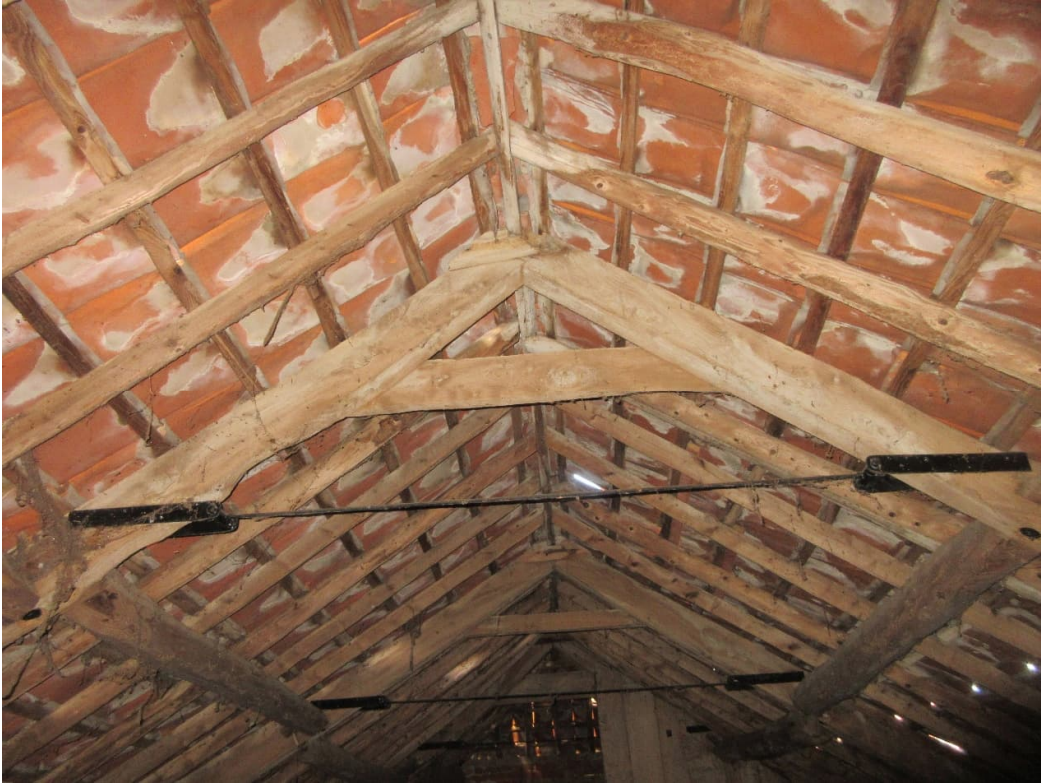
Typical truss, collar tie and lower steel tie rod

- BC- Remove small diameter tie and end bracket assembly and replace with new tie assembly suitable for the actual roof load and added rafter loads
- BD- Install a paired timber ridge beam above the existing ridge plate that takes new rafters loads directly into the trusses apex. The ridge will cantilever past the end trusses such that the two hip ends have enhanced support.

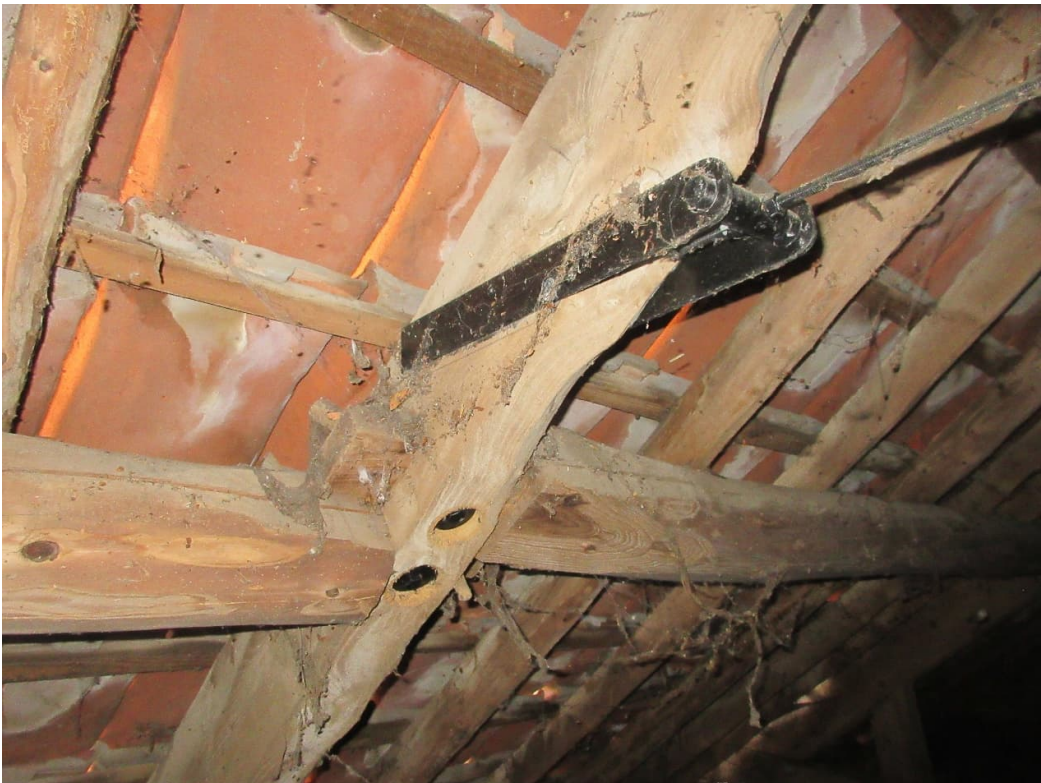
Tie rod end detail and bolted "pegged" purlin tenon

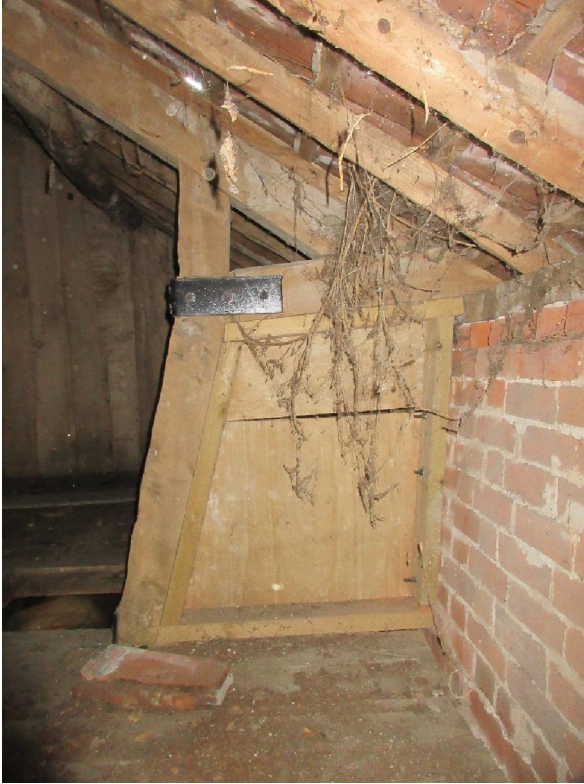
- Access via a small hatch in the floor.
- Subdivided by 4 bays that correspond to the 3 roof trusses.
- At the eaves there are originally vertical timber posts with horizontal ties that provide vertical support to the roof trusses. The large deflection of the ridge due to lack of vertical support with corresponding lateral splay of the eaves has caused a failure in the pegged mortice and tenon joints. Similarly, the continued movement since the steel u shape brackets have been added has caused excessive bending in the posts and full cracks in places.

Eaves detail showing high lateral deflection and bent post (some are cracked)

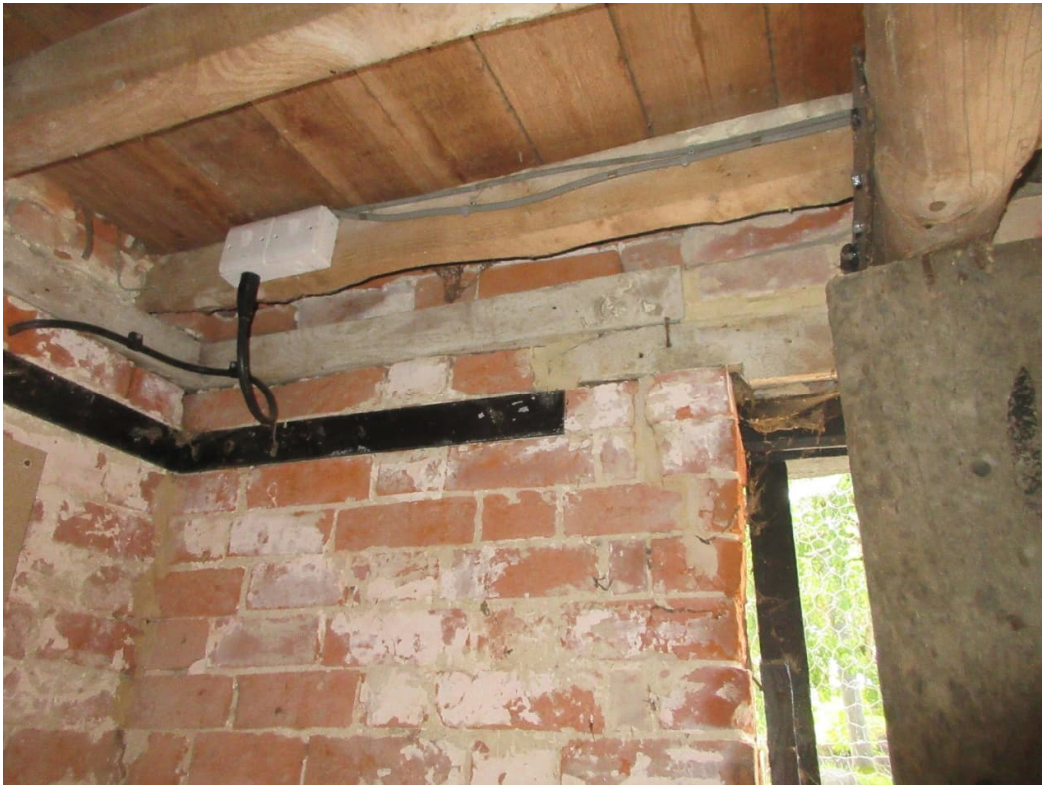
- The high lateral wall movement when combined with the timber bearers has resulted in failure in the brick bearings.
- Corner steel braces and embedded timber binders appear to be functioning to tie the corners.

Corner steel braces

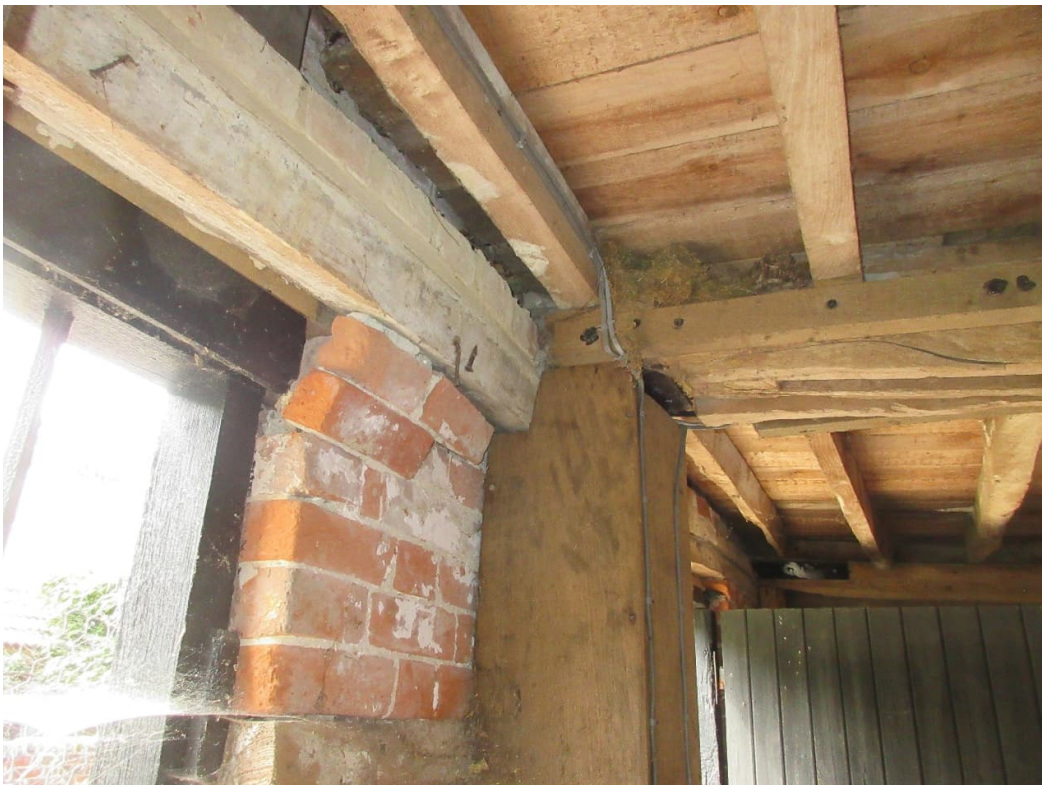
Failed beam bearing having pulled over the binder and 3 courses of bricks
