# Technical Note

## Tudor House west cross-frame structural proposals

| PROJECT INFORMATION | | | | |
|---|---|---|---|---|
| Project title | | Church House, Salisbury | | |
| Document ref. | | 14914.4 | | |

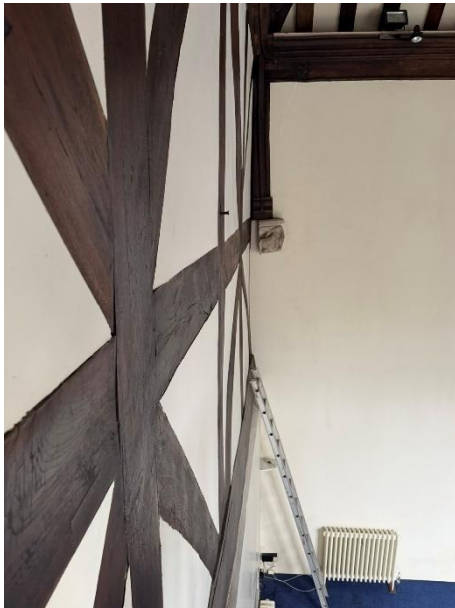
Figure 15 – north elevation, east end

The main beam has rotated significantly at its north end, with the top moving westwards towards the Solar. The remainder of the cross-frame has moved locally with it. A substantial gap is present between the wall-piece corbel and the cross-frame, which illustrates the scale of movement. The movement is considered to be predominantly historic, as indicated by intact finishes, earlier strengthening attempts (including a saddle and bolts), and pieces of timber inserted to fill gaps. It is understood that the building has not been subject to significant maintenance or renovation for several decades. Notwithstanding that most of the movement is likely to be historic, there is evidence of more recent change.

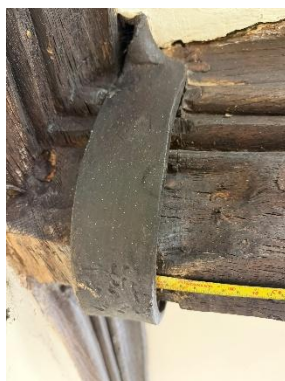
There is evidence of earlier attempts to address the movement. A wrought-iron saddle is present on the central secondary beam, with an access panel formed in the main beam on the opposite side. A bolt, possibly a coach screw, is present at the north end of the main beam, fixing into the north secondary beam. A timber post supports the end of the central secondary beam furthest from the cross-frame, as shown in Figures 10 and 15. This post does not match the appearance of the surrounding beams and may have been inserted to provide additional support.

Figure 19 – central secondary beam saddle

The incoming central secondary beam is currently hung from the side of the main beam. To resist further rotation, a rigid connection will be created. A stainless steel plate will be inserted into the centre of the secondary beam for its full length, extending as far as the timber post support. A perpendicular plate will be welded to the end at the main beam connection, and the plate will be bolted to the main beam. The fixings will be concealed within the existing timber panelling.

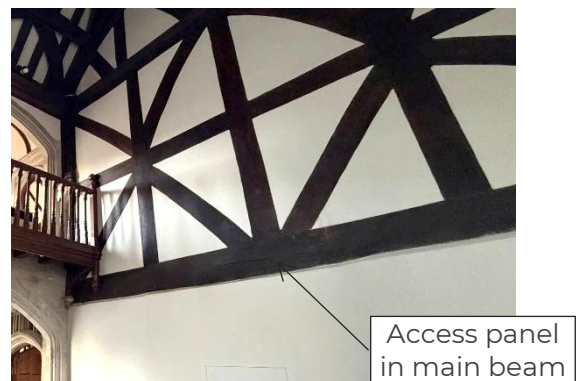
Figure 20 – timber access panel on opposite side to saddle

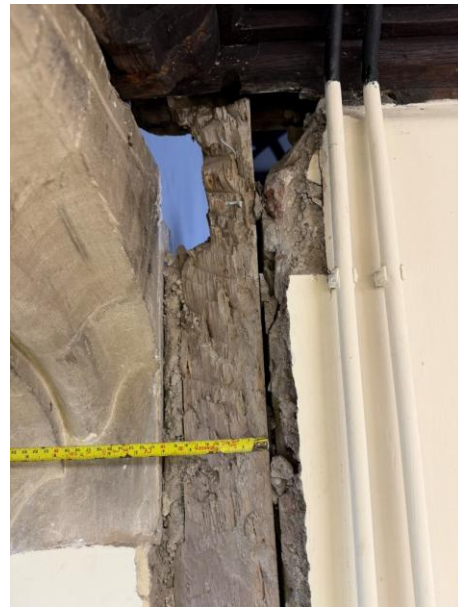
A concealed steel frame has been devised within the existing fabric. A single timber stud is currently present at the north end of the ground-floor partition. As the partition does not align with the window reveal, the stud has been heavily chamfered. The proposal is to replace this stud with a steel box-section post, securely fixed to the external wall and tied into the brick partition.

Figure 21 – general view from Solar undercroft    Figure 22 – partition stud viewed within Solar undercroft

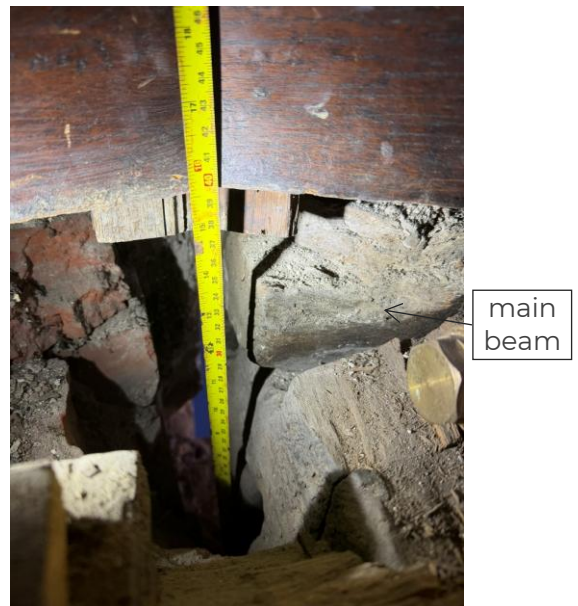
Figure 24 – void at end of main beam viewed from Solar

The post will support a small steel PFC (parallel flange channel) positioned within an existing void at the end of the main beam. The channel is cranked to avoid projecting beyond the profile of the main beam. Its purpose is to brace the head of the box-section post and to provide vertical support to an angle fixed to the cross-frame stud above.

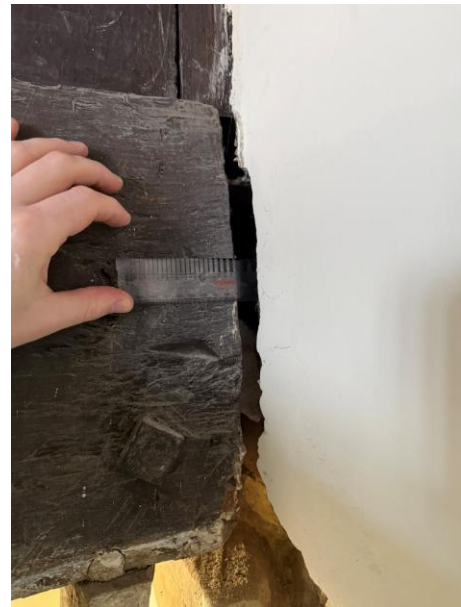
Figure 26 – deep void at north end of main beam viewed from Hall

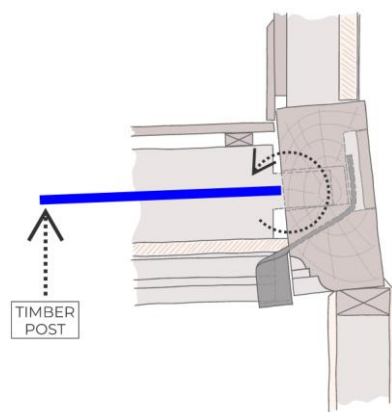
Figure 27 – Diagram to illustrate how flitch will resist rotation [blue = flitch]

The flitched beam will act as a substantial lever arm clamped to the main beam. Rotation of the main beam will be resisted through vertical support at the timber post. The partition below the main beam will continue to provide vertical support to the beam.
