# **Heritage Impact Assessment**

**Unit 5, Wilton Shopping Village,  
Wilton, Wiltshire**

Reference: 261036

**Heritage Impact Assessment**

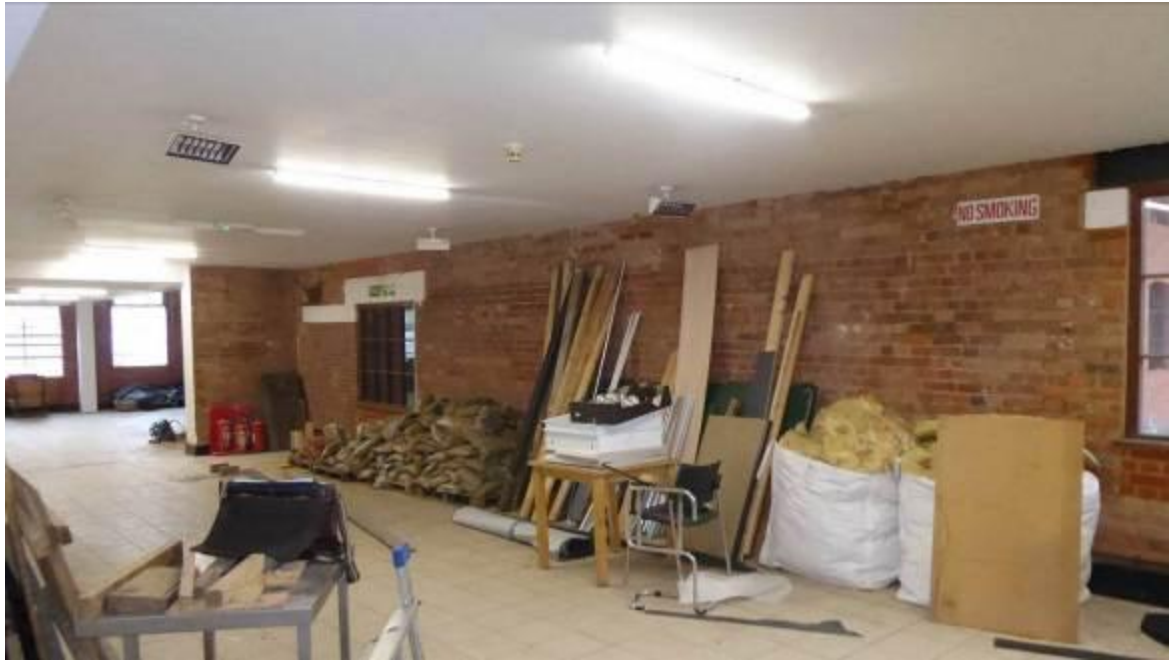
Fig 3.1: Area 1

- 3.1.1 The external wall to the north end of this part appears to be a modern structure dating to the third quarter of the 20<sup>th</sup> C and finished with hard cement type render. This shows where other buildings have been removed from this side.

- 3.1.2 The north end of the east wall to the ground floor section is of brickwork with a blocked up door and window openings in this and a modern staircase running up across this face. The other part of the east wall of this area to Unit 4 is largely obscured by equipment and other fittings as well as plaster wall finish etc and so a full inspection was possible. This wall contains a heavy duty iron fire door, which would have separated one part of the mill from the other as would have been required and is typical of that type required by insurance companies for this type of building in the 19<sup>th</sup> C, but has been welded shut historically. It bears the maker's name of Gardener & Sons from Bristol.

- 3.1.3 The south wall at the west end, where this survives at ground floor level, is all in brickwork and where it can be seen internally within the part of the building.

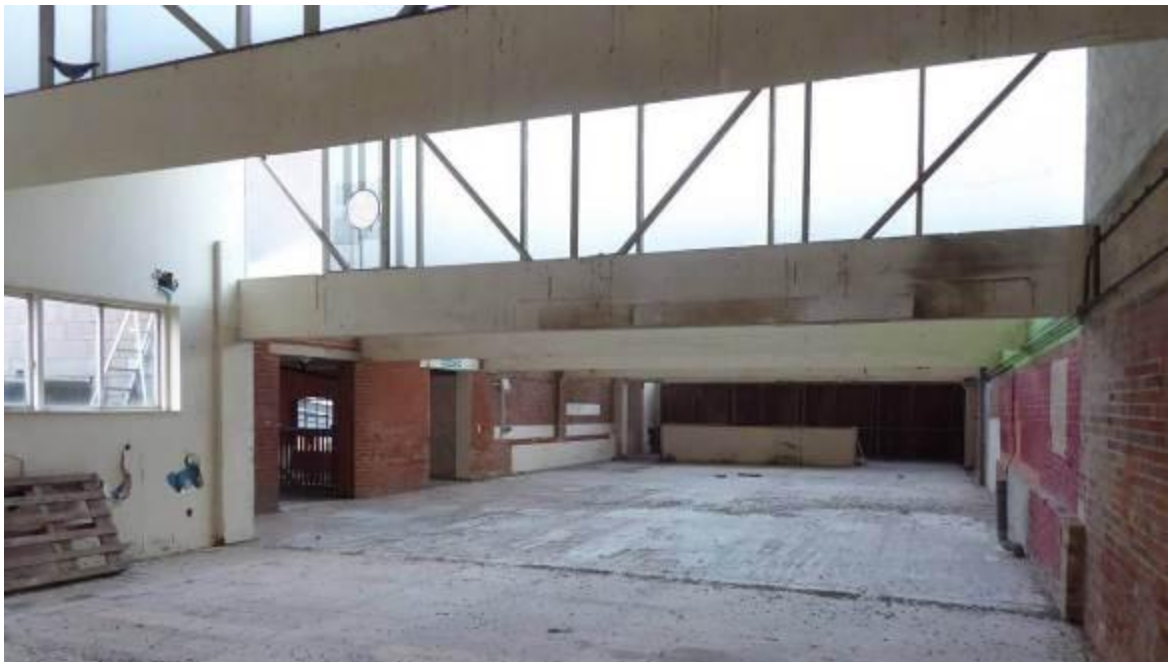
Fig 3.1.9: Area 1 first floor

- 3.1.9 The extended first floor over this area is a suspended timber structure where the joists span on to cross beams and is covered with softwood boarding, where the south part is covered with carpet over hardboard.

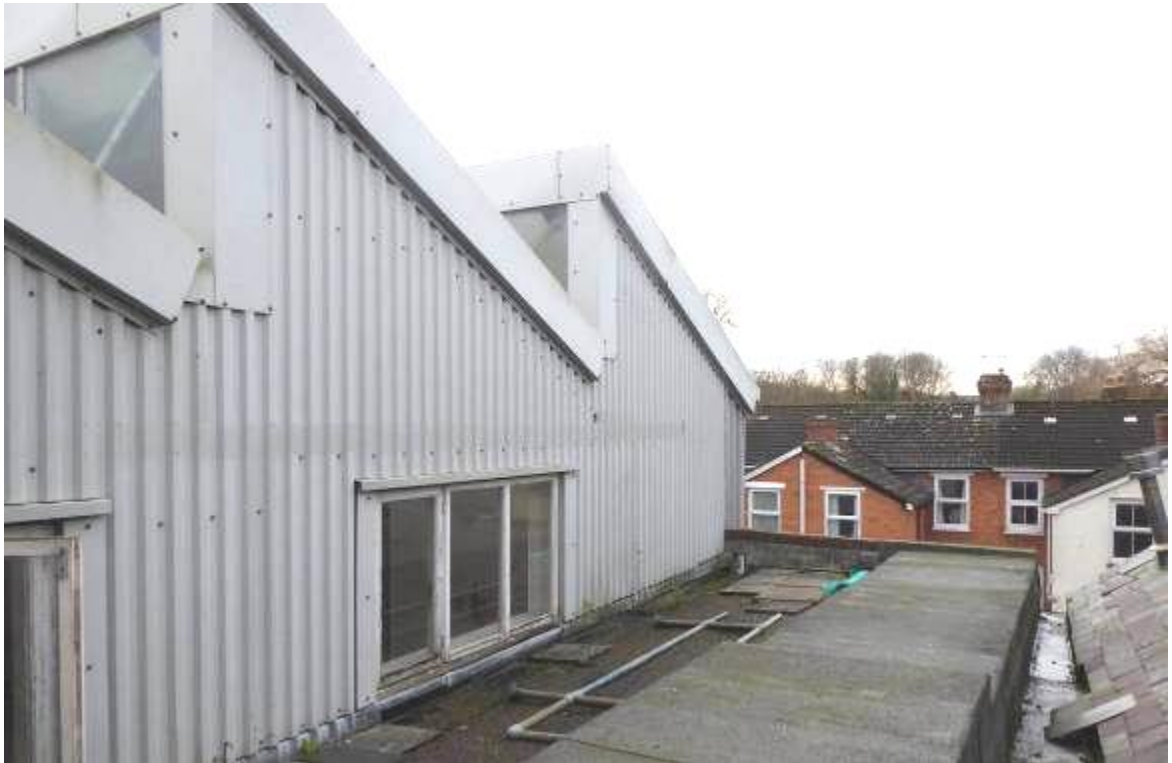
Fig 3.1.12 West side of area 1 roof

- 3.1.11 To the west side of this area is a flat roof in two sections between the west side upper wall to area 1 and the east most roof slope to area 3. Part of this area appears to contain a service duct or similar.

- 3.1.12 The upstanding west side wall to area 1 roof is clad with vertical profile metal sheeting to the side of the north light roof. The windows in this are single glazed standard joinery storm proof units. The south side wall to the east end of area 5 and a section of that to area 1 is a mixture of construction. Part of this is double storey structure over the top of a lift shaft where the sides are clad with artificial slates, in a fair condition. The section of the wall to area 5 is in brickwork with the top capped with brick on edge to the valley gutter behind with lead flashings to the abutting roof over area 3.

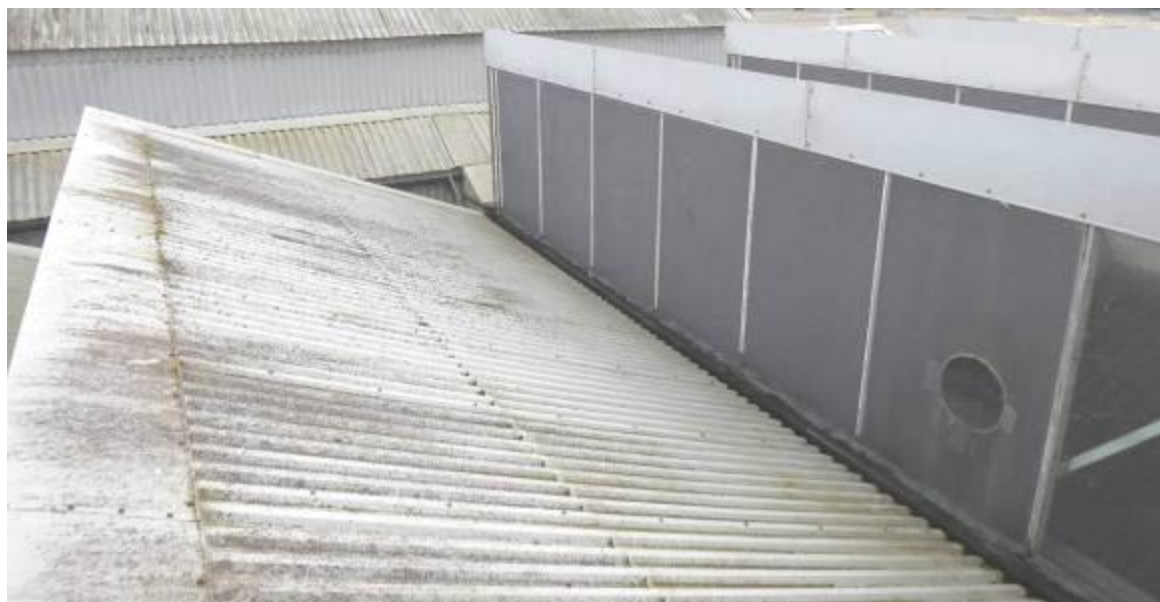
Fig 3.1.13: Area 1 north light roofs

- 3.1.13 Only limited viewing was possible to the top of the roof to area 1, where this is of colour coated profile metal sheeting that runs down from the tops of the north lights to valley gutters at the bottom of the trusses.

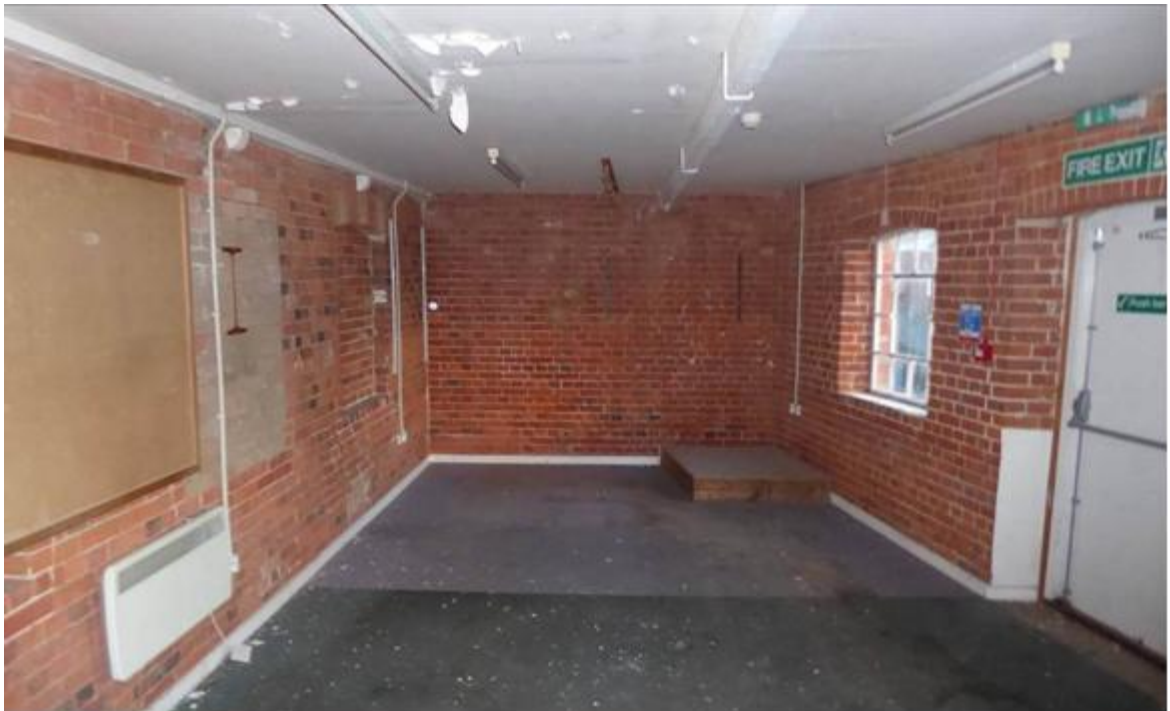
Fig 3.2: Area 2 first floor

- 3.2.1 This extends across the back of Unit 1 and Unit 4.
- 3.2.2 The floor is of solid construction covered with ceramic tiles in a fair condition.
- 3.2.3 Walls are all in brickwork with some evidence of blocked up windows and doors. No structural cracking or other significant movement within it.

- 3.2.4 Windows are small pane single glazed cast iron with central tilt-and-turn opening lights and brick semi-circular arches over them.
- 3.2.5 The ceiling over this is the underside of the extended floor deck from Area 1 that has been previously reported on in this area.

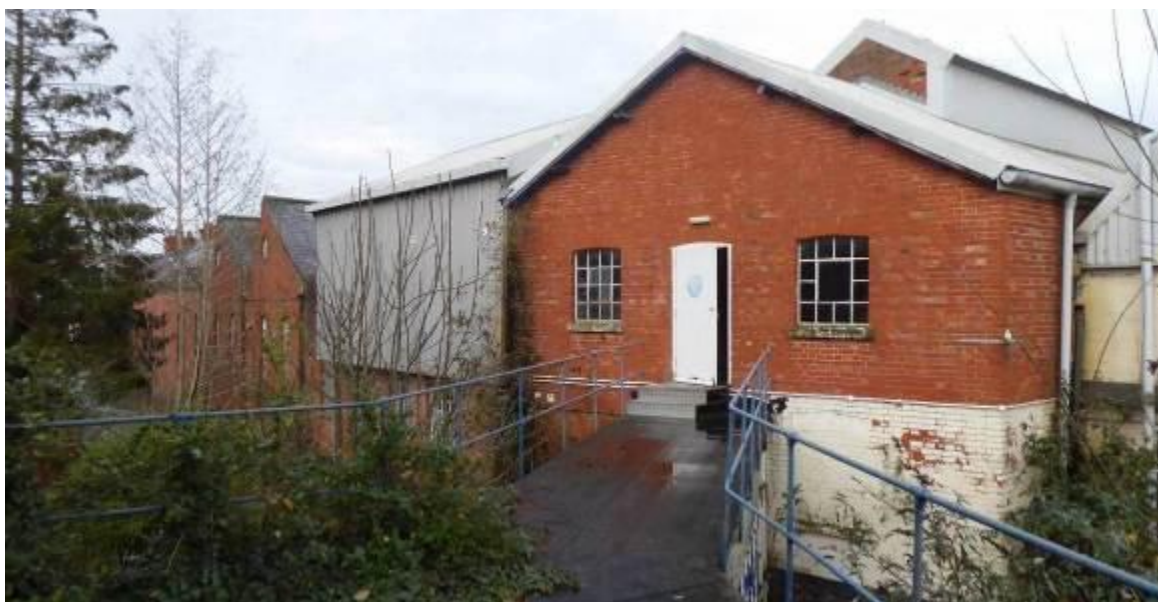
Fig 3.2.7: Area 2 south wall

- 3.2.7 The south wall to this is also has a short section of the east end of the east wall, all in brickwork laid in English garden wall bond to the lower part and Flemish garden wall to the head of the gable. The lower part of this wall to the river is rendered.

- 3.2.8 The lower section of wall to the west section of this block is of brickwork with rendered band to the river at the base and the upper section, where Area 1 has been extended over it, is clad with metal sheeting.

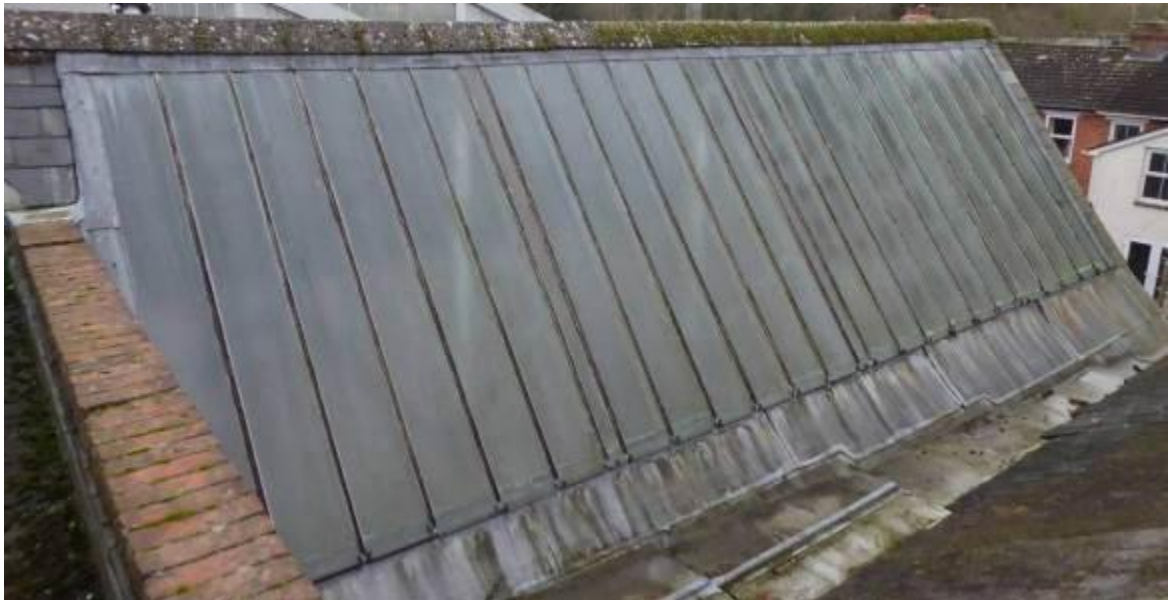
Fig 3.3.7: West light to roof over area 3

- 3.3.6 The roof coverings over the closed sides to the west lights are natural slates running up to a top where this is capped with half round section concrete ridge tiles. The slopes contain many tingles to slates as well as the use of mastic and other glues to hold slipped slates in place. Glazing within the west light system appears to be silicone bonded to the timber glazing bars on either side and set within this is a large extractor fan housing.

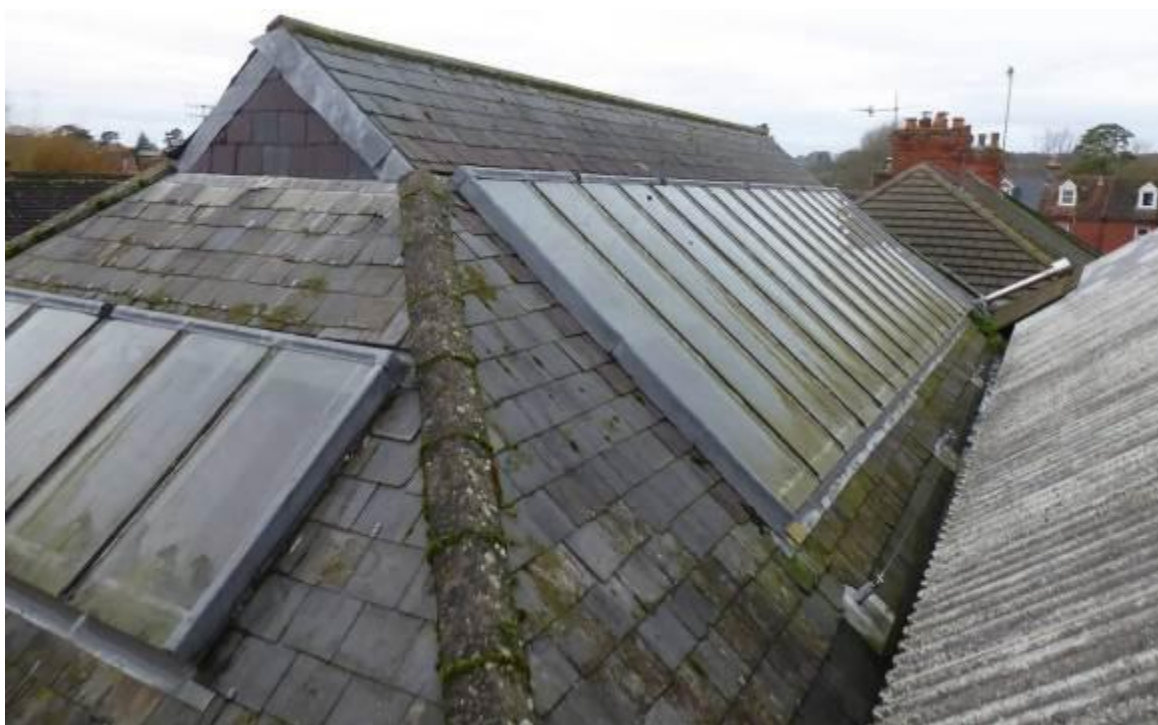
Fig 3.4.5: Area 4 roof

- 3.4.5 The roof over this area is covered with slates with modern concrete hip and ridge tiles that are mortar bedded together.
- 3.4.6 The valley along the bottom of the slating on the junction to the roof to area 6 is lined with bituminous felt.
- 3.4.7 From distant viewing of the southwest corner of this roof there appears to be a valley gutter between this and the adjoining house on that side.
- 3.4.8 At the west end of the north side there is a collapsed metal flue lying on roof to area 6.

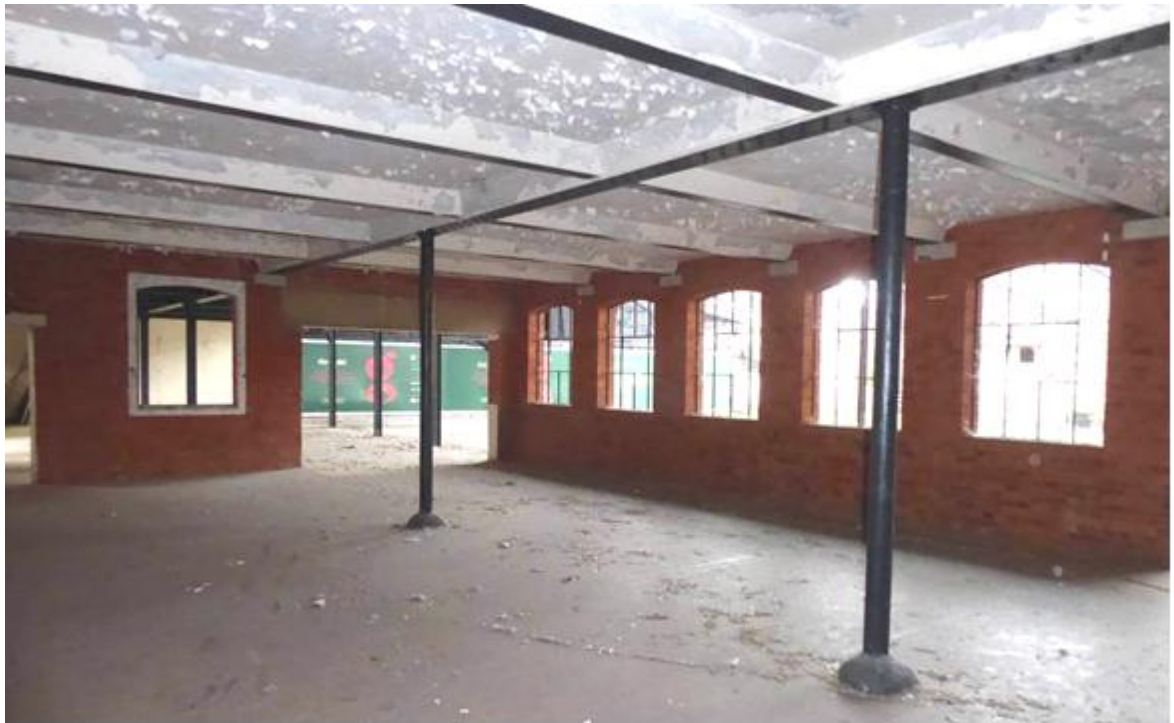
Fig 3.5.1: Area 5 ground floor

- 3.5.2 The first floor is carried on a central beam running the length of the building, supported on metal circular columns and from which beams run to the side walls where they bear onto stone pad stones. This supports what appears to be a concrete floor cast between them. However, this may be suspended timber

structure that has been lined underneath with fire proofing render and so further investigation will be needed to determine its exact form.

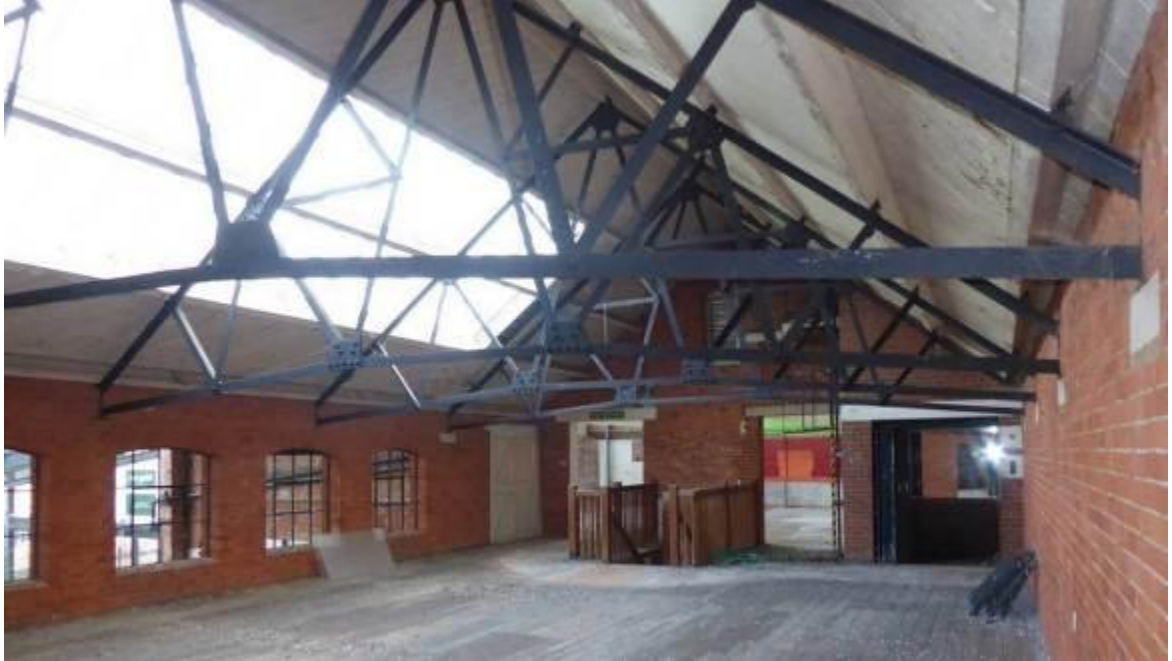
Fig 3.5.4: Area 5 first floor

- 3.5.3 The first floor is covered with softwood boarding that shows where recent and historic repairs have been made.
- 3.5.4 The roof structure consists of a series of steel plate and angled trusses with bolted gusseted joints supporting timber purlins that run to a gable at the west end. Where these run into the walls on the south side to area 3 pad stones are built in and to the north wall the trusses are set into the brickwork.

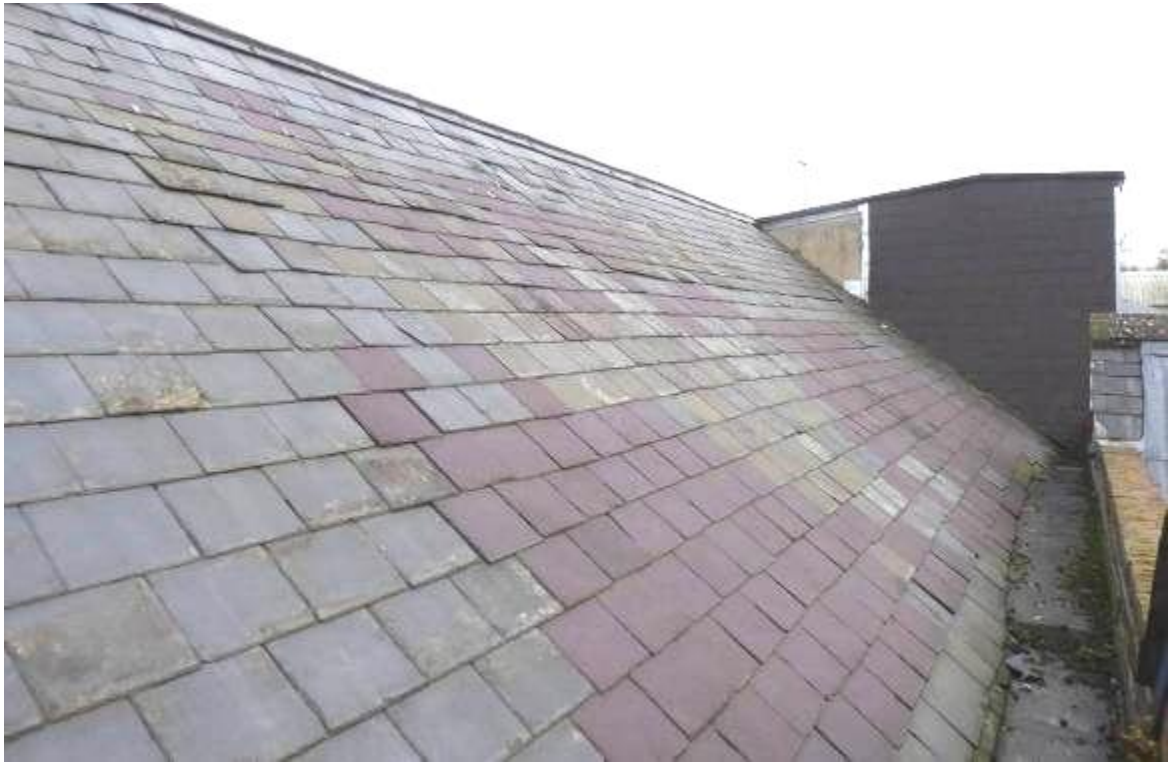
Fig 4.5: Area 5 roof, south side

- 3.5.7 The glazing within the north side appears to be some form of patent glazing support system with lead flashings to the trim and surrounds.
- 3.5.8 The south roof slope is covered with slates with no glazing within this. However, there is an area of roofing towards the upper section that has many tingles set within it and lifted slates within the surface that could suggest that this is where there is glazing framing is below that has been roofed over and has caused this disruption.

- 3.5.9 The valley gutter at the bottom of the south slope is in stepped configuration covered with bituminous felt that is failing.

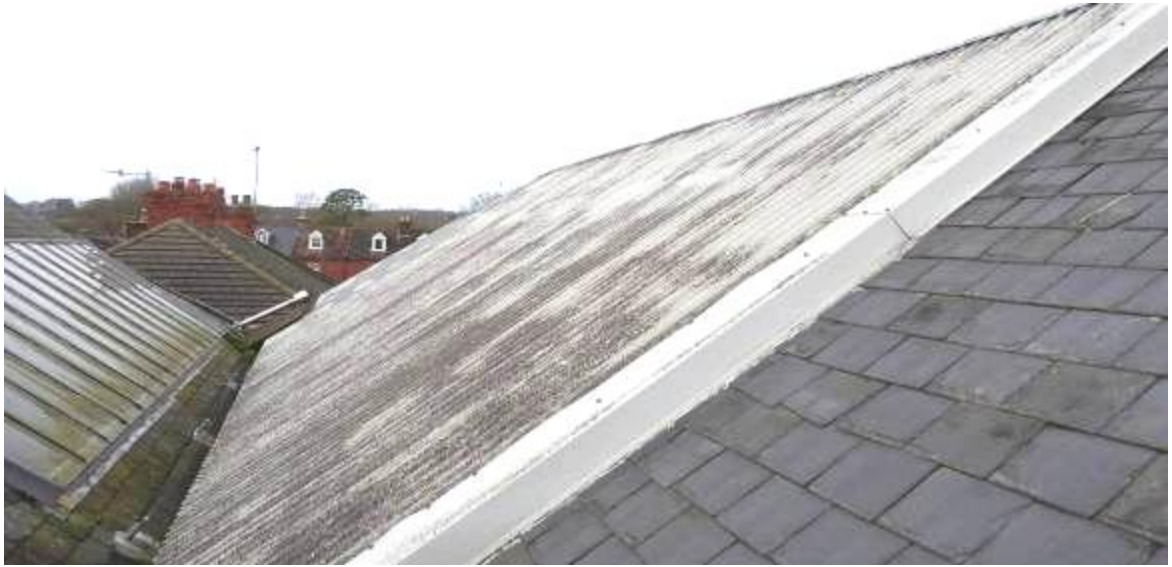
Fig 3.6.5: Area 6 south roof slope

- 3.6.5 The south roof slope of this section appears to be covered profiled metal sheeting, generally as that described for area 1 roof. This is raised above the covering for area 5 on the junction between the two with a metal covered and upstand and flashing between them.
- 3.6.6 The north slope of this roof was very difficult to view and from the small glimpses possible it seems to be of profiled metal sheeting similar to the south side.

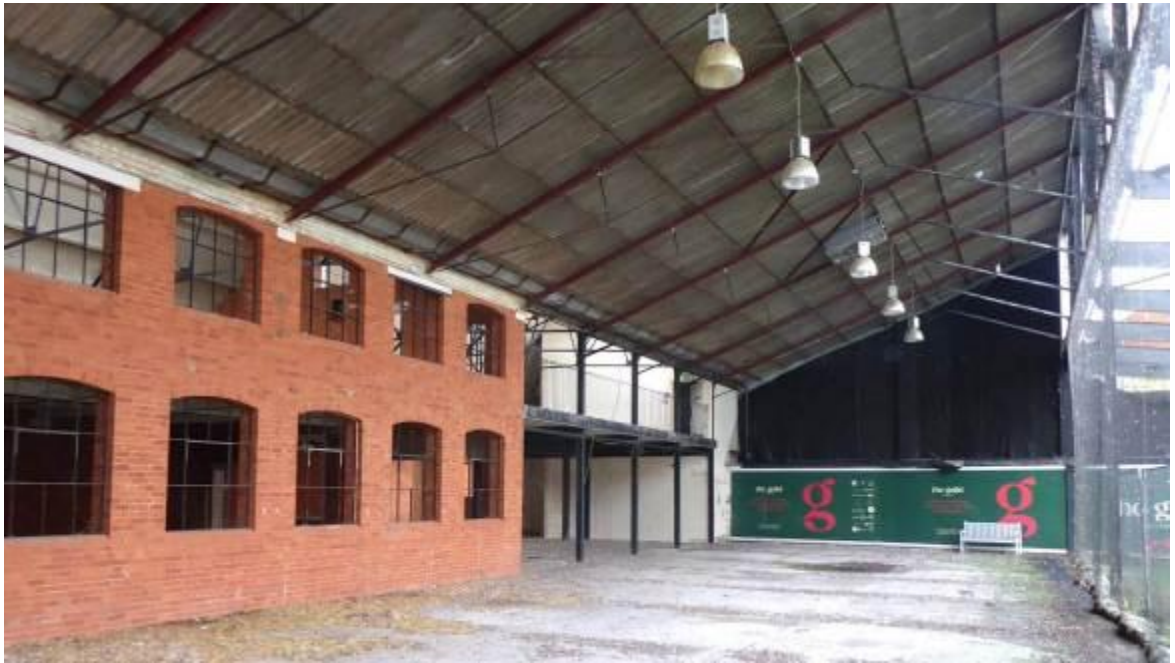
Fig 3.7.1: Area 7 interior

- 3.7.1 This is a large open area that extends across the north side of areas 5 and 6 and abuts to the west side of area 1, where there is a concrete floor throughout.

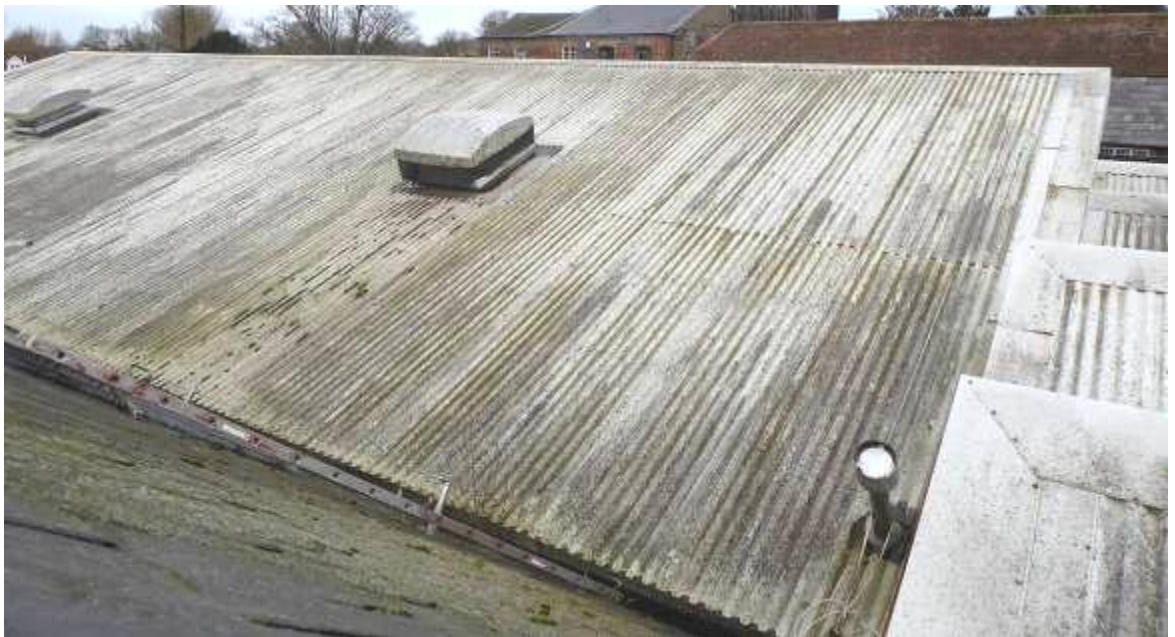
Fig 3.7.3: Area 7 roof

- 3.7.3 Over this area is a mono pitch roof that slopes down to the south against the north side of areas 5 and 6 from a large and long span lattice girder that runs across the north side at high level between the east and west side walls of this part with intermediate steel post supports. From the top of the truss steel rafters run down to the head of the north side wall to areas 5 and 6, and between these purlins span

carrying the roof coverings above. The outer face of the lattice girder is clad with vertical patent glazing in the manner of a north light as seen to the north end of area 1 and elsewhere on this site.

- 3.7.4 Viewing the roof of this part was very difficult and from what could be seen this is of profiled metal sheeting similar to the roofs to area 1 and 6. At the west end this finishes over the head of a brick wall with a simple pressed metal cover flashing. Set within the surface are two large ventilator hoods.

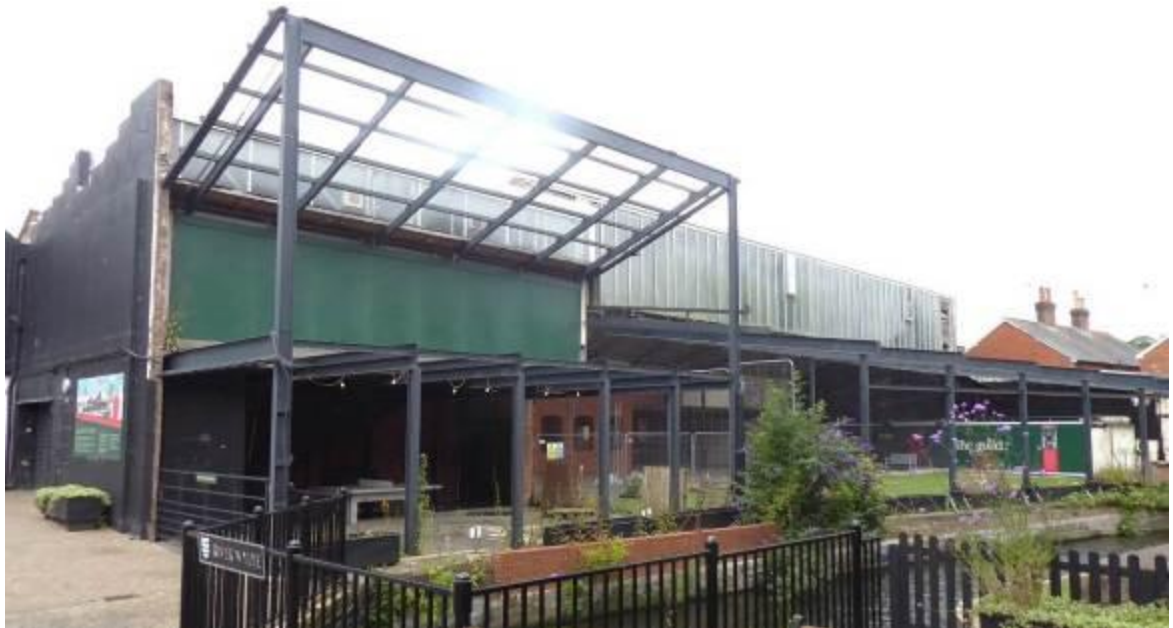
Fig 3.8: Area 8 from the northeast

- 3.8.1 This is a steel framed structure that lies across the to the north side of area 7as well as across the north end of area 1. The section against 7 has a roof structure that runs down from the bottom of the lattice girder to that part to posts against the bank of the north branch of the River Wylfe. At the east end there is a very different form of structure where it is apparently part of the steel frame that forms the north end of area 1, with a first floor as well as a north light type roof structure over it.

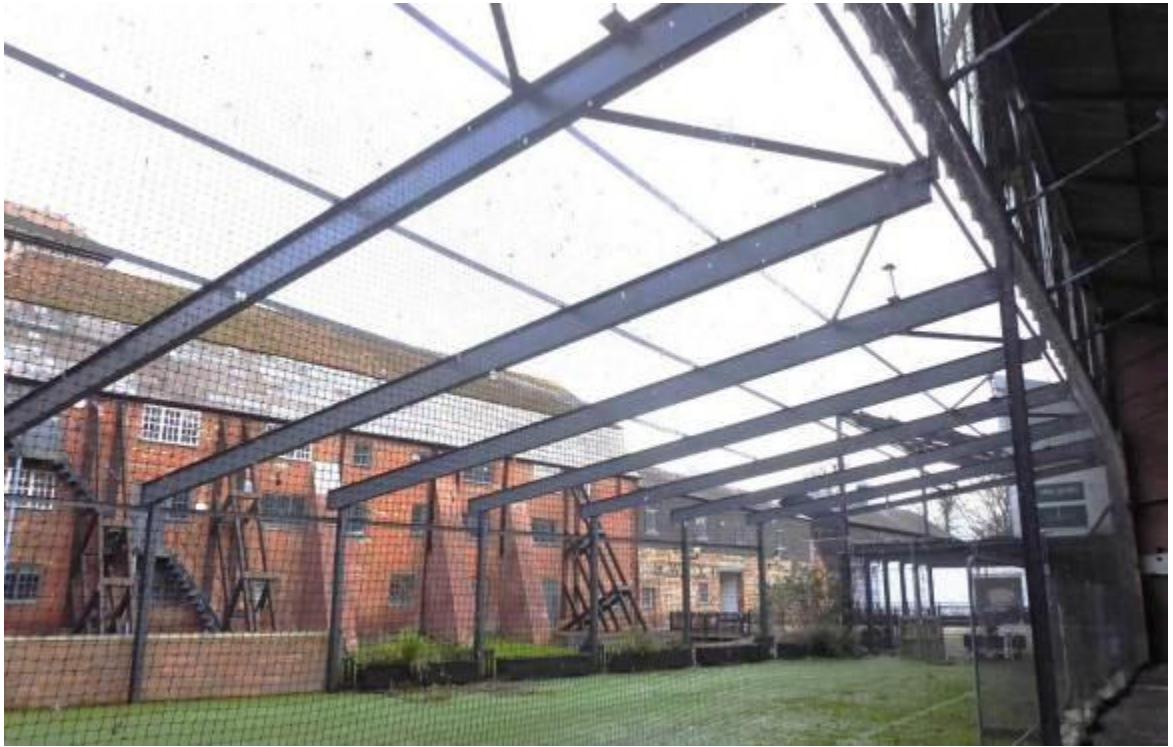
Fig 3.8.2: Area 8 from area 7, looking northeast

- 3.8.2 Across what can be considered the ground floor of this are it is of a concrete with a coloured top surface. At the west end it is closed with a brick wall to the gardens of houses that lie beyond and at the east end it has a simple metal farm type gate to the main central area to the Wilton Shopping Village. Against the edge of the river there is a mixture of low brick walls and metal railings and at the west end there is a link bridge that connects this area with buildings on the north side.
