# **HERITAGE STATEMENT**

## **Rebuilding of Brick Chimney Stack**

### **WEAVERS, EAST STREET (SALISBURY ROAD), HINDON**

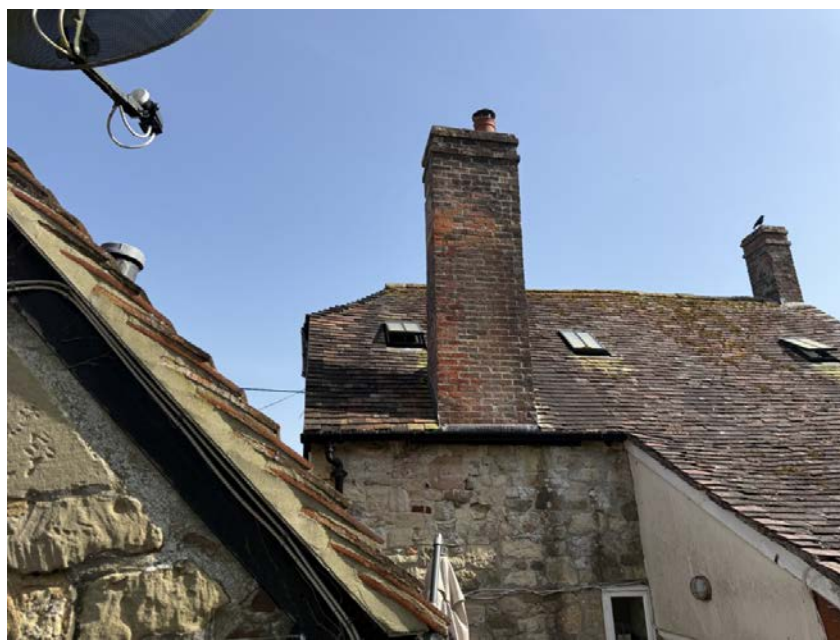
The chimney stack is currently causing water penetration into the roof of the building during periods of rain. This is a common consequence of ageing brick chimneys, typically caused by one or a combination of: perished or open mortar joints allowing moisture to track through the brickwork; spalled or frost-damaged brick faces; cracked or missing flaunching around the pot; and/or failed lead flashings at the roof abutment.

No formal structural or condition survey has yet been commissioned; the defect has been identified from visible external symptoms together with active water ingress internally during wet weather. The photograph at Section 7 below, taken from the rear roof slope, shows the tall, slender brick stack rising well above the ridge line. Clearly visible are: pronounced dark vertical staining running down the brick face, particularly to the north-facing side, consistent with water tracking through open or eroded mortar joints rather than surface soiling alone; a marked difference in the condition of the pointing between the upper courses near the pot and the lower courses, with the lower joints appearing recessed and eroded; and patchy discolouration consistent with prolonged saturation of the brickwork. These are all consistent with a stack that has been allowed to weather for a considerable period without repointing.

*Photo 1: View of the main chimney stack from the rear roof slope, showing brick staining and eroded pointing.*

On this evidence, piecemeal repair (repointing alone) is not considered sufficient to resolve the defect, and the applicant proposes a full rebuild of the stack from roofline level upwards, retaining the stone/masonry below roofline where sound.

- Carefully hand-dismantle the existing brick chimney stack from roofline level upwards, setting aside sound original bricks and the existing chimney pot(s) for re-use.

- Rebuild the stack in matching brickwork, using reclaimed bricks from the dismantled stack supplemented by handmade or hand-finished bricks to match the existing in size, colour, texture and bond (English bond, matching the front elevation of the house), where make-up bricks are required.

- Bed and point in a lime mortar mix to match the existing in colour, joint width and profile — no cement mortar to be used.
- Reinstall flaunching around the base of the pot(s) in lime mortar (not cement), with the existing pot(s) reset or matched exactly if replacement is unavoidable.

- Renew lead flashings/soakers at the roof abutment in code 4 (or as appropriate) lead, dressed in the traditional manner.
- Reinstall a lead or slate damp-proof tray within the rebuilt stack at roofline level, concealed within the brickwork, to prevent recurrence of water penetration without altering external appearance.

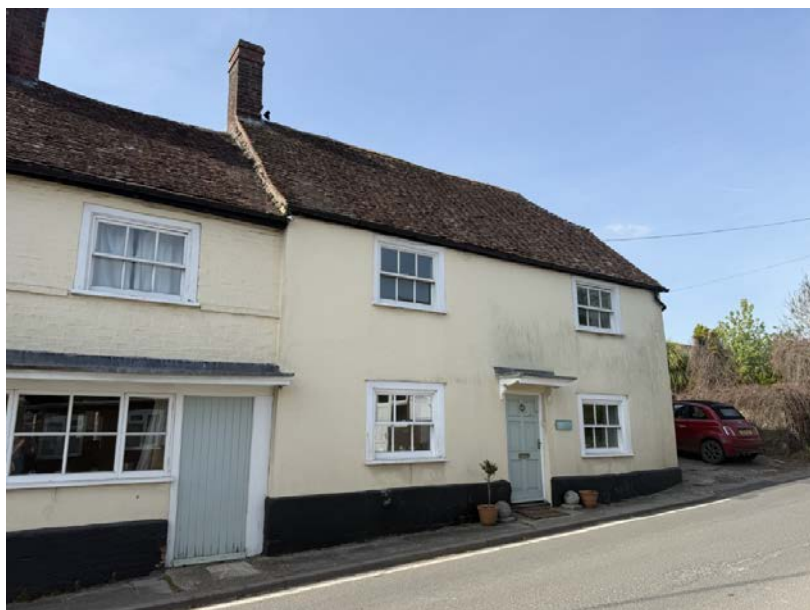
*Photo 2: Front (East Street) elevation.*

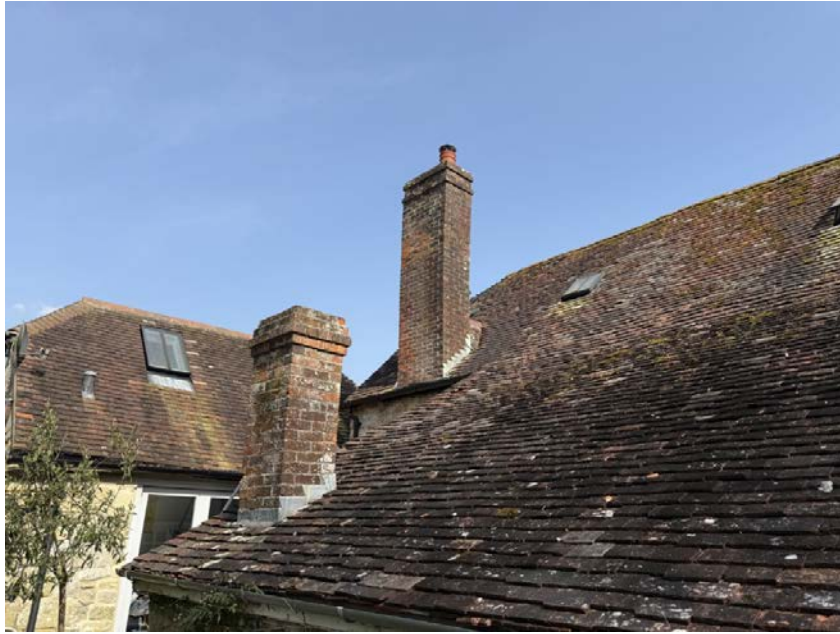
Photo 3 at Section 7 below, taken from a wider vantage point showing both stacks on the roof, illustrates that the base of the defective stack is obscured from ground level, whereas the lead flashing to the smaller, adjacent stack is visible and appears intact. Given that the condition of the flashing to the main stack cannot be confirmed by visual inspection alone, its renewal as part of the rebuild (see Section 8) is proposed as a precautionary measure, consistent with good conservation practice when a stack is already being taken down to roofline level.

*Photo 3: Wider view showing the main leaking stack alongside the smaller stack to the rear of the property Lead flashing is visible at the roof abutment of the nearer, shorter stack; the base of the taller, defective stack slightly obscured and is difficult to inspect from ground level.*
