1 Shaftesbury Drove, Salisbury  
– Aerial tree inspection findings (23.06.26).

T1

T2

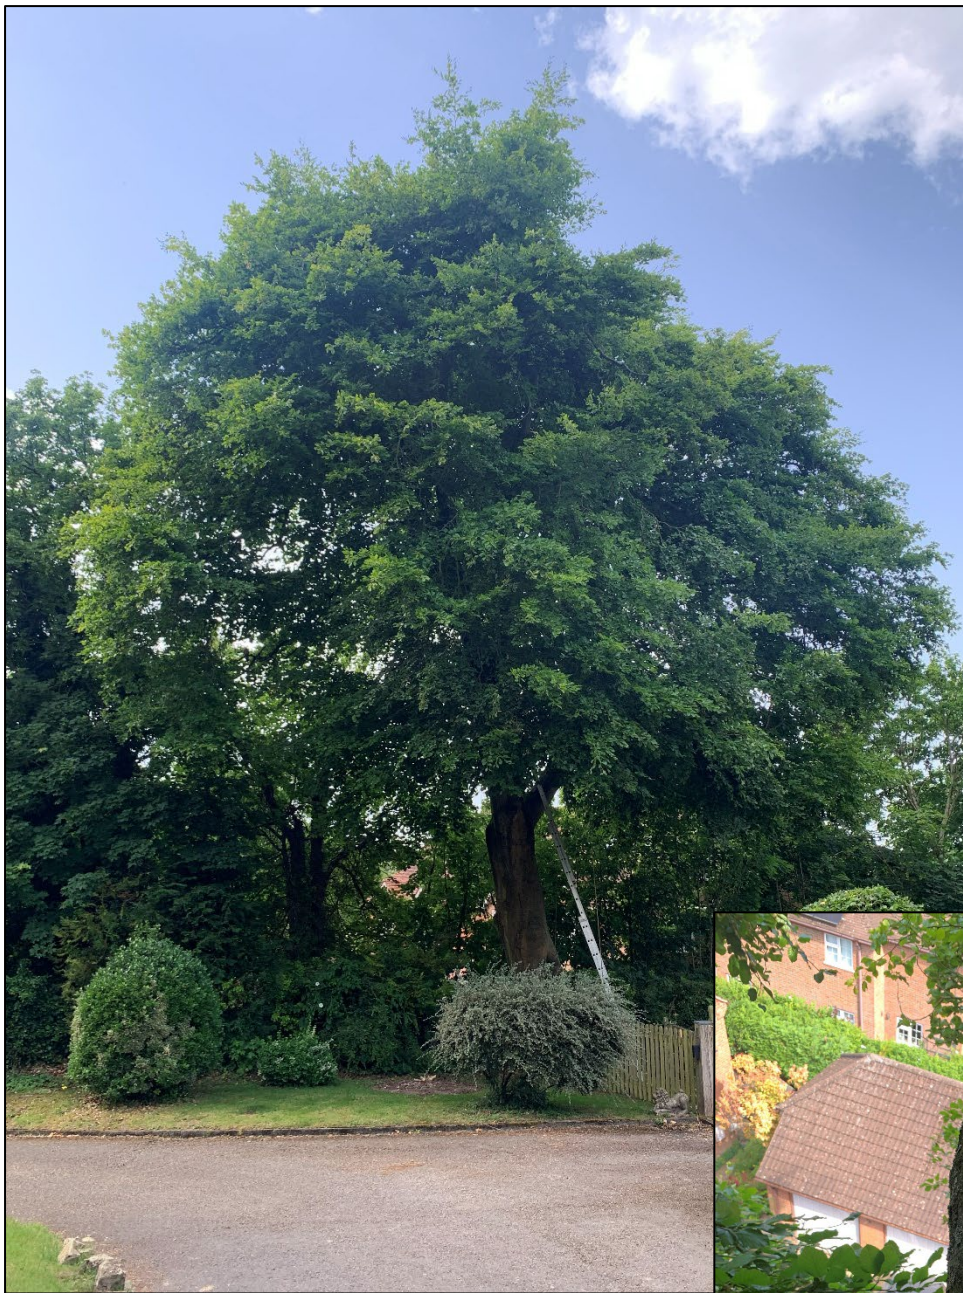
Photo 1

This tree has a history of branch failures. Historically, a large stem failed into the nearby footpath (see photo 10) and in recent years smaller branches have failed onto the driveway below. The reason for the recent failures is squirrel damage as seen in Photo 3. After conducting a climbing inspection, many more squirrel damaged branches have been found (Photos 4-9 on next page all show squirrel damage). Reducing the upper portion of the tree (where the damaged branches are) will significantly reduce the likelihood of future branch failure. The tree shows good vigour, and it is expected to tolerate the pruning.

Crown reduction to reduce sail area of upper canopy by 2-4m, tapering into the lower branches (lower branches can be retained with little pruning). An approximate pruning line is outlined in yellow on the above photo.

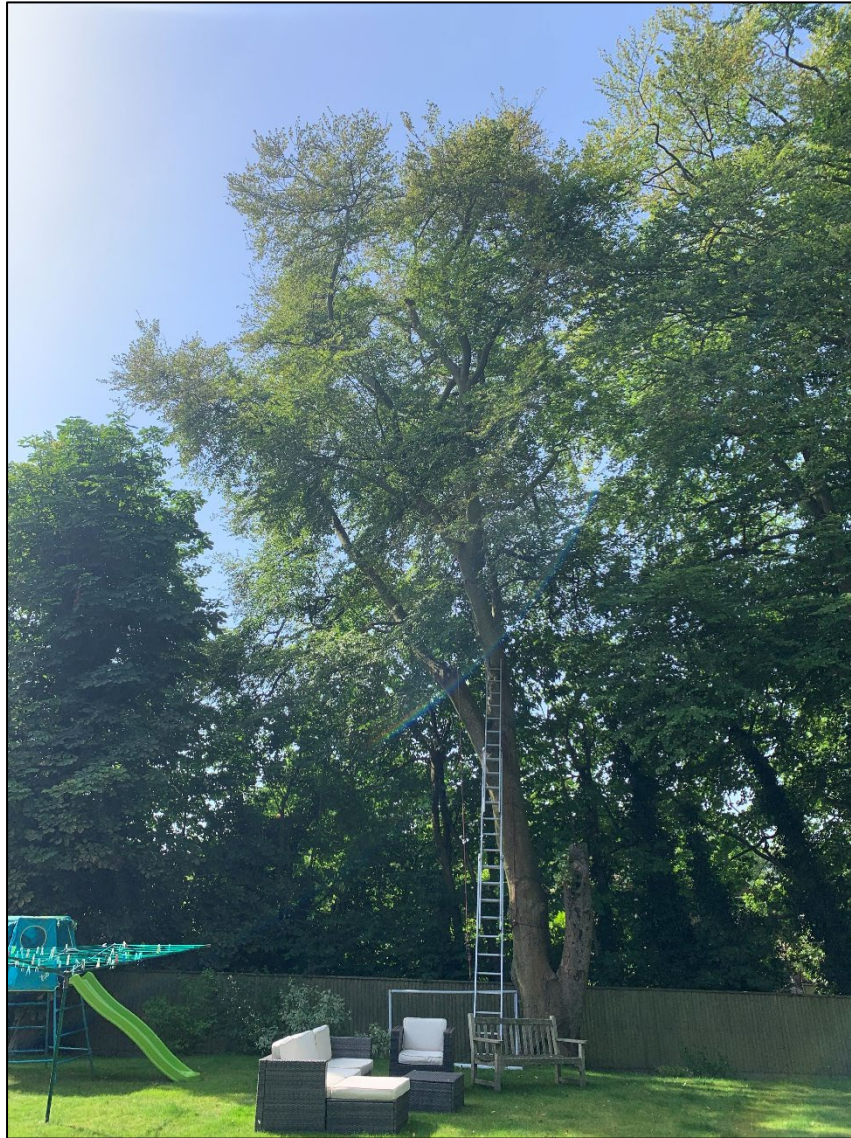
Photo 11 – T2 Overview

Selectively prune co-dominant stem by 2-3m to suitable growth points.

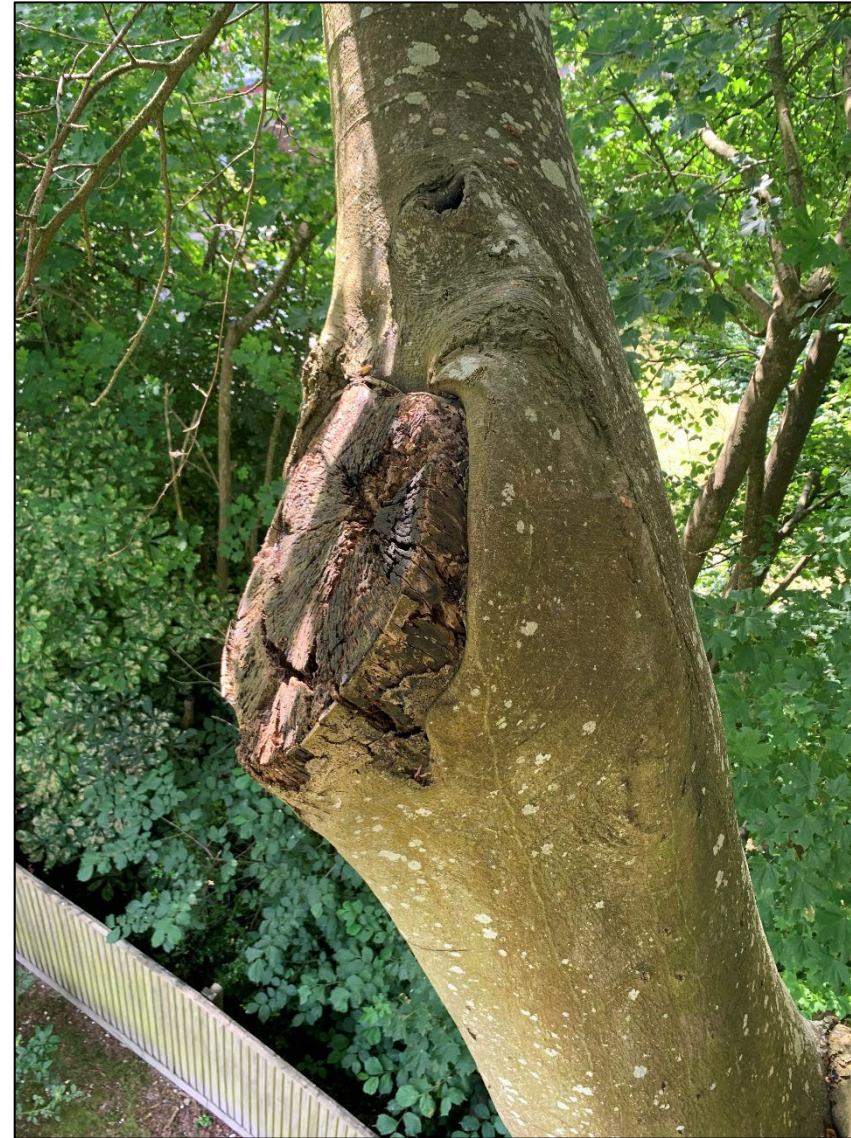
Photo 12 – Decayed wound

A large wound can be seen at 8m (photo 12) near the source of the co-dominant stem. Decay is evident and the area creates a weak point on the stem. Minor pruning work to alleviate the wind stresses on this stem is proposed to prevent its failure.

Harder pruning has been considered but is not recommended as further decay areas are present on the adjacent dominant stem and greater works would expose the rest of the canopy to wind forces that would otherwise have been dampened by the co-dominant stem branches.

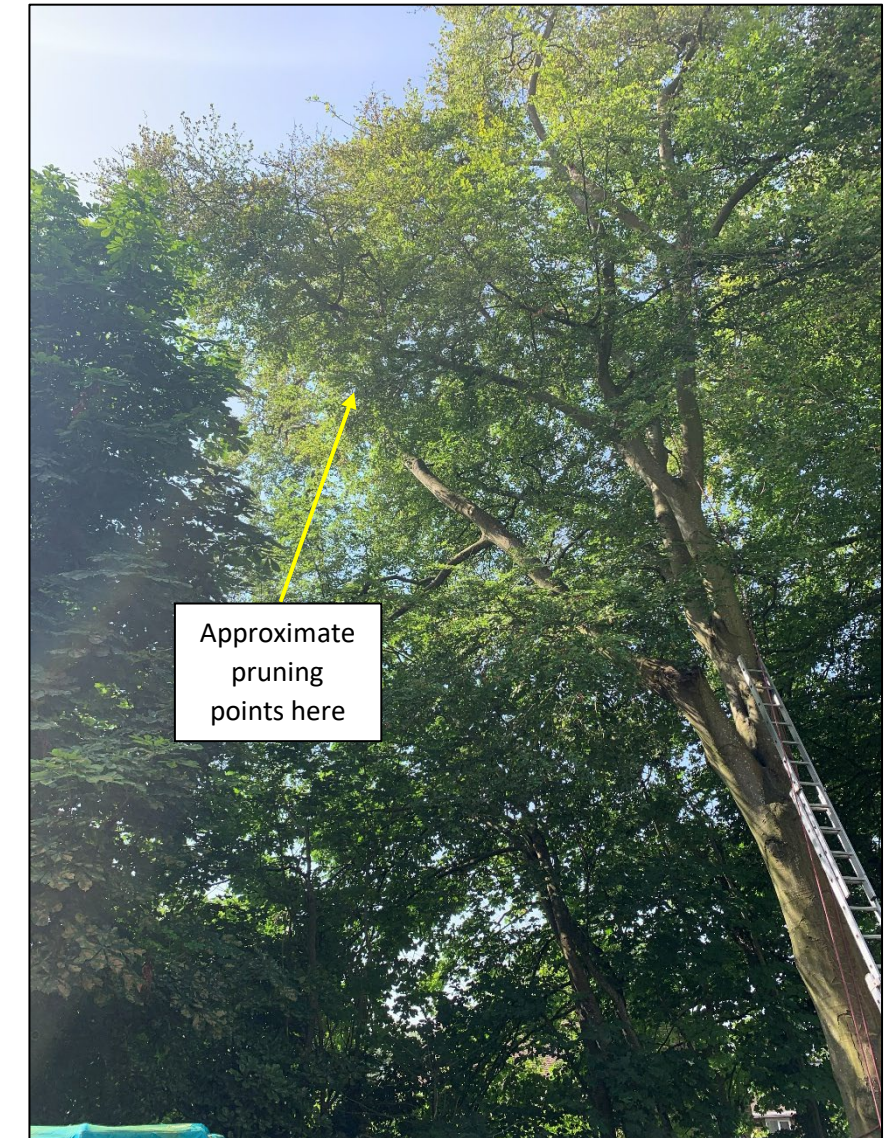
Photo 13 – Proposed approximate pruning point
