# Canal Cottage, 154 Avoncliff

## Tree Risk Assessment 2026

Ben Rose BSc(Hons) MSc DipArb(RFS) MICFor RCarborA  
*Chartered Arboriculturist*  
*Arboricultural Association Registered Consultant*

27<sup>th</sup> July 2026

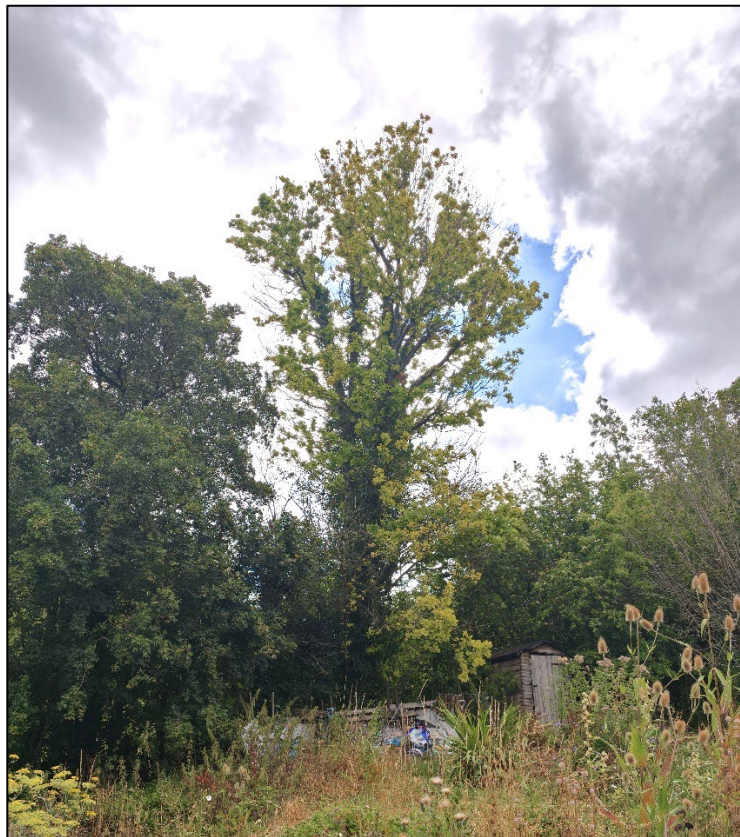
- 2.5.1 The oak tree (T1) has yellow leaves (chlorosis) and crown dieback. The base of the tree has patches of dead bark. Several other trees in the vicinity have also died in recent years.

**Figure 1: T1 has yellow leaves and crown dieback.**

- 2.5.2 In my opinion the symptoms are most likely to have been caused by a Phytophthora (e.g. *P. ramorum*, *P. cinnamomi*, *P. quercina*). There are no obvious management options that are likely to reverse the decline of this tree. A VALID assessment of T1 is provided as Appendix 2. The tree is not imminently dangerous but I advise that the best course of action would be to fell the tree before it becomes dangerous.

| Tree Number | Tree Species | dbh (cm) | Height (m) | Age Class | Overall Health | Notes on Structural Condition and Local Environment | Risk Level | Recommended Management | Works Priority |
|---|---|---|---|---|---|---|---|---|---|
| T1 | Pedunculate oak | 47 | 14 | M | P | Bark necrosis around the base of the tree, Bark exudation from the lower trunk up to 1m. Leaf chlorosis and crown dieback. | Not Tolerable | Fell the tree. | Non-urgent |

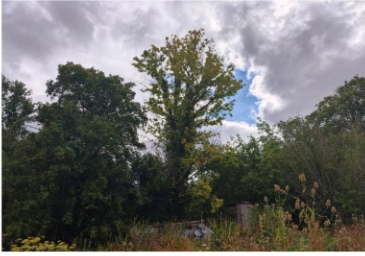
## English Oak (T1)

Leaf chlorosis and crown dieback.

Bark necrosis all around base and bark exudations up to 1m.

The highest risk is basal failure and the tree falling into the road.

| Tree Management | Fell the tree. |
