## **Listed Building Application**

### **Maintenance & Repair Works**

**Newton House**

### **Statement of heritage significance and schedule of proposed works and Design and Access statement**

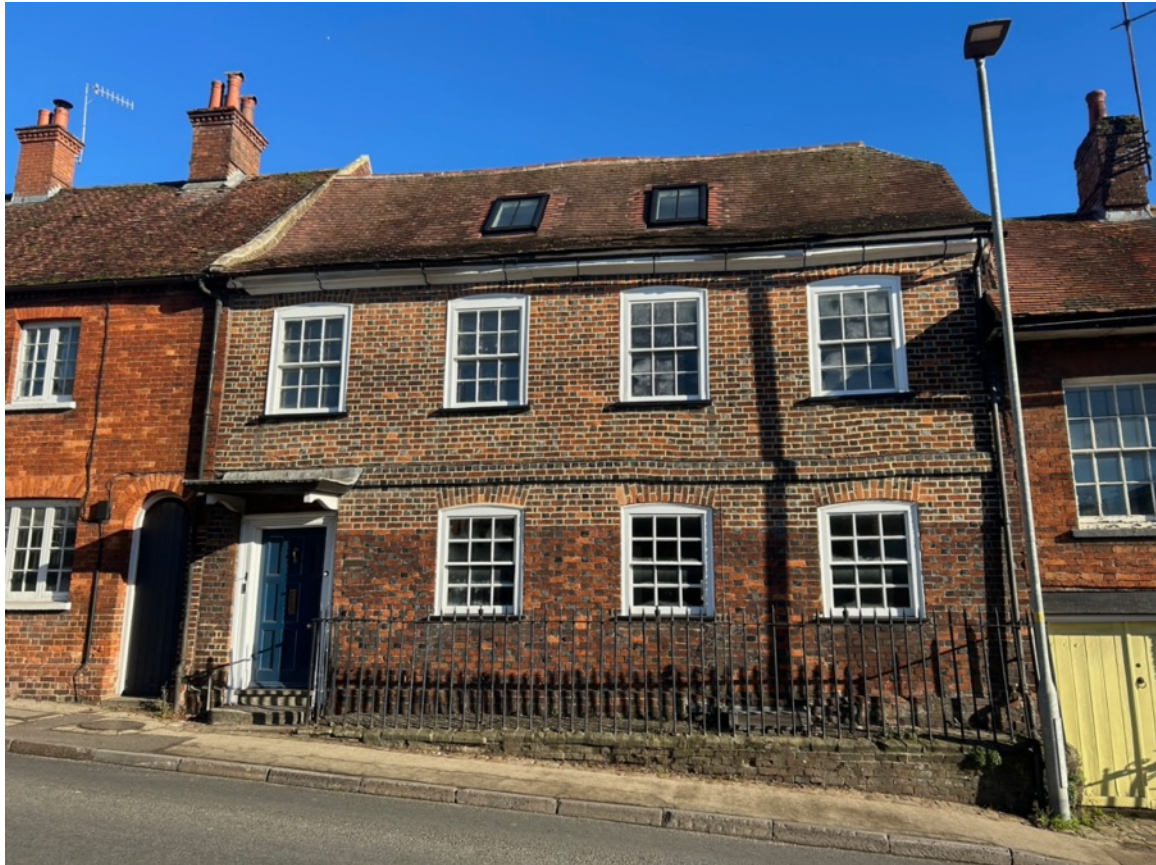
*Photo 1 - View of the front elevation from Barn Street*

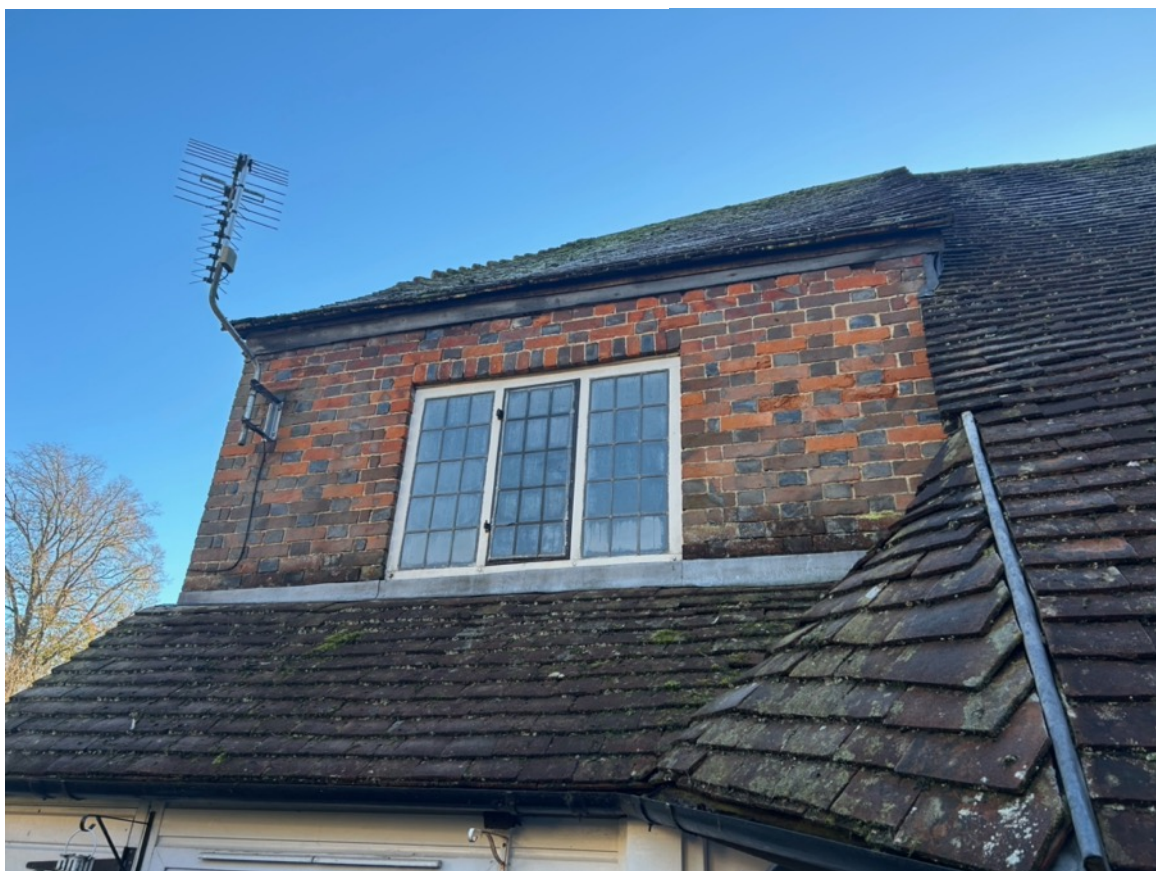
*Photo 2 View of existing brickwork to the rear*

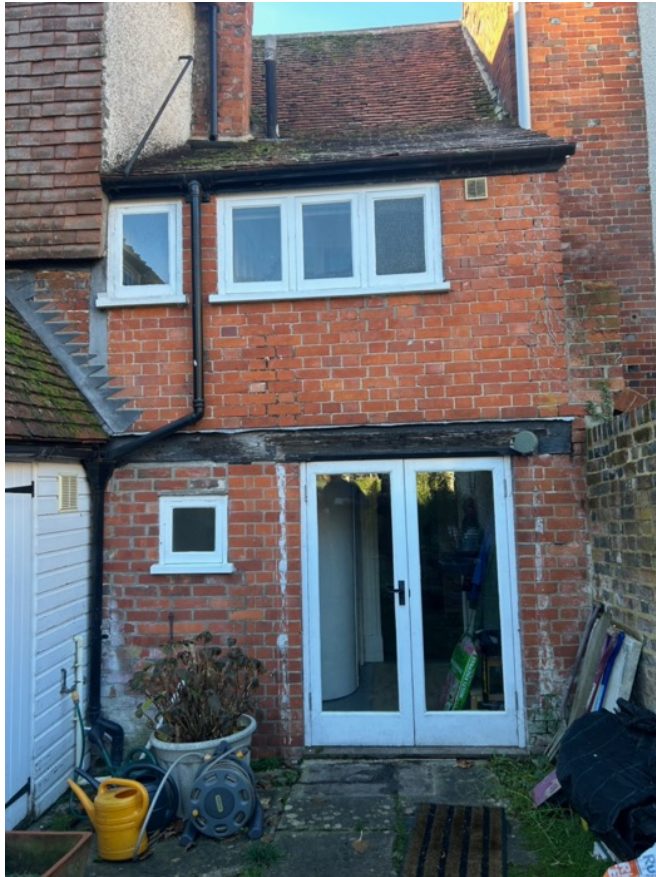
*Photo 3 View of existing more modern brickwork to the rear*

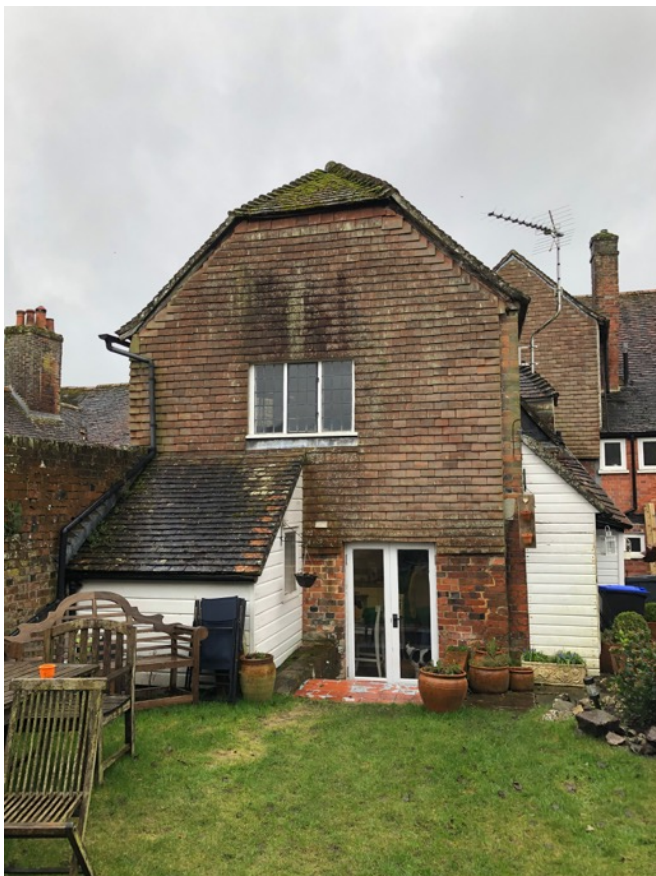
*Photo 4 View of rear elevation from the garden*

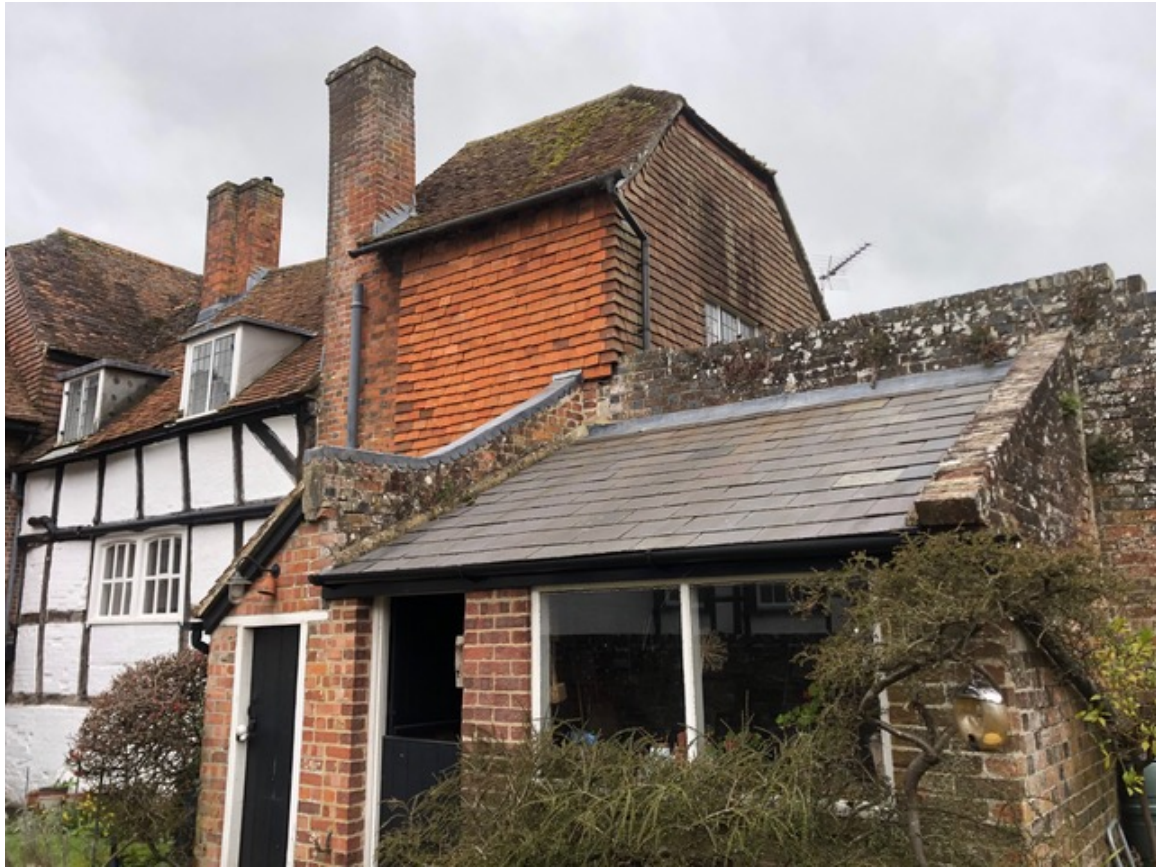
*Photo 5 - View of the side elevation chimneys*
