**PHOTOGRAPHIC RECORD SURVEY OF B66  
GUARDROOM  
BUCKLEY BARRACKS**

Stephen Golding  
Martin Ralph Group Ltd

VINCI FACILITES Ltd

**REF:** 25237

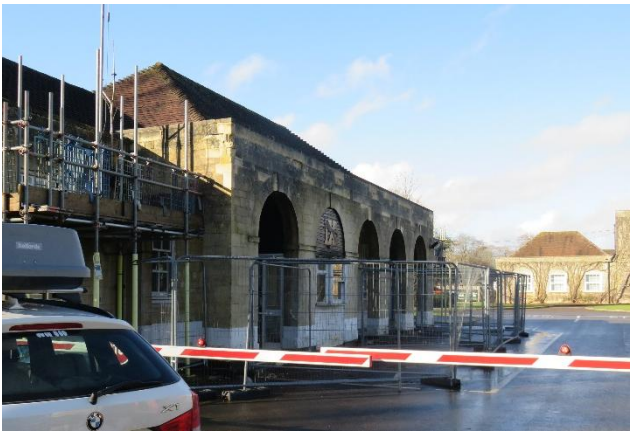
| 1.01 | | <p>View of front façade which is affected by spalling stonework (North East elevation) as seen from the entrance barrier.</p> <p>Works required:<br/>Stone parapet wall repairs/ replacement, oriel window replacement</p> |

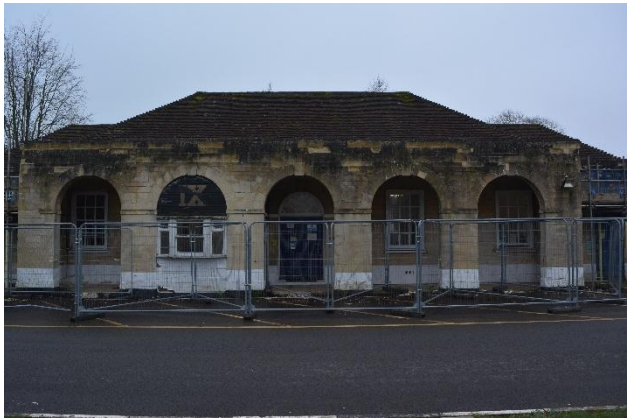
| 1.02 | | <p>View of front façade (North East elevation) as seen flat on to façade. Shows extent of stonework spalling.</p> <p>Works required:<br/>Stone parapet wall repairs/ replacement, oriel window replacement</p> |

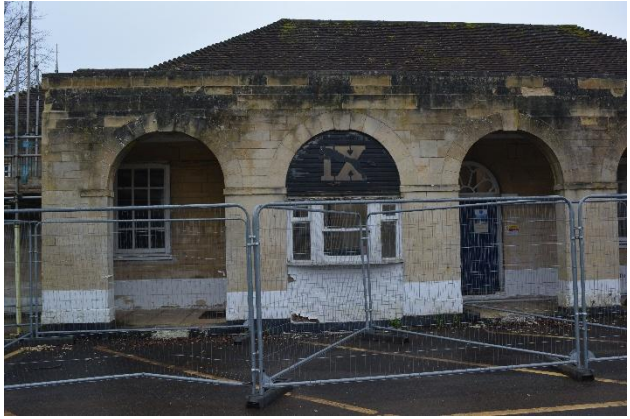
| 1.03 | | <p>View of front façade (North East elevation) as seen flat on to façade, including oriel window infill / pass lobby entrance. Shows extent of stonework spalling.</p> <p>Works required:<br/>Stone parapet wall repairs/ replacement, oriel window replacement</p> |

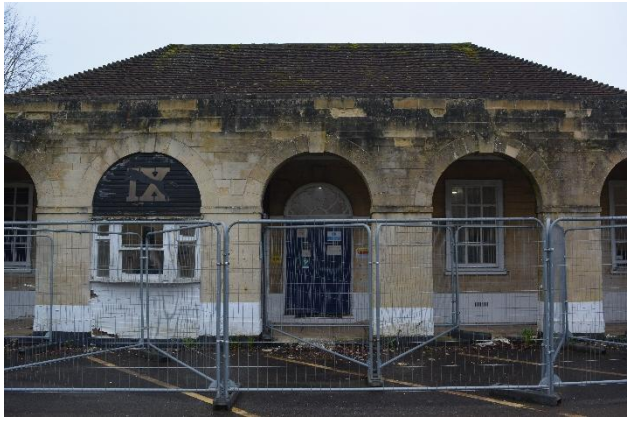
| 1.04 | | <p>View of front façade (North East elevation) central arcade section. Shows extent of stonework spalling.</p> <p>Works required:<br/>Stone parapet wall repairs/ replacement, oriel window replacement</p> |

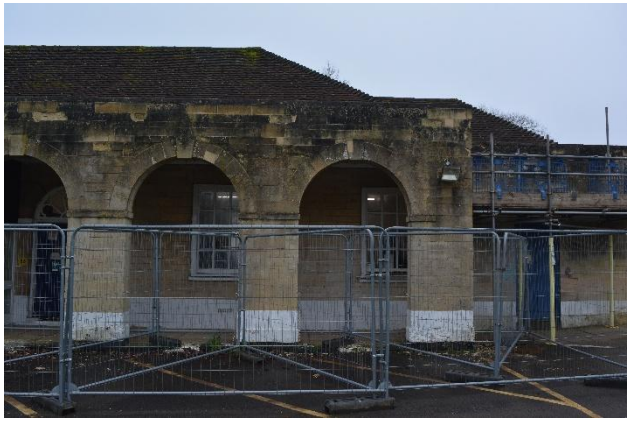
| 1.05 | | <p>View of front façade (North East elevation) Western end. Shows extent of stonework spalling.</p> <p>Works required:<br/>Stone parapet wall repairs/ replacement.</p> |

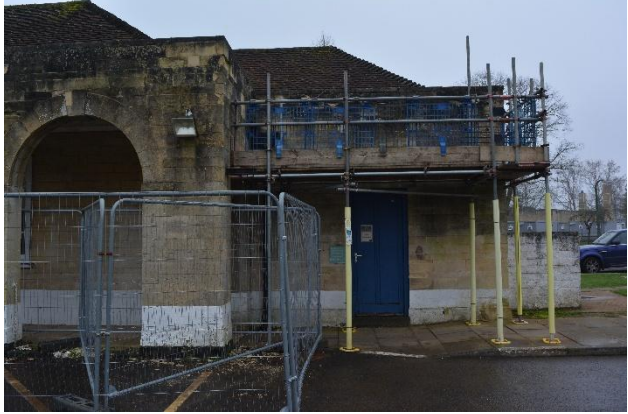
| 1.06 | | <p>View of front façade (North East elevation) Western corner. Shows extent of stonework spalling.</p> <p>Works required:<br/>Stone parapet wall repairs/ replacement.</p> |

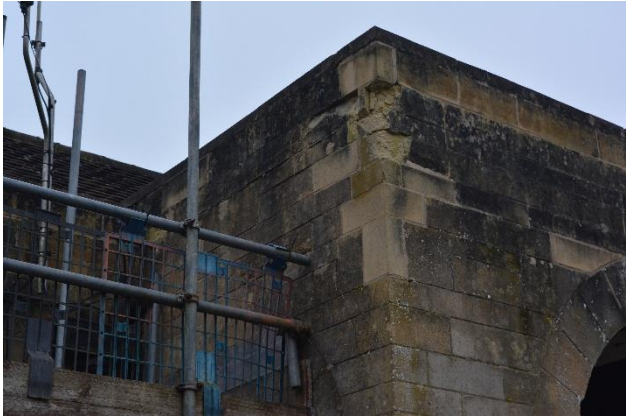
| 1.07 | | <p>North East Arcade corner, showing extent of stone spalling at parapet.</p> <p>Works required:<br/>Stone parapet wall repairs/ replacement.</p> |

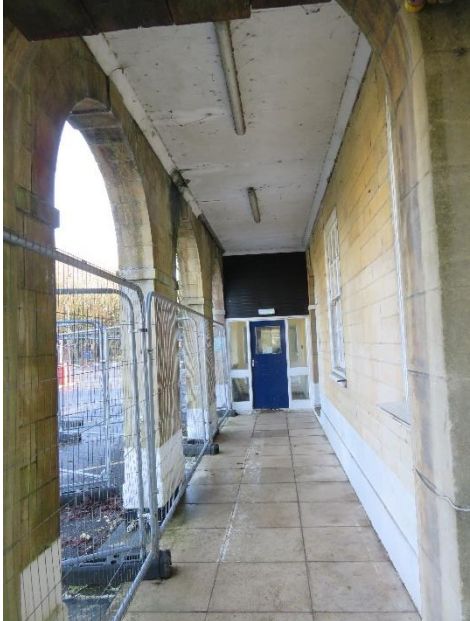
| 1.08 | | <p>View looking along arcade from North West end towards pass lobby, note leaks above to inside face of walling</p> <p>Works required:<br/>Opening up of ceiling, replacement ceiling, coving and decorations.</p> |

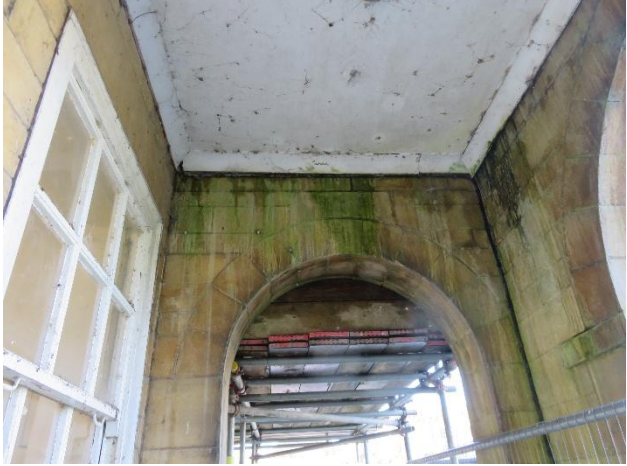
| 1.09 | | <p>View of North Western end of arcade inside face of walling, showing leaks.</p> <p>Works required:<br/>Opening up of ceiling, replacement ceiling, coving and decorations.</p> |

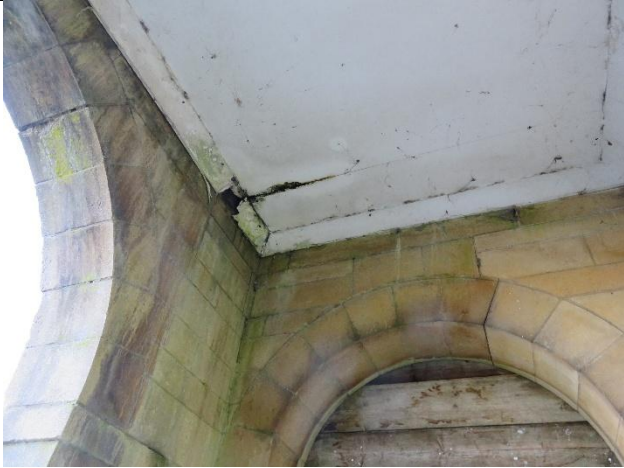
| 1.10 | | <p>View of North Eastern end of arcade inside face of walling, showing leaks.</p> <p>Works required:<br/>Opening up of ceiling, replacement ceiling, coving and decorations.</p> |

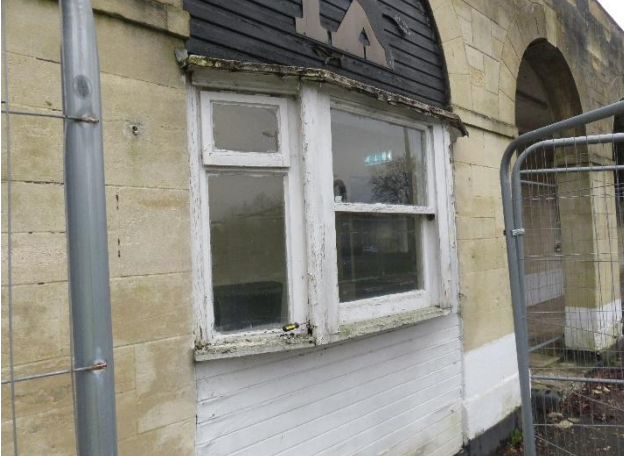
| 1.11 | | <p>View of oriel window showing fabric in poor condition.</p> <p>Works required:<br/>Oriel window and timber cladding replacement.</p> |

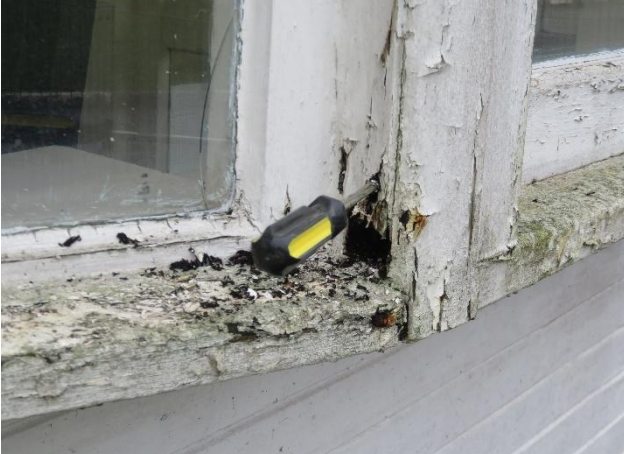
| 1.12 | | <p>Oriel window frame showing depth of rotten timber.</p> <p>Works required:<br/>Oriel window and timber cladding replacement.</p> |

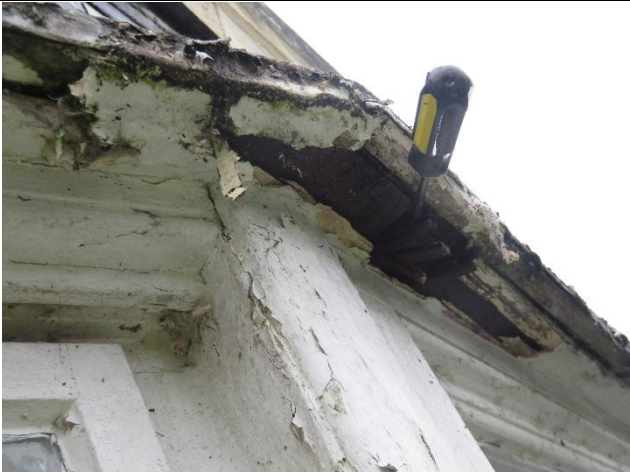
| 1.13 | | <p>Oriel window frame head showing depth of rotten timber.</p> <p>Works required:<br/>Oriel window and timber cladding replacement.</p> |

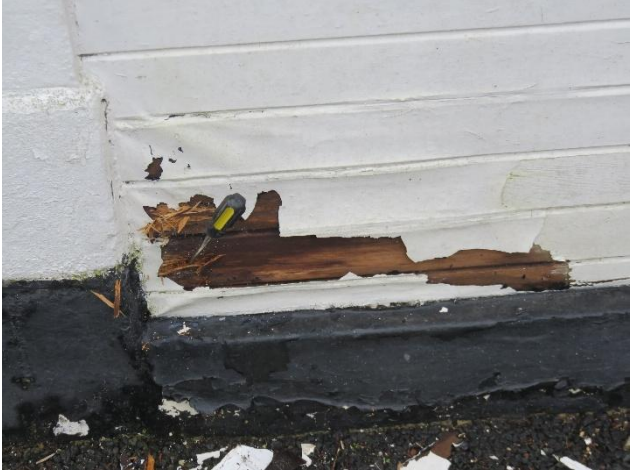
| 1.14 | | <p>Oriel window lower section boarding showing rotten timber.</p> <p>Works required:<br/>Timber cladding replacement.</p> |

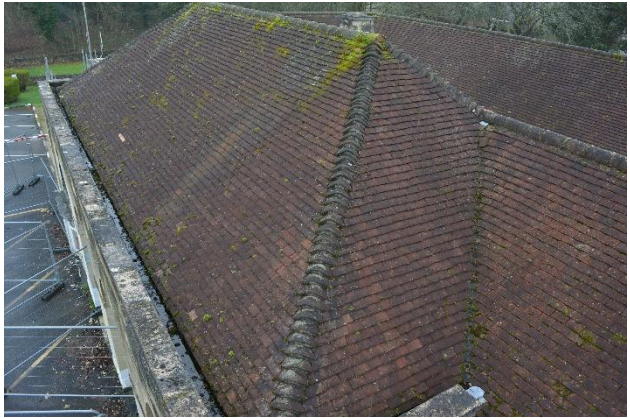
| 1.15 | | <p>Front façade/ arcade roof and parapet.</p> <p>Works required:<br/>Parapet wall and coping repairs / replacement.<br/>Parapet gutter replacement. Roof repairs along line of gutter replacement.</p> |

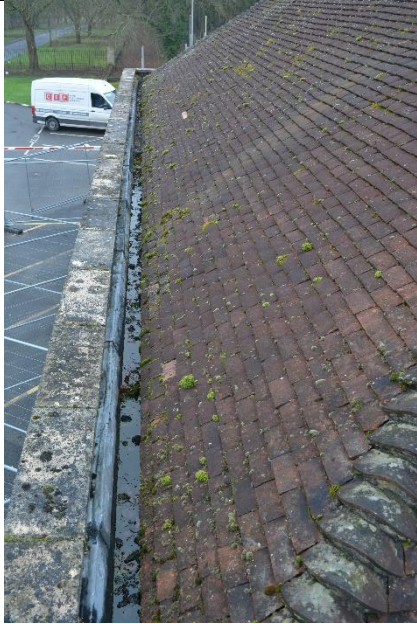
| 1.16 | | <p>Front façade parapet, showing parapet gutter holding water with apparent 'backfall' towards centre.</p> <p>Works required:<br/>Parapet wall and coping repairs / replacement.<br/>Parapet gutter replacement. Roof repairs along line of gutter replacement.</p> |

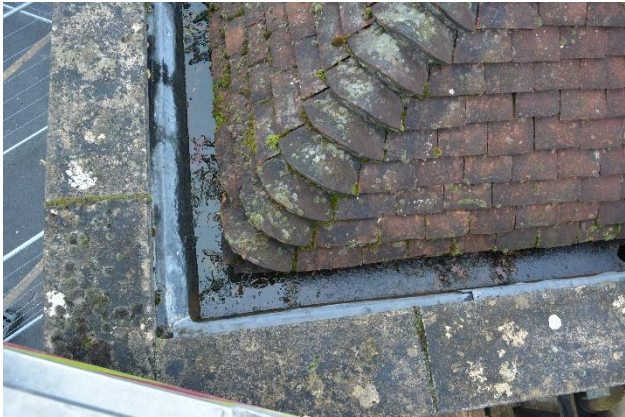
| 1.17 | | <p>Front façade / arcade Western end gutter return. Image shows the extent of parapet gutter holding water runs up to the return corner.</p> <p>Works required:<br/>Parapet wall and coping repairs / replacement.<br/>Parapet gutter replacement. Roof repairs along line of gutter replacement.</p> |

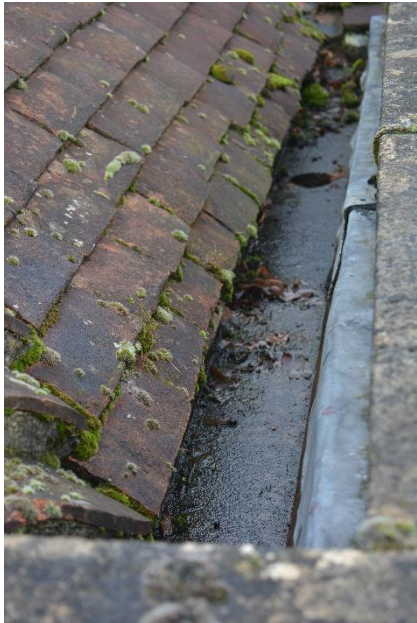
| 1.18 | | <p>Front façade / arcade Western end gutter return. Image showing return gutter section and outlet.</p> <p>Works required:<br/>Parapet wall and coping repairs / replacement.<br/>Parapet gutter replacement. Roof repairs along line of gutter replacement.</p> |

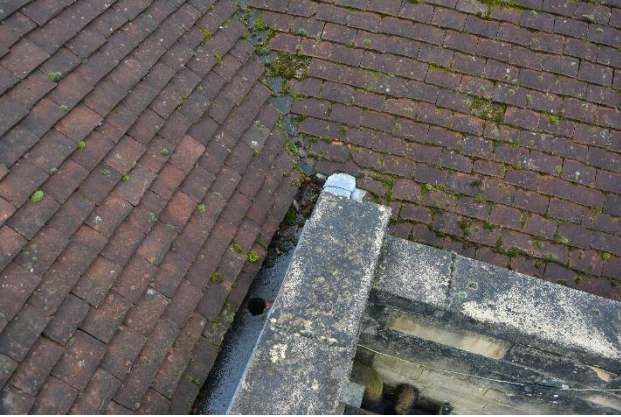
| 1.19 | | <p>Front façade / arcade<br/>Western end gutter return.<br/>Image showing gutter stop end.</p> <p>Works required:<br/>Parapet wall and coping repairs / replacement.<br/>Parapet gutter replacement. Roof repairs along line of gutter replacement.</p> |

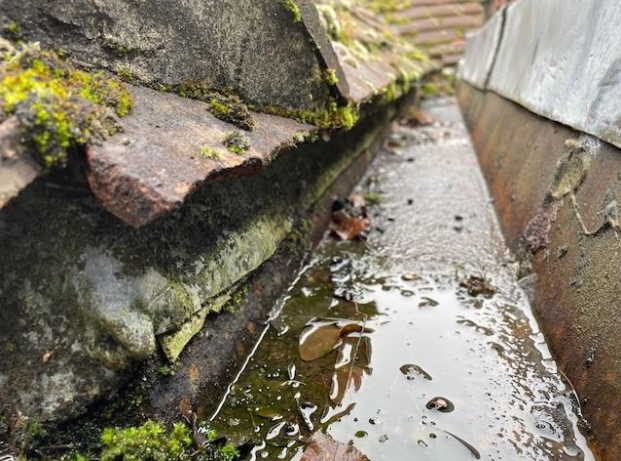
| 1.20 | | <p>Image within gutter taken from hip end. View shows flashing overlap arrangement to both roof and parapet wall side.</p> <p>Works required:<br/>Parapet wall and coping repairs / replacement.<br/>Parapet gutter replacement. Roof repairs along line of gutter replacement.</p> |

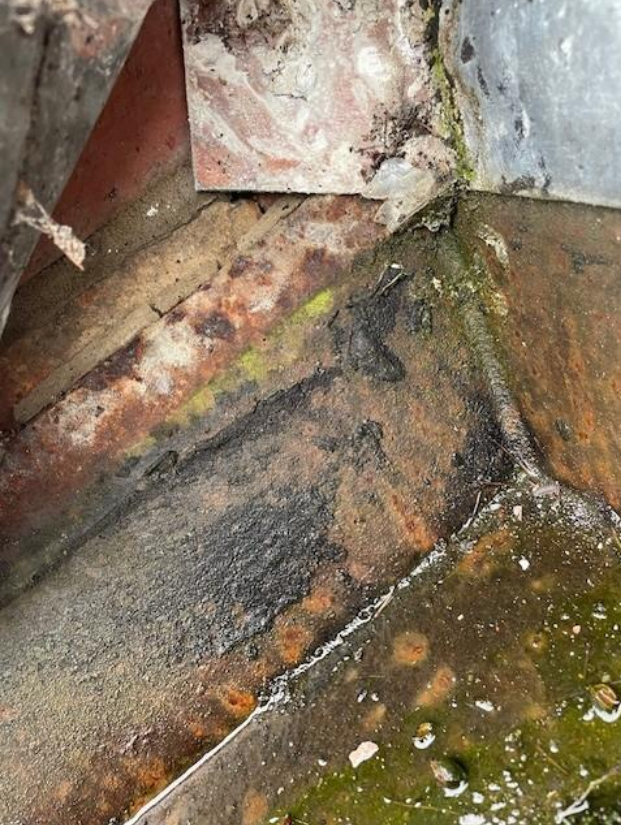
| 1.21 | | <p>Image showing parapet gutter flashing lifted to reveal extent of flashing/ gutter overlap.</p> <p>Works required:<br/>Parapet wall and coping repairs / replacement.<br/>Lead flashing replacement.</p> |

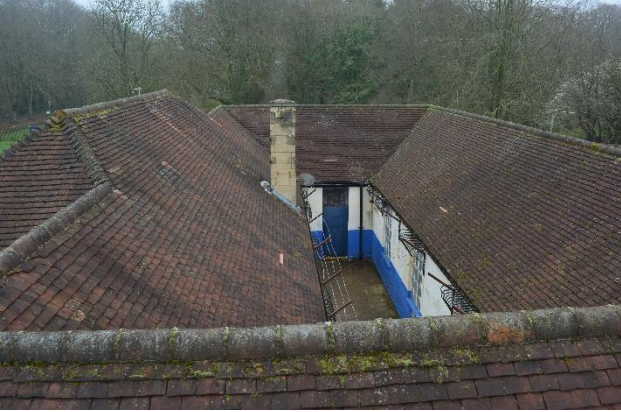
| 1.22 | | <p>Image showing building roofscape and courtyard from Western end of building.</p> <p>Works required:<br/>Chimney stack take down and rebuild, new flashings, coping and ventilation.</p> |

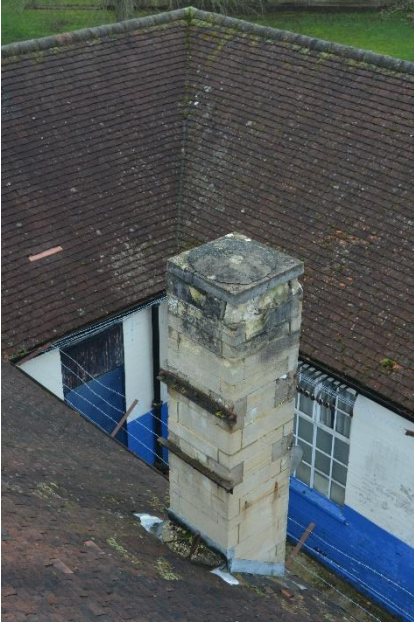
| 1.23 | | <p>Image showing chimney stack head from front elevation roof.</p> <p>Works required:<br/>Chimney stack take down and rebuild, new flashings, coping and ventilation.</p> |

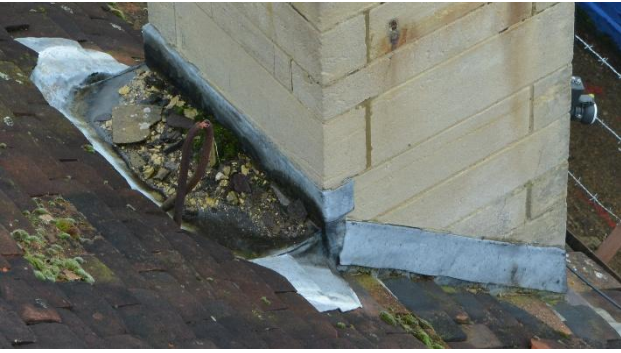
| 1.24 | | <p>Chimney stack back gutter and side flashing.</p> <p>Works required:<br/>Chimney stack take down and rebuild, new flashings, coping and ventilation.</p> |

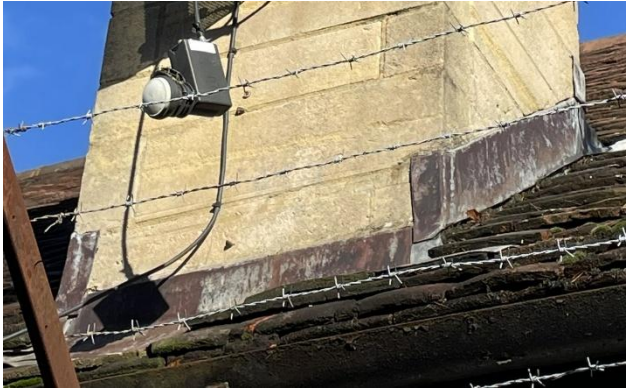
| 1.25 | | <p>Chimney stack front and side flashing.</p> <p>Works required:<br/>Chimney stack take down and rebuild, new flashings, coping and ventilation.</p> |

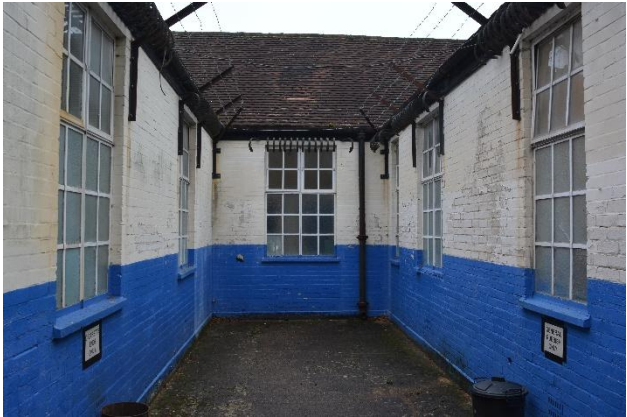
| 1.26 | | <p>View of courtyard looking North West. Image shows arrangement of barbed wire, anti-climb guards, courtyard windows and walling.</p> <p>Works required : Take down existing cast iron gutters, prepare, refurbish and redecorate. Remove barbed wire and supports. Prepare and redecorate anti climb bars. Helibar repairs to masonry walls to reinforce cracking.</p> |

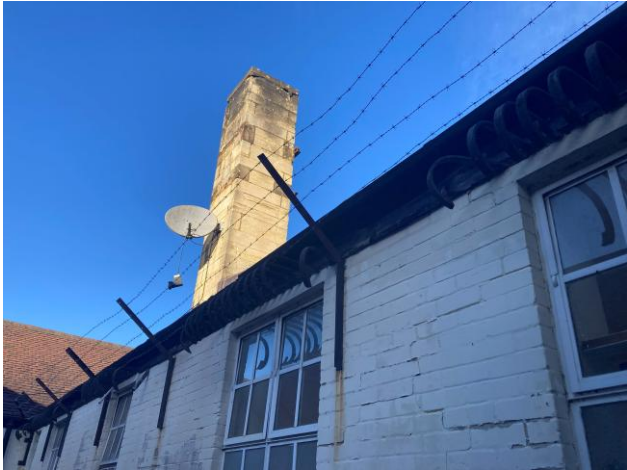
| 1.27 | | <p>View of Courtyard walling looking North, towards south facing courtyard wall and chimney stack. Image shows extent of cracking along with barbed wire and metal supports, fascia and guttering.</p> <p>Works required : Take down existing cast iron gutters, prepare, refurbish and redecorate. Remove barbed wire and supports. Prepare and redecorate anti climb bars. Helibar repairs to masonry walls to reinforce cracking.</p> |

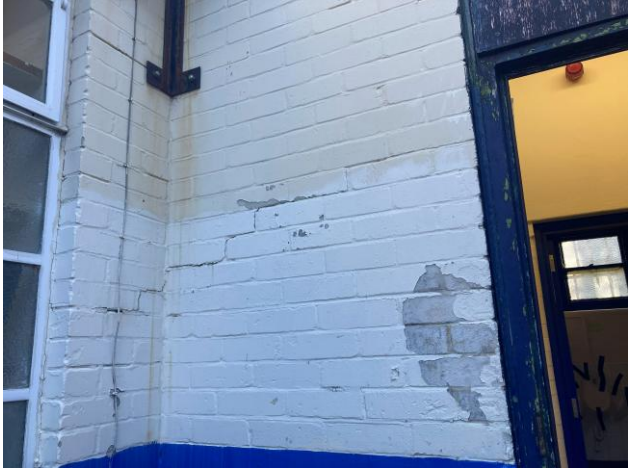
| 1.28 | | <p>View of Courtyard walling looking South East, towards North west facing end wall/ door. Image shows extent of cracking.</p> <p>Works required : Helibar repairs to masonry walls to reinforce cracking.</p> |

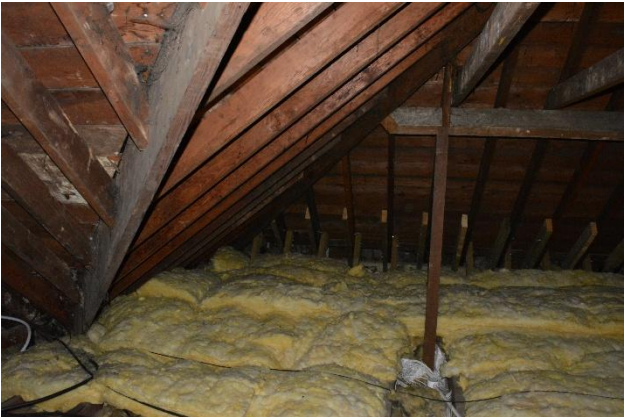
| 2.1 | | <p>View of roof internal structure looking North towards front façade/ arcade roof (Western end). Image shows extent of timber amendments to counter previous roof spread including poling board, bracing timbers, hangers and what present as retro fitted purlins.</p> <p>Works required : Upgrade existing bolt connections to timbers. Inspect timbers for signs of rot (where embedded into walling) and provide new spliced timber where required.</p> |

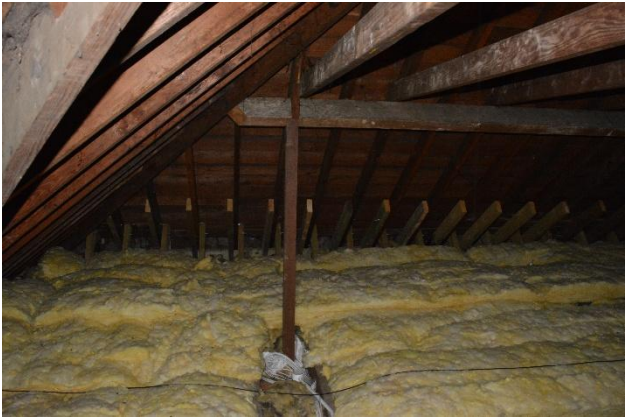
| <p>2.2</p> | | <p>View of roof internal structure looking North towards front façade/ arcade roof (Western end / Centre). Image shows extent of timber amendments to counter previous roof spread including poling board, bracing timbers, hangers and what present as retro fitted purlins.</p> <p>Works required : Upgrade existing bolt connections to timbers. Inspect timbers for signs of rot (where embedded into walling) and provide new spliced timber where required.</p> |

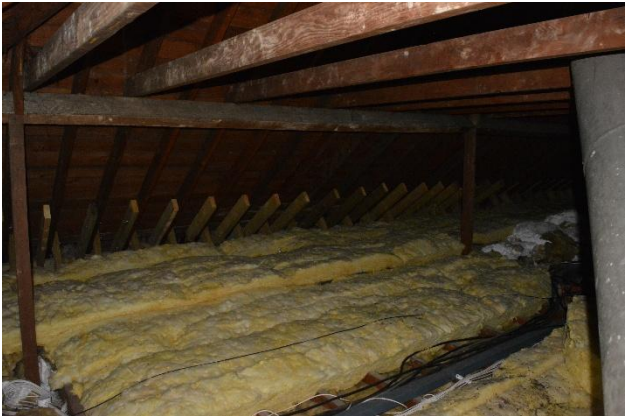
| <p>2.3</p> | | <p>View of roof internal structure looking North towards front façade/ arcade roof (centre). Image shows extent of timber amendments to counter previous roof spread including poling board, bracing timbers, hangers and what present as retro fitted purlins.</p> <p>Works required : Upgrade existing bolt connections to timbers. Inspect timbers for signs of rot (where embedded into walling) and provide new spliced timber where required.</p> |

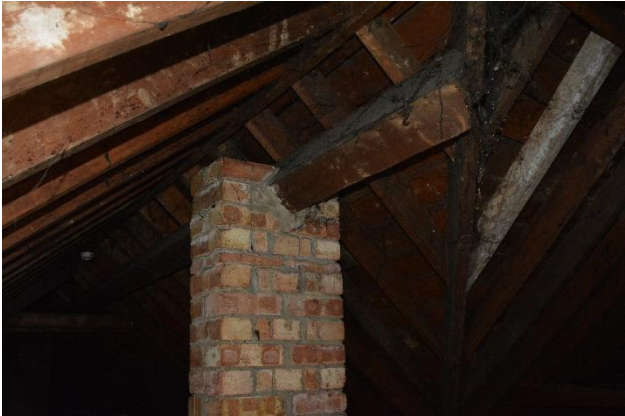
| <p>2.4</p> | | <p>Internal roof, showing what presents as a retro fitted purlin</p> <p>No works to purlins</p> |

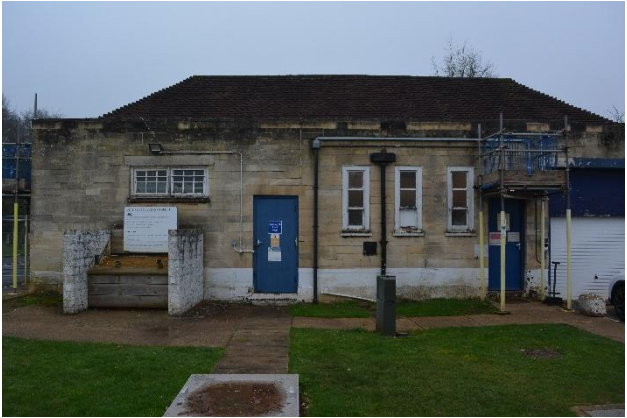
| 3.1 | | <p>North Western elevation</p> <p>Works required : prepare redecorate and refix existing rainwater hopper and downpipe</p> |

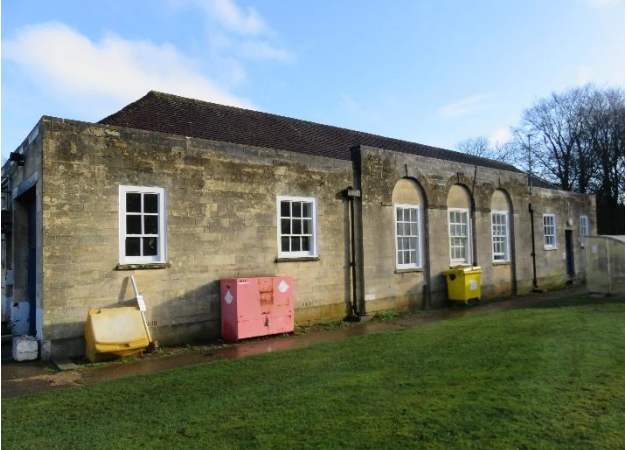
| 3.2 | | <p>South Western elevation</p> <p>Works required : prepare redecorate and refix existing rainwater hopper and downpipe, replace broken gully kerb to 1 nr downpipe.</p> |

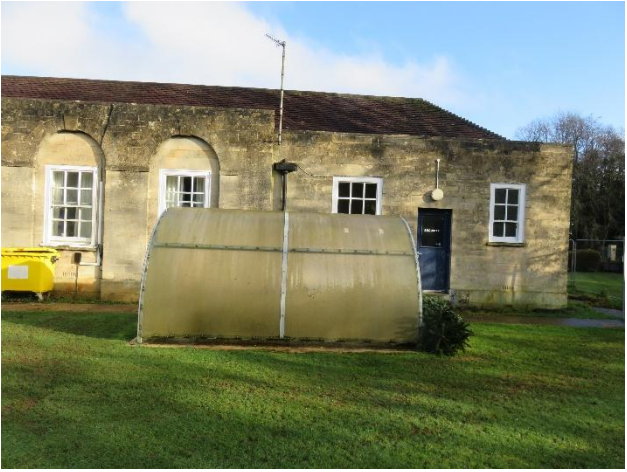
| 3.3 | | <p>South Western elevation including smoking shelter</p> <p>Works required : prepare redecorate and refix existing rainwater hopper and downpipe, replace broken gully kerb to 1 nr downpipe.</p> |

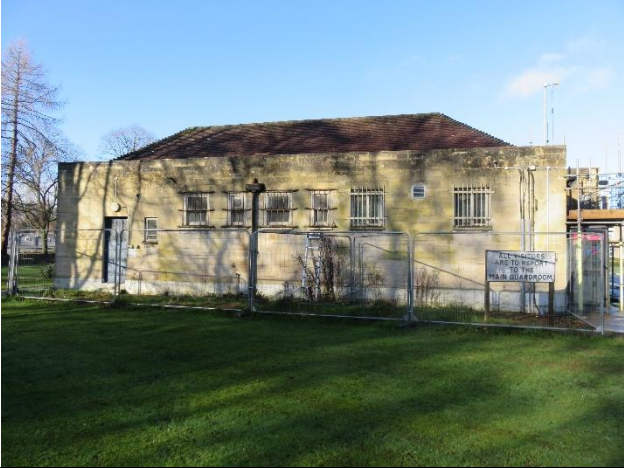
| 3.4 | | <p>South Eastern elevation</p> <p>Works required : prepare redecorate and refix existing rainwater hopper and downpipe.</p> |
