### Project

**Project Name:** 5795C1 Scotland Road  
**Project Number:** 5795/C1  
**Project Date:** 11/05/2026  
**Inspection Standard:** MSCC5 Sewers & Drainage GB (SRM5 Scoring)

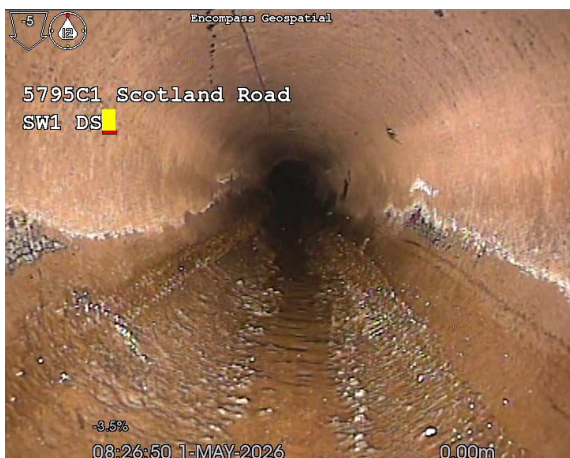
| Section | PLR | Grade | Description |
|---|---|---|---|
| 1 | SW1X | 3 | Settled deposits, fine, 5% cross-sectional area loss, finish |

SW1X\_cca77ac0-2b28-43e5-941e-e3228ee24f81\_20260511\_095940\_180.jpg, 00:00:00, 0.00 m  
Settled deposits, fine, 5% cross-sectional area loss, start

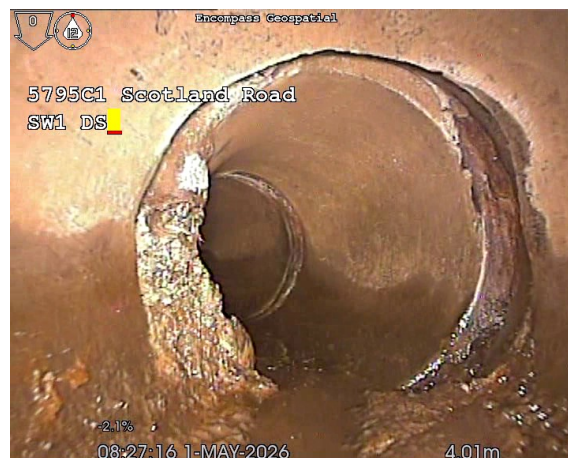
SW1X\_22024b9f-98b7-4a9e-9673-4d2d928e13b0\_20260511\_100016\_121.jpg, 00:00:26, 4.01 m  
Open joint, medium

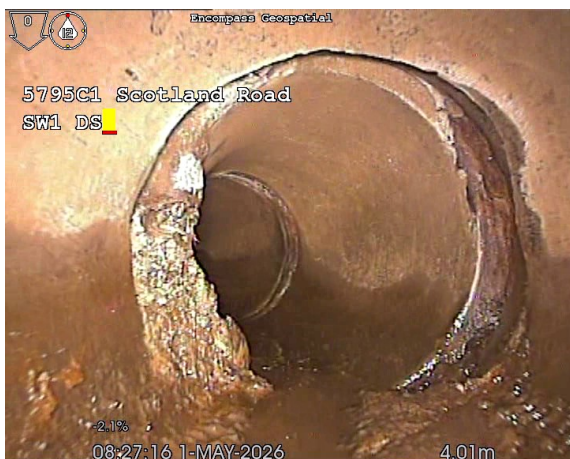
SW1X\_1b22a431-9095-4804-9cc5-71301ad68ce7\_20260511\_100030\_503.jpg, 00:00:26, 4.01 m  
Line deviates left, SLIGHT

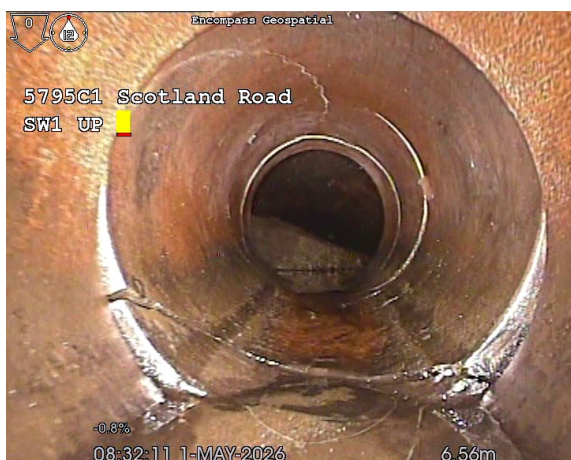
| Scale: | 1:63 | Position [m] | Code | Observation | MPEG | Photo | Grade |
|---|---|---|---|---|---|---|---|
| | | 6.56 | FCJ | Fracture, circumferential at joint from 5 o'clock to 8 o'clock | 00:00:40 | SW1<br>UPX_6abb<br>af7d-ad44- | 3 / 2 |

UPX\_6abbaf7d-ad44-4236-b471-6d1ac66b780b\_20260511\_100756\_692.jpg, 00:00:40, 6.56 m  
Fracture, circumferential at joint from 5 o'clock to 8 o'clock

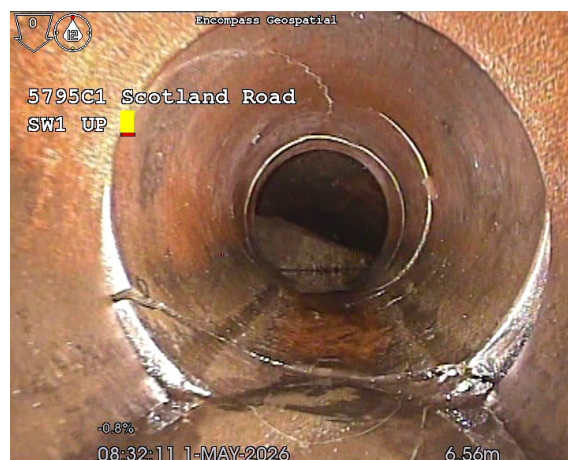
| Scale: | 1:63 | Position [m] | Code | Observation | MPEG | Photo | Grade |
|---|---|---|---|---|---|---|---|
| | | 6.56 | CL | Crack, longitudinal at 12 o'clock | 00:00:40 | SW1<br>UPX_c683<br>9105-8111 | 2 / 2 |

UPX\_c6839105-8111-4749-b9d4-c44966ff4854\_20260511\_100805\_999.jpg, 00:00:40, 6.56 m  
Crack, longitudinal at 12 o'clock

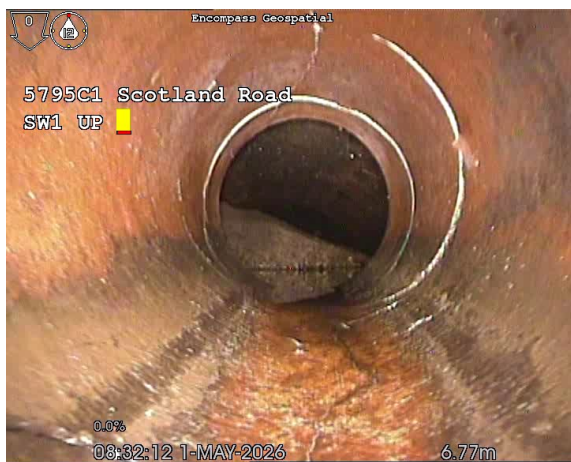
| Scale: | 1:63 | Position [m] | Code | Observation | MPEG | Photo | Grade |
|---|---|---|---|---|---|---|---|
| | | 6.77 | FC | Fracture, circumferential from 1 o'clock to 5 o'clock | 00:00:42 | SW1<br>UPX_51cc<br>50fa-c620- | 3 / 2 |

UPX\_51cc50fa-c620-44cc-a8fe-e7043ad501a3\_20260511\_100825\_076.jpg, 00:00:42, 6.77 m  
Fracture, circumferential from 1 o'clock to 5 o'clock

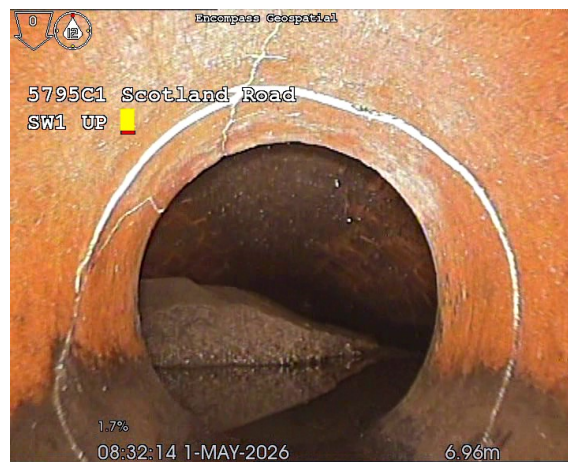
| Scale: | 1:63 | Position [m] | Code | Observation | MPEG | Photo | Grade |
|---|---|---|---|---|---|---|---|
| | | 6.96 | FC | Fracture, circumferential from 7 o'clock to 5 o'clock | 00:00:43 | SW1<br>UPX_of25<br>320d-2a6a | 3 / 2 |

UPX\_0f25320d-2a6a-49e8-a8e0-06656015c8c8\_20260511\_100837\_733.jpg, 00:00:43, 6.96 m  
Fracture, circumferential from 7 o'clock to 5 o'clock

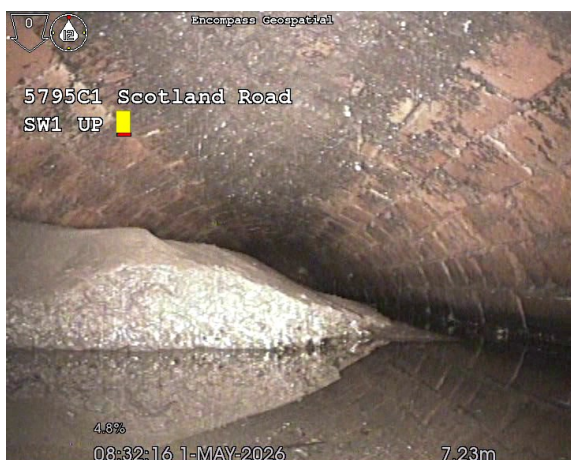
UPX\_232381a4-88a6-4bfd-80f4-8a30e1ace0d5\_20260511\_100  
 910\_350.jpg, 00:00:45, 7.23 m

Finish node, other special chamber, reference: SW1 UP,  
 FINISHES AT A LARGER BRICK PIPE

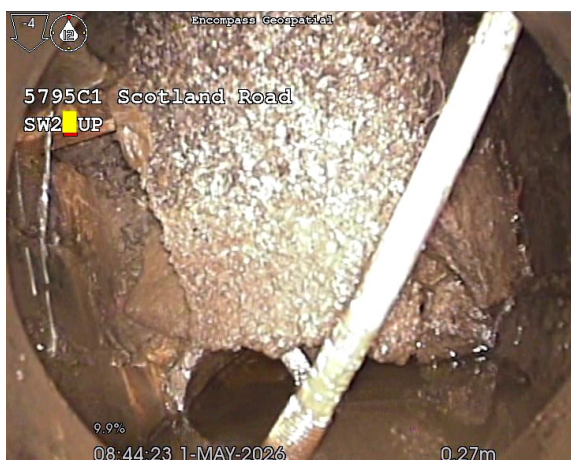
UPX\_2dc6cd17-7301-4e95-9f2c-d863581873fe\_20260511\_101  
 230\_620.jpg, 00:00:11, 0.27 m

Survey abandoned, WE BELEIVE THE LINE MAY BE  
 COLLAPSED OR BLOCKED BUT UNSURE HOW FURTHER  
 INVESTIGATION IS REQUIRED

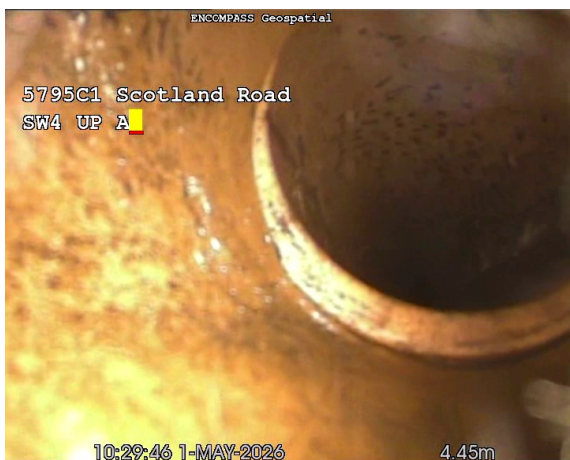
| Scale: | 1:57 | Position [m] | Code | Observation | MPEG | Photo | Grade |
|---|---|---|---|---|---|---|---|
| | | 4.45 | JDM | Joint displaced, medium | 00:00:42 | SW5X_5d<br>e816cb-a3<br>b1-47db-9 | 1 / 3 |

SW5X\_5de816cb-a3b1-47db-9a60-9a4c93cc8d9a\_20260511\_101913\_661.jpg, 00:00:42, 4.45 m  
Joint displaced, medium

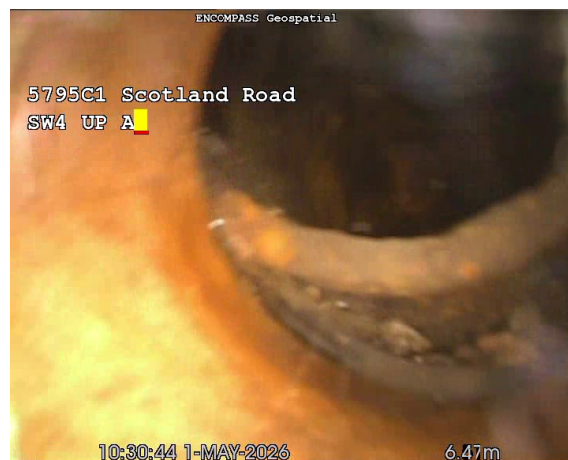
| Section | PLR | Grade | Description |
|---|---|---|---|
| 7 | SW5X | 4 | Joint displaced, large |

| Scale: | 1:57 | Position [m] | Code | Observation | MPEG | Photo | Grade |
|---|---|---|---|---|---|---|---|
| | | 6.47 | JDL | Joint displaced, large | 00:01:40 | SW5X_4cf<br>b9dfb-1a5<br>5-4993-bdf | 1 / 4 |

SW5X\_4cfb9dfb-1a55-4993-bdf2-4b12c2f311d5\_20260511\_102019\_781.jpg, 00:01:40, 6.47 m  
Joint displaced, large

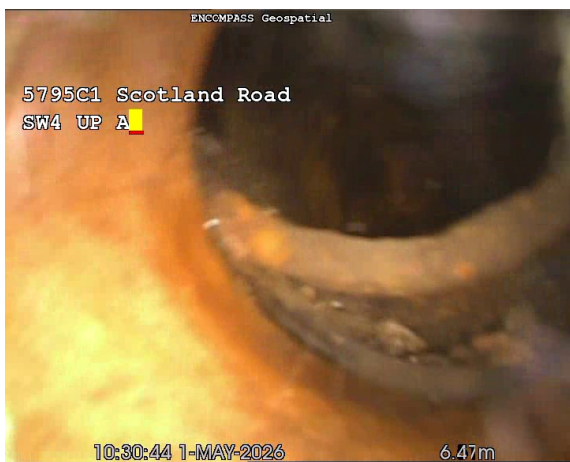
| Scale: | 1:57 | Position [m] | Code | Observation | MPEG | Photo | Grade |
|---|---|---|---|---|---|---|---|
| | | 6.47 | SA | Survey abandoned: UNABLE TO SURVEY OVER THE JOINT | 00:01:40 | SW5X_46<br>4c6baf-bd5<br>1-4aec-9b6 | |

SW5X\_464c6baf-bd51-4aec-9b69-e566cd002e00\_20260511\_102038\_147.jpg, 00:01:40, 6.47 m  
Survey abandoned, UNABLE TO SURVEY OVER THE JOINT

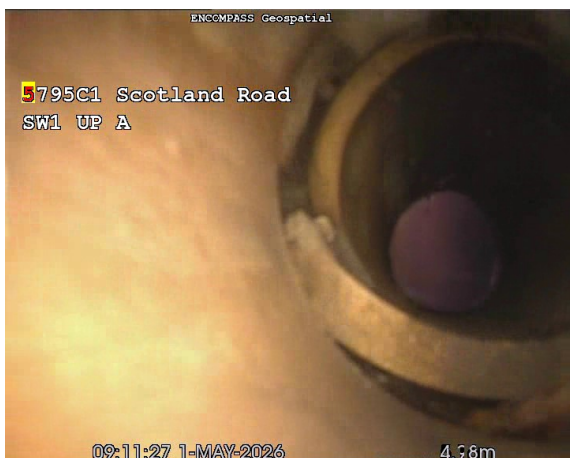
| Section | PLR | Grade | Description |
|---|---|---|---|
| 9 | GY1X | 4 | Joint displaced, large |

SW1 UP  
AX\_1319379e-1f4b-403f-afbe-5195f6e8edd5\_20260511\_10041  
2\_262.jpg, 00:00:20, 4.98 m  
Joint displaced, large
