# Encompass Geospatial CCTV Outcome Report

**Job Number: 5795/C1      Site: Scotland Road**  
**Date: 11/05/2026      Surveyor: Archie Scorey**

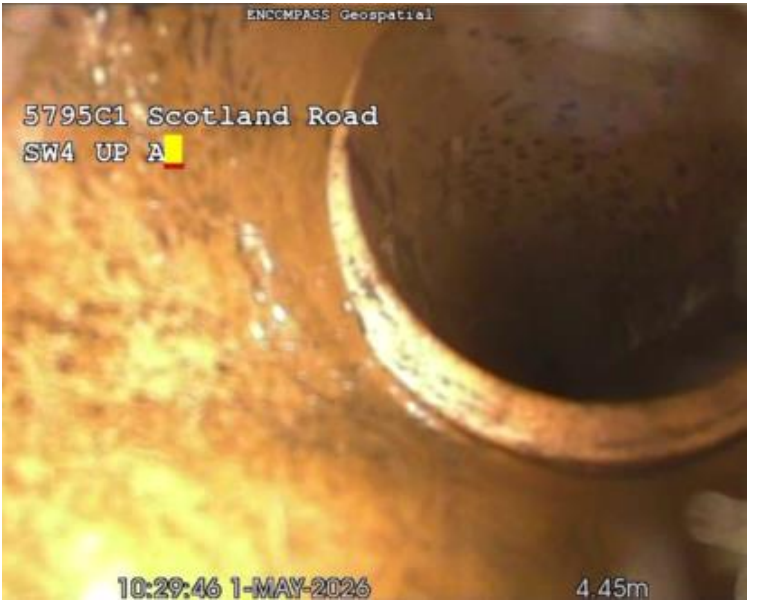
| Pipe reference | Fault & recommended resolution | Image |
|---|---|---|
| SW1 DS SW2,<br>SW4 UP A,<br>SW1 UP GY1,<br>SW6 UP GY3 | Displaced joints. These require lining or patch repairs to seal the joint, stop ingress of any foreign objects, allow for smooth flow and to prevent any further pipe movement. In the more severe cases excavation may be required to replace the affected section of pipe. | |
