Structural Assessment of East Wing at  
Littlecott Mill, Enford  
Pewsey, Wiltshire,  
SN9 6AW

Job No.: 4271  
Report: 4271-R01  
Rev. B

August 2026

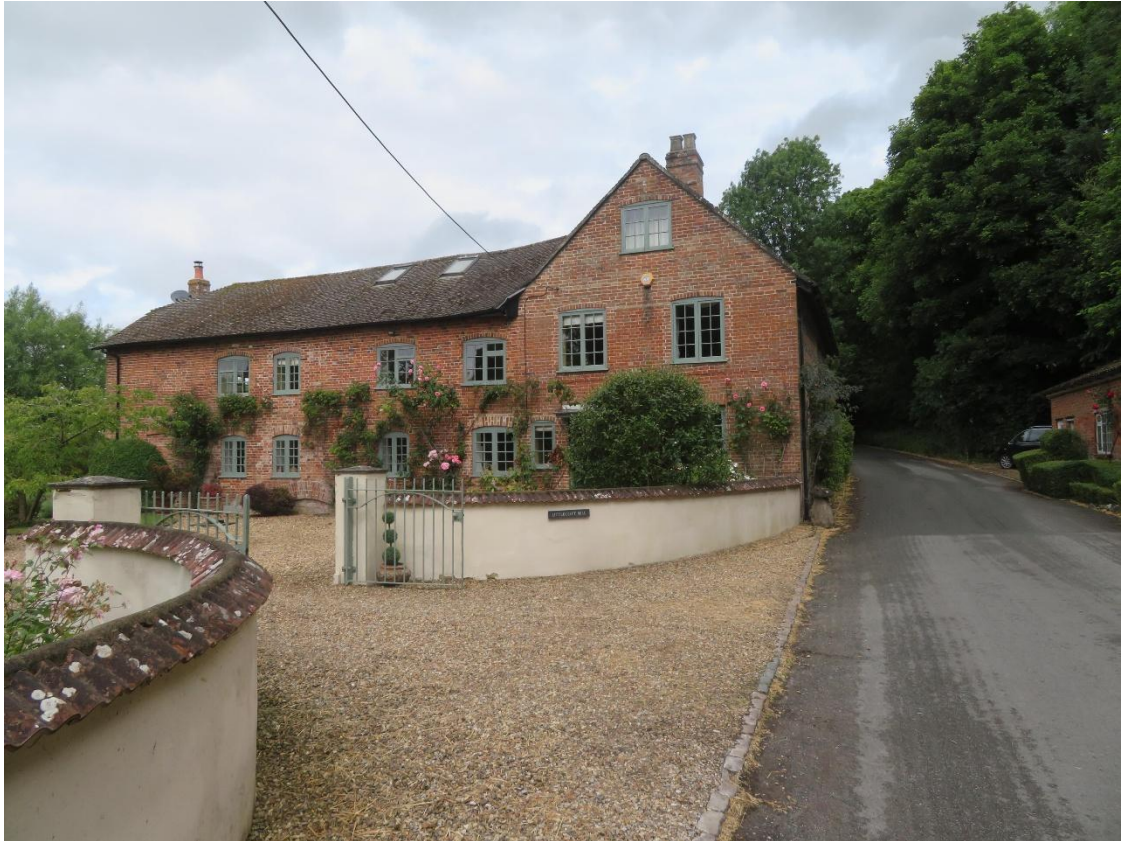
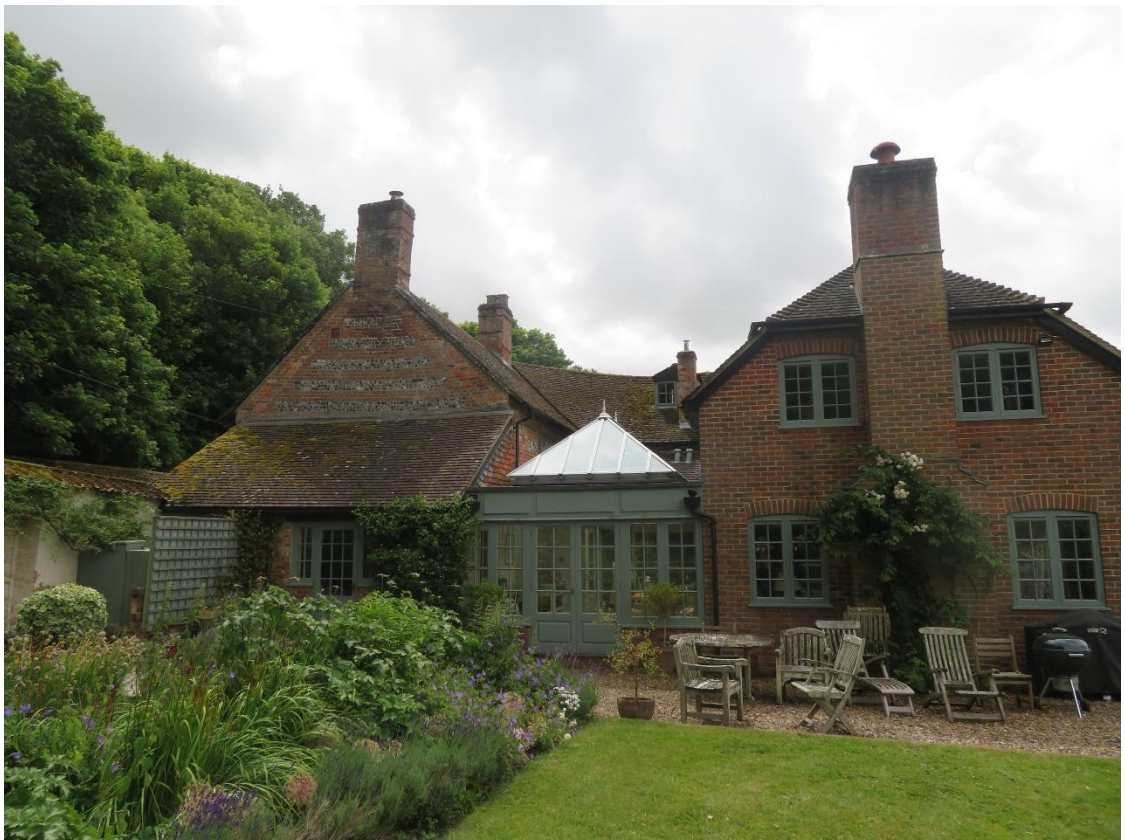
Littlecott Mill is a domestic, two storey masonry structure with a timber roof situated near to the River Avon (001, 002).

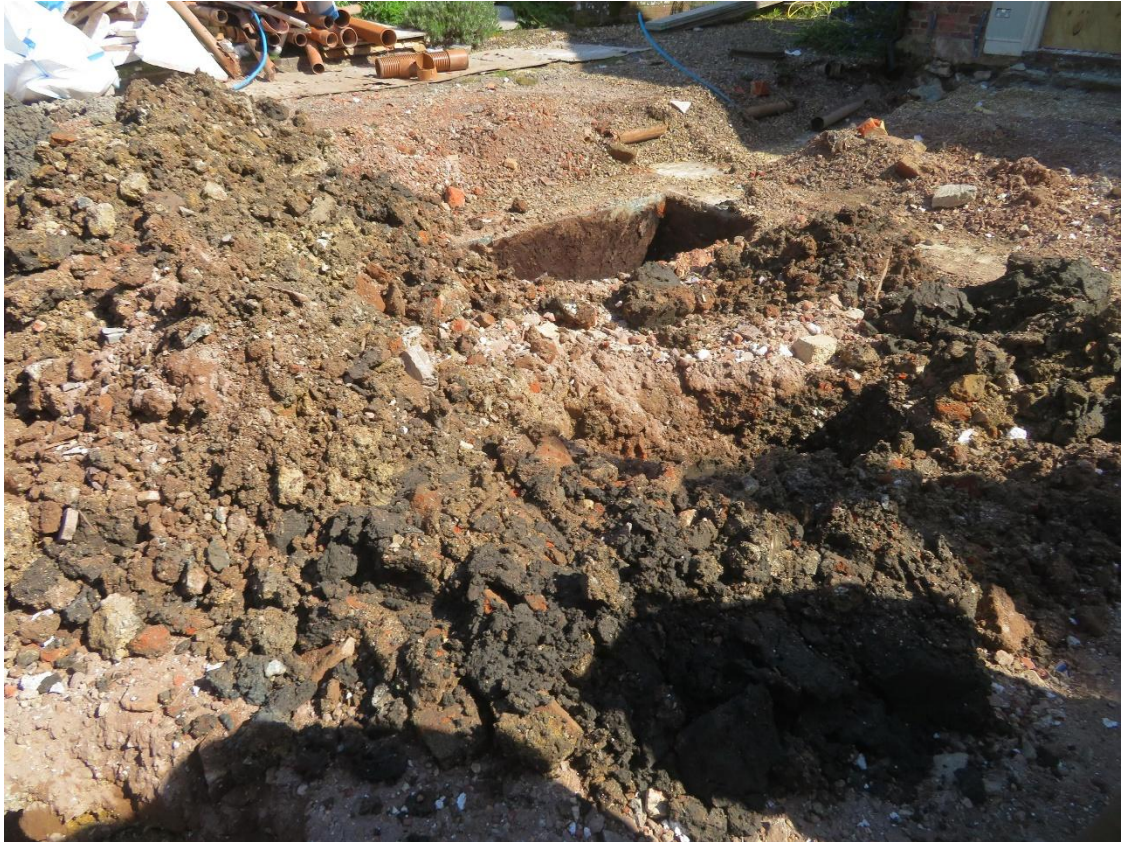
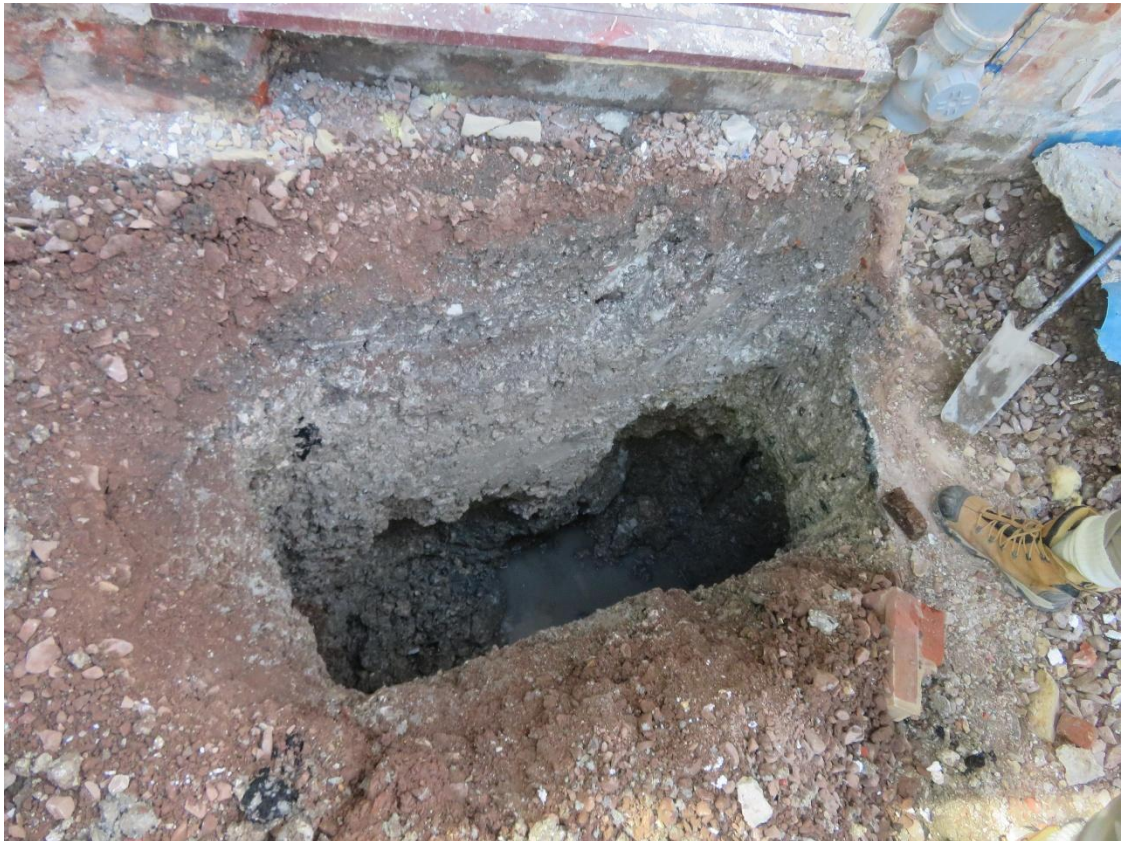
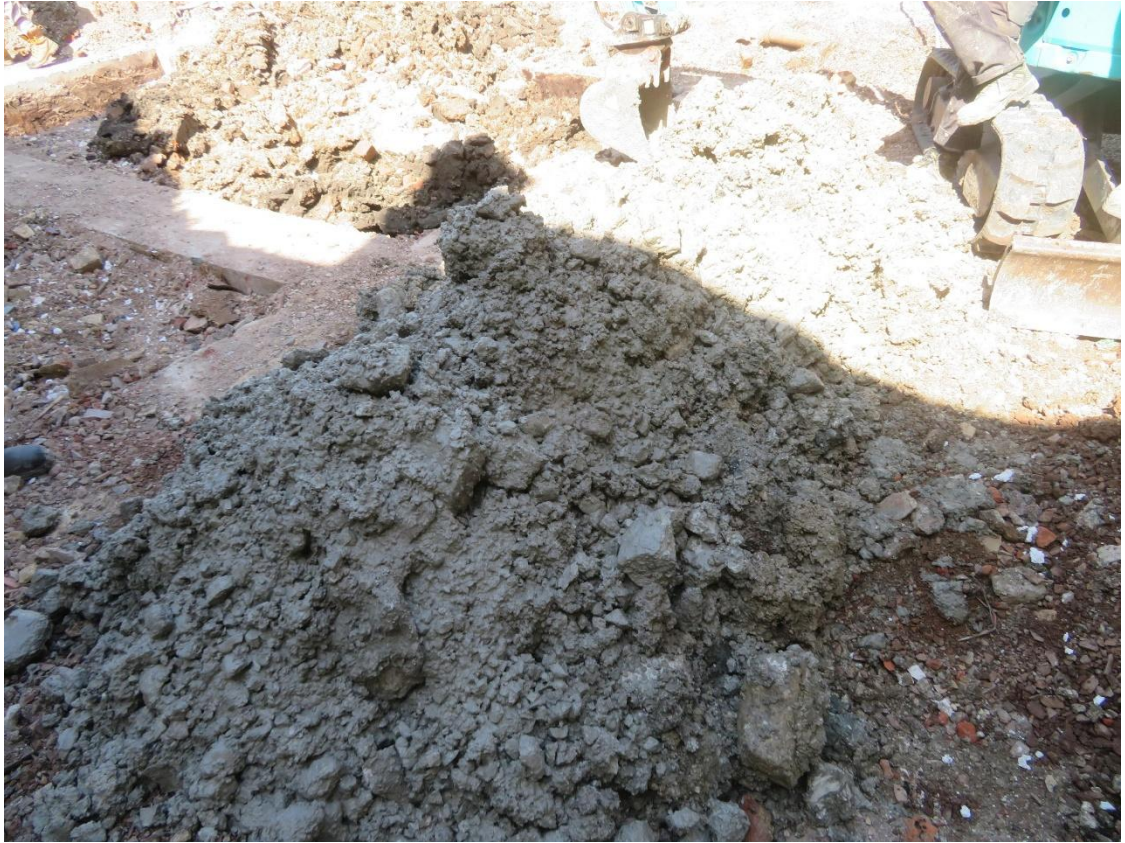
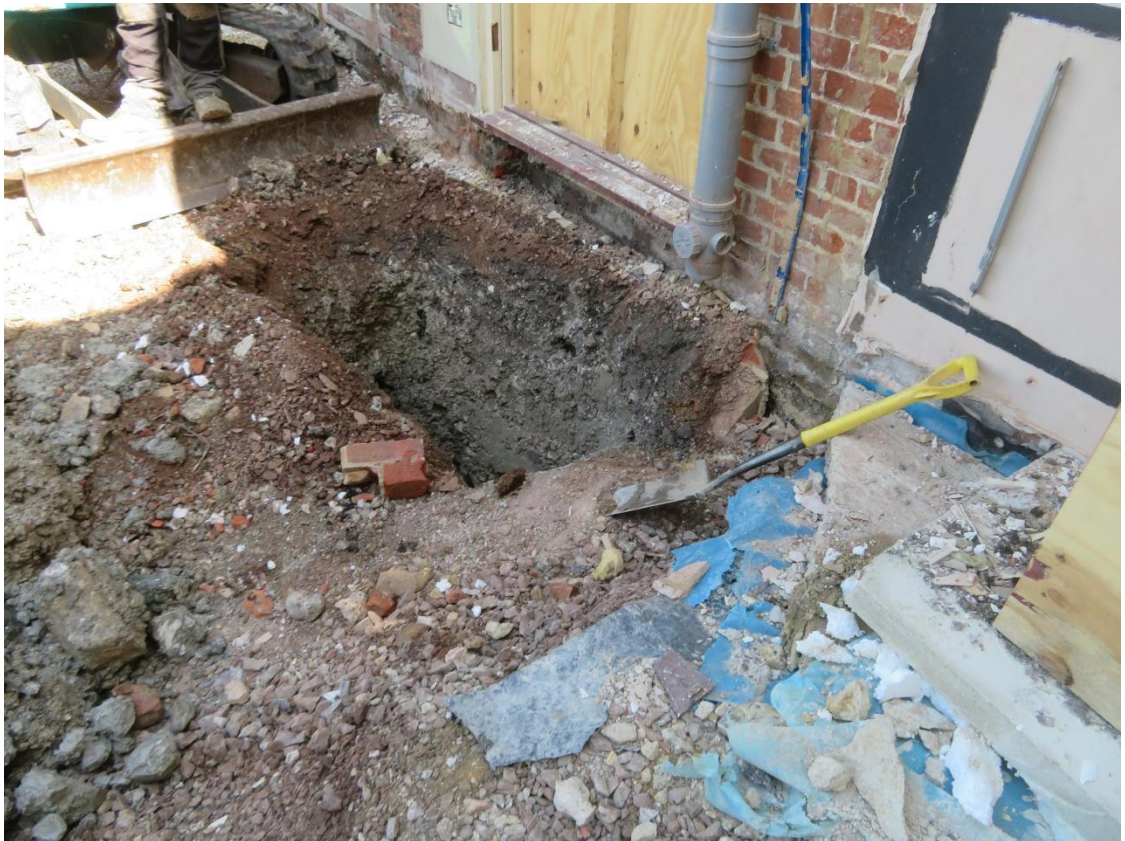
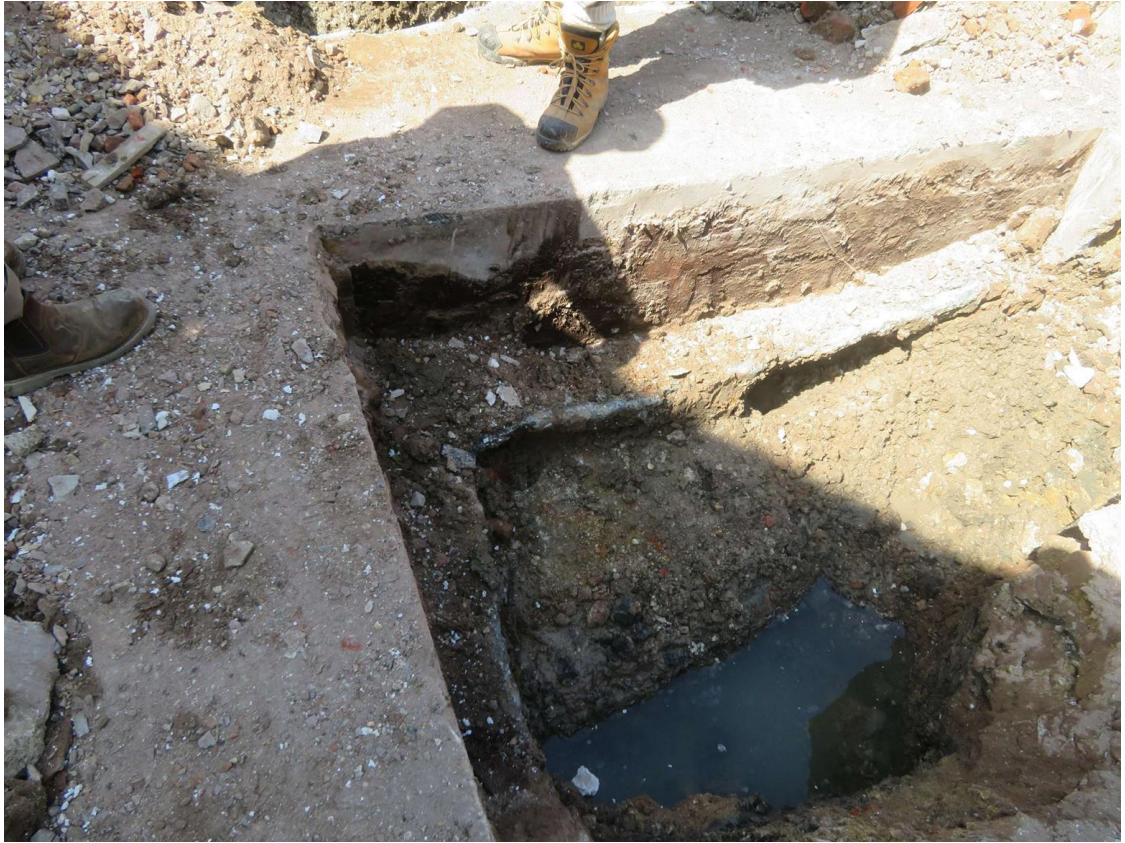
Subsequent trial pits were carried out in the centre of the footprint in April 2026 and assessed in MLDE's letter of 22/04/26. These excavations demonstrated that the inner wall of the east wing is founded on the same extremely poor-quality fill, however it extends to a minimum of 1.8m below ground. The water table in this region is around 700mm below ground level (007 to 011). This disparity in founding conditions is believed to be the cause of differential settlement.

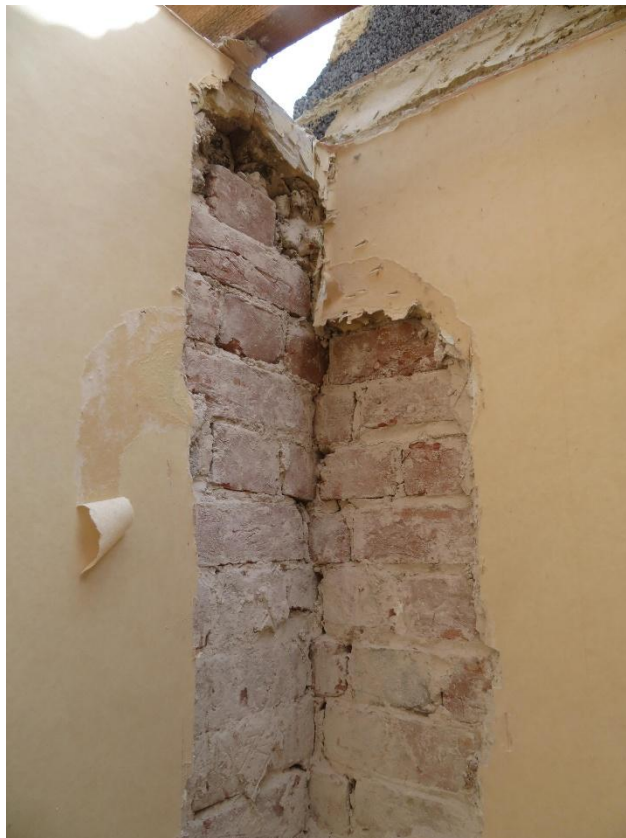
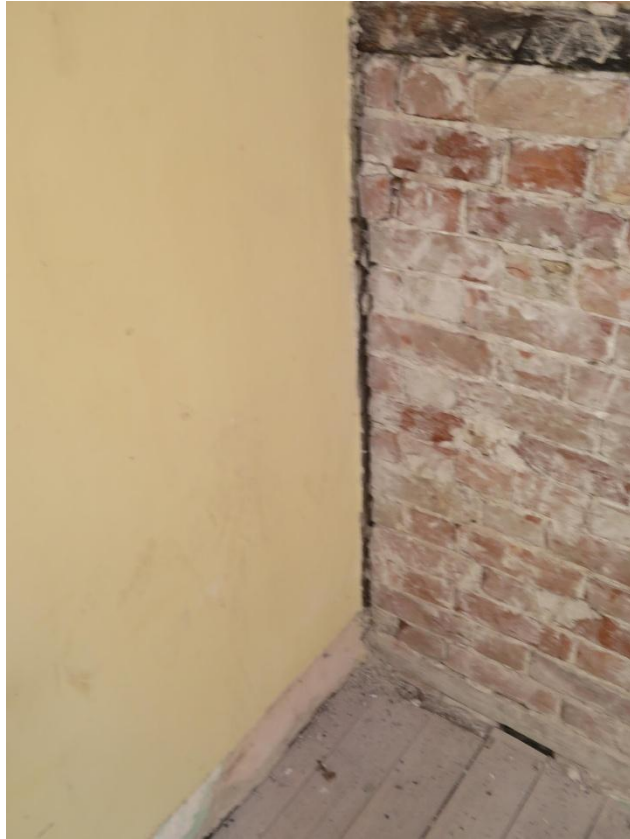
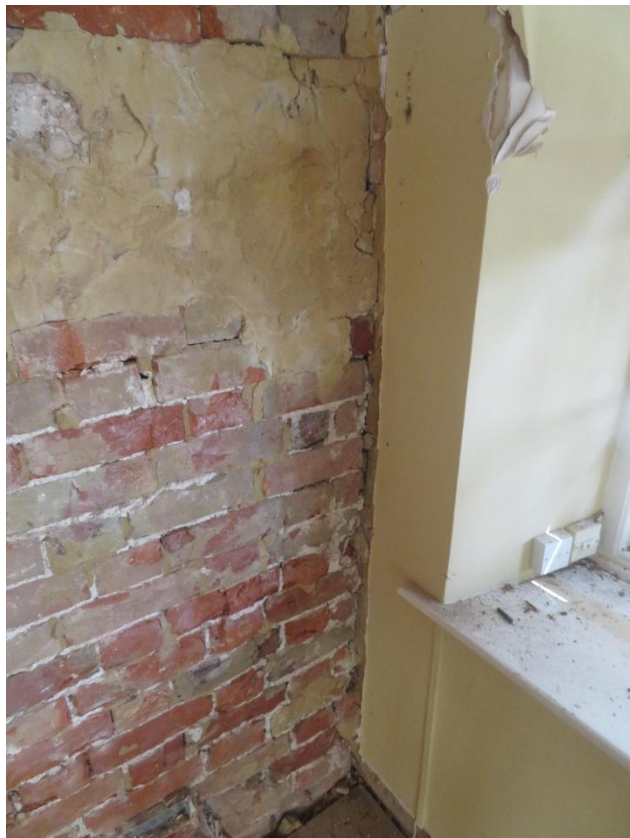
Some internal cross walls are not bonded to the external skin and are simply butted against each other (012 to 014). There are also numerous cracks that have propagated around openings, further indicating a level of ongoing movement. Several walls are not sufficiently toothed together within the building and are an eclectic, haphazard mix of steel and timber elements, thus they provide no lateral support to one another.

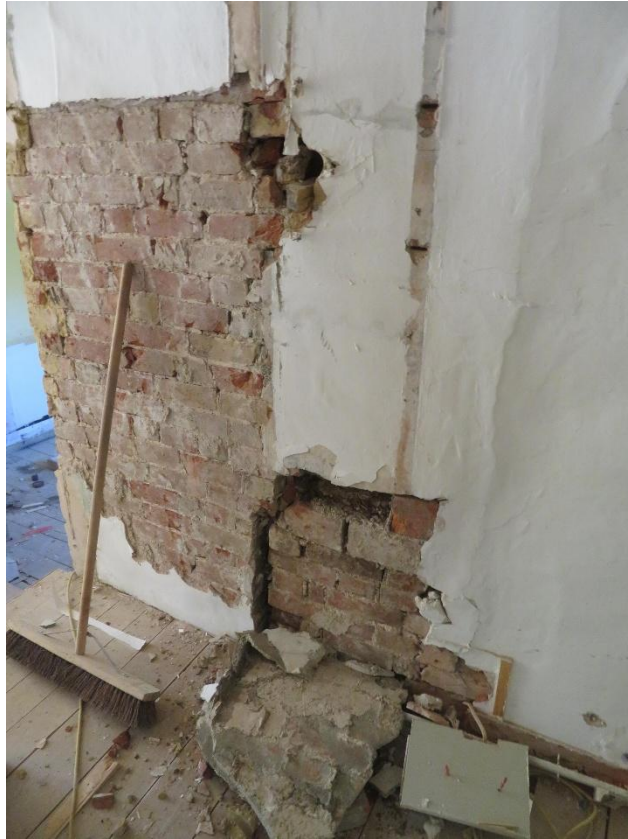
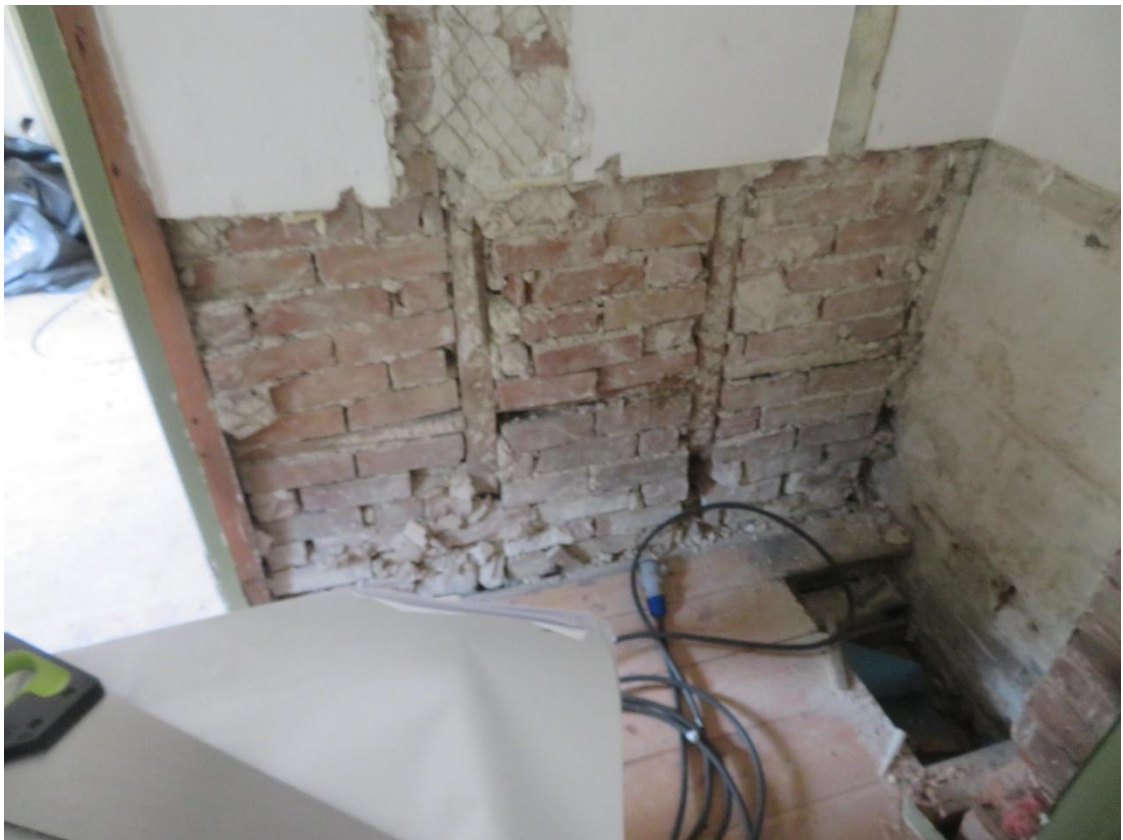
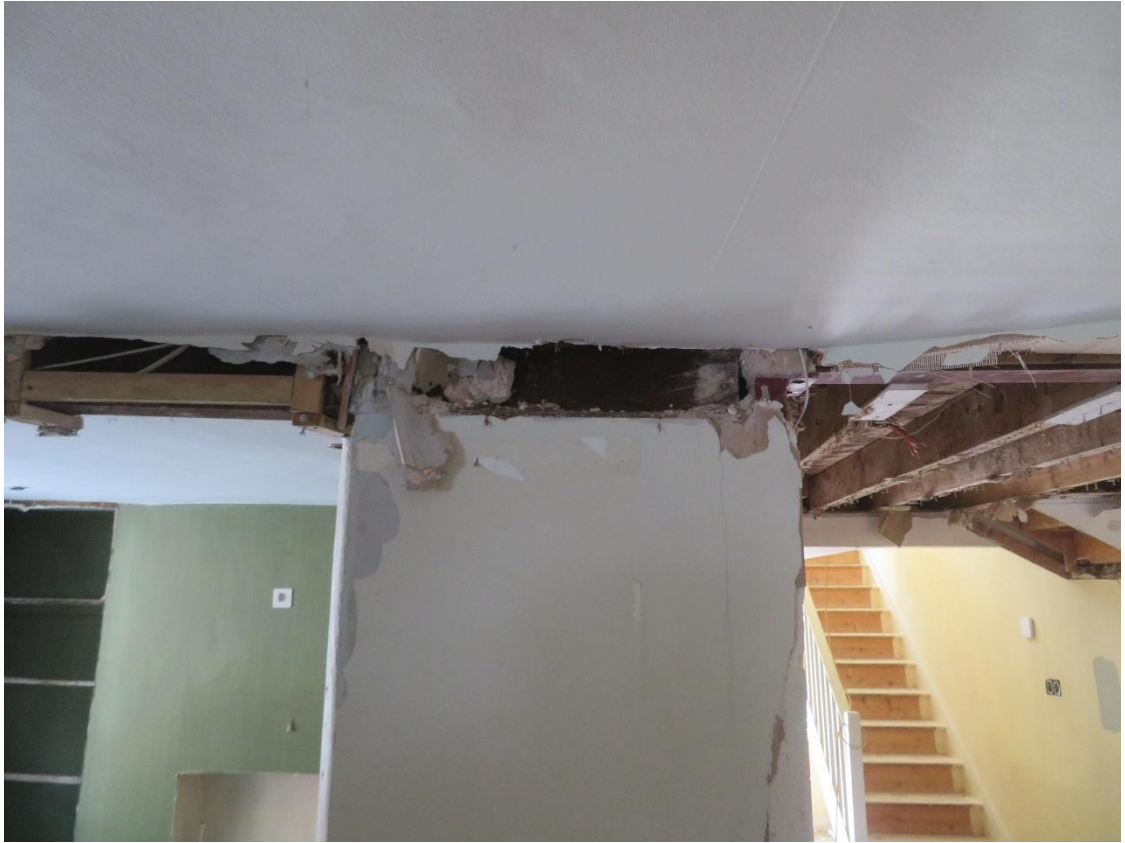
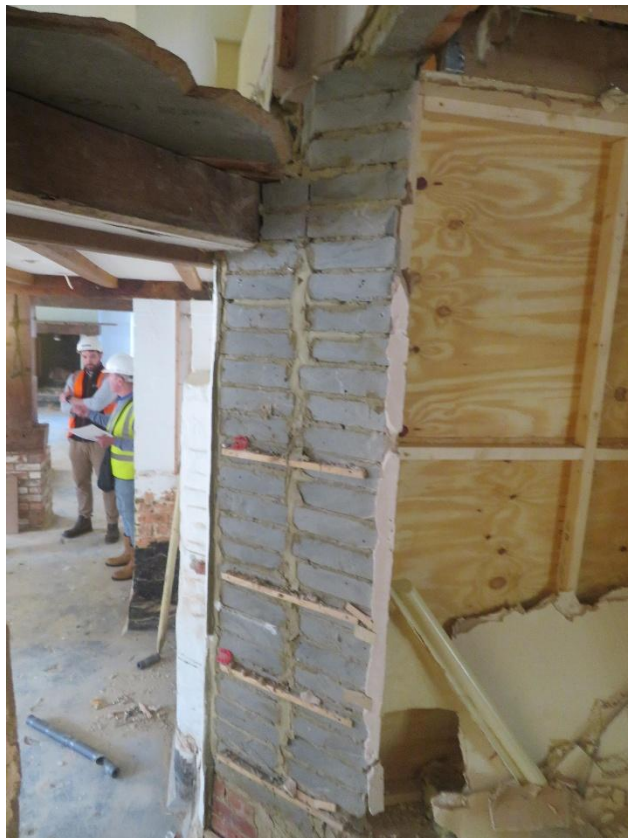
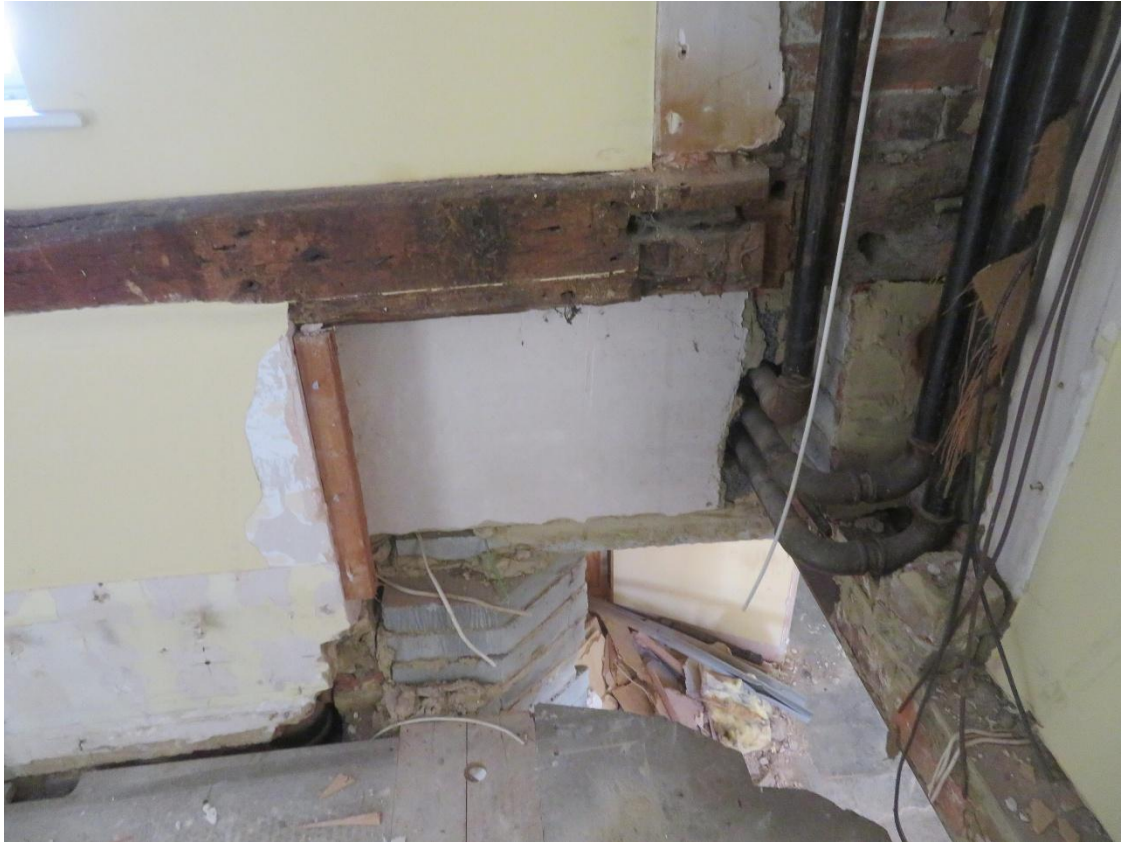
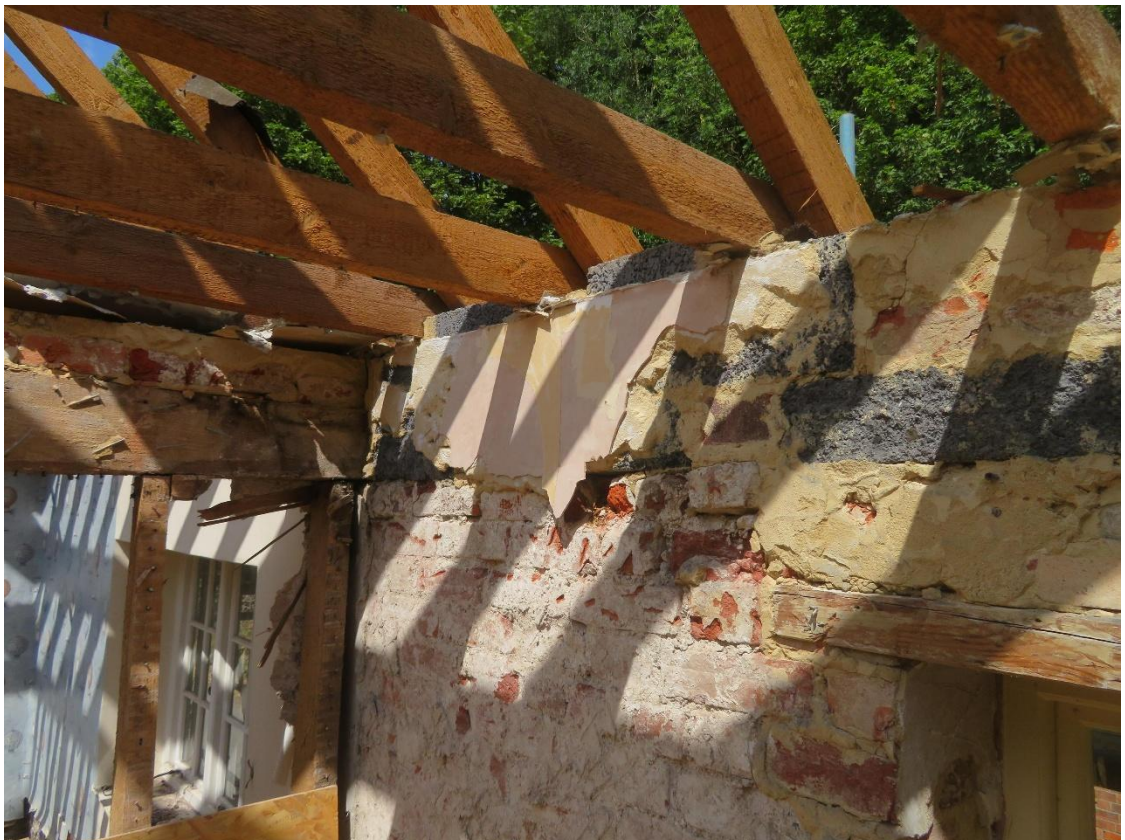
Poorly bonded masonry highlights historic positions of doors and openings, but these now provide little in the way of structural robustness or support to the wider structure (015 to 020).

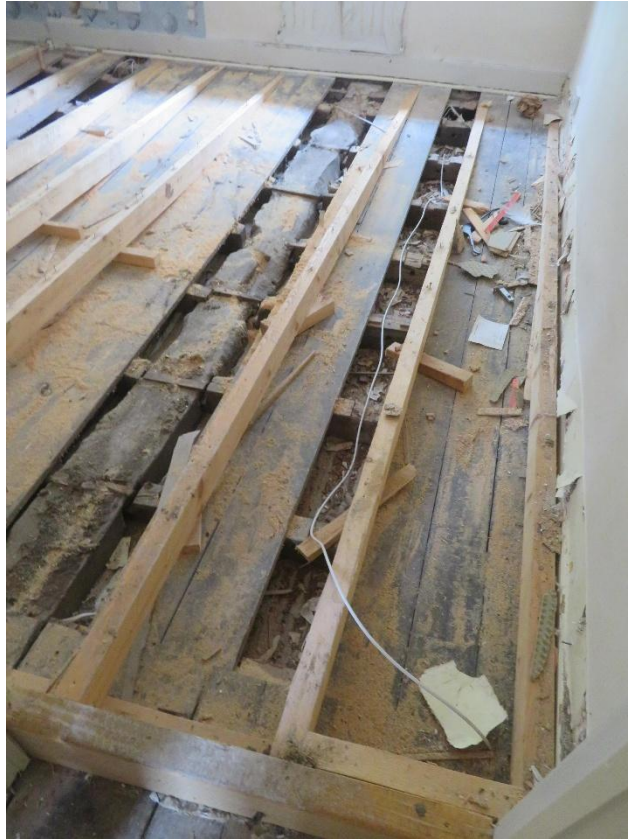
021

The actual magnitude of the ongoing differential settlement which has occurred to the walls and supporting foundations of the east wing became very evident and apparent on the first floor once all existing boards were lifted. Furrings were previously added on top of the existing joists in an attempt to level the floors. These taper from say 5mm to around 300mm in height, over the 5m width of the footprint.

Further evidence of the historic movement has been uncovered during this package of enabling works as discussed in Section 2.1. Furrings have been found across first floor zones, where efforts have been made to re-level floors (021). The 250-300mm settlement of the inner wall has never been fully addressed, but rather adjustments to finishes and internal structure have been made to mask this ongoing movement.

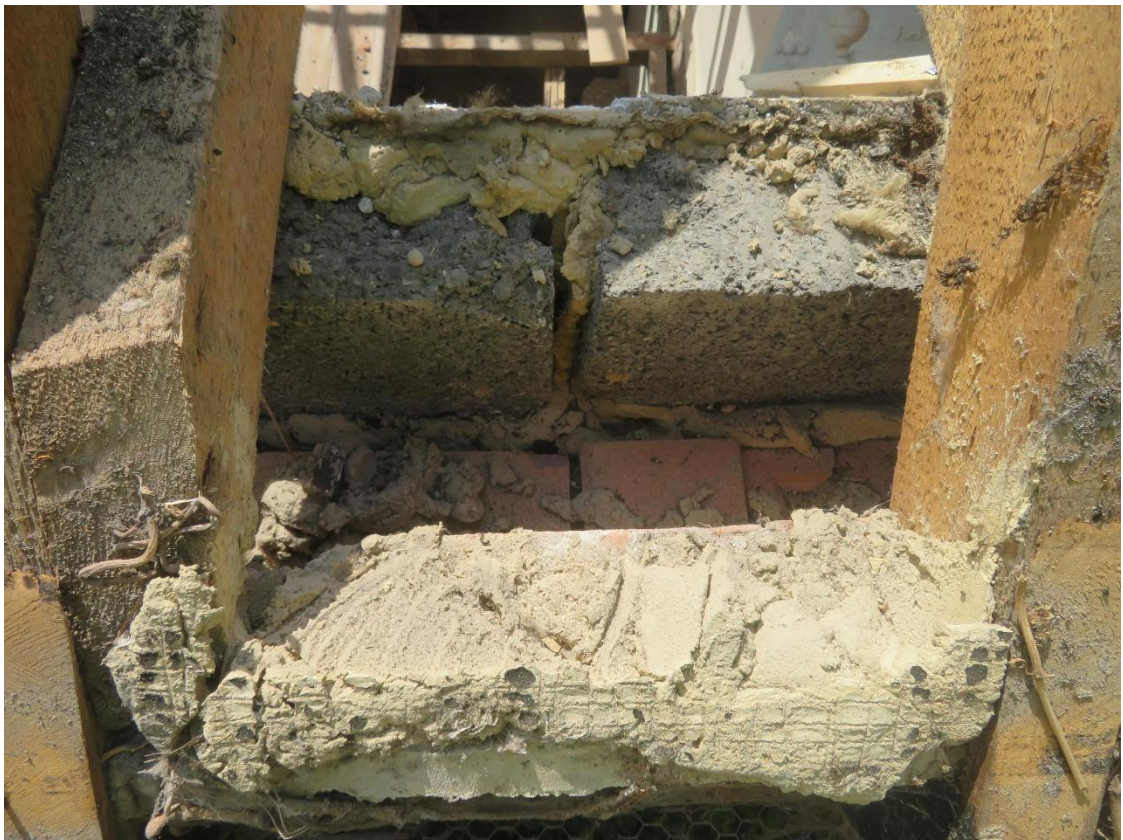
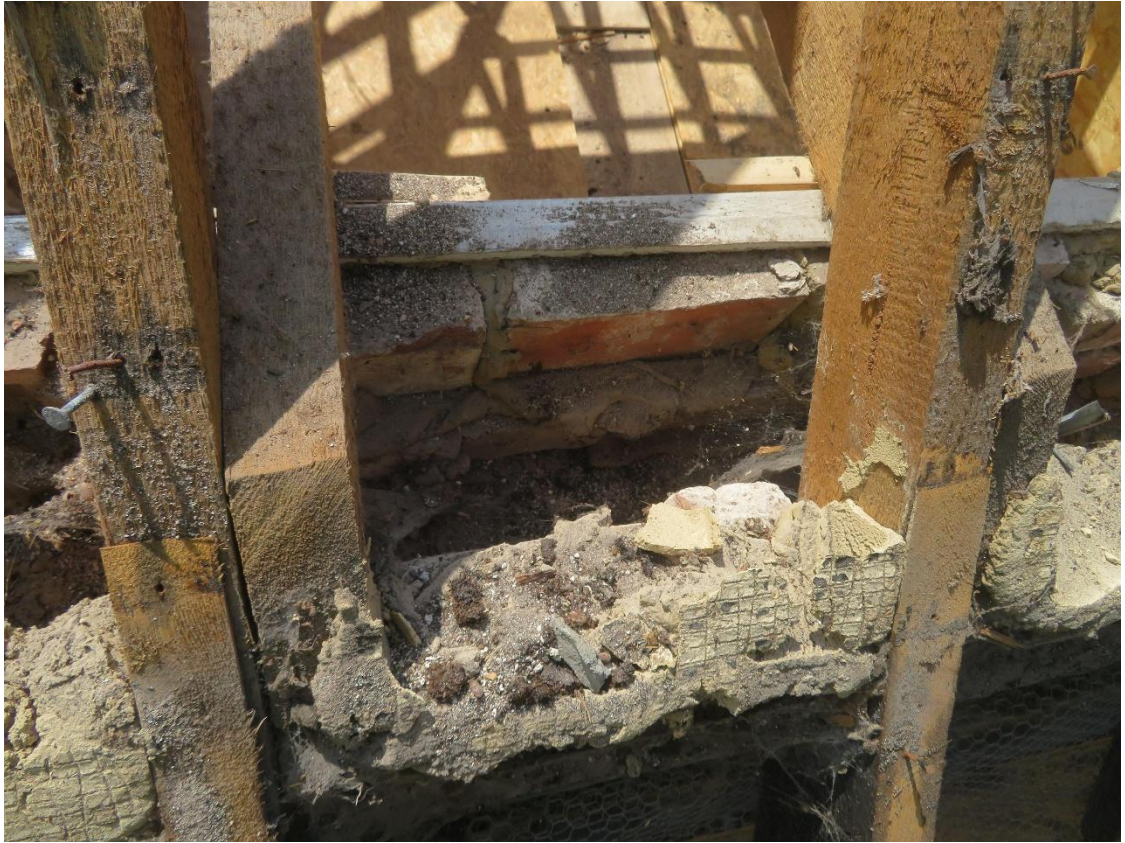
When viewed from eaves level, the roadside wall appears to be constructed of three distinct separate 100mm thick skins which are practically not bonded together (as opposed to a solid leaf of fully toothed masonry) (022, 023). Areas of flint throughout the wall act as structural breaks in the masonry and prevent the wall from acting effectively as a single panel (024, 025). Modern blockwork can be found interspersed between old brickwork.

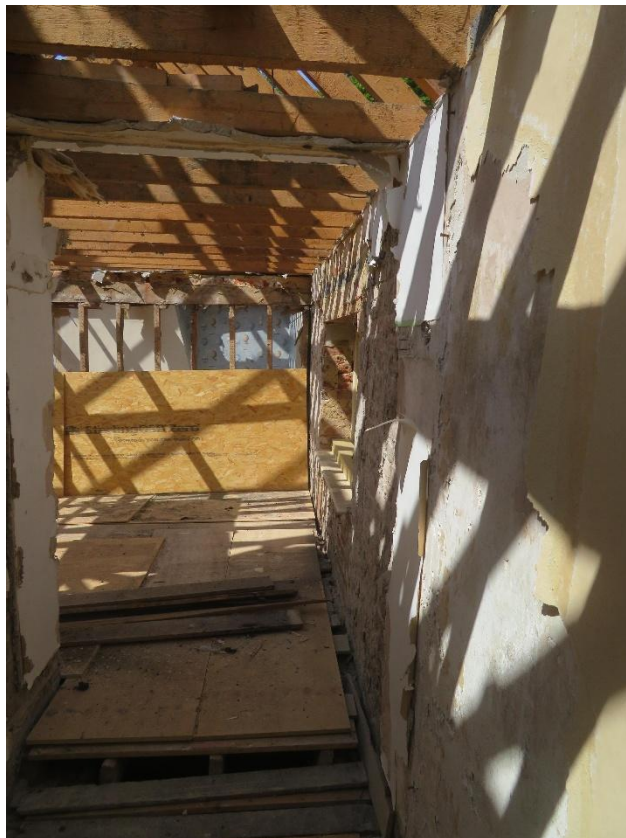
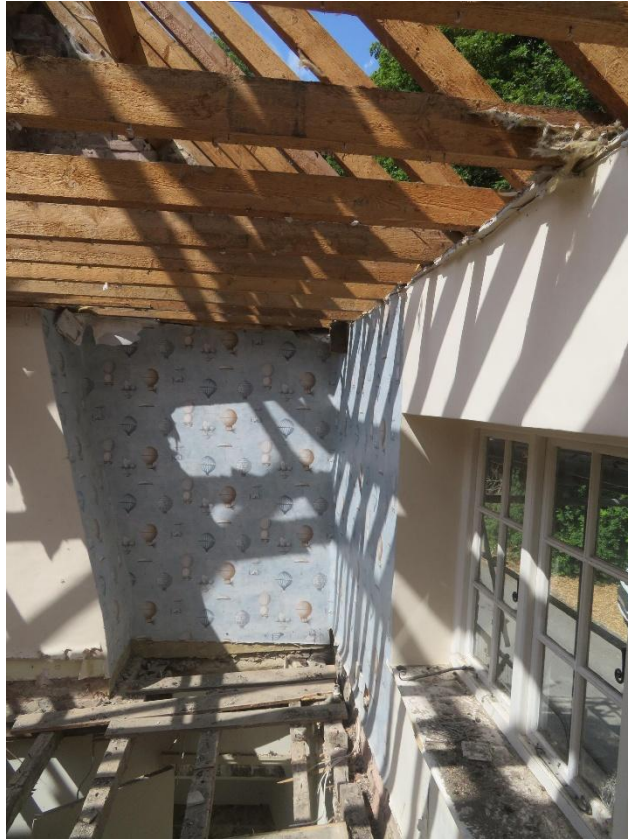
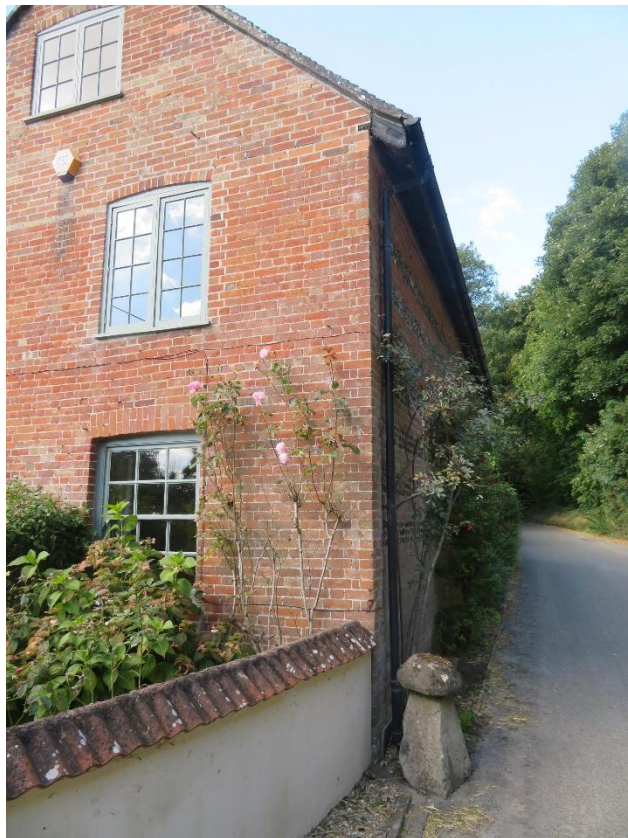
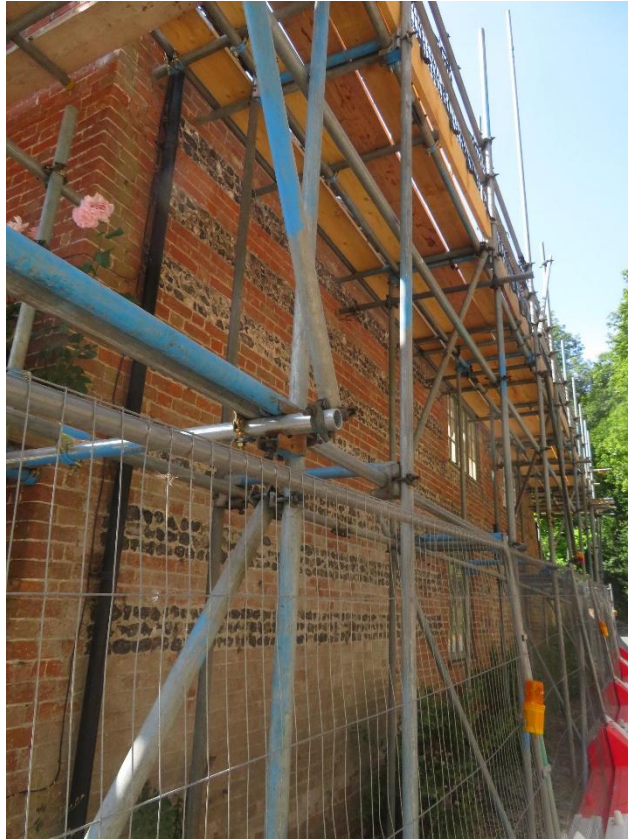
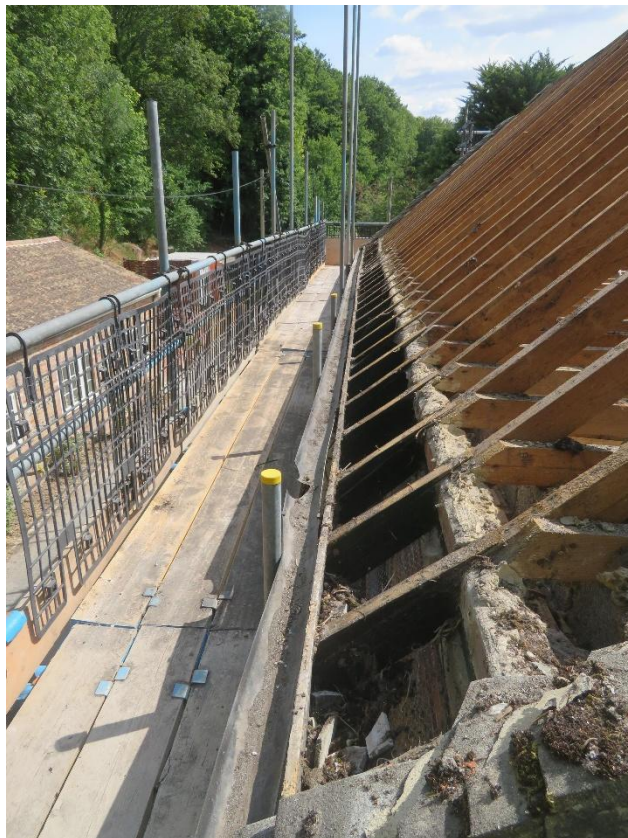
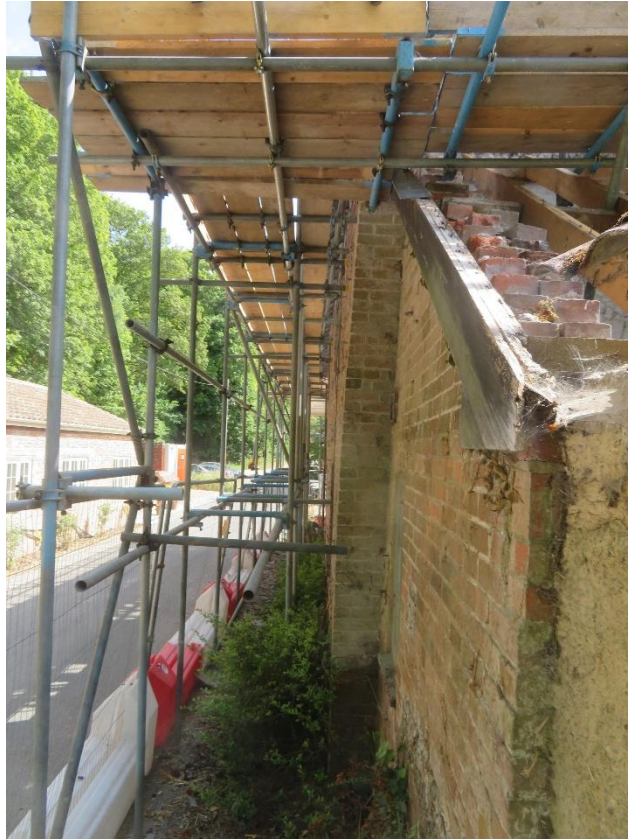
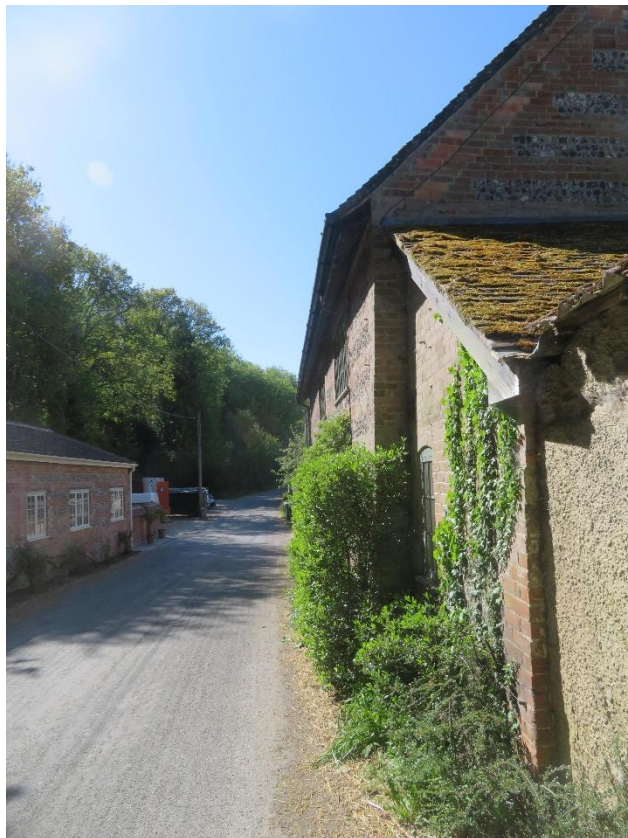
The entire roadside wall has experienced a global rotational settlement toward the highway. The upper section at first floor is now bowed toward the centre, possibly as a result of unresolved lateral forces imparted by the roof (026 to 032).

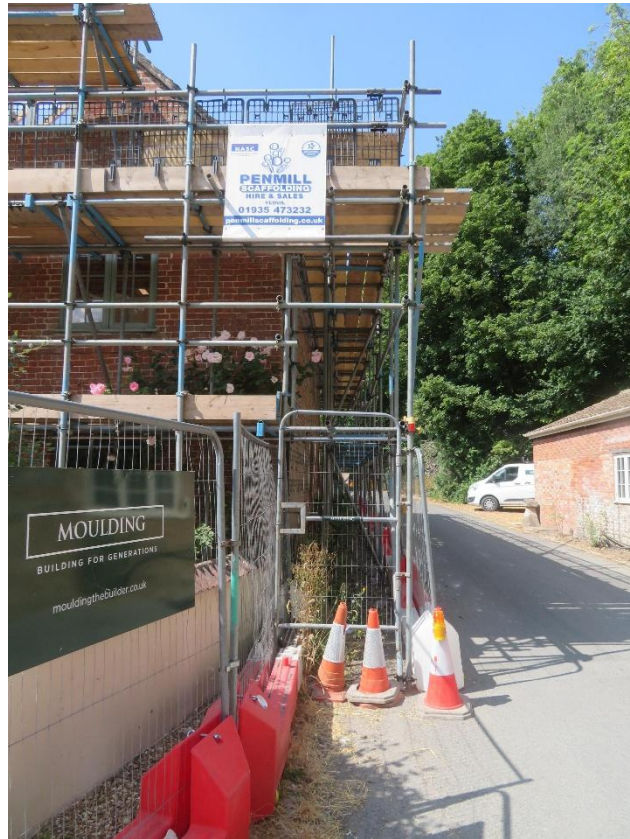
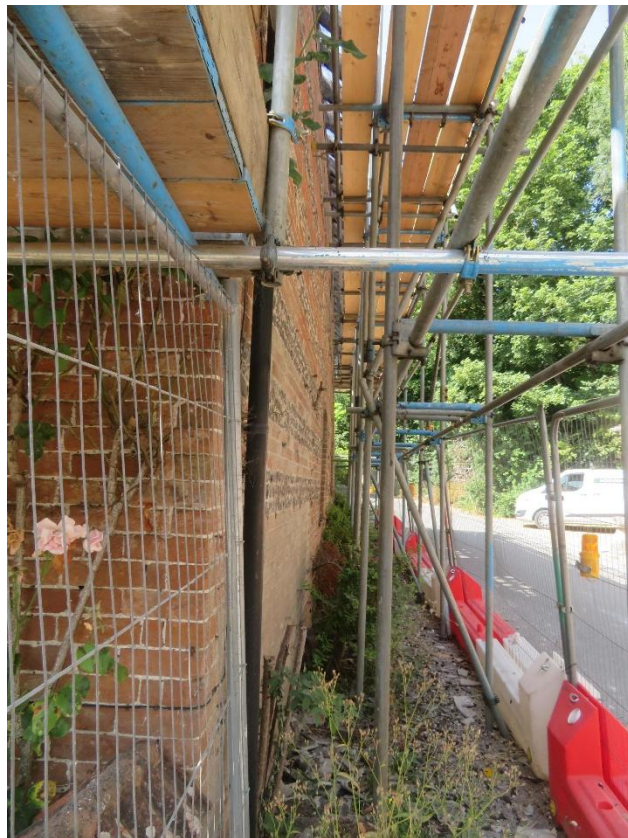
The east wing sits directly adjacent to a single lane section of public highway which links between the villages of Littlecott and East Chisenbury. No support can be provided to the wall from the roadside so any temporary works must be designed in both a tension and compression capacity. At the time of writing this report, a scaffold is in place against the roadside wall, but this highlights the limited space that could be made available during any works for protective measures (033, 034).
