Our Ref: 26-033\_P2  
12<sup>th</sup> August 2026

**Lower Hook Farm**

**Structural inspection and assessment**

**Date of inspection; 07.08.26**

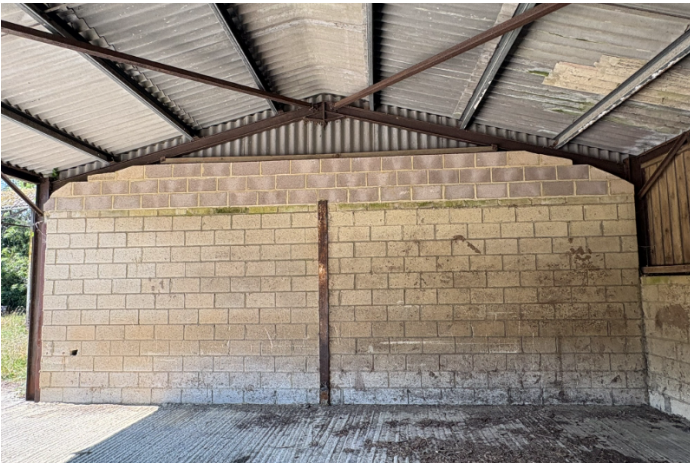
North gable end of Barn B1

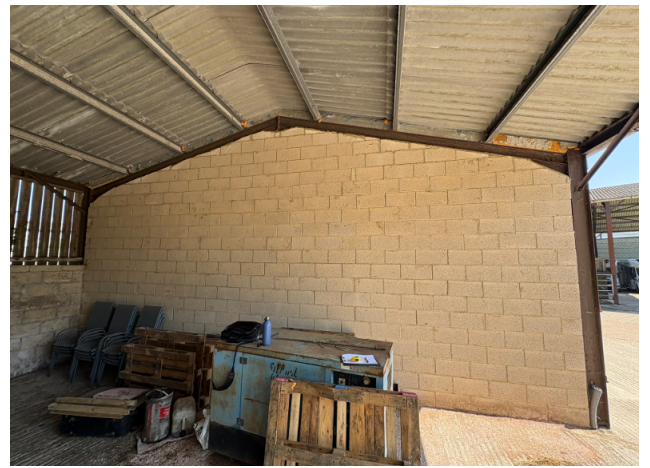
View of storage area within Barn B1 (not accessible)

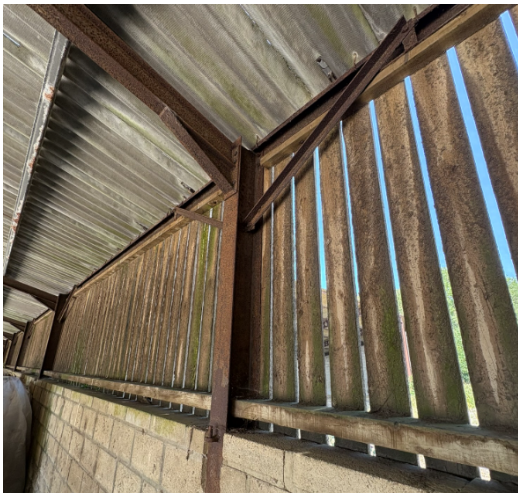
Eaves detail showing knee-braces, haunch and cladding details

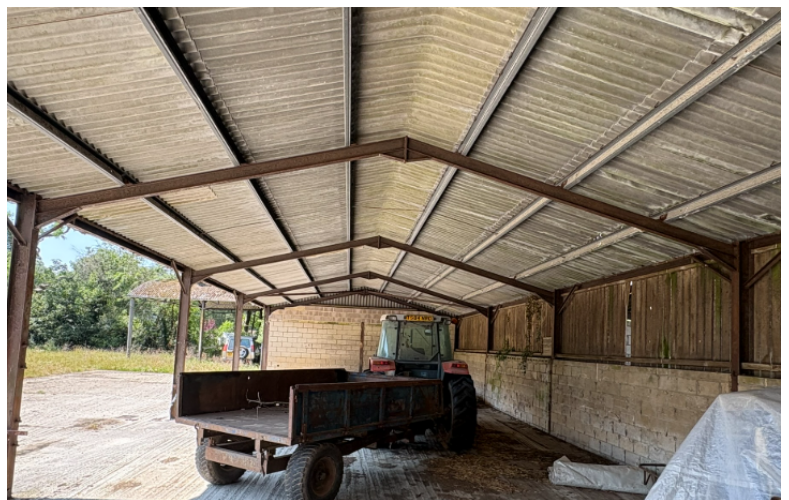
- The steelwork is in a good condition for its age, with only localised corrosion at some of the column bases. Several of these bases have been previously made good with angle brackets and concrete surrounds.

Typical portal frame view (Barn B1)

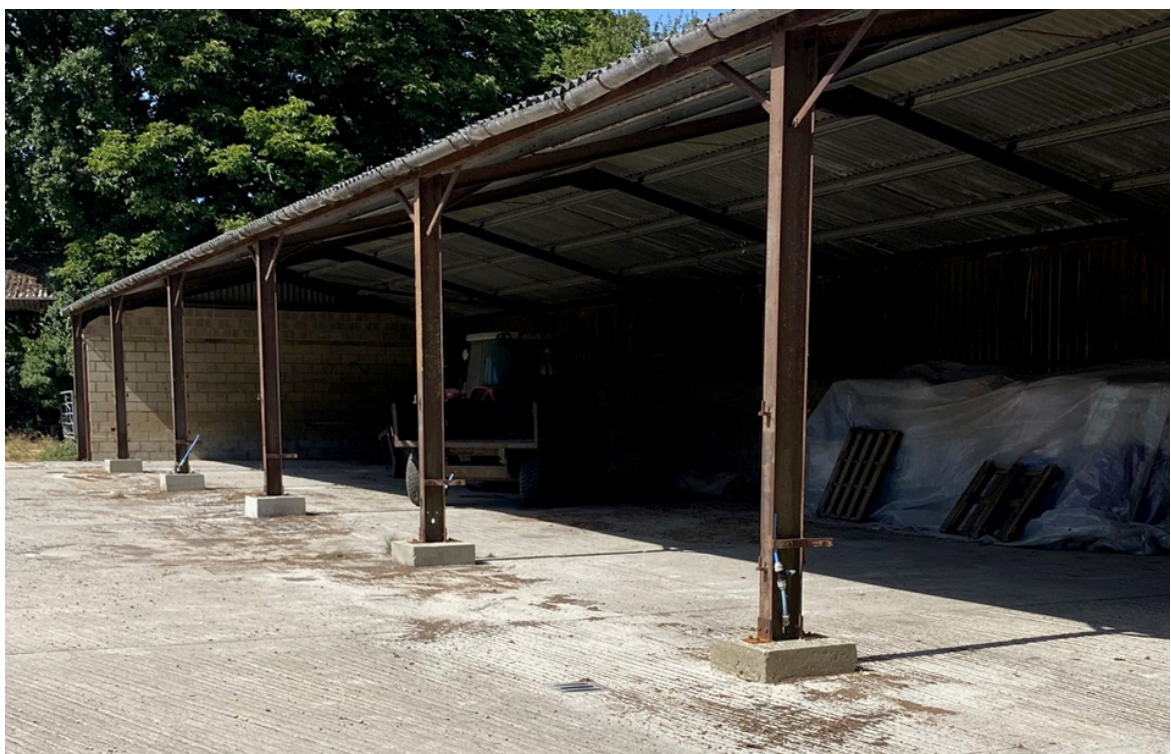
Front elevation of Barn B1 portal frames

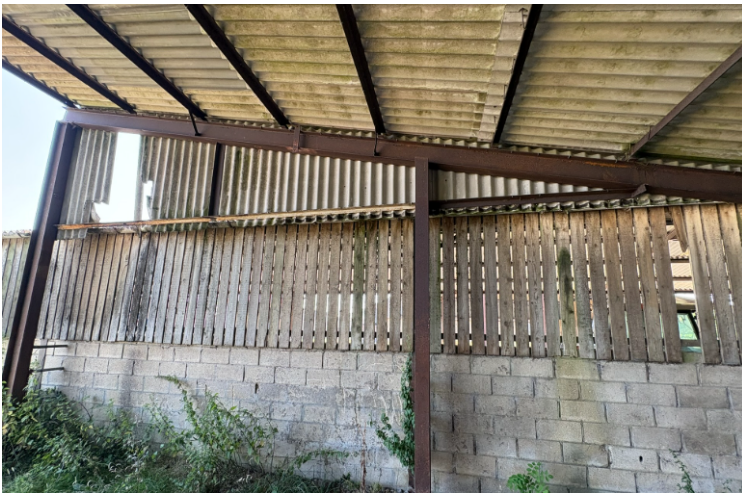
- The west elevation is open but connected back to the Barn B1 frame with steel tubes at the lower level.
- N-S stability is achieved through the knee-braces connected to the rafter and column at the higher end.

Barn B2 junction with B1.

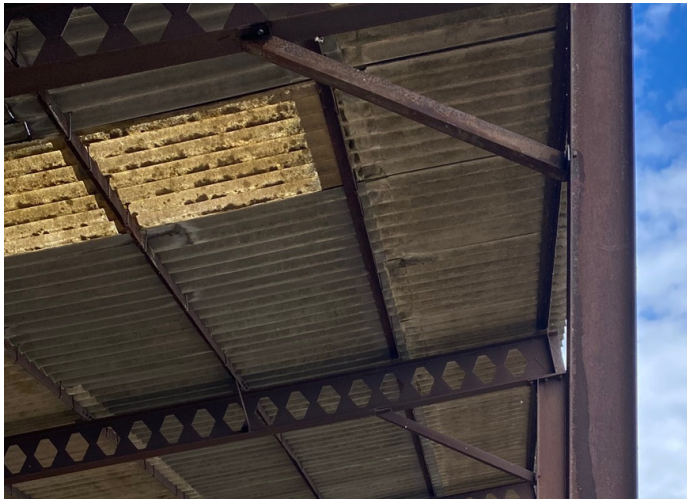
Barn B2 knee-brace detail between stanchion and castellated roof beams

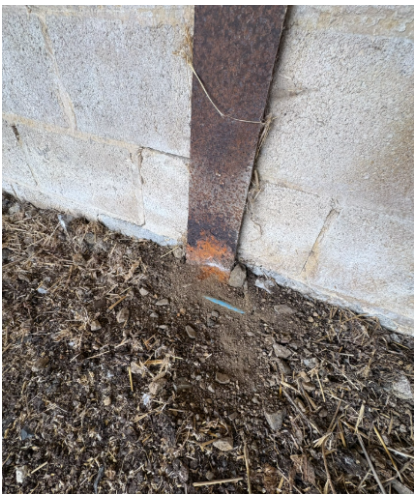
- E-W stability is provided by the rear wall and the ties back to the B1 structure.
- The steelwork is in a good condition for its age, with only localised corrosion at some of the column bases. Several of these bases have been previously made good with angle brackets and concrete surrounds.

Example of surface corrosion at column base in B2

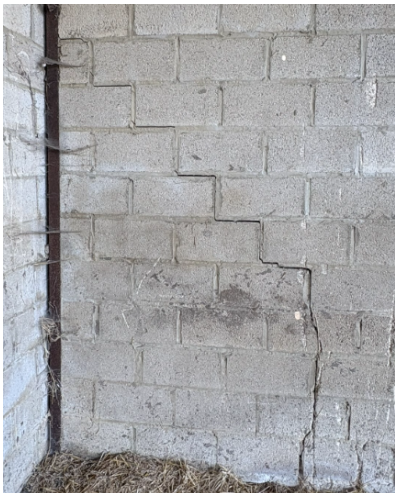
Diagonal crack in B2 requiring helibar repairs

- There are no signs of settlement of the floor slab of Barn B1.
- There is cracking in the East gable wall of barn B2 that will require a helibar type stitch repair as part of the conversion works.

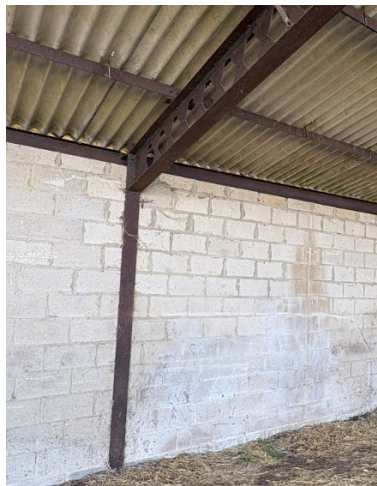
Lower eaves detail to Barn B2

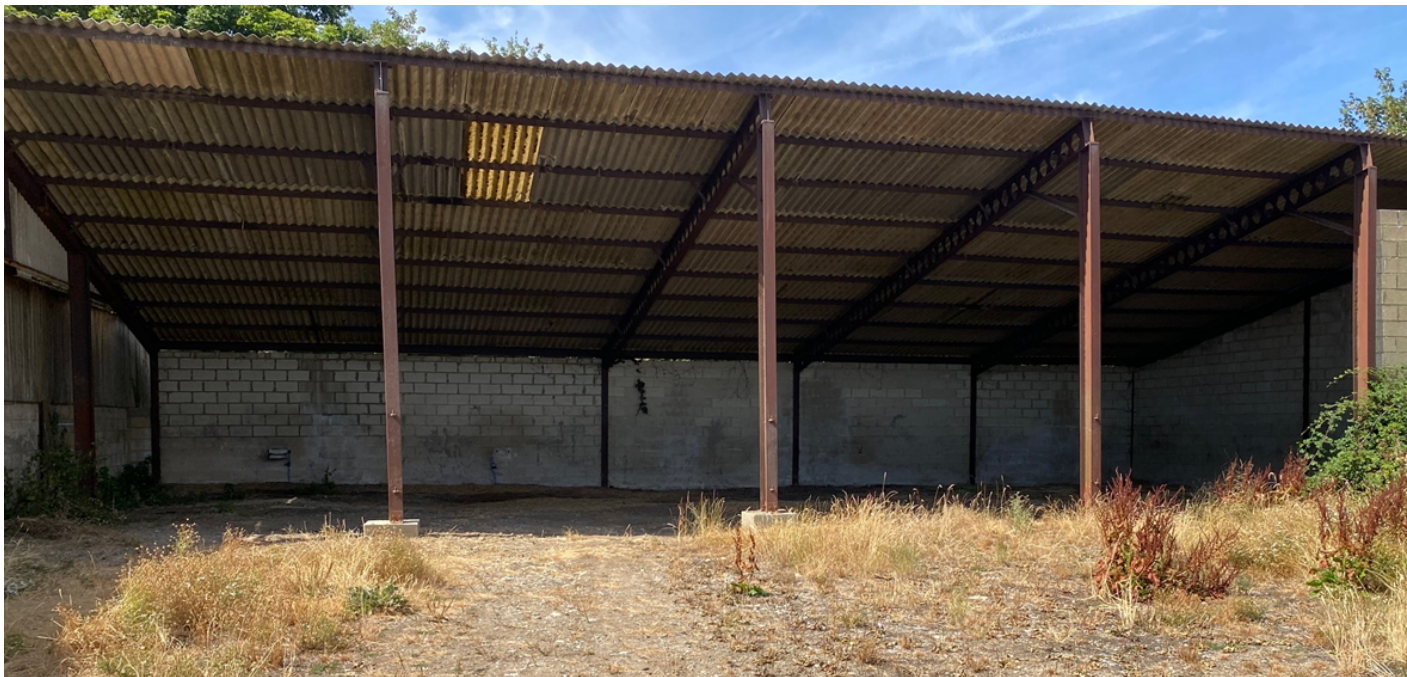
Front elevation of Barn B2
