13/08/2026  
Our Ref: 11108

## Window Condition Survey Report

**Property Address:** 33 Silver Street, Warminster

**Grade:** II

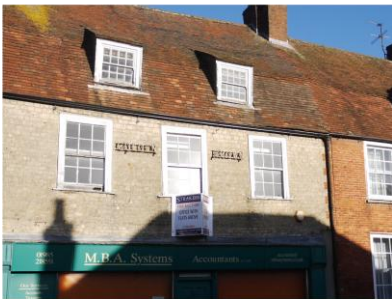
Having reviewed the property's online listing, it is clear from the two documented photographs the listing holds, (one from 2016<sup>Fig1</sup> and one from 2020<sup>Fig2</sup>), that there has been noticeable deterioration to the windows on the front elevation. These photos would also indicate that they have not been painted or substantially maintained for at least 10 years.

| Fig1. | Fig2. | Fig3. |
|---|---|---|
| <p>2016 photo of the front elevation shown on the official listing information<br/> <a href="https://historicengland.org.uk/listing/the-list/list-entry/1364409?section=comments-and-photos">https://historicengland.org.uk/listing/the-list/list-entry/1364409?section=comments-and-photos</a></p> | <p>2020 photo of the front elevation shown on the official listing information<br/> <a href="https://historicengland.org.uk/listing/the-list/list-entry/1364409?section=comments-and-photos">https://historicengland.org.uk/listing/the-list/list-entry/1364409?section=comments-and-photos</a></p> | <p>Front elevation first floor windows<br/> Photo taken August 2026</p> |

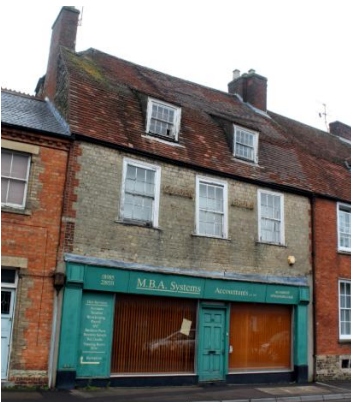
The three first-floor sash windows<sup>Fig3</sup> are traditional timber box sash windows, hung on ropes and weights. They are single-glazed, with the glass traditionally bedded in putty.

All three windows are currently in poor external condition. The following observations were noted:

- The glazing has slipped out of the rebates<sup>Fig4</sup>.
- Staff beads are missing from the bottom sections of all three windows.
- There is evidence of previous repairs to the windows.
- The existing glass does not appear to have any significant heritage value, such as crown or other historic/heritage glass.
- Due to the property having been unoccupied for a number of years, there are also signs of internal damp-related damage to the timber.

Taking the above factors into consideration, our view would be that repair and refurbishment of these three windows would not be the most appropriate or cost-effective option. We propose replacements.

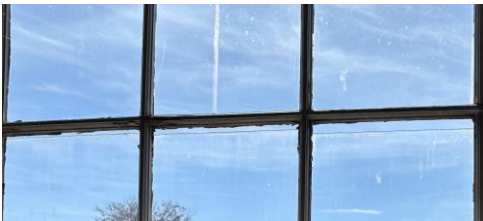
| Fig4. | Fig5. | Fig6. |
|---|---|---|
| <p>Photo showing glazing slipping out of rebates photo taken August 2026</p> | <p>Front elevation top floor windows<br/> Photo taken August 2026</p> | <p>Front elevation top floor windows- showing spring balances<br/> Photo taken August 2026</p> |

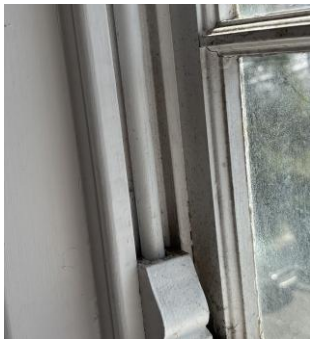
The two-dormer sash windows<sup>Fig5</sup> on the top-floor level are clearly not original to the building. However, they are timber, single-glazed windows with putty beading but the sashes are hung on spring balances<sup>Fig6</sup>.

Both windows appear to have been poorly fitted into the original timber sash box frames.

The windows themselves may be capable of repair and refurbishment. Based on our inspection, the works would potentially include:

- New external cheeks.
- Replacement of the front sections of the cills.
- Replacement of the bottom rails<sup>Fig7</sup>.
- New spring balances.
- Re-puttying.
- Full preparation and redecoration.

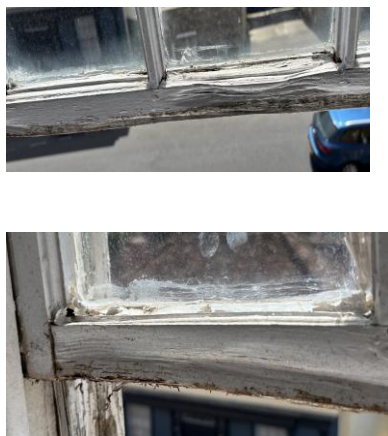
| <p>Front elevation top floor windows-bottom rails<br/>Photo taken August 2026</p> | <p>Front elevation top floor windows-showing window sitting in original frames<br/>Photo taken August 2026</p> | <p>Front elevation top floor windows-showing deteriorating outer original frames<br/>Photo taken August 2026</p> |

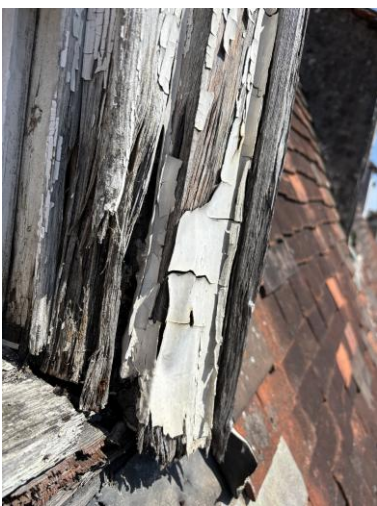
However, as can be seen in the accompanying photographs<sup>Fig8</sup>, the original timber outer frames into which these windows are currently fitted are severely deteriorated<sup>Fig9</sup>. Both windows have substantial voids beneath them as a result of the windows incorrectly sitting on the existing cills<sup>Fig9&10</sup>.

These existing outer frames would therefore require complete replacement.

It would not be impossible to remove the existing sash windows, repair them and then refit them into new outer frames. However, considering the amount of work that would be required, our recommendation would be to discuss with the Listed Building Officer whether permission could be obtained for complete replacement of the windows.

If replacement is considered acceptable, we would recommend that the new sash windows are constructed as traditional box sash windows and hung on **ropes and weights**, replicating the traditional arrangement of the original windows.

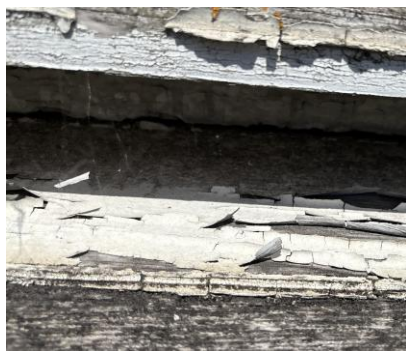
| <p>Front elevation top floor windows-showing large gap between window and outer original frames<br/>Photo taken August 2026</p> | <p>Front elevation top floor windows-Internal photo taken August 2026</p> | <p>Rear North Elevation UPVC bathroom double glazed window<br/>Photo taken August 2026</p> |

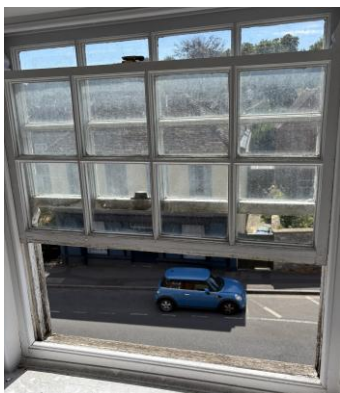
We highly recommend that these two dormer windows are treated as a **priority**. Internally, the windows themselves appear relatively sound<sup>Fig11</sup> and there are currently no obvious signs of movement. However, the surrounding outer timber frames are severely deteriorated and depending on how the inner windows have been installed and supported, further deterioration could potentially result in the sash boxes becoming loose or unstable.

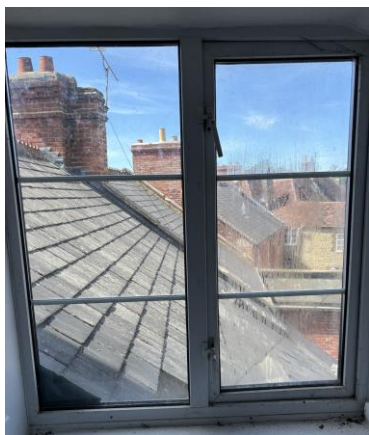
- Double-glazed uPVC window. (bathroom) [Fig12](#)
- Timber stormproof casement window, single-glazed. (kitchen) [Fig13](#)
- Standard off-the-shelf timber stormproof casement window, single-glazed. [Fig14](#)

All of these windows appear to be in a condition where repair and refurbishment could be possible.

However, having discussed your intentions for the property and your desire to restore the elevations as closely as possible to their original appearance, I would recommend discussing the rear windows with your contact at the Listed Building Department to establish whether replacement of the existing windows would be acceptable.

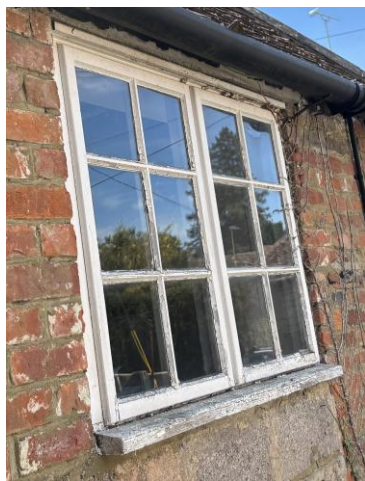
| Rear North Elevation kitchen window- timber, single glazed<br>Photo taken August 2026 | Rear North Elevation off the shelf window- timber, single glazed<br>Photo taken August 2026 | |

If the Council is supportive of replacement windows, we would suggest considering a design based on the existing kitchen window [Fig13](#). In our opinion, this would be more sympathetic to the character and history of the property and would provide a more consistent appearance across the rear elevation.
