## BANK HOUSE

### Repairs to Tie-Beam Archbrace Pendants & Finials to Bargeboards

#### Heritage Justification, Design & Access Statement (L11.01)

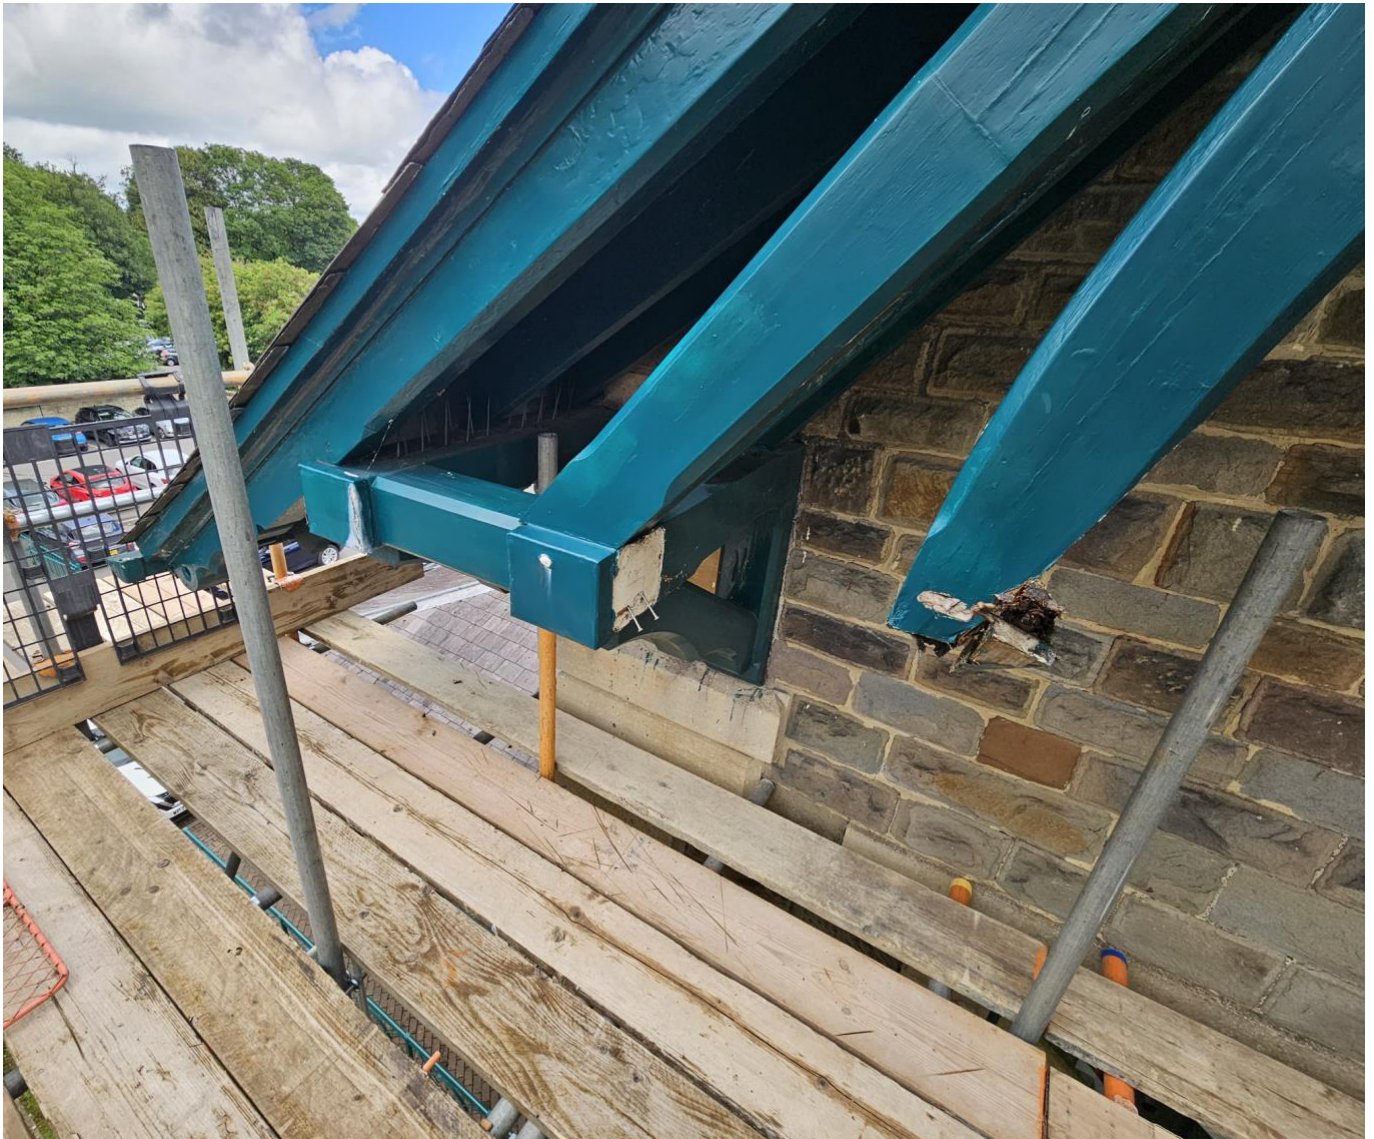
Fig.3: Damage to bottom of archbrace and missing finial section

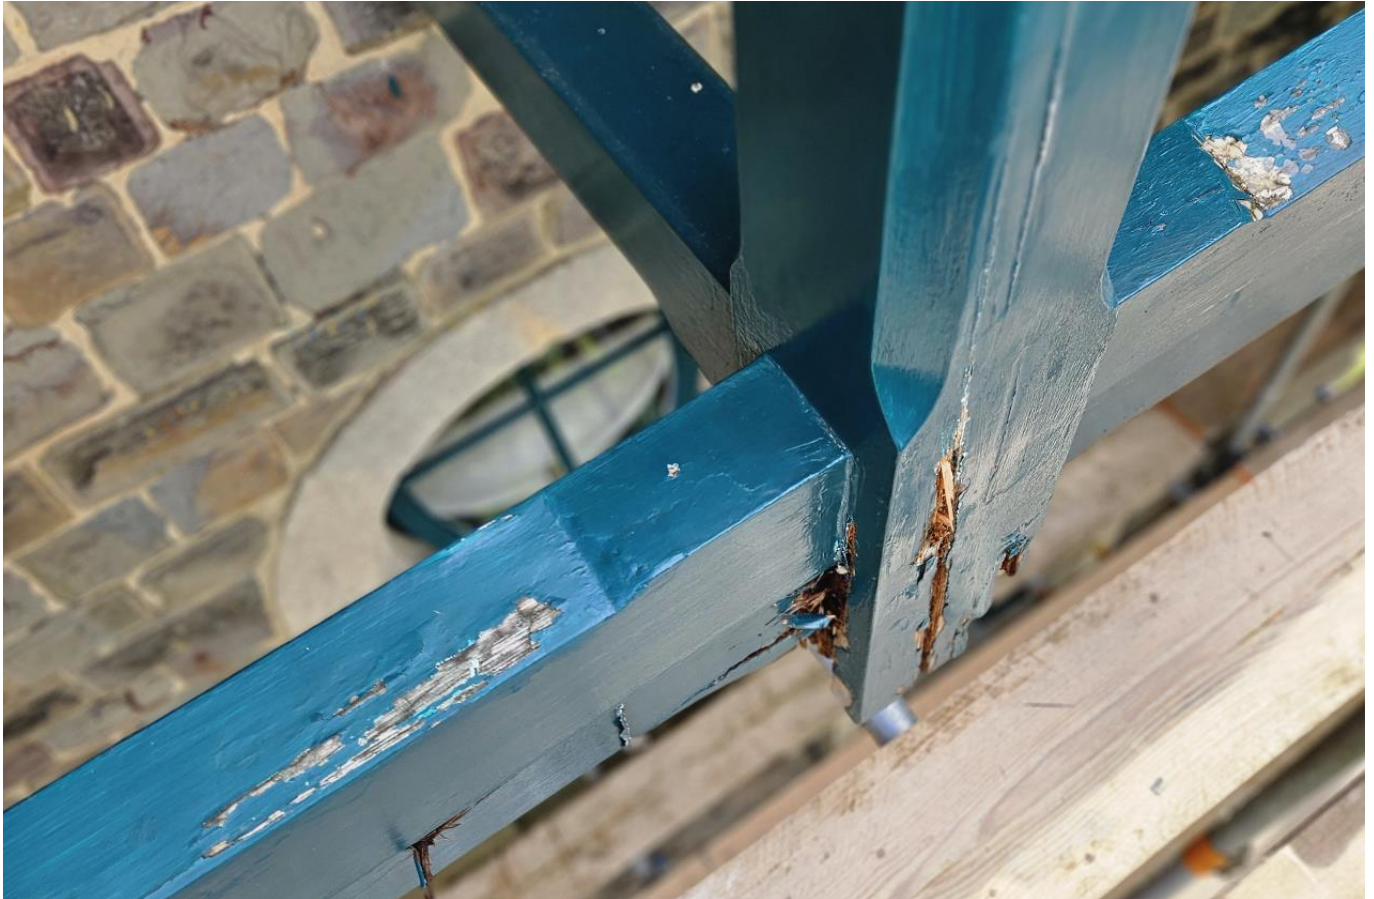
Fig.4: Damage to timber pendants and tie-beam to gable end

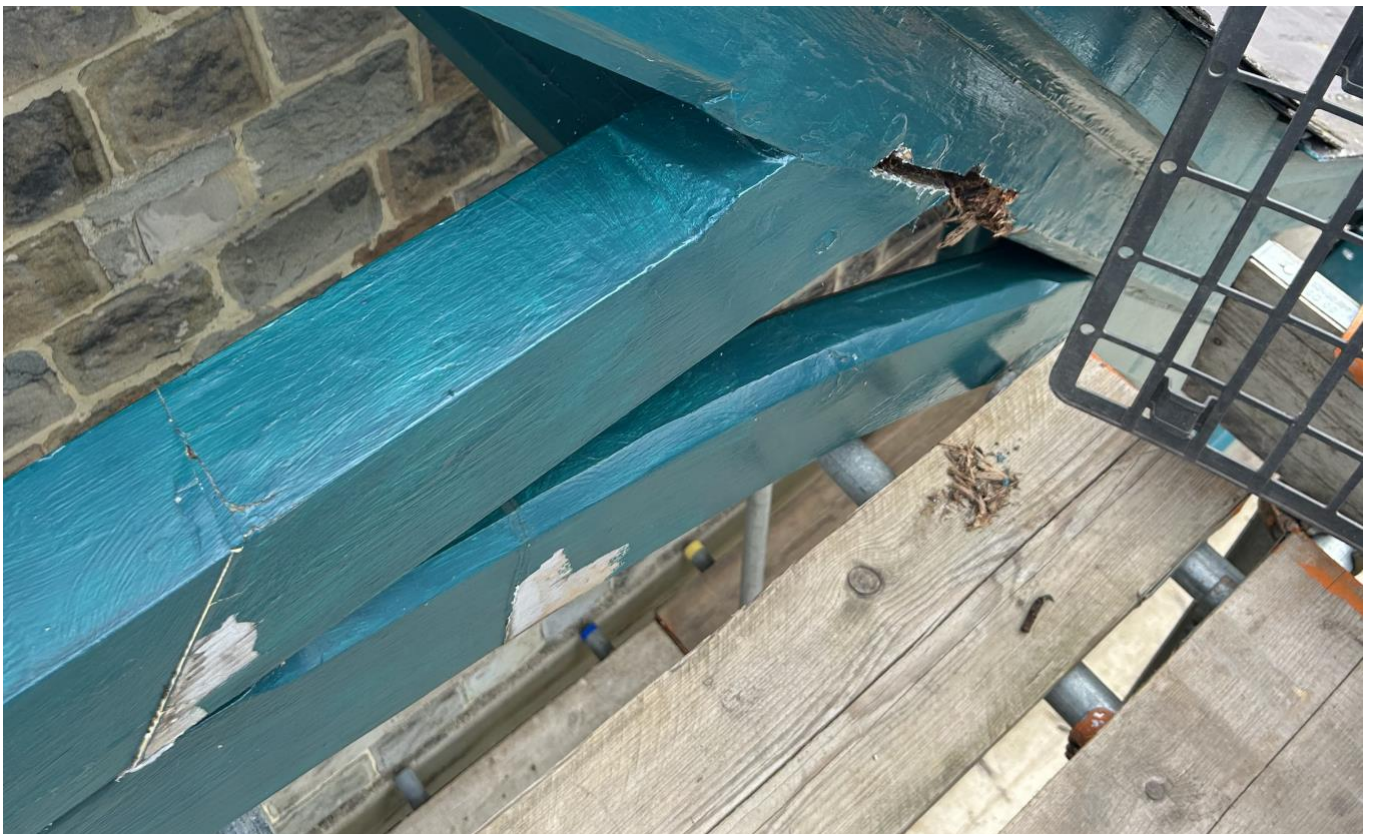
Fig.5: Damage to timber pendants and tie-beam to gable end

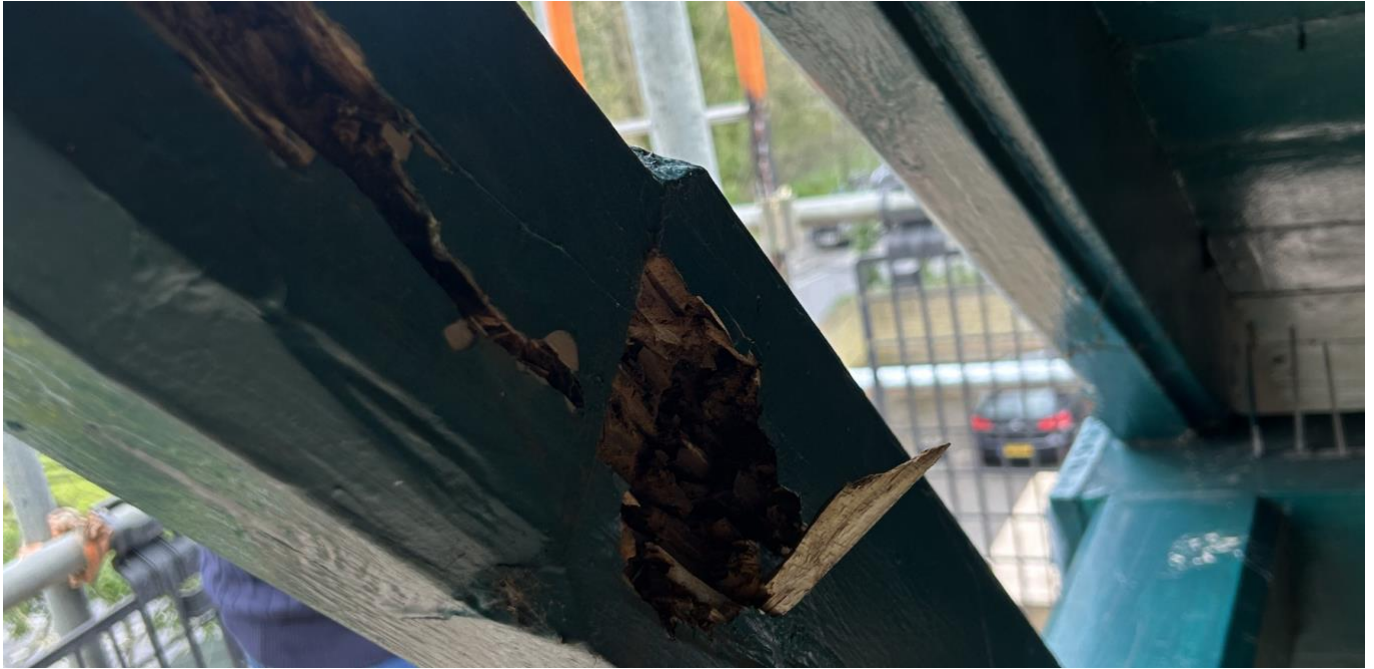
Fig.6: Damage to archbrace
