REPAIRS TO TIE-BEAM ARCHBRACES PENDANTS & FINIALS TO BARGEBOARDS  
BANK HOUSE, BATH ROAD, CHIPPENHAM SN15 2SA  
APPLICATION FOR LISTED BUILDING CONSENT: DETAILED PROPOSALS 1:10@A0

| DAVID BRAIN PARTNERSHIP | | | |
|---|---|---|---|
| Drawing Title: | LISTED BUILDING CONSENT PROPOSALS | Drawn: RWL | Job No: 1379 |
| Project Name: | Bank House | Date: AUGUST 2026 | Paper Size: A0 |
| Project Address: | Bath Rd, Chippenham, SN15 2SA | Scale: 1:10 | Drawing No: A401 |

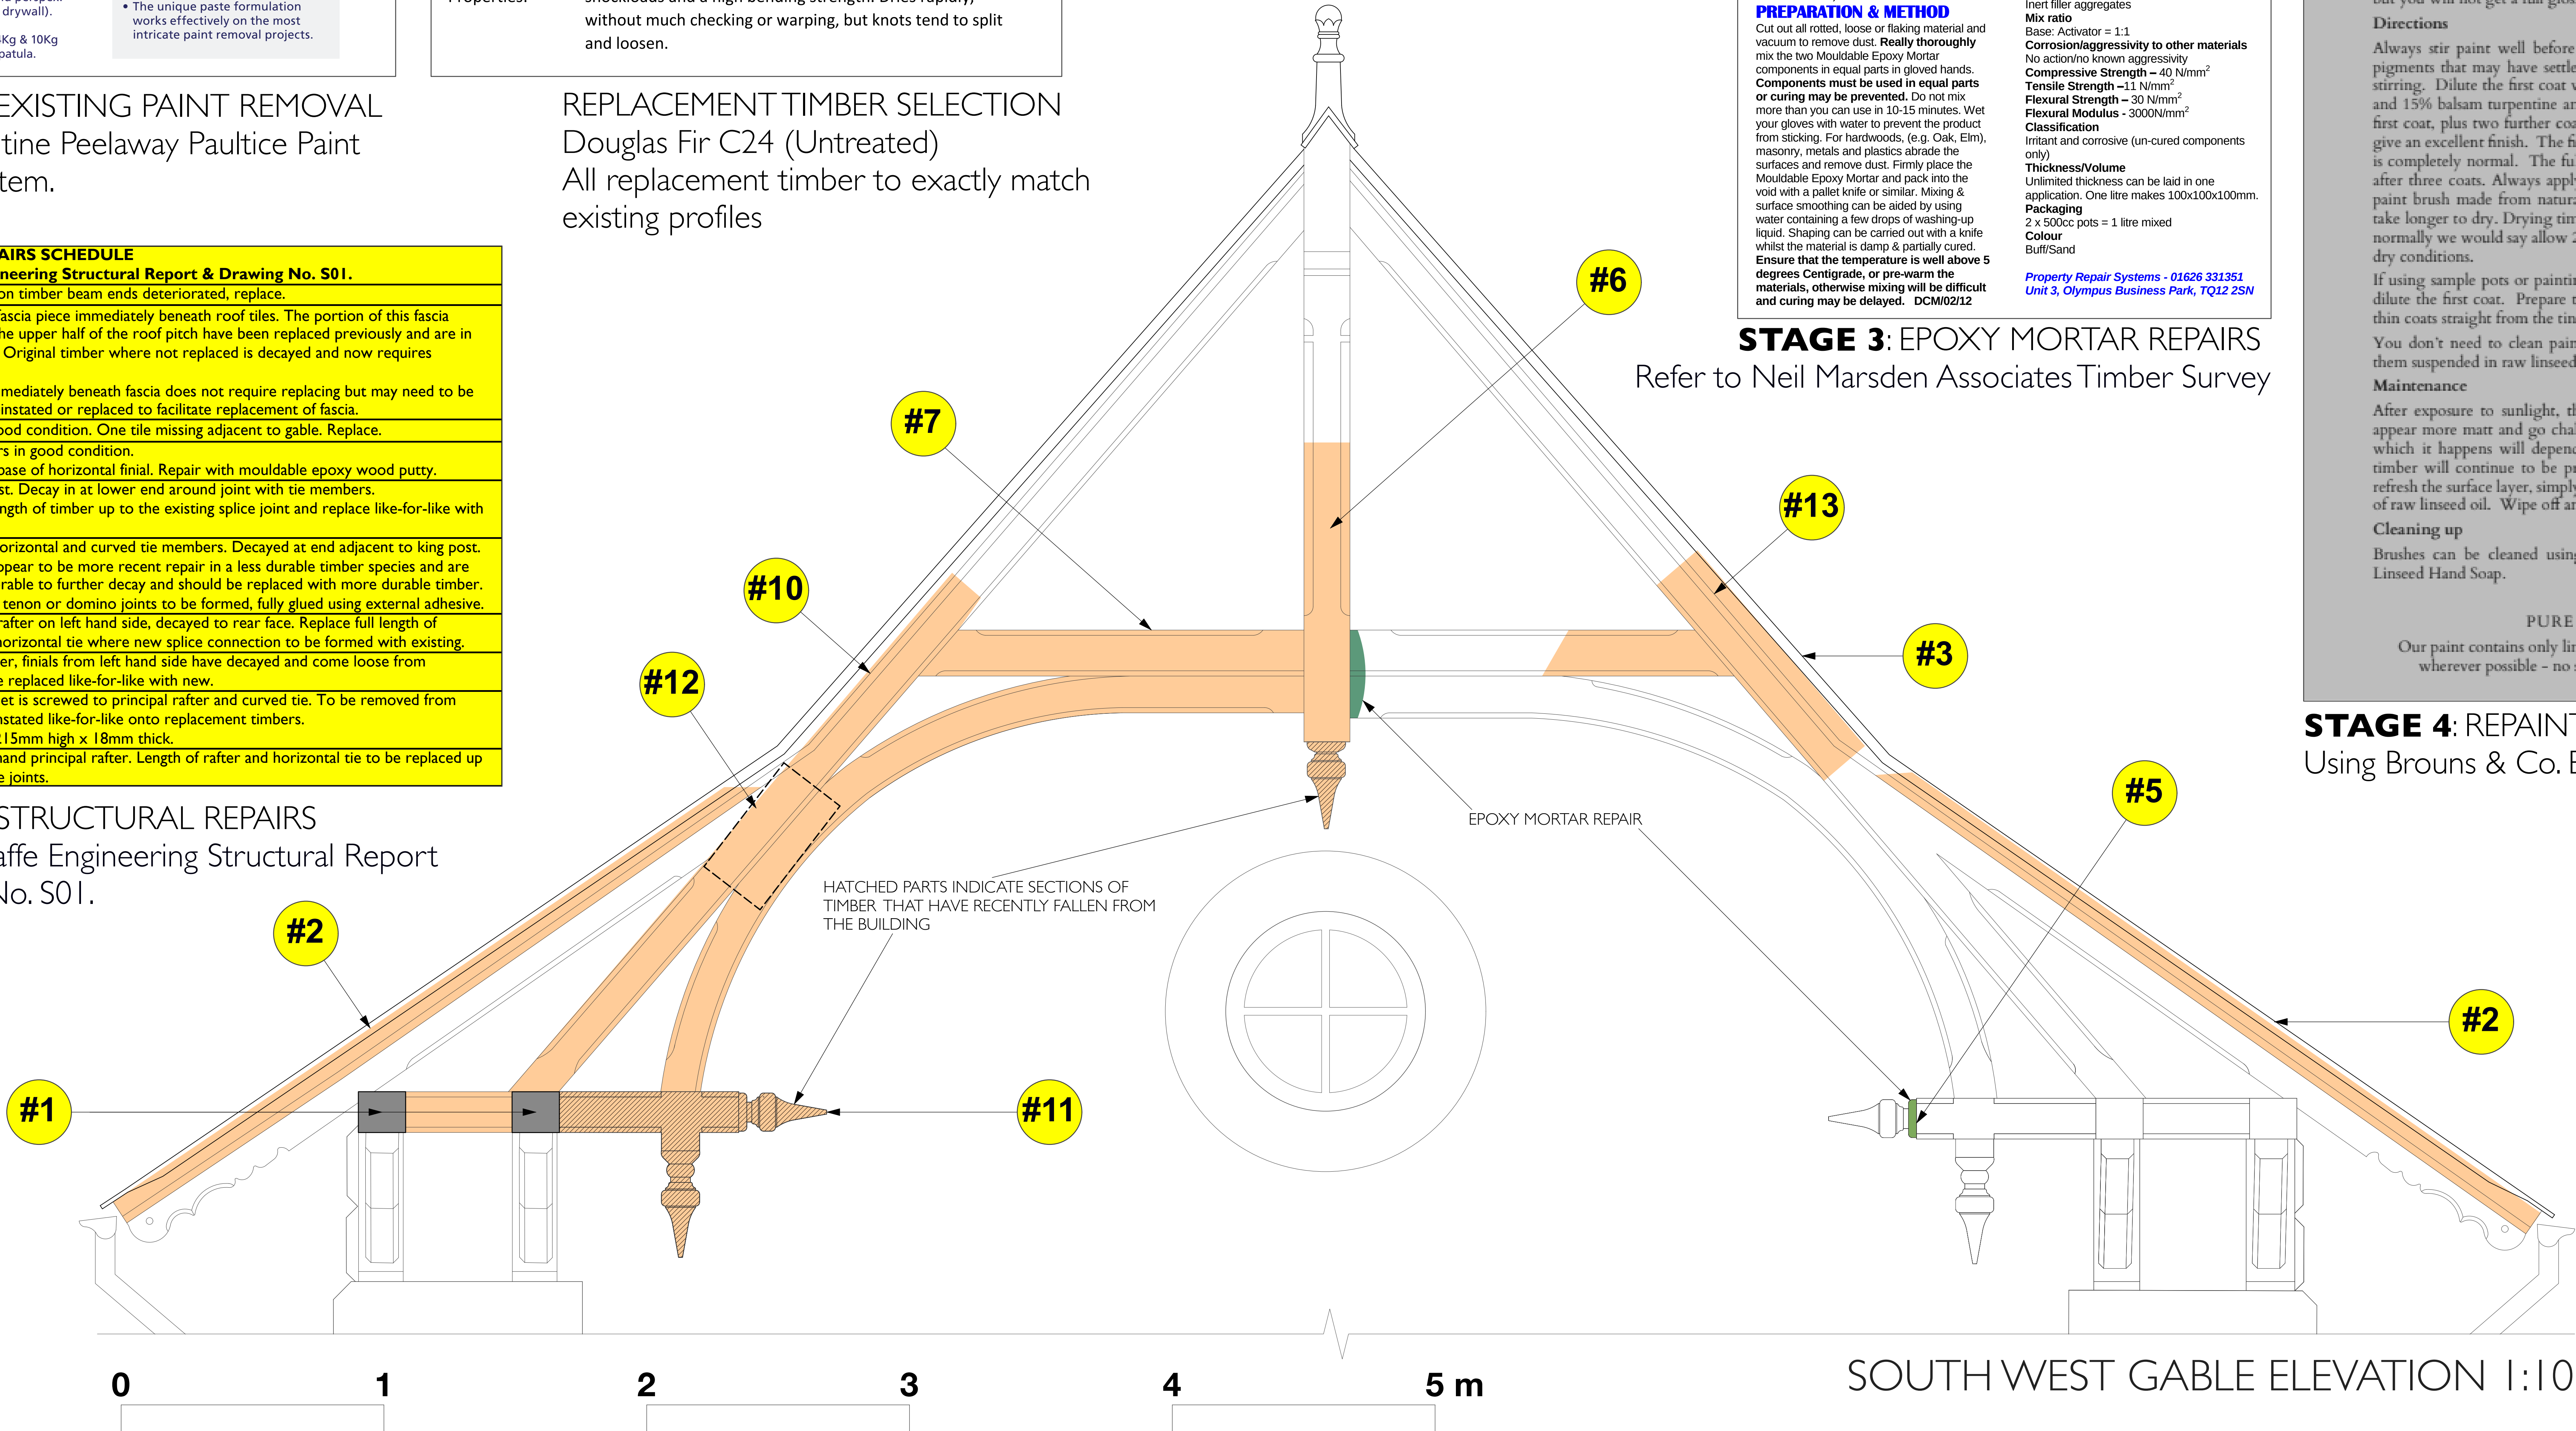
| STRUCTURAL REPAIRS SCHEDULE | |
|---|---|
| #1 | 2No. lead caps on timber beam ends deteriorated, replace. |
| #2 | Painted timber fascia piece immediately beneath roof tiles. The portion of this fascia piece towards the upper half of the roof pitch have been replaced previously and are in good condition. Original timber where not replaced is decayed and now requires replacing.<br>Coving piece immediately beneath fascia does not require replacing but may need to be removed and reinstated or replaced to facilitate replacement of fascia. |
| #3 | Roof slates in good condition. One tile missing adjacent to gable. Replace. |
| #5 | Timber members in good condition.<br>Some decay to base of horizontal finial. Repair with mouldable epoxy wood putty. |
| #6 | Vertical king post. Decay in at lower end around joint with tie members.<br>Removed the length of timber up to the existing splice joint and replace like-for-like with new timber. |
| #7 | Left hand side horizontal and curved tie members. Decayed at end adjacent to king post. Both sections appear to be more recent repair in a less durable timber species and are therefore, vulnerable to further decay and should be replaced with more durable timber. New mortice & tenon or domino joints to be formed, fully glued using external adhesive. |
| #10 | Truss principal rafter on left hand side, decayed to rear face. Replace full length of member up to horizontal tie where new splice connection to be formed with existing. |
| #11 | Horizontal timber, finials from left hand side have decayed and come loose from structure. To be replaced like-for-like with new. |
| #12 | Existing ply gusset is screwed to principal rafter and curved tie. To be removed from existing and reinstated like-for-like onto replacement timbers.<br>615mm long x 215mm high x 18mm thick. |
| #13 | Decay to right hand principal rafter. Length of rafter and horizontal tie to be replaced up to existing splice joints. |

STAGE 2: STRUCTURAL REPAIRS  
Refer to Giraffe Engineering Structural Report & Drawing No. S01.
