Bank House, Bath Road, Chippenham SN15 2SA

**SOUTHWEST ELEVATION EXTERNAL JOINERY - STRUCTURAL  
REPORT**

[1850GE]

July 2026

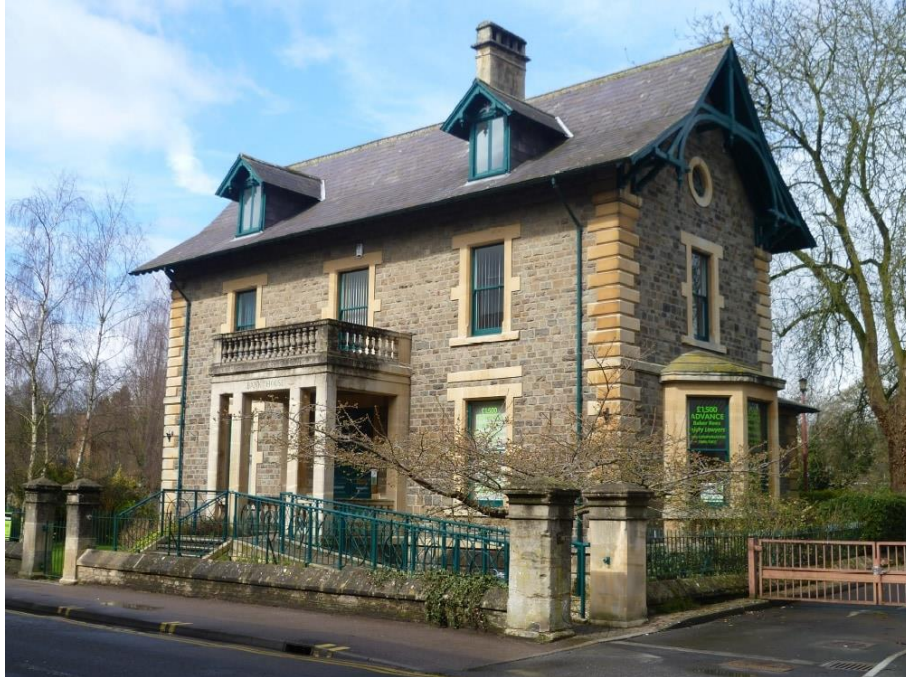
*Figure 1: Front elevation showing external joinery on northeast gable elevation.*

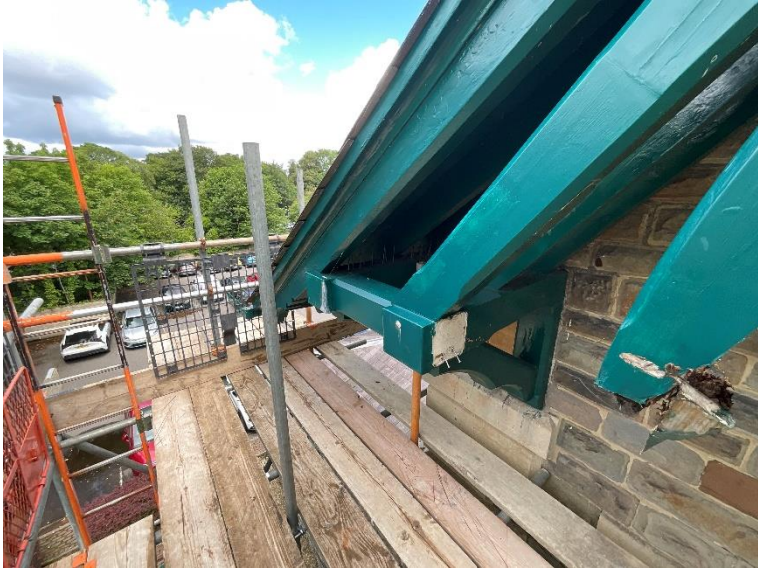
| Ref | Description | Figure |
|---|---|---|
| #1 | 2No. lead caps on timber beam ends deteriorated, replace. | |

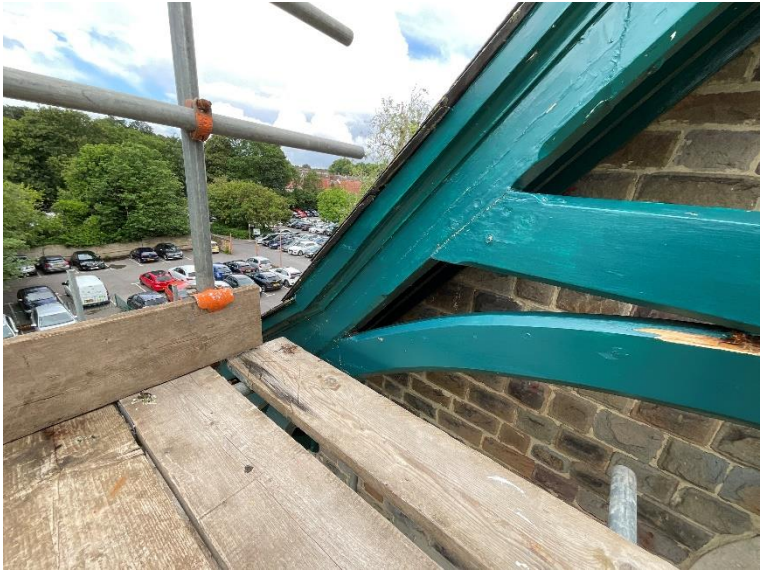
| <p>#2</p> | <p>Painted timber fascia piece immediately beneath roof tiles. The portion of this fascia piece towards the upper half of the roof pitch have been replaced previously and are in good condition. Original timber where not replaced is decayed and now requires replacing.</p> <p>Coving piece immediately beneath fascia does not require replacing but may need to be removed and reinstated or replaced to facilitate replacement of fascia.</p> | |

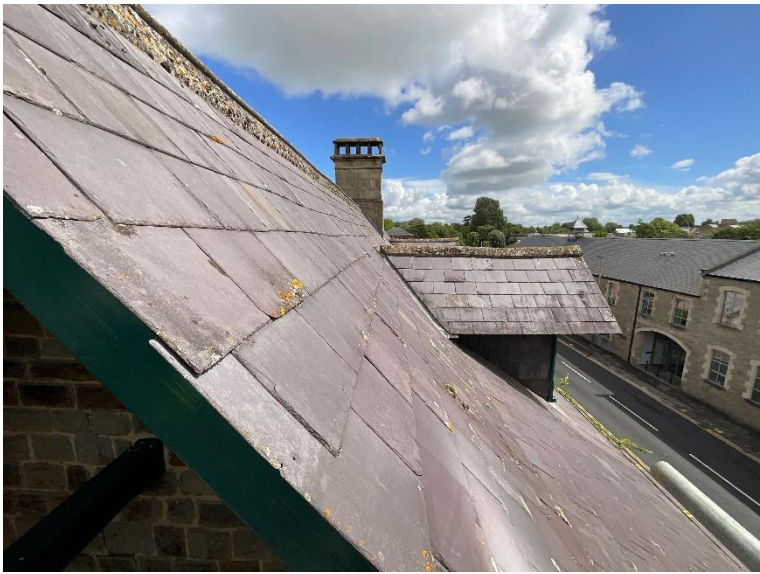
| <p>#3</p> | <p>Roof slates in good condition. One tile missing adjacent to gable. Replace.</p> | |

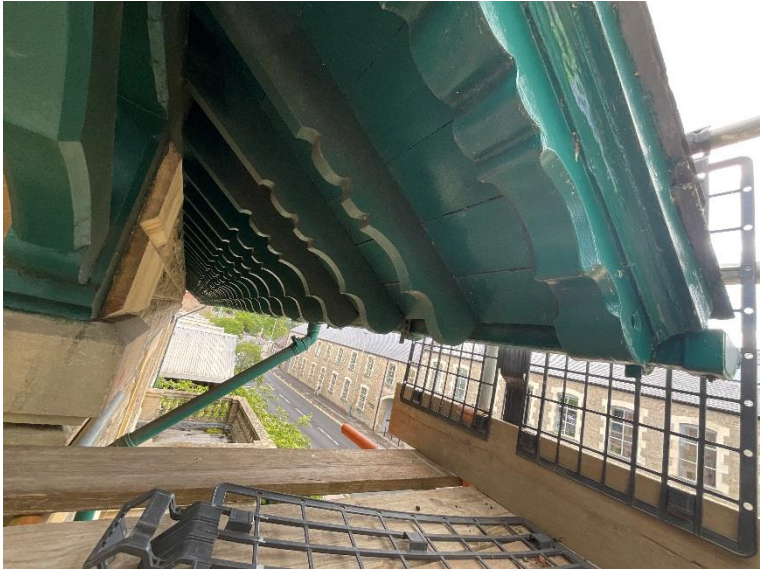
| <p>#4</p> | <p>Rafters and rafter ends in good condition.</p> <p>Rafters typically 50mm wide at 300mm centres. The end rafters is 100mm wide.</p> | |

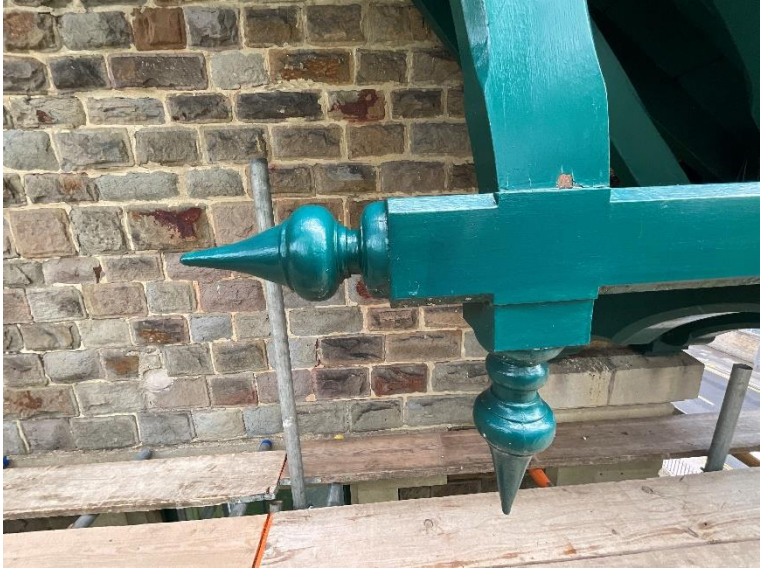
| <p>#5</p> | <p>Timber members in good condition.</p> <p>Some decay to base of horizontal finial. Repair with mouldable epoxy wood putty.</p> | |

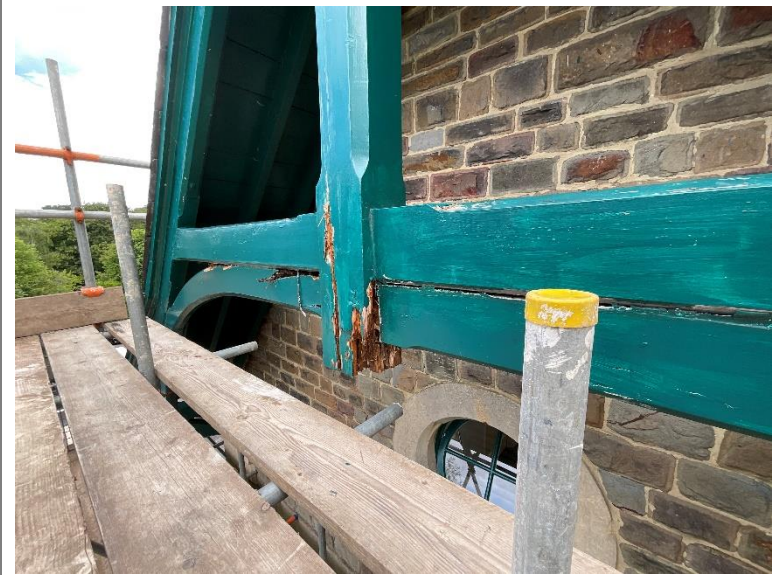
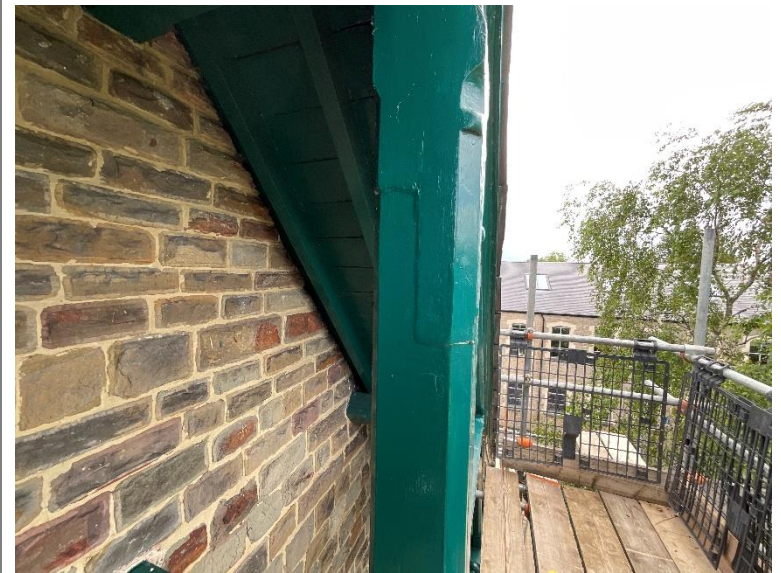
- #6 Vertical king post. Decay in at lower end around joint with tie members.
- Removed the length of timber up to the existing splice joint and replace like-for-like with new timber.

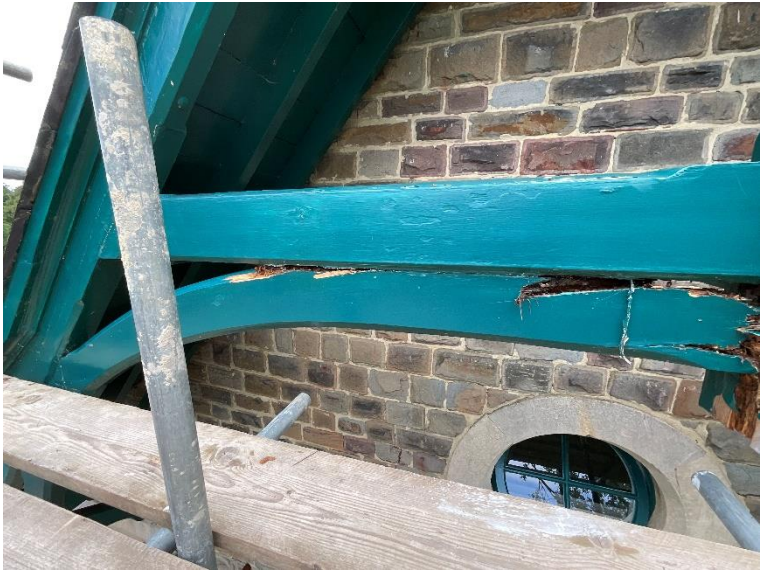
| <p>#7</p> | <p>Left hand side horizontal and curved tie members. Decayed at end adjacent to king post. Both sections appear to be more recent repair in a less durable timber species and are therefore vulnerable to further decay and should be replaced with more durable timber.</p> <p>New mortice &amp; tenon or domino joints to be formed, fully glued using external adhesive.</p> | |

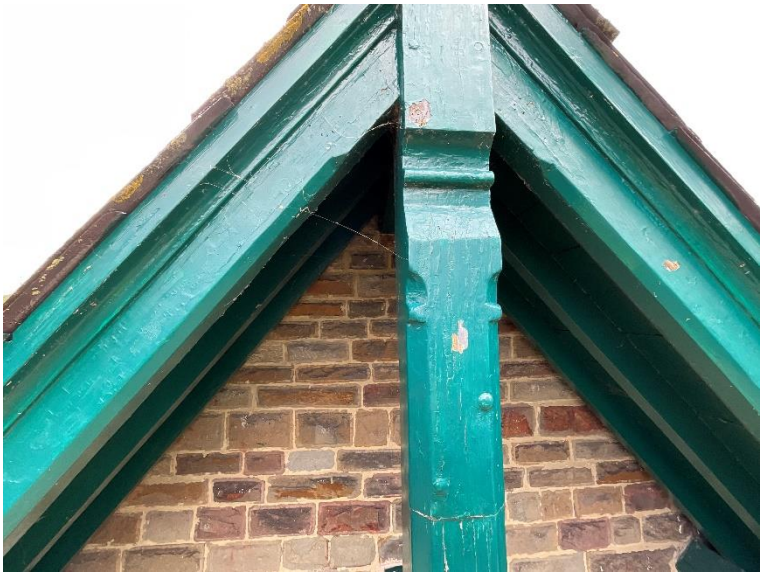
| <p>#8</p> | <p>Timberwork at ridge. Good condition. Repainting required.</p> | |

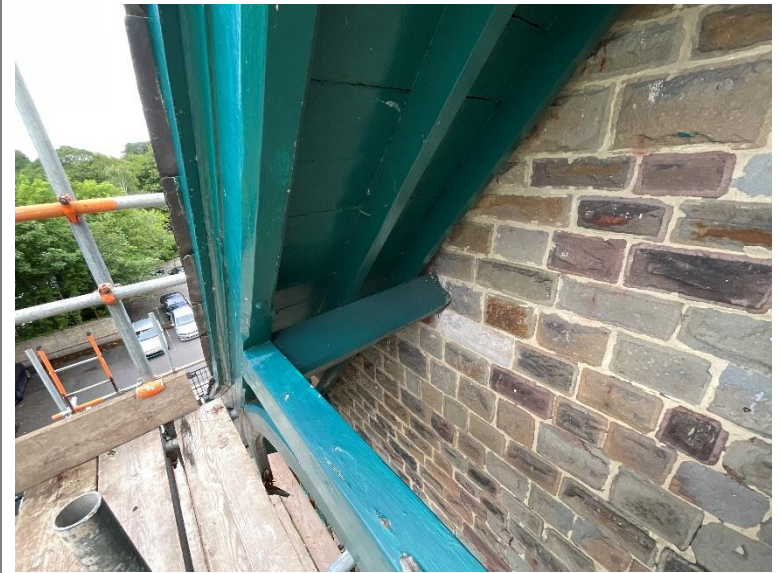
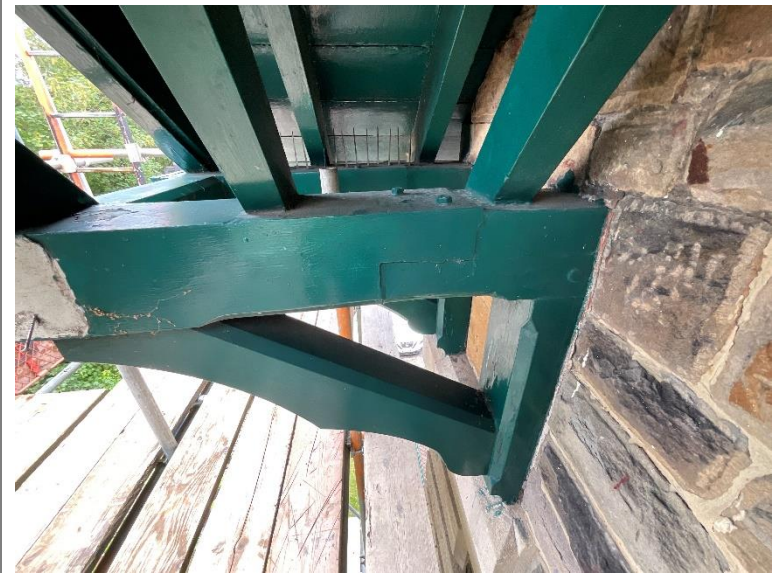
#9 High level and low level purlins and braces on both sides all in good condition. No action.

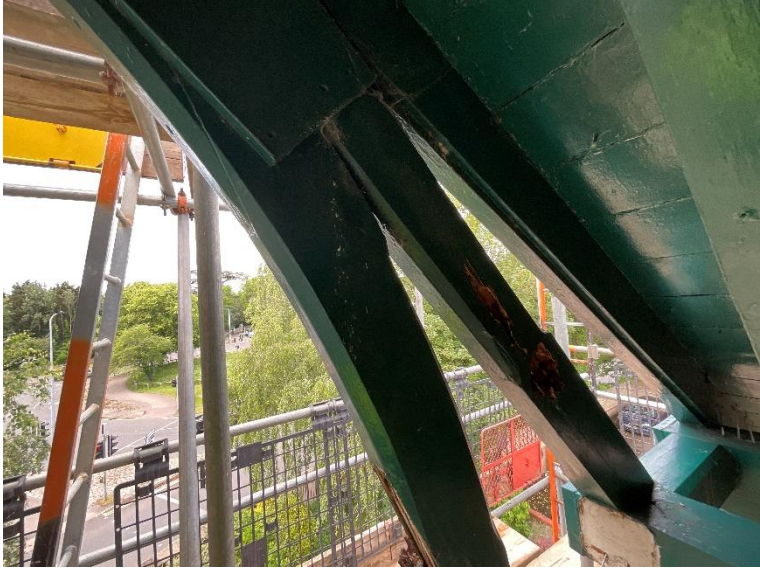
| #10 | Truss principal rafter on left hand side, decayed to rear face. Replace full length of member up to horizontal tie where new splice connection to be formed with existing. | |

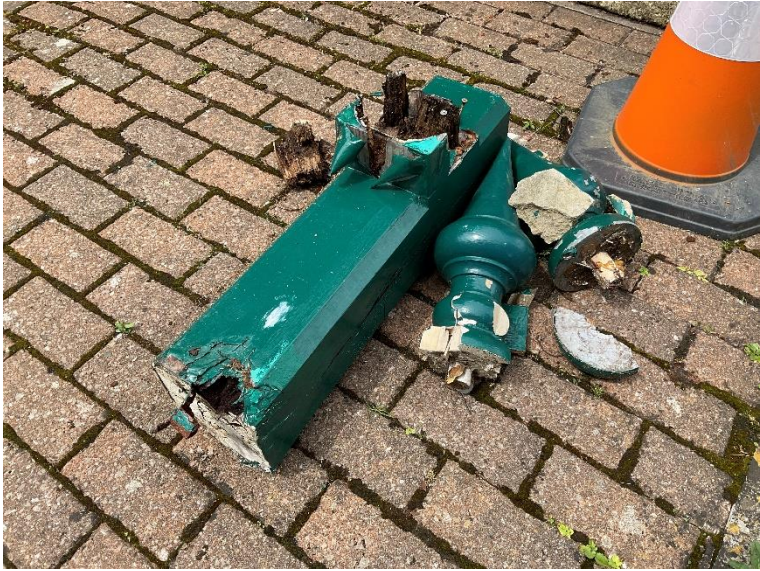
| #11 | Horizontal timber, finials from left hand side have decayed and come loose from structure. To be replaced like-for-like with new. | |

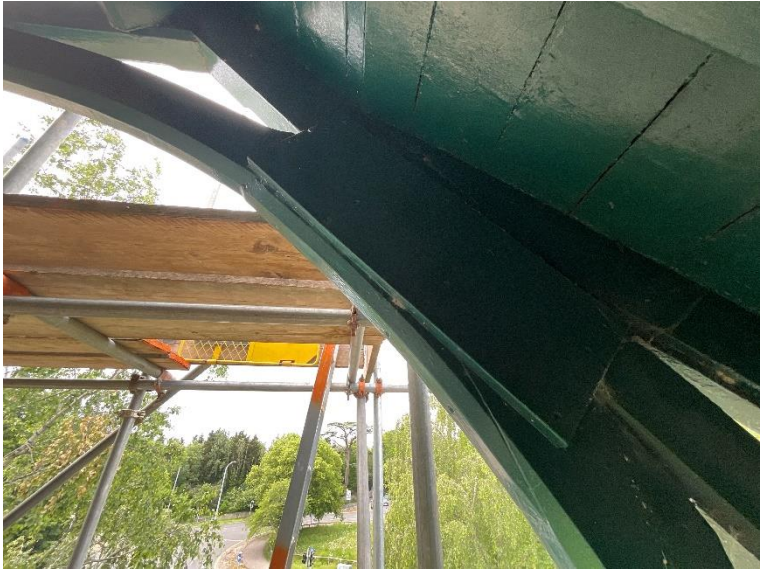
| #12 | <p>Existing ply gusset is screwed to principal rafter and curved tie. To be removed from existing and reinstated like-for-like onto replacement timbers.</p> <p>615mm long x 215mm high x 18mm thick.</p> | |

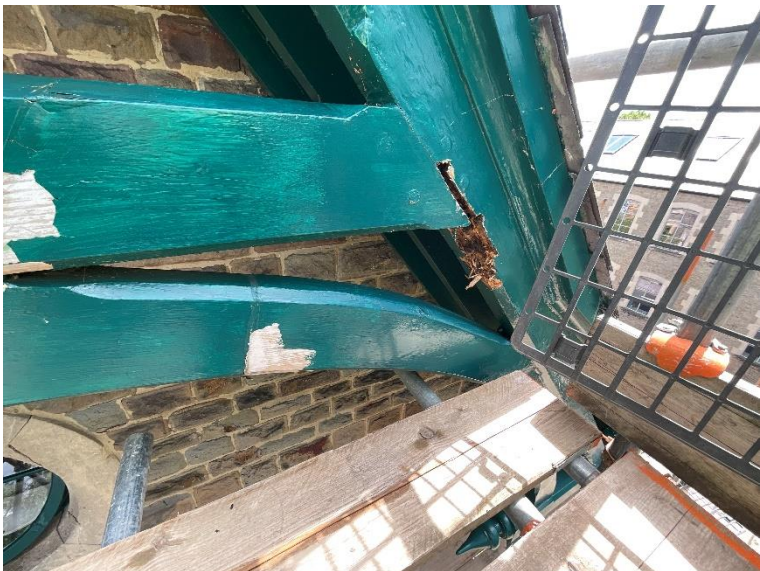
| #13 | <p>Decay to right hand principal rafter. Length of rafter and horizontal tie to be replaced up to existing splice joints.</p> | |
