## Off Mains Drainage Survey Report Prepared For:

Brunton  
SN8 3SE

**Date of Survey:** 27/10/2025

**Project Name:** Slingfield Cottage, Brunton, Marlborough SN8 3SE

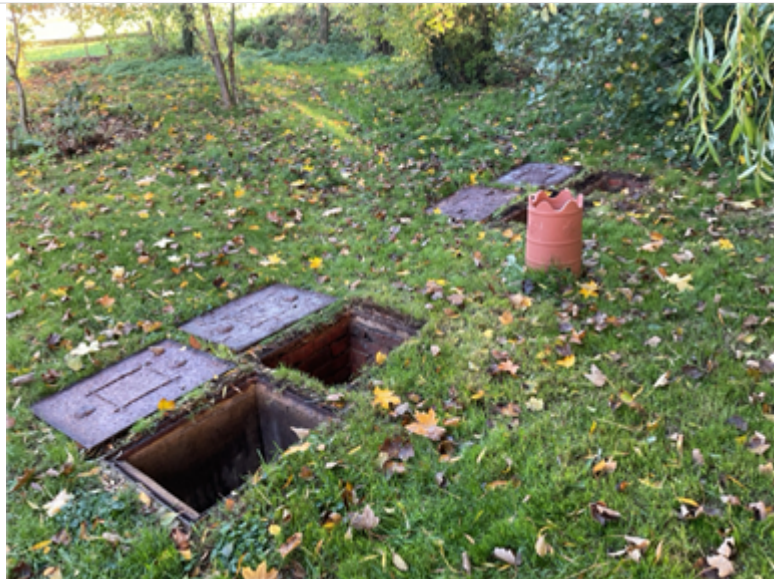
Photograph of the general area of the tank:

| <b>Overall condition of the tank:</b> | Satisfactory |
| <b>Was there any damage observed to the tank during the inspection?</b> | No |

Excavate and install a new 6 person sewage treatment plant (STP) with integral pumped outlet, to be located on the grass lawn adjacent to the existing septic tank, inlet invert depth 1.1m.

Empty, backfill, cap off and decommission the existing septic tank, DC and MH4.

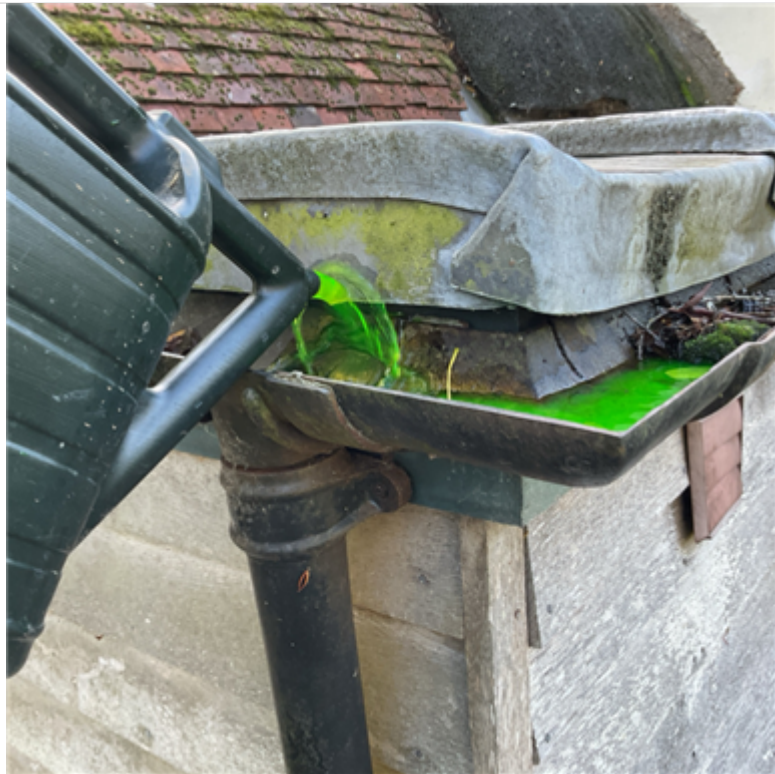
Photograph of dye test undertaken

Were there any cross connections found between the rainwater system and the foul system?

No

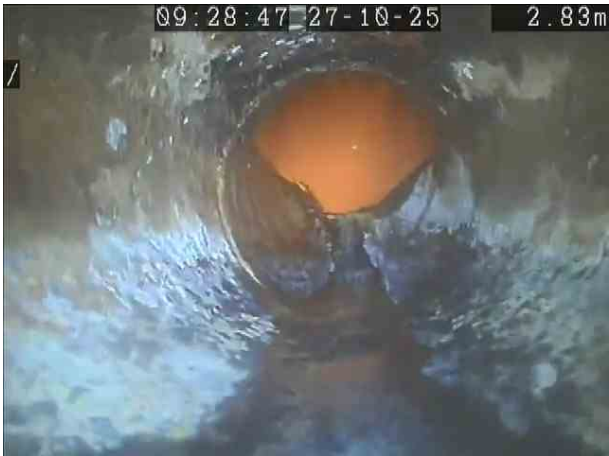
81f02555-0d89-468c-ae4f-4796d978f216.png, 00:00:32,  
2.83 m  
Line deviates up

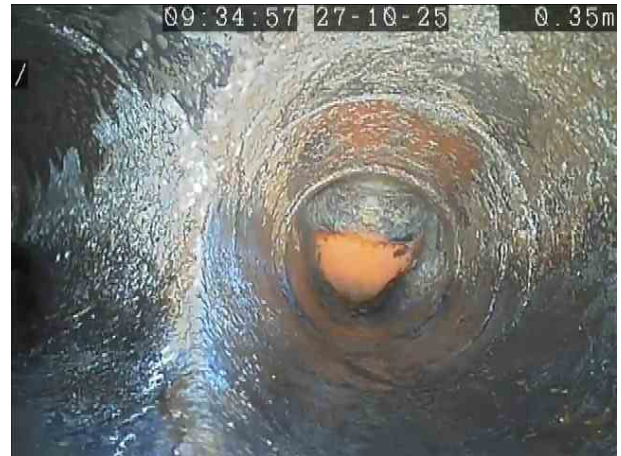
1c8a0ad6-aeab-4bb6-9fd2-4ac4f40f7d13.png, 00:00:24,  
0.35 m  
Junction at 10 o'clock, 100mm dia

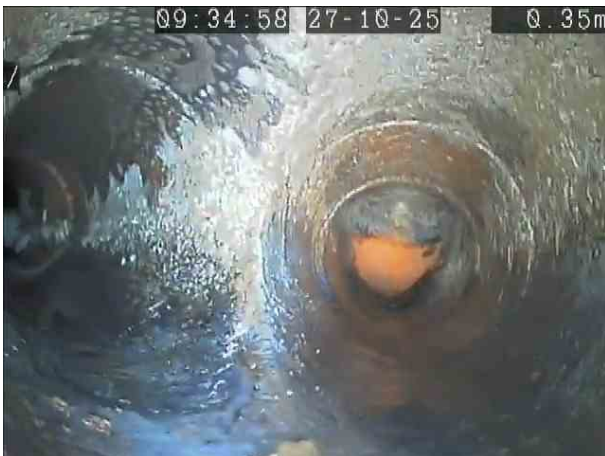
fdbf41fb-321d-4a69-baa3-74e95a19d159.png, 00:00:25,  
0.35 m  
Line deviates left

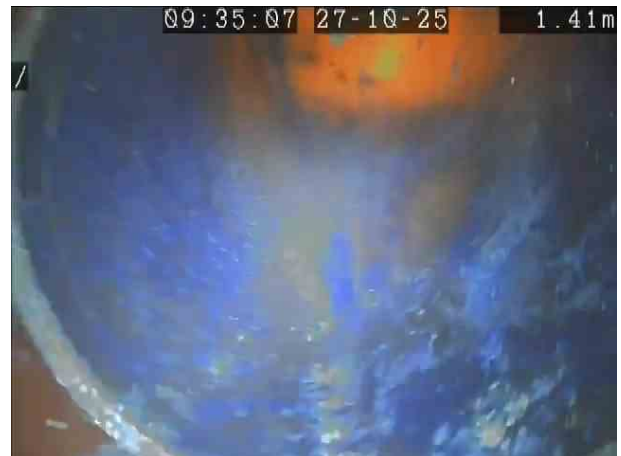
50fdef2b-6cfa-4c52-9996-b7f7f37fb40f.png, 00:00:33, 1.41  
m  
Line deviates up

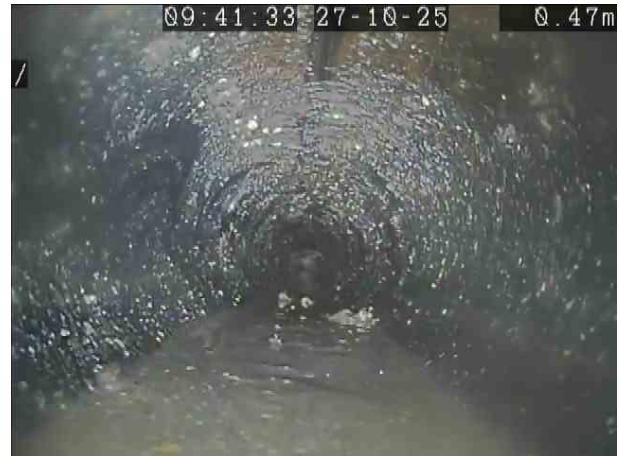
| Item No. | PLR | Grade | Description |
|---|---|---|---|
| 4 | MH4X | 5 | Attached deposits, grease from 4 o'clock to 8 o'clock, 20% cross-sectional area loss, finish |

f6fc9649-c0df-4c5c-85c3-4e7f7474a6b6.png, 00:00:13,  
0.47 m  
Attached deposits, grease from 4 o'clock to 8 o'clock, 20%

Expose the upstream drainage and install a new inspection chamber (IC) to pick up runs 3 and 4 prior to MH4.

The upstream drainage requires high pressure water jetting to remove a build up of fat & grease debris, the customer is going to have this completed while the tank is still empty.

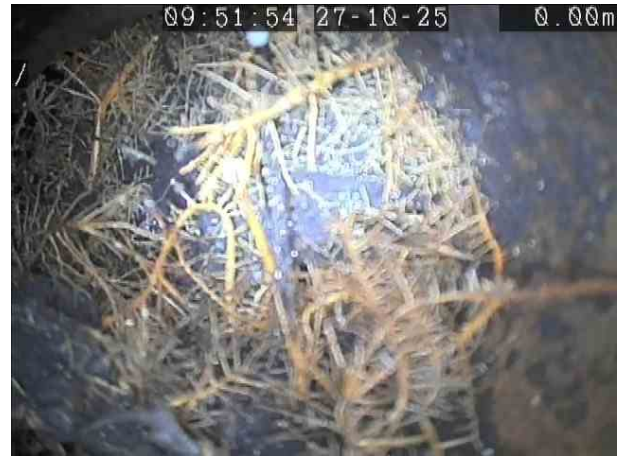
| Item No. | PLR | Grade | Description |
|---|---|---|---|
| 5 | DCX | 5 | Roots, mass, 90% cross-sectional area loss |

a465fbca-864e-420a-ad48-71e227b3eb67.png, 00:00:11,  
0.00 m  
Roots, mass, 90% cross-sectional area loss

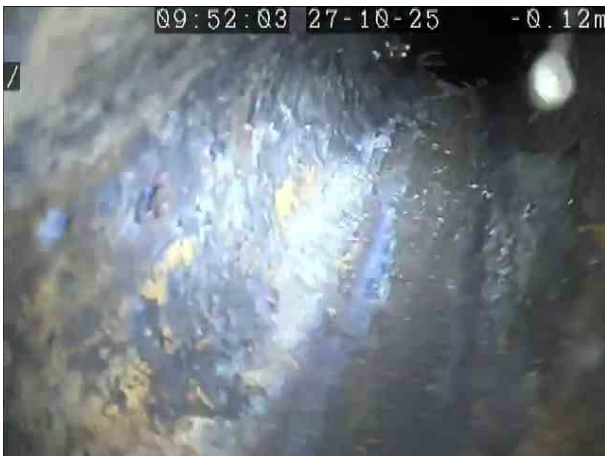
6855cfa0-9eec-44c3-ac4c-b3886c4e1f71.png, 00:00:19,  
0.00 m  
Line deviates down

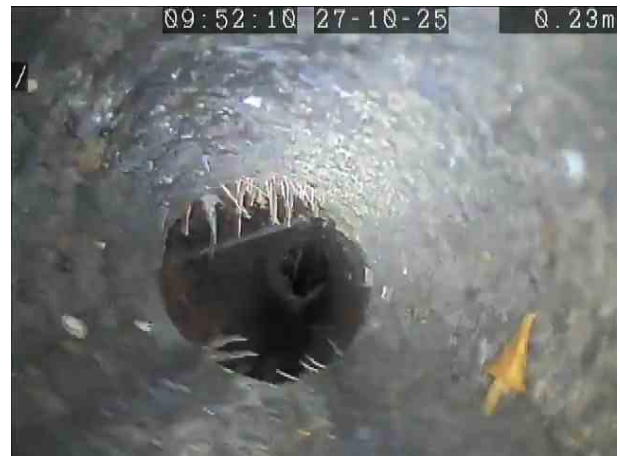
b6bfe3b5-66ea-476b-b329-acc1f32709ec.png, 00:00:26,  
0.23 m  
General remark, LEVELS OUT

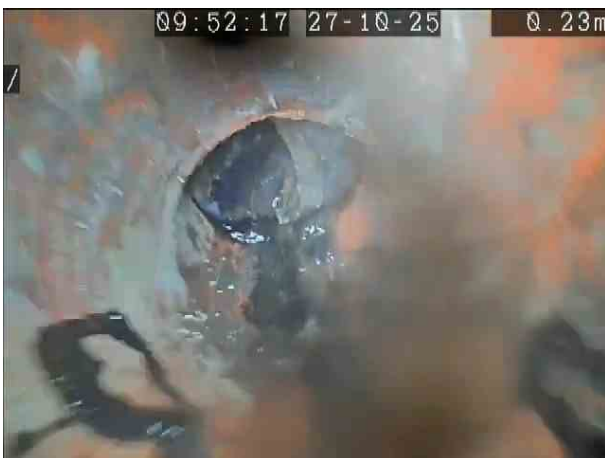
d9e60f67-580e-42dd-902c-660e65af7d8f.png, 00:00:34,  
0.23 m  
Joint displaced, large

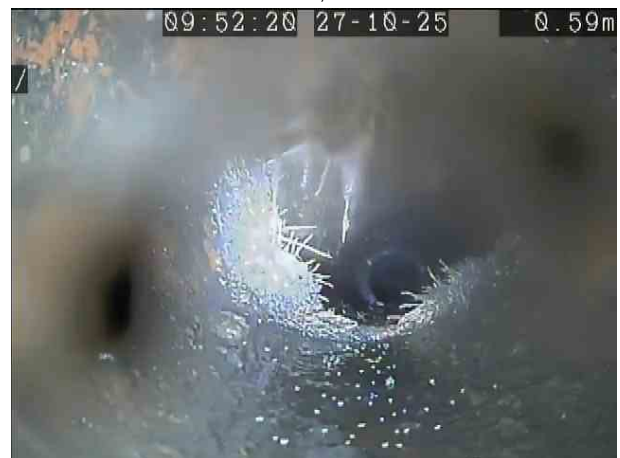
29b8a449-81a2-480e-afa3-6606c811843e.png, 00:00:37,  
0.59 m  
Roots, mass, 5% cross-sectional area loss

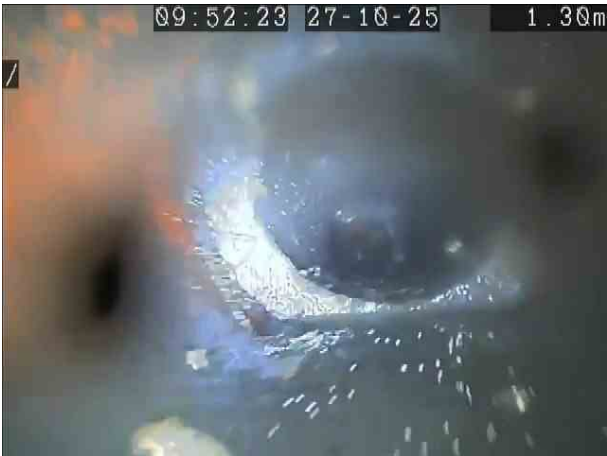
b6ac3f45-bb0a-4dc4-821e-189c033a0e48.png, 00:00:40,  
1.30 m  
Joint displaced, medium

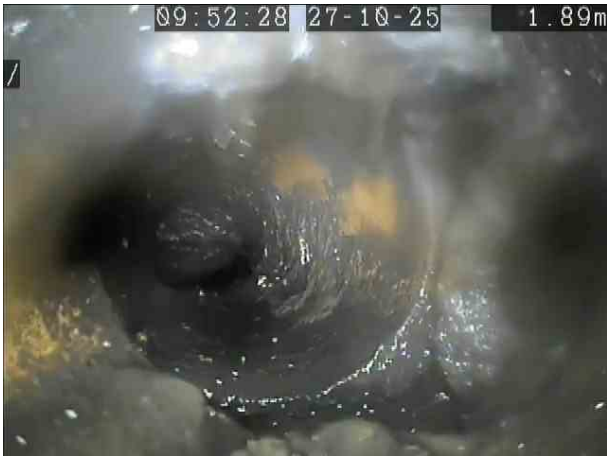
cf23fff4-fcc7-4db6-99b7-12f25f3ce381.png, 00:00:44, 1.89  
m  
Line deviates left
