## Off Mains Drainage Survey Report Prepared For:

Frog Lane Farmhouse, 84 Sand Street, Longbridge Deverill  
Warminster  
BA12 7DS

**Date of Survey:** 18/11/2024

## Drainage Survey

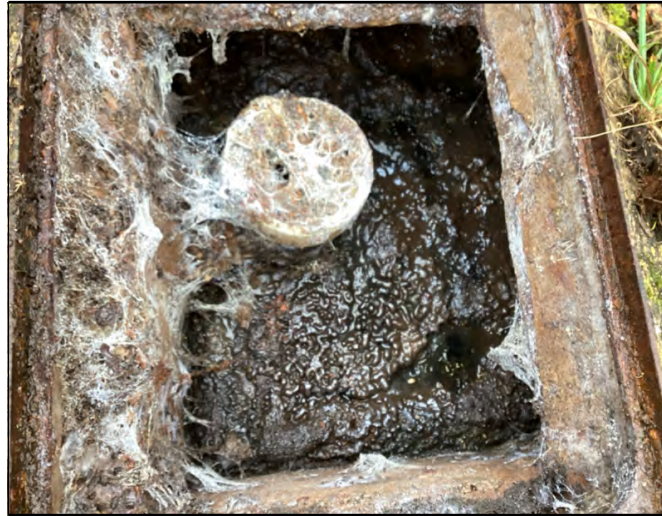
septic tank chamber 1 on arrival

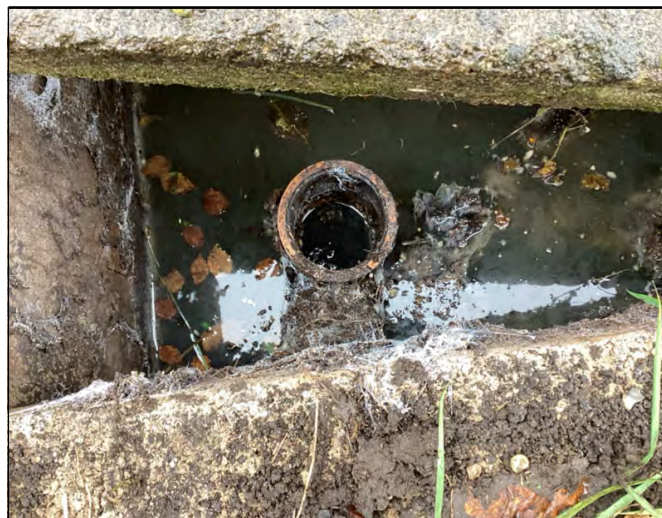
septic tank chamber 2 on arrival

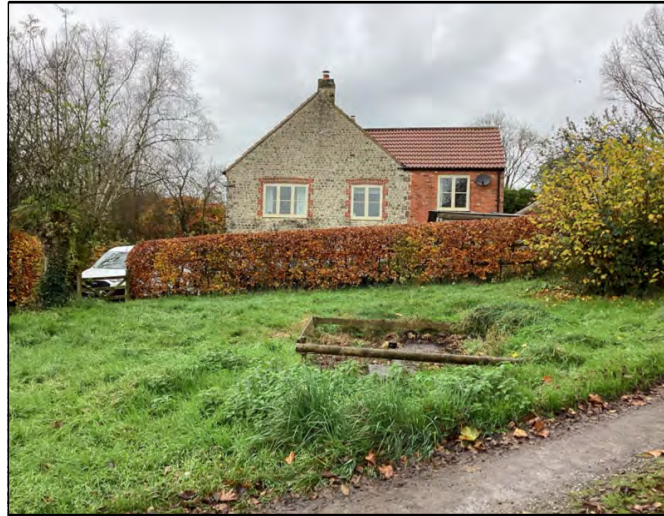
| <b>Final discharge destination - please specify:</b> | Due to the sludge in the pipework the camera picture was lost so the final discharge point could not be observed however the location of the septic tank and the distance travelled with the camera suggests the tank discharges to a single point soakaway |
| <b>Is the existing discharge functioning correctly?</b> | Yes |

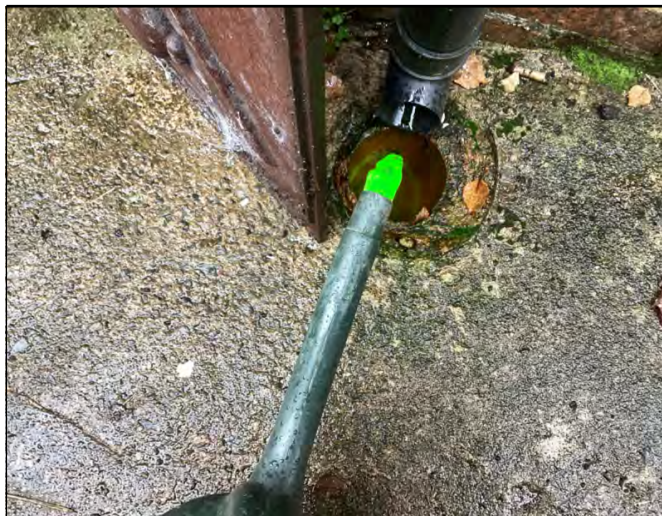
| Was a dye test carried out to the accessible upstream rainwater pipes? | Yes |
| Were there any cross connections found between the rainwater system and the foul system? | No |

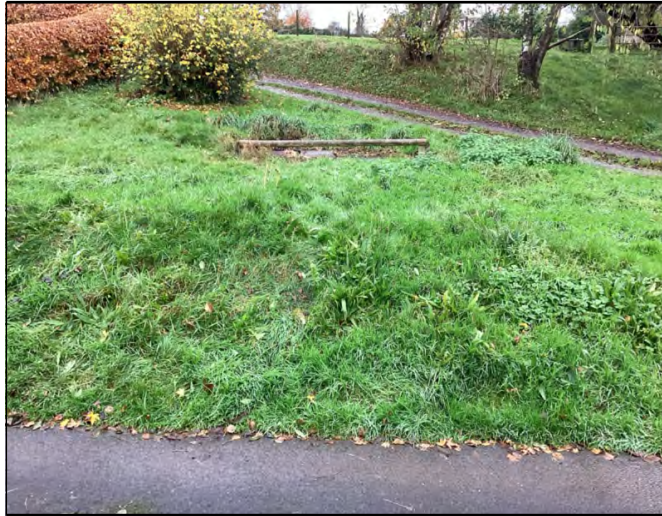
possible single point  
soakaway location to  
the septic tank

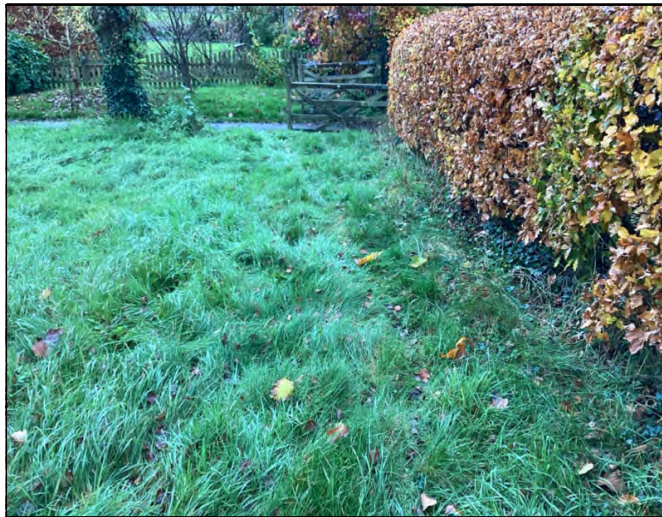
new manhole and STP  
location

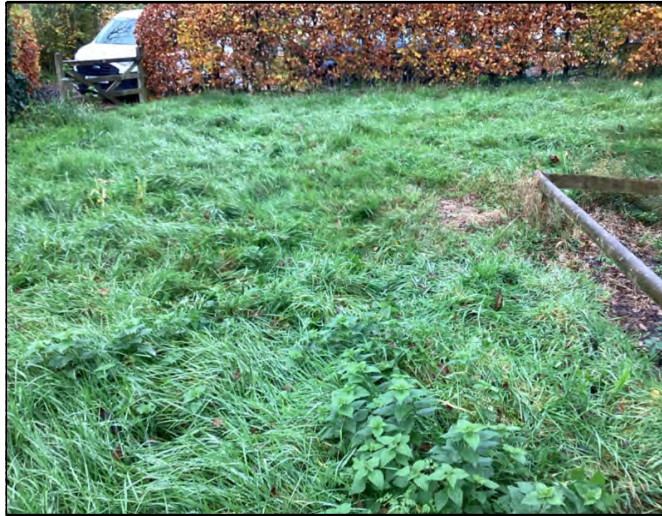
new sample chamber  
location to the new STP

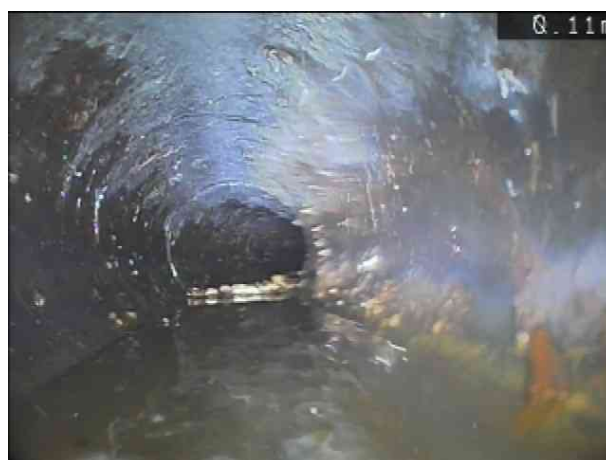
| Scale: | 1:62 | Position [m] | Code | Observation | MPEG | Photo | Grade |
|---|---|---|---|---|---|---|---|
| | | 0.11 | WL | Water level, 10% of sewer height | 00:00:39 | SepticTan<br>kX_ac0d3<br>62a-7093- | |

SepticTankX\_ac0d362a-7093-4bd5-8352-febdf298b11a\_20241121\_114126\_359.jpg, 00:00:39, 0.11 m  
Water level, 10% of sewer height

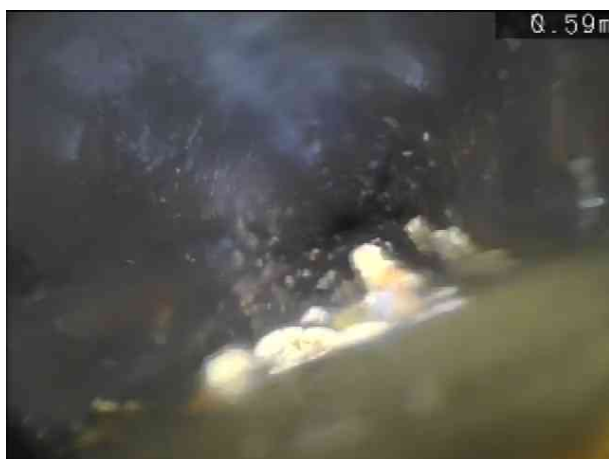
| Scale: | 1:62 | Position [m] | Code | Observation | MPEG | Photo | Grade |
|---|---|---|---|---|---|---|---|
| | | 0.59 | S01 DE | Debris, other, 20% cross-sectional area loss, start: Loose | 00:00:46 | SepticTan<br>kX_5f9b4a<br>6d-f3c4-4f | 4 |

SepticTankX\_5f9b4a6d-f3c4-4fd8-994f-b6769e08f054\_20241121\_114236\_609.jpg, 00:00:46, 0.59 m  
Debris, other, 20% cross-sectional area loss, start, Loose

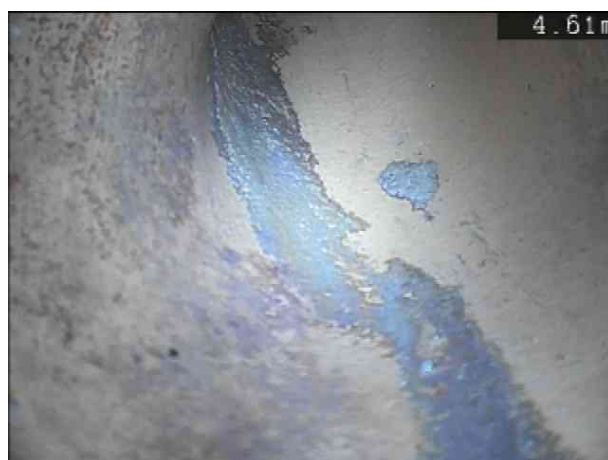
SVP1X\_f82cc0eb-303f-4990-85ef-8a8e4e07672b\_20241121\_1  
14918\_286.jpg, 00:00:23, 4.61 m  
Line of sewer deviates up, Rest bend

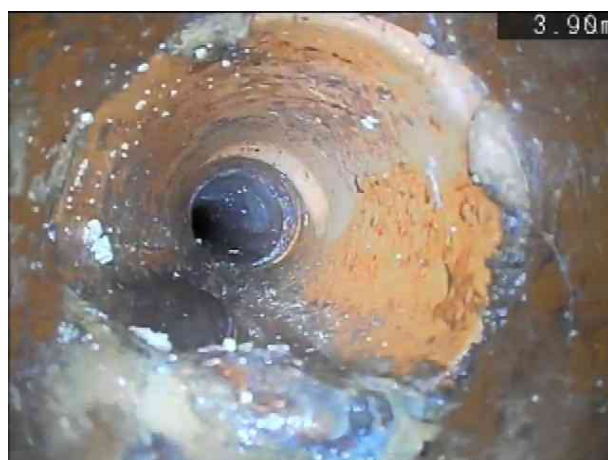
| Scale: | 1:86 | Position [m] | Code | Observation | MPEG | Photo | Grade |
|---|---|---|---|---|---|---|---|
| | | 3.90 | ESMJ | Scale, medium at joint from 4 o'clock to 8 o'clock, 15% cross-sectional area loss | 00:00:47 | WG1X_28<br>c188eb-0d<br>7b-46e3-8 | 3 |

WG1X\_28c188eb-0d7b-46e3-8c54-585fb1c6387e\_20241121\_115643\_279.jpg, 00:00:47, 3.90 m  
Scale, medium at joint from 4 o'clock to 8 o'clock, 15% cross-sectional area loss

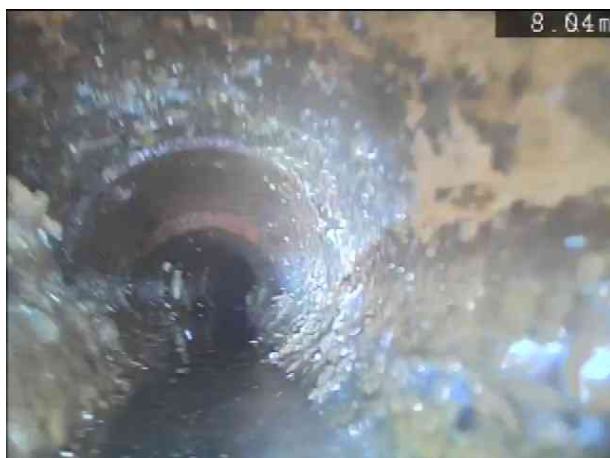
| Scale: | 1:86 | Position [m] | Code | Observation | MPEG | Photo | Grade |
|---|---|---|---|---|---|---|---|
| | | 8.04 | DE | Debris, other, 15% cross-sectional area loss: Sludge | 00:01:29 | WG1X_d2<br>b3d92d-5d<br>2f-4ae0-95 | 3 |

WG1X\_d2b3d92d-5d2f-4ae0-95b3-ab1038b4e698\_20241121\_115526\_427.jpg, 00:01:29, 8.04 m  
Debris, other, 15% cross-sectional area loss, Sludge

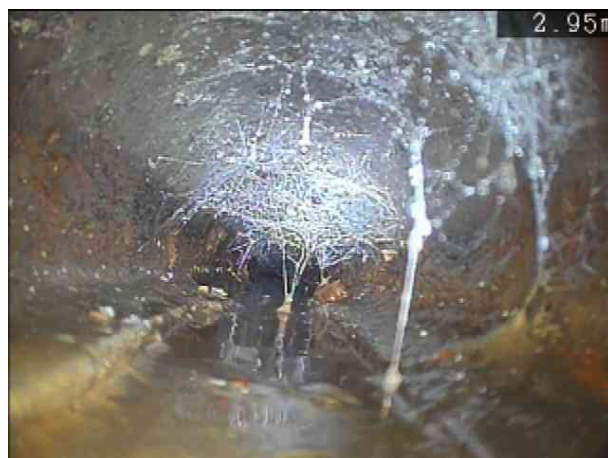
| Scale: | 1:114 | Position [m] | Code | Observation | MPEG | Photo | Grade |
|---|---|---|---|---|---|---|---|
| | | 2.95 | DEG | Debris, grease from 4 o'clock to 8 o'clock, 15% cross-sectional area loss | 00:00:33 | MH2X_83<br>ed2d8c-00<br>c5-405c-a | 3 |

MH2X\_83ed2d8c-00c5-405c-a74f-aaf52ac2fdb8\_20241121\_120135\_798.jpg, 00:00:33, 2.95 m  
Debris, grease from 4 o'clock to 8 o'clock, 15% cross-sectional area loss
