Project: **Kings Arms**

Title: **CCTV Drainage Survey**

| Job No.: | 2405 | Date: | 21/08/26 |

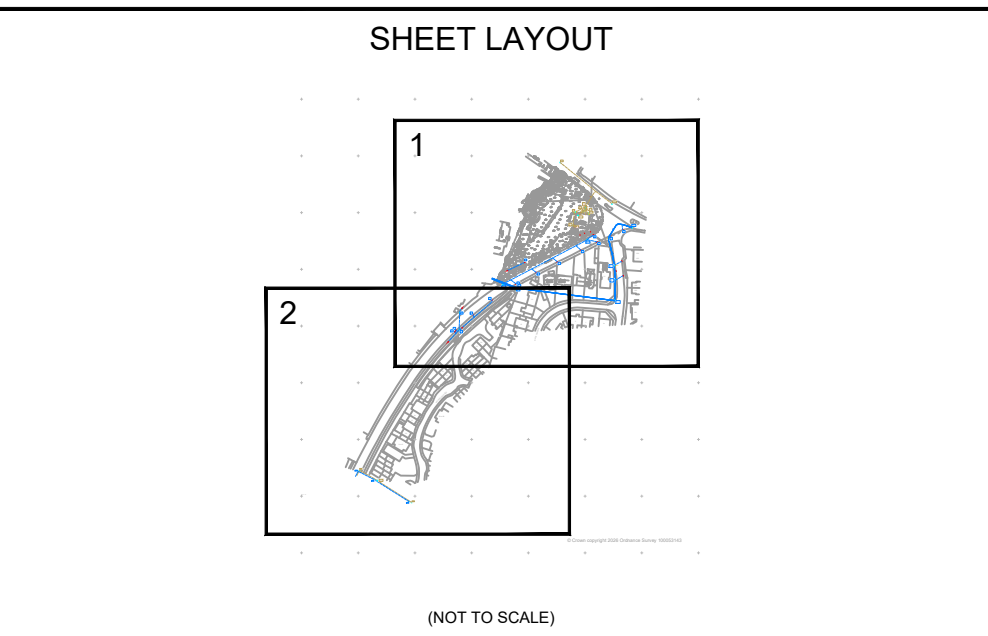
| Sheet No.: | 2 | Approved: LF |

When surveying GY1 behind the truck we were pulled up by someone who said they worked for the council who insisted we had traffic management for surveying the Gullies, hence why the highway gullies haven't been surveyed.

The F/W system around the property appears to be working as intended.

Some of the SW system on Wyke road was surcharged and could do with HPWU to clean out.

MH14's cover is a hinged Triangular cover and the hinges appeared to be seized so we could only open it slightly.

We couldn't survey Outlet1. The pipe was offset back under the fence and the access wasn't very safe.

We couldn't survey Outlet1. The access was blocked by a section of concrete pipe.
