## Structural Inspection Report

### Eastfield House Plough Lane, Marston SN10 5SR

1972-REVB

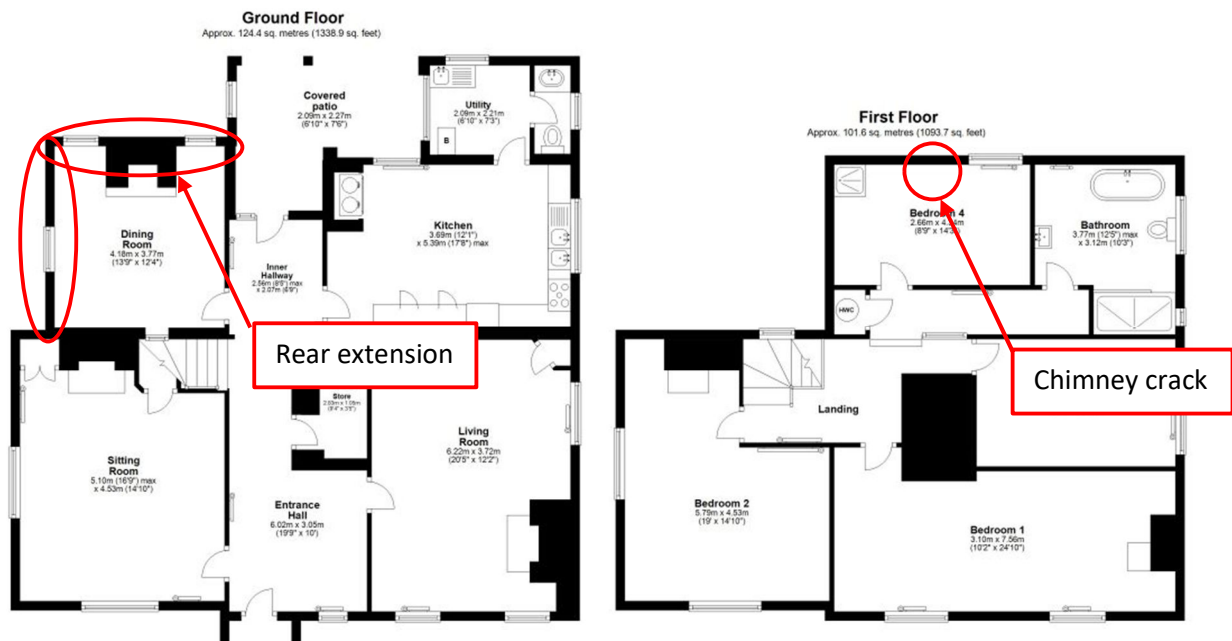
Figure 5 Floor Plan

Approximate floor plans produced for the Estate Agent details are included in figure 5 below. The two main areas of concern have been marked on plan for ease of reference. Our comments and advise will follow in section 3.0 and 4.0.

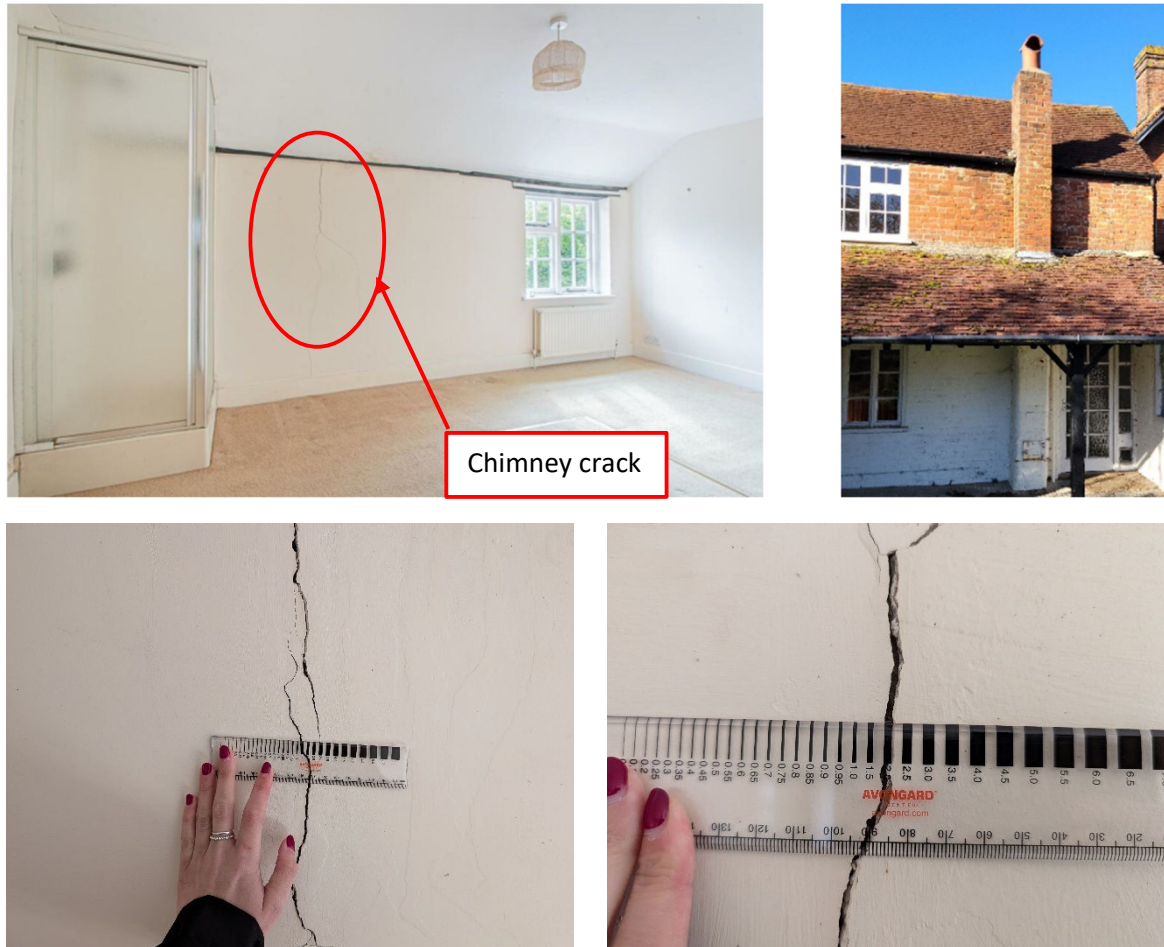
The crack which ran vertically from wall plate to floor, was measured to be approximately 2.5mm wide at the top. The wall exhibited outward lean measurements of 16mm at 1.0m and 35mm at 2.7m, equating to a 1.30-degree inclination. This remains well within the allowable tolerance. There was no visible cracking to the external. If the appearance of the crack bothers the client, they may choose to have it repaired; however, this would be a cosmetic fix rather than a structural necessity.

Figure 6 showing position of crack (internally/externally)

To do this we'd recommend removing the plaster, stitching the crack by using horizontal Helifix bars, and re-plastering over.

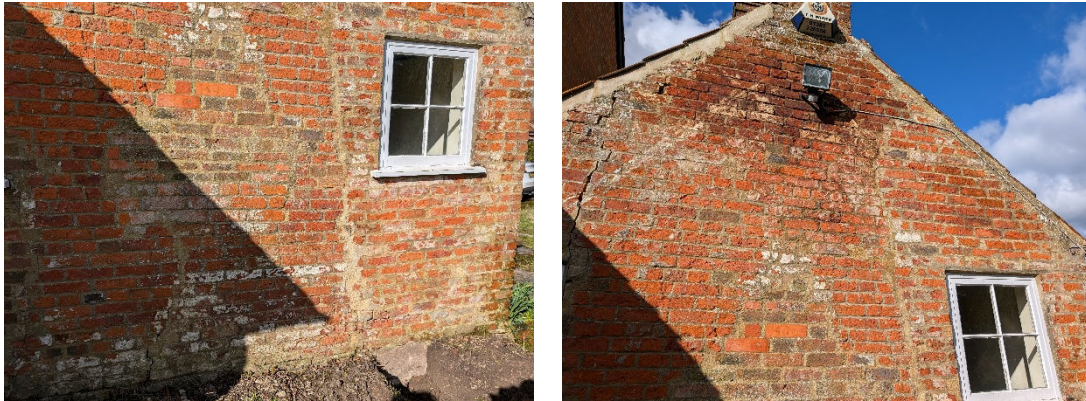
Cracking in the single storey rear extension appears to be more significant. Diagonal cracks are visible across the entire rear elevation. A large section on the right-hand side of the rear elevation appears to have been rebuilt, with a new lintel installed above the right-side window. The cracking along the rear elevation have been repointed, though some on the left-hand side have reopened once more.

*Figure 7 showing cracking externally to rear elevation.*

The orientation of the cracking along the rear elevations is consistent with subsidence of the underlying clay subgrade. Subsidence in conventional foundations can result from either shrinkage of the clay due to water abstraction from nearby trees or softening caused by leaking drains. We consider the following trees to have the potential to contribute to subsidence:

1. Underpin the rear elevation to a depth of 1.95m (subject to soil analysis)
2. Deepen the existing underpinning along the side elevation to match the required depth of 1.95m

1. Once foundation repairs are complete, the external cracks should be raked out and stitched using helical reinforcement bars, followed by repointing with a lime-based mortar.
2. Similarly, the corner where the single-storey rear extension meets the main house should be stitched with heli-fix corner bars and repointed.
3. Internal Finishes: Carry out internal redecoration upon completion of structural works.
4. Note internal Crack repair detail Helifix CS01 detail in Appendix 3

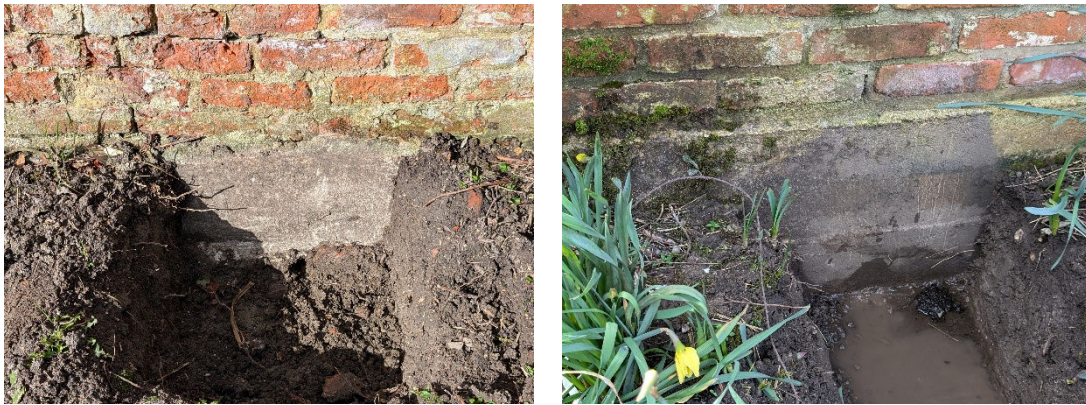
At the time of inspection, two trial pits had been excavated along the rear elevation. The depth of the concrete footings in both pits was measured at approximately 200–250mm. The concrete was flush with the brickwork above, indicating a relatively narrow foundation. Additionally, the top of the concrete was level with the external ground surface.

Along the side elevation, the brickwork was found to be in better condition. The original footings here were observed to be of the same width and depth as those at the rear elevation but may have been underpinned. The theory of previous underpinning is supported with presence of a new damp-proof course (DPC) and low-level brickwork. However, this could not be confirmed as the concrete

extends underneath the nearby flowerbed. The DPC to the top of the concrete was measured at 650mm. The depth could not be determined.

*Figure 8 trial pit at rear (no underpinning) and trial pit alongside (underpinning present)*

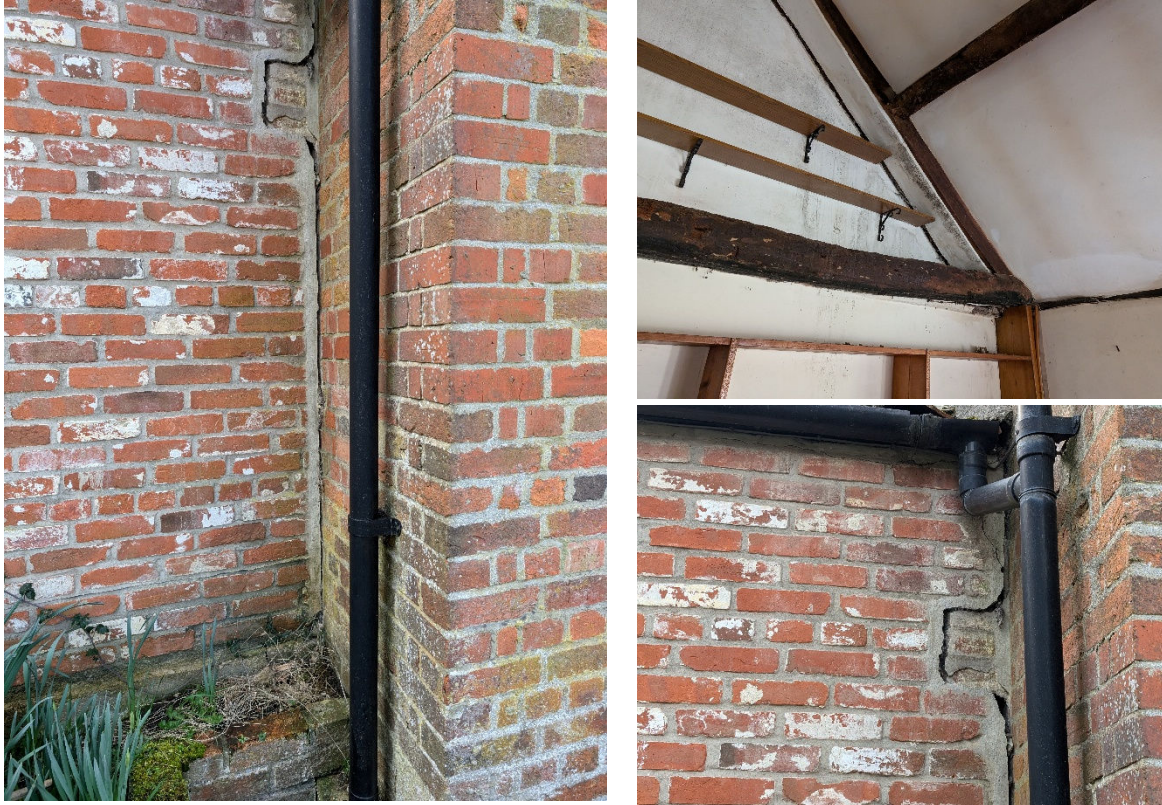
A significant vertical crack was also observed between the main house and the rear extension, measuring 7mm in width at DPC level and widening to 17mm 20 courses above. Additionally, the masonry has moved outward by 25mm from the face of the crack. The absence of diagonal cracking on this elevation suggests rotational movement at the rear corner. Heli-fix corner bars could be installed to improve the connection and tie the two constructions together.

*Figure 9 showing corner separation between rear extension and house*
