# Schedule of Window Repairs

## 44-45 Market Place, Chippenham, SN15 3HU

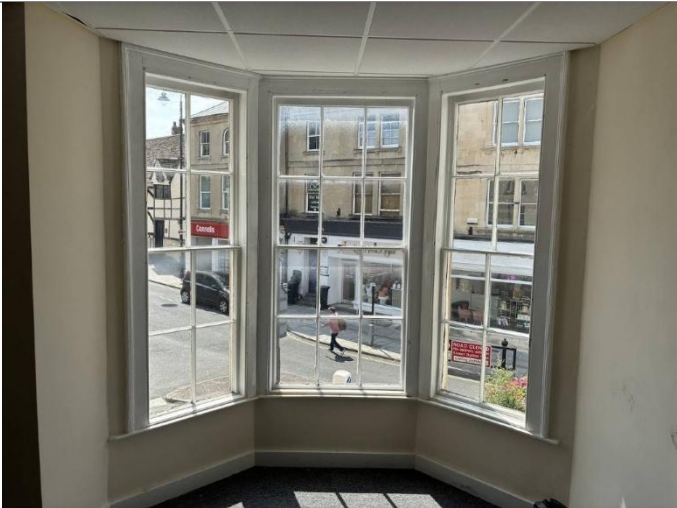
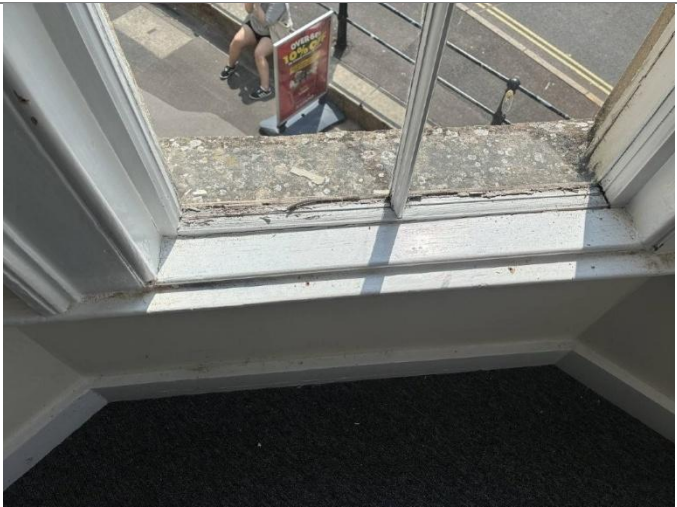
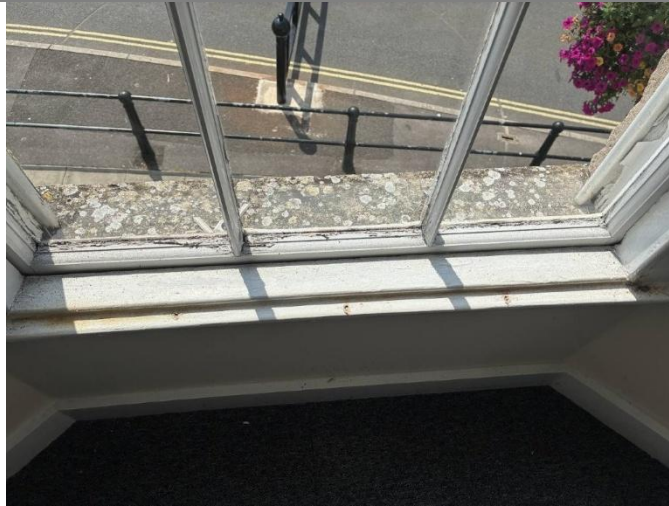
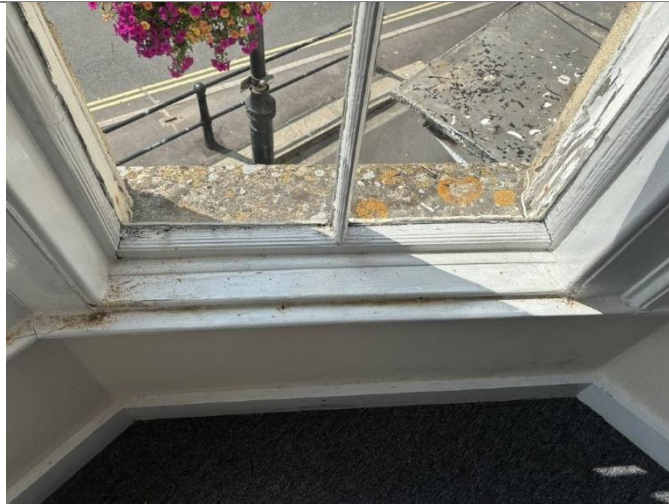
| <u>Window No.</u> | <u>Photo</u> | <u>Repairs</u> |
|---|---|---|
| 1.1-1.3 | | <p>MINOR REPAIRS.</p> <p>REPLACEMENT OF IRONMONGERY.</p> <p>CILL EXTENSION OF 25mm TO ACCEPT SECONDARY GLAZING.</p> <p>ALL REQUIRE MINOR REPAIRS INCLUDING REPLACEMENT OF IRONMONGERY AND SASH CORDS AND PULLYS. UNLESS REPLACEMENT IS SPECIFIED ALL OTHER REPAIRS WILL BE UNDERTAKEN BY STRIPPING AND SANDING TIMBER BACK TO SOUND TIMBER AND REPAIRCARE TWO PART EPOXY RESIN APPLIED. LIKE FOR LIKE TIMBER SPECIES WILL BE EMPLOYED FOR ANY SPLICING REPAIRS IDENTIFIED.</p> |

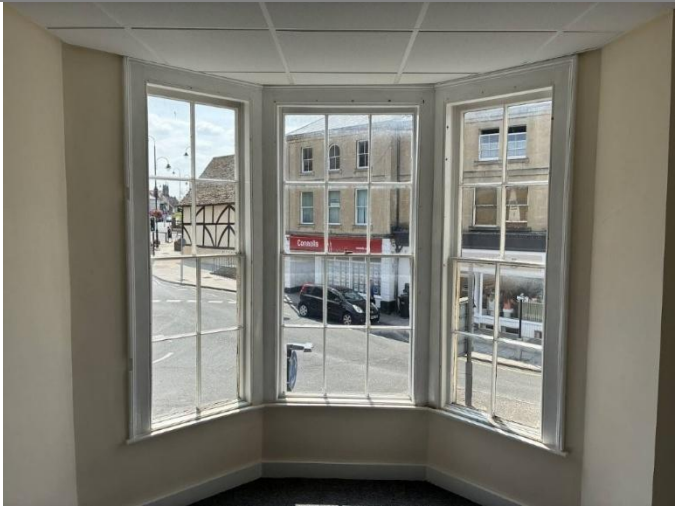
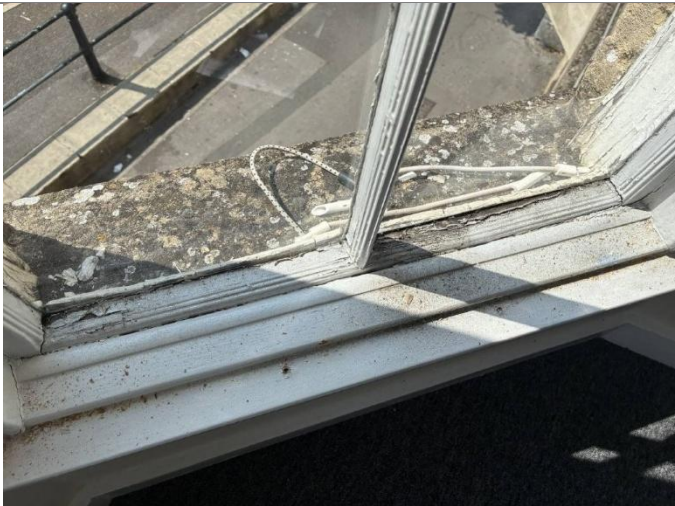
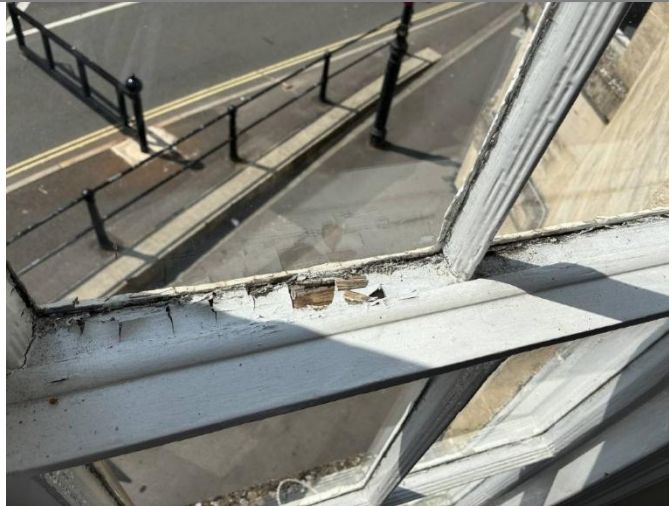
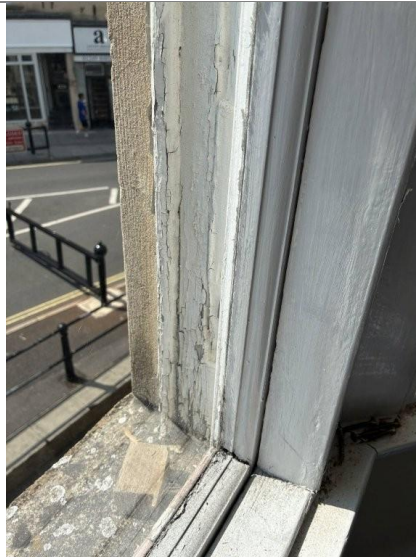
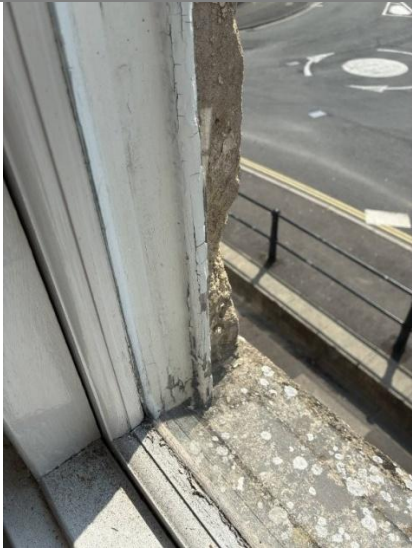
| <p>1.4-1.6</p> | | <p>2no. BOTTOM RAILS ON FRAMES REQUIRE REPLACEMENT.</p> <p>ALL SASH STILES SHOW AREAS OF DECAY. SASH BOX COVERS ARE DECAYED.</p> <p>1no. MID RAIL ON WINDOW 1.4 REQUIRES REPLACEMENT.</p> <p>CILL EXTENSION OF 25mm TO ACCEPT SECONDARY GLAZING.</p> <p>ALL REQUIRE MINOR REPAIRS INCLUDING REPLACEMENT OF IRONMONGERY AND SASH CORDS AND PULLYS. UNLESS REPLACEMENT IS SPECIFIED ALL OTHER REPAIRS WILL BE UNDERTAKEN BY STRIPPING AND SANDING TIMBER BACK TO SOUND TIMBER AND REPAIRCARE TWO PART EPOXY RESIN APPLIED. LIKE FOR LIKE TIMBER SPECIES WILL BE EMPLOYED FOR ANY SPLICING REPAIRS IDENTIFIED.</p> |

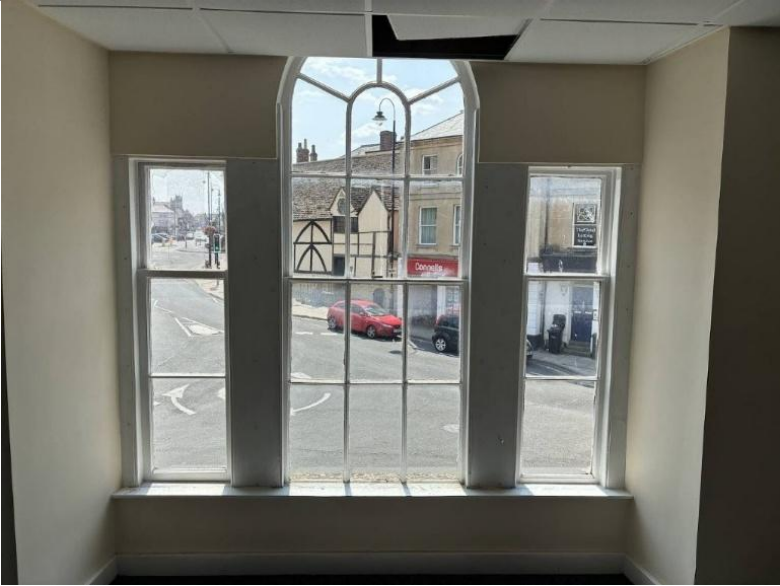
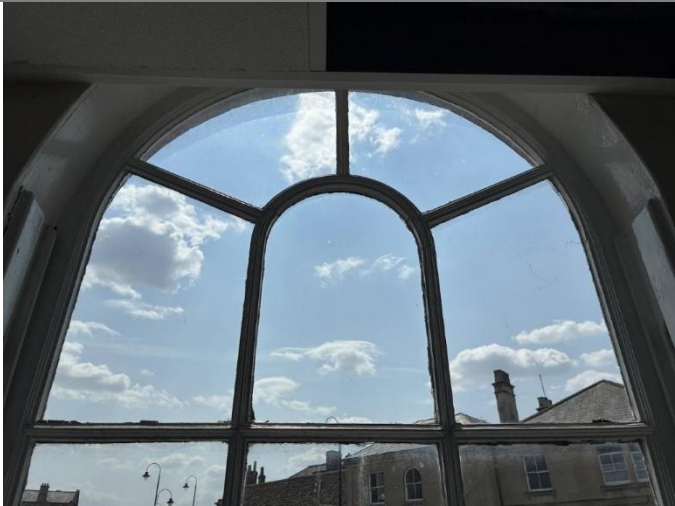
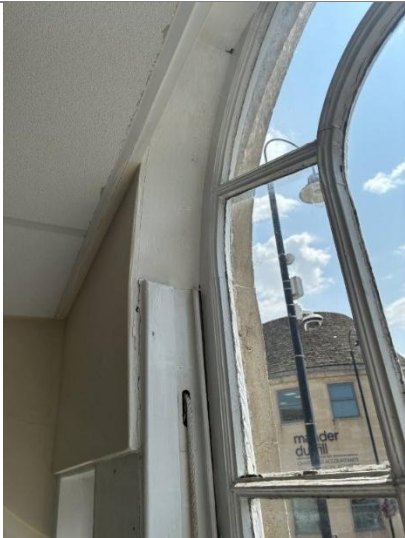
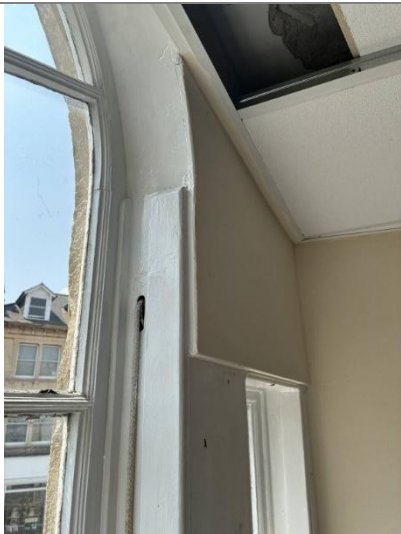
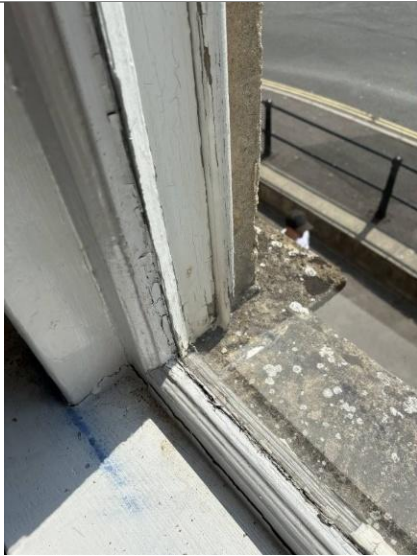
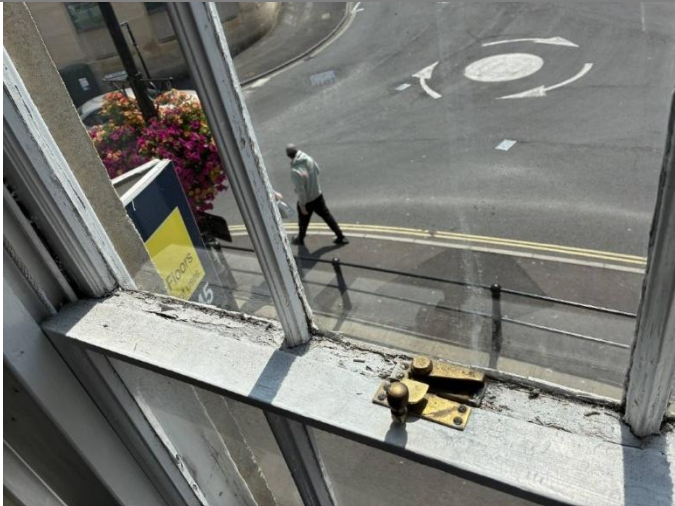
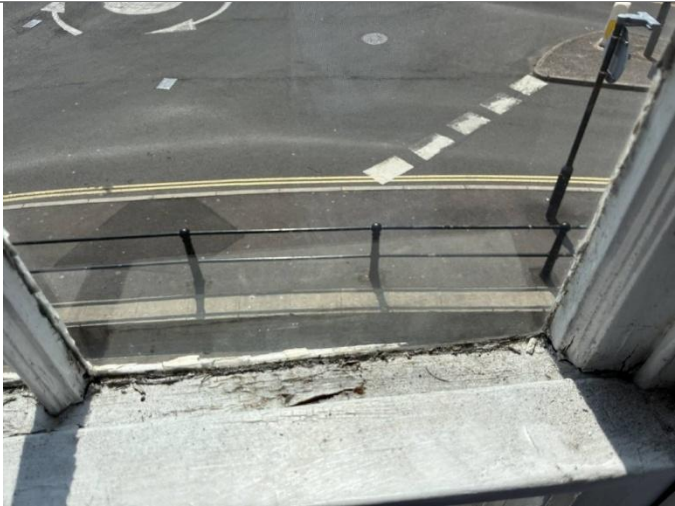
| <p>1.7-1.9</p> | | <p>ALL BOTTOM RAILS ON FRAMES REQUIRE REPLACEMENT.</p> <p>REPLACE MID RAIL ON ARCHED FRAME.</p> <p>REPLACE 1no. BROKEN PANE ON 1.9. REPLACE WITH 3MM HERITAGE GLASS.</p> <p>EXTERNAL STAFF BEADS, SASH BOX COVERS AND GLAZING BARS ARE SHOWING DECAY.</p> <p>CILL EXTENSION OF 25mm TO ACCEPT SECONDARY GLAZING.</p> <p>ALL REQUIRE MINOR REPAIRS INCLUDING REPLACEMENT OF IRONMONGERY AND SASH CORDS AND PULLYS. UNLESS REPLACEMENT IS SPECIFIED ALL OTHER REPAIRS WILL BE UNDERTAKEN BY STRIPPING AND SANDING TIMBER BACK TO SOUND TIMBER AND REPAIRCARE TWO PART EPOXY RESIN APPLIED. LIKE FOR LIKE TIMBER SPECIES WILL BE EMPLOYED FOR ANY SPlicing REPAIRS IDENTIFIED.</p> |

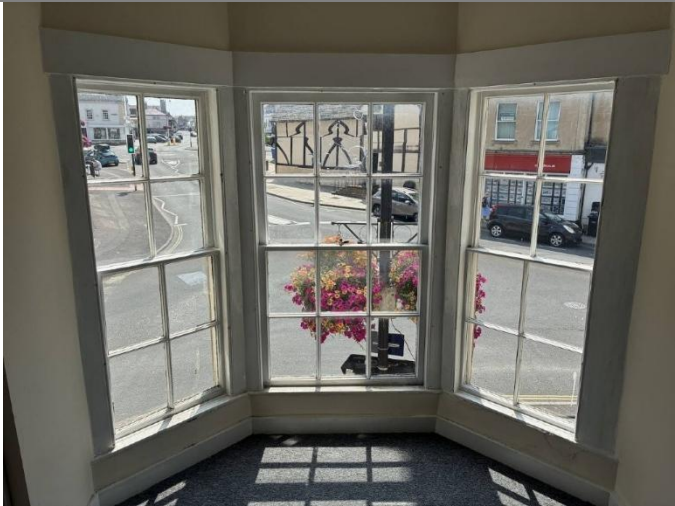
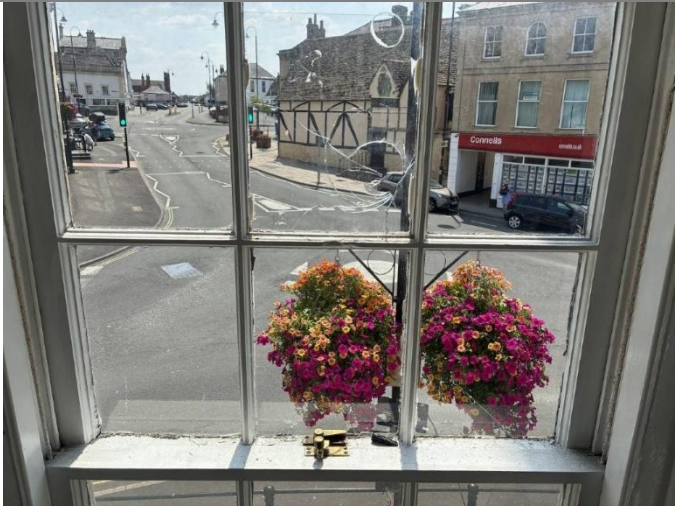
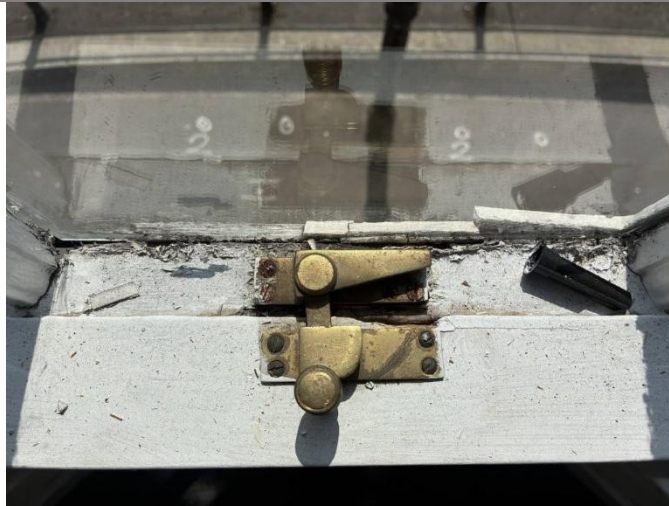
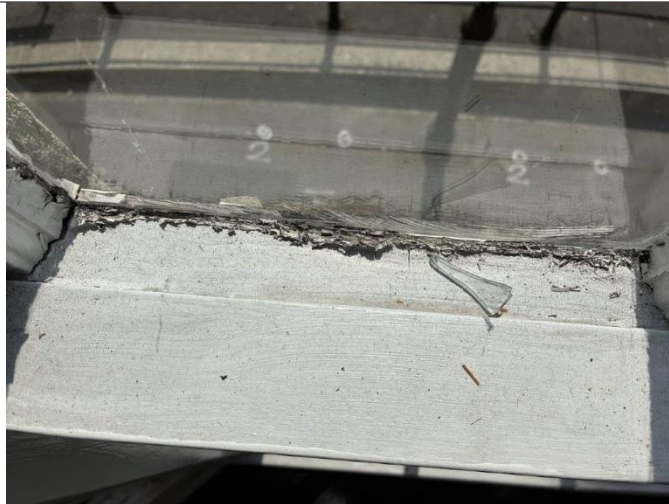
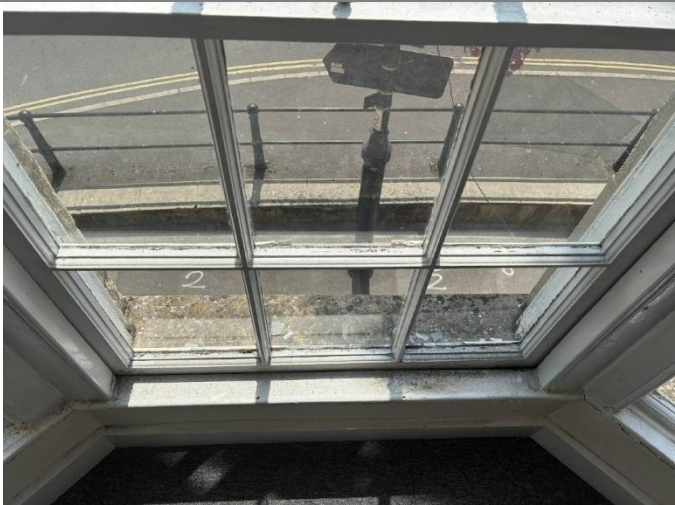
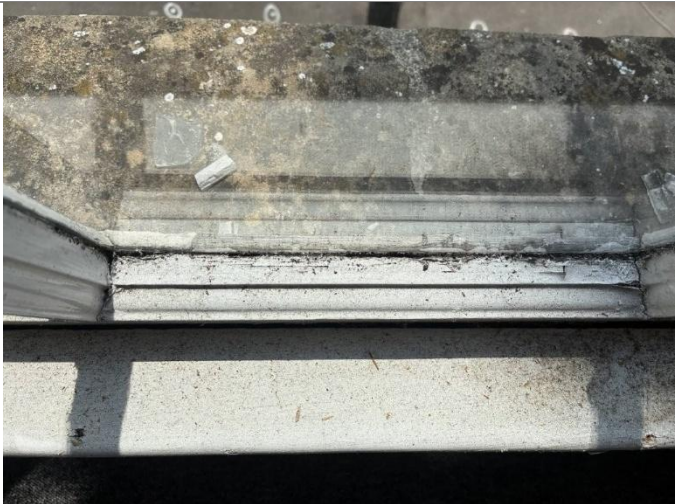
| <p>1.10-1.12</p> | | <p>1no. BOTTOM RAIL ON 1.12 FRAME REQUIRES REPLACEMENT.</p> <p>REPLACE 1no. BROKEN PANE ON 1.11. REPLACE WITH 3MM HERITAGE GLASS.</p> <p>EXTERNAL STAFF BEADS, SASH BOX COVERS AND GLAZING BARS ARE SHOWING DECAY WITH PUTTY ALSO MISSING.</p> <p>CILL EXTENSION OF 25mm TO ACCEPT SECONDARY GLAZING.</p> <p>ALL REQUIRE MINOR REPAIRS INCLUDING REPLACEMENT OF IRONMONGERY AND SASH CORDS AND PULLYS. UNLESS REPLACEMENT IS SPECIFIED ALL OTHER REPAIRS WILL BE UNDERTAKEN BY STRIPPING AND SANDING TIMBER BACK TO SOUND TIMBER AND REPAIRCARE TWO PART EPOXY RESIN APPLIED. LIKE FOR LIKE TIMBER SPECIES WILL BE EMPLOYED FOR ANY SPLICING REPAIRS IDENTIFIED.</p> |

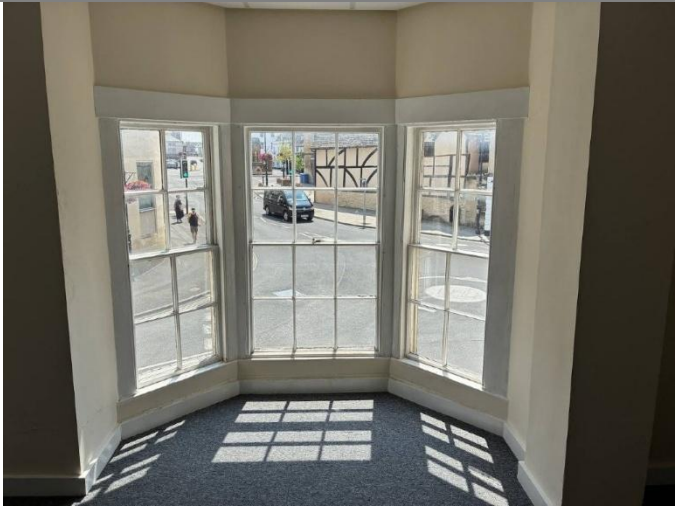
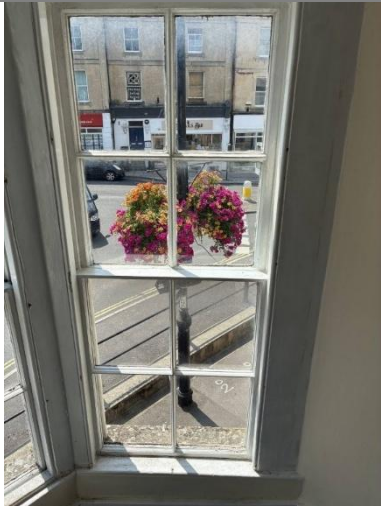
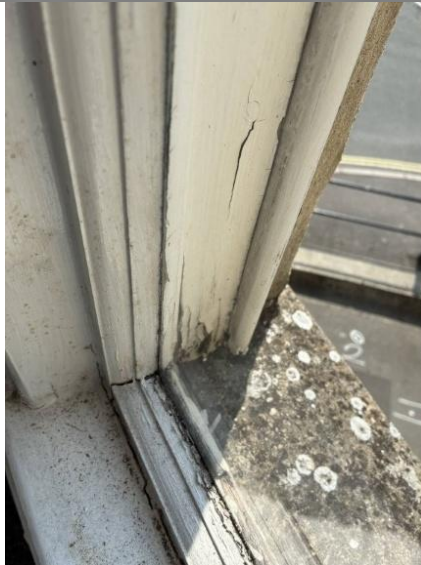
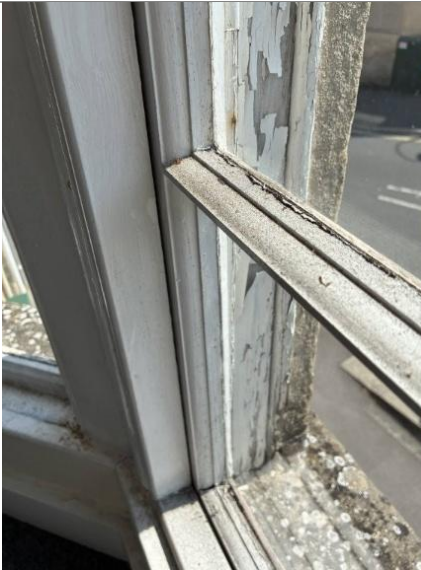
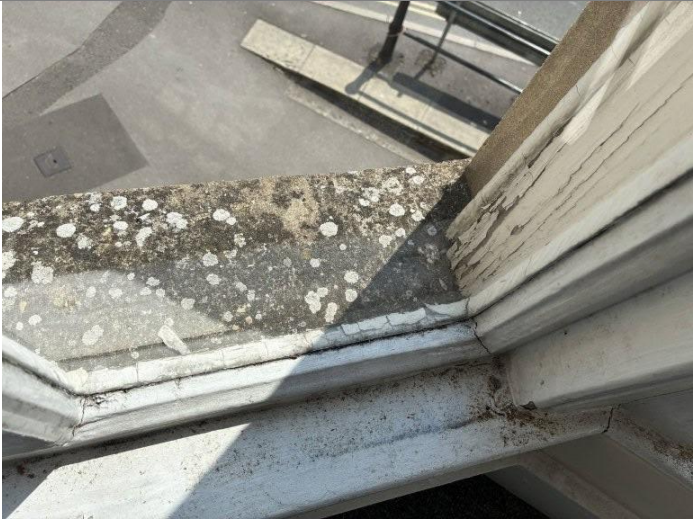
| <p>1.13-1.15</p> | | <p>1no. TOP SASH GLAZING BAR IS SHOWING DECAY AND BOTTOM RAIL TO BOTTOM SASH.</p> <p>MID RAIL SHOWING DECAY.<br/>BOTTOM RAIL AND STILE JOINTS SHOWING DECAY.</p> <p>ALL EXTERNAL STAFF BEADS ARE SHOWING DECAY.</p> <p>CILL EXTENSION OF 25mm TO ACCEPT SECONDARY GLAZING.</p> <p>ALL REQUIRE MINOR REPAIRS INCLUDING REPLACEMENT OF IRONMONGERY AND SASH CORDS AND PULLYS. UNLESS REPLACEMENT IS SPECIFIED ALL OTHER REPAIRS WILL BE UNDERTAKEN BY STRIPPING AND SANDING TIMBER BACK TO SOUND TIMBER AND REPAIRCARE TWO PART EPOXY RESIN APPLIED. LIKE FOR LIKE TIMBER SPECIES WILL BE EMPLOYED FOR ANY SPLICING REPAIRS IDENTIFIED.</p> |

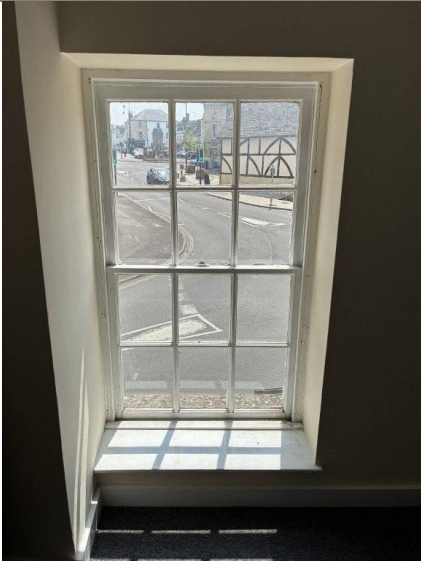
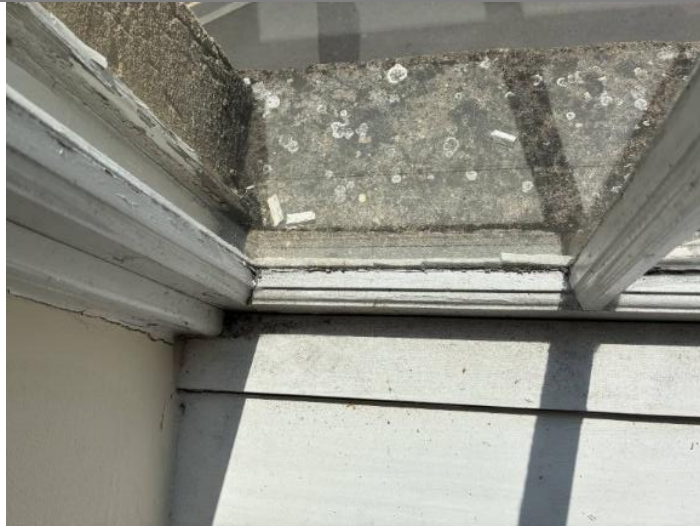
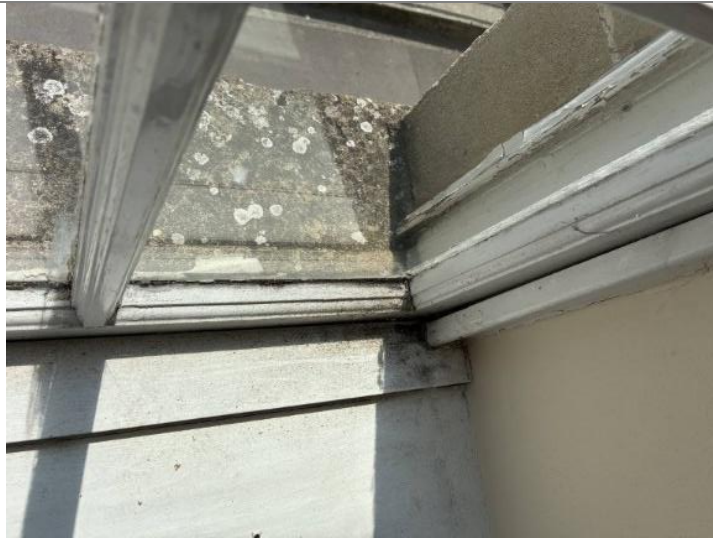
| 1.16 | | <p>BOTTOM SASH BOTTOM RAIL AND EXTERNAL STAFF BEADS ARE SHOWING DECAY.</p> <p>CILL EXTENSION OF 25mm TO ACCEPT SECONDARY GLAZING.</p> <p>MINOR REPAIRS REQUIRED INCLUDING REPLACEMENT OF IRONMONGERY AND SASH CORDS AND PULLYS. UNLESS REPLACEMENT IS SPECIFIED ALL OTHER REPAIRS WILL BE UNDERTAKEN BY STRIPPING AND SANDING TIMBER BACK TO SOUND TIMBER AND REPAIRCARE TWO PART EPOXY RESIN APPLIED. LIKE FOR LIKE TIMBER SPECIES WILL BE EMPLOYED FOR ANY SPlicing REPAIRS IDENTIFIED.</p> |

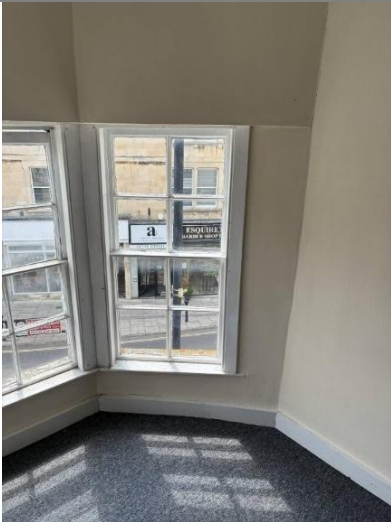
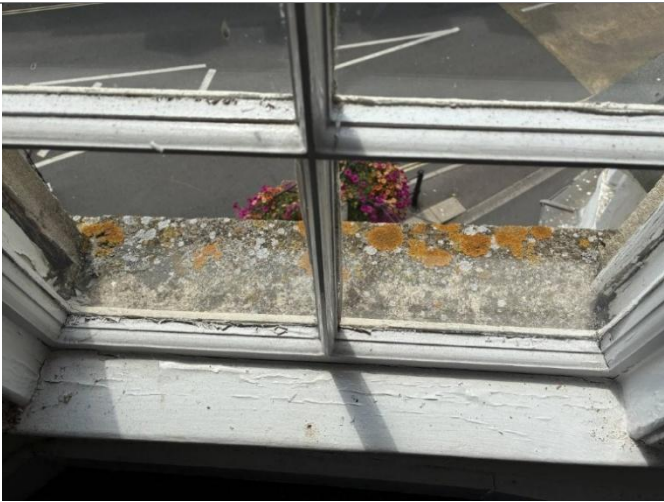
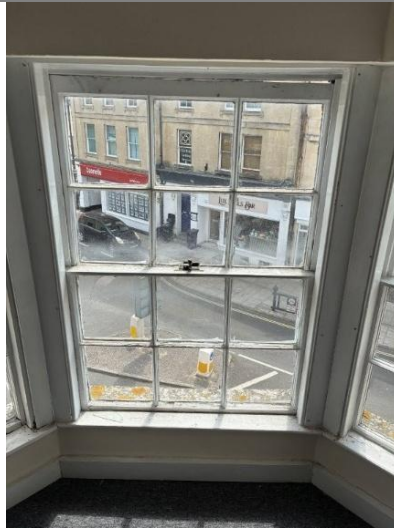
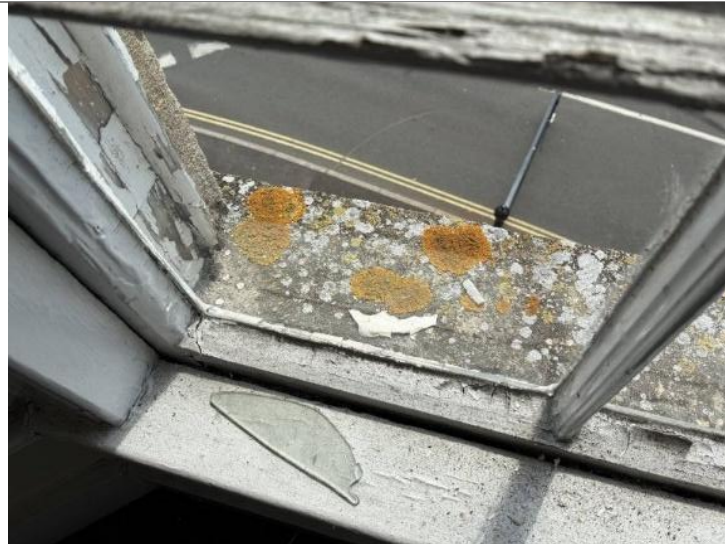
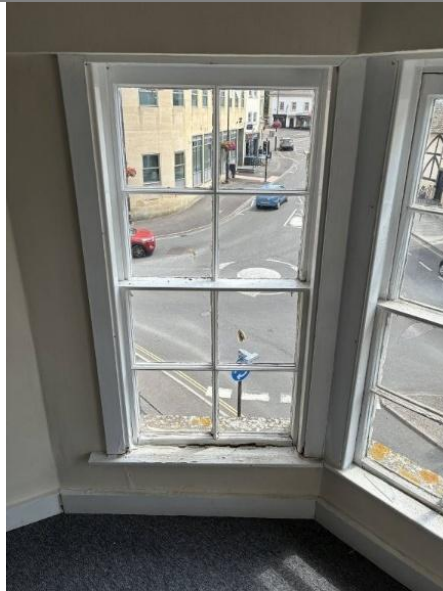
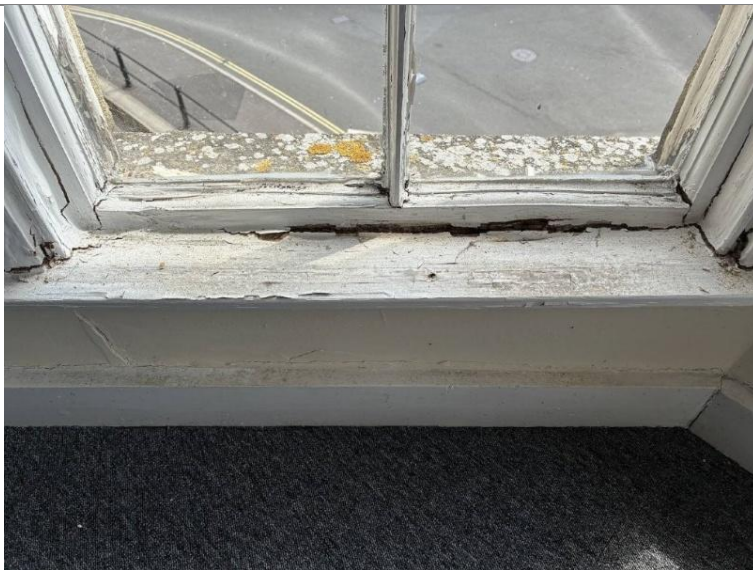
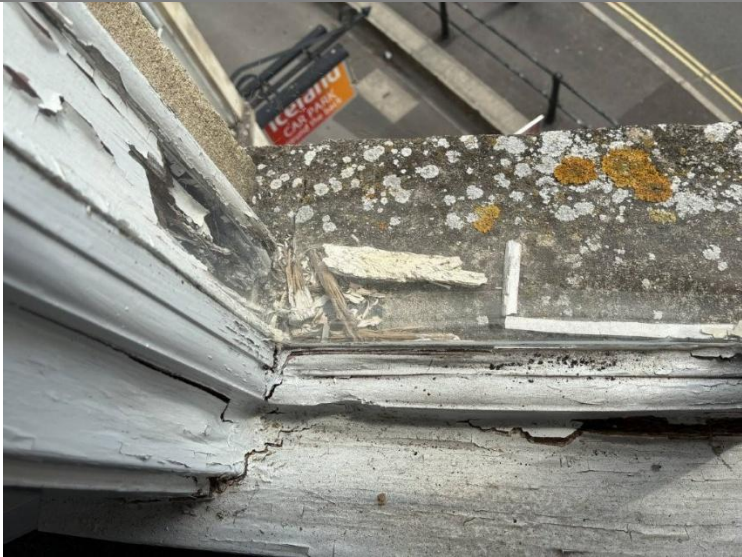
| <p>2.1</p> | | <p>2.1 - MID RAIL SHOWING DECAY.</p> <p>2.2 - BROKEN PANE AND BOTTOM RAIL SHOWING DECAY. REPLACE BROKEN PANE WITH 3MM HERITAGE GLASS.</p> <p>2.3 - BOTTOM RAIL SHOWING DECAY. ALL EXTERNAL STAFF BEADS ARE SHOWING DECAY.</p> <p>CILL EXTENSION OF 25mm ACROSS BAY TO ACCEPT SECONDARY GLAZING.</p> <p>ALL REQUIRE MINOR REPAIRS INCLUDING REPLACEMENT OF IRONMONGERY AND SASH CORDS AND PULLYS. UNLESS REPLACEMENT IS SPECIFIED ALL OTHER REPAIRS WILL BE UNDERTAKEN BY STRIPPING AND SANDING TIMBER BACK TO SOUND TIMBER AND REPAIRCARE TWO PART EPOXY RESIN APPLIED. LIKE FOR LIKE TIMBER SPECIES WILL BE EMPLOYED FOR ANY SPLICING REPAIRS IDENTIFIED.</p> |

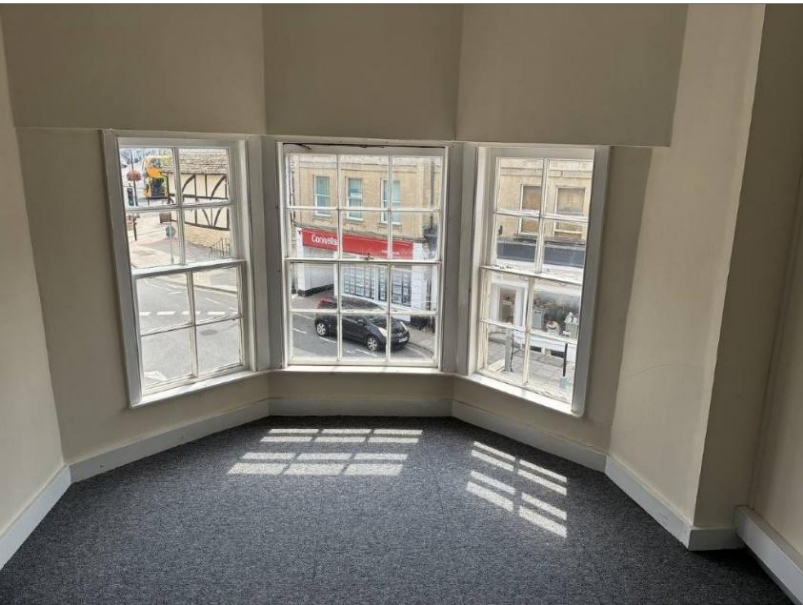
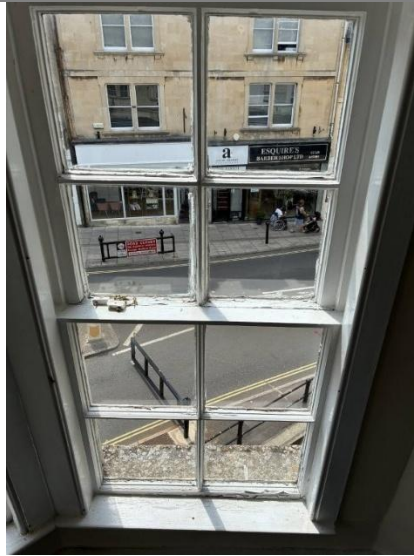
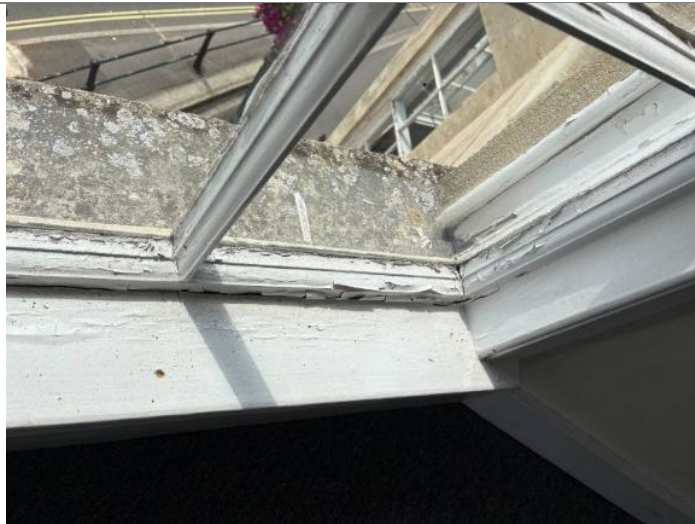
| <p>2.4-2.6</p> | | <p>2.4 - MID RAIL SHOWING DECAY.</p> <p>2.5 - 2no. BROKEN PANES AND BOTTOM RAIL SHOWING DECAY. REPLACE BROKEN PANE WITH 3MM HERITAGE GLASS.</p> <p>2.6 - BOTTOM RAIL DECAYED.</p> <p>ALL EXTERNAL STAFF BEADS ARE SHOWING DECAY.</p> <p>CILL EXTENSION OF 25mm ACROSS BAY TO ACCEPT SECONDARY GLAZING.</p> <p>ALL REQUIRE MINOR REPAIRS INCLUDING REPLACEMENT OF IRONMONGERY AND SASH CORDS AND PULLYS. UNLESS REPLACEMENT IS SPECIFIED ALL OTHER REPAIRS WILL BE UNDERTAKEN BY STRIPPING AND SANDING TIMBER BACK TO SOUND TIMBER AND REPAIRCARE TWO PART EPOXY RESIN APPLIED. LIKE FOR LIKE TIMBER SPECIES WILL BE EMPLOYED FOR ANY SPLICING REPAIRS IDENTIFIED.</p> |

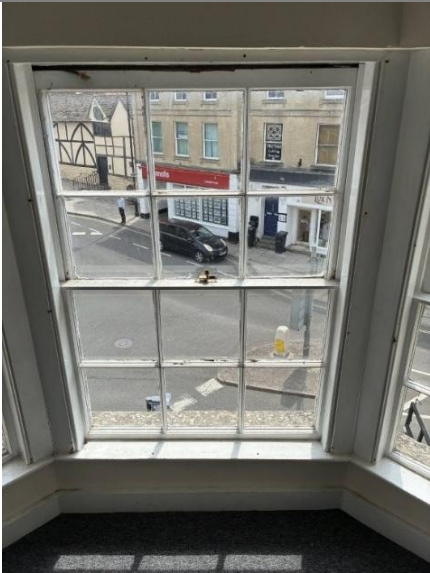
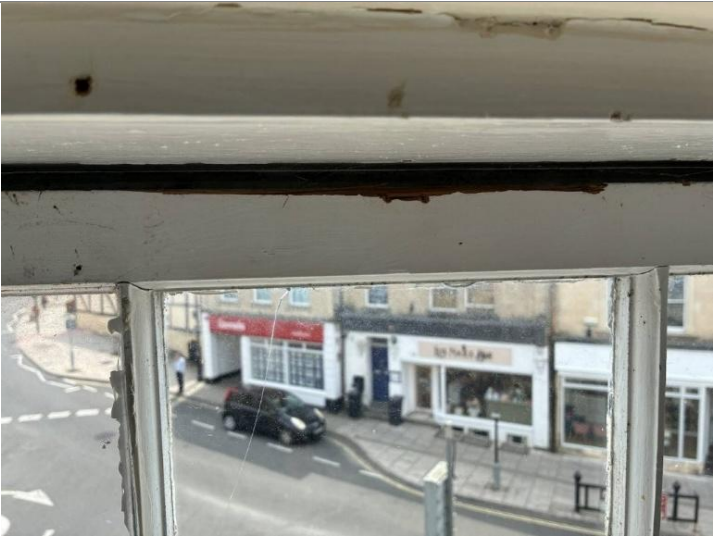
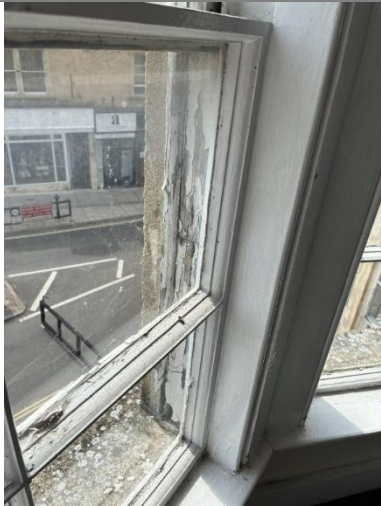
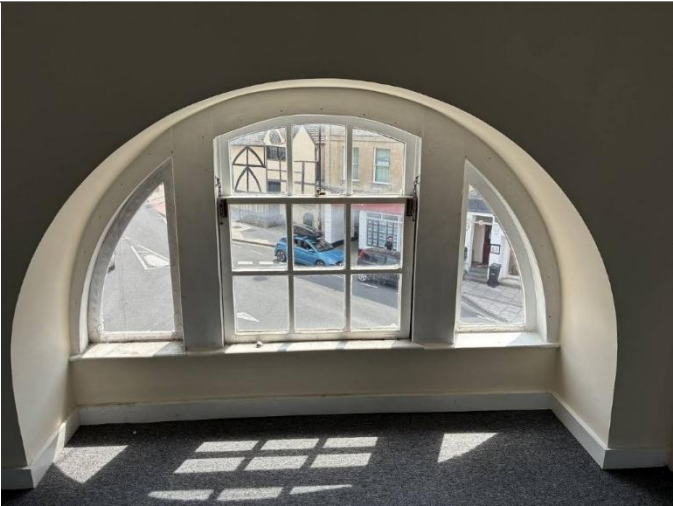
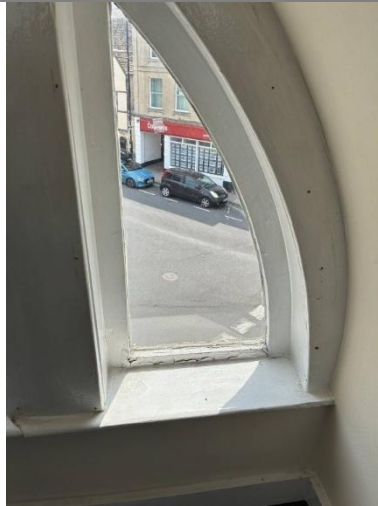
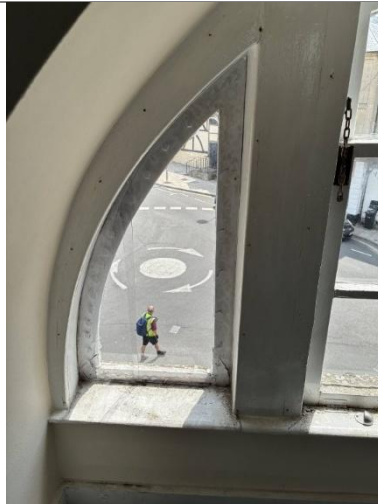
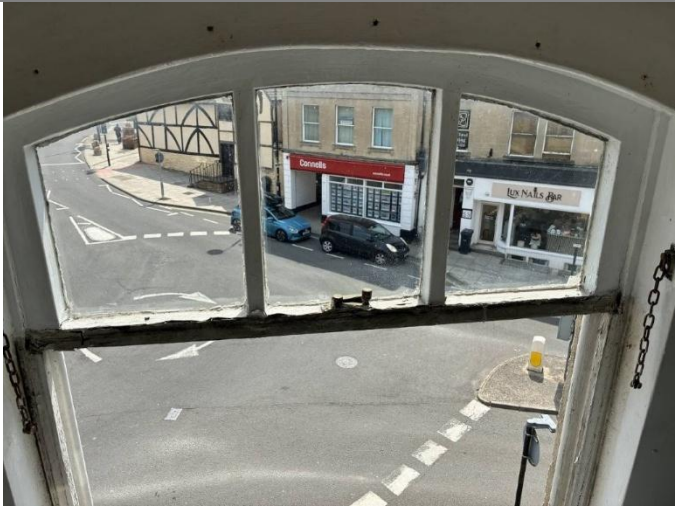
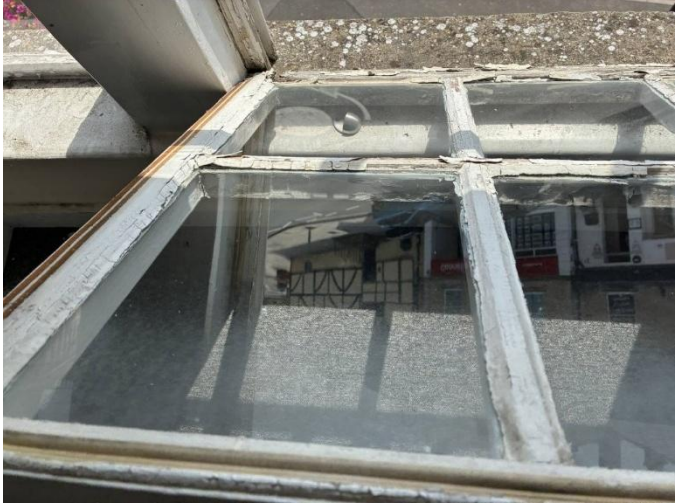
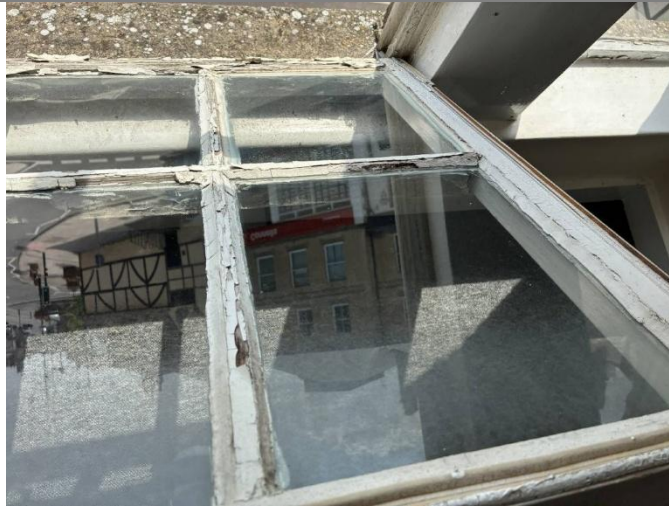
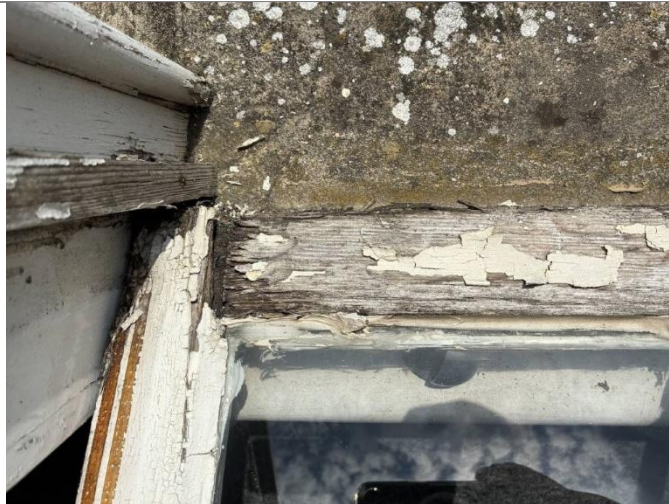
| 2.7-2.9 | | <p>REPLACEMENT OF PERSPEX SHEETING ON WINDOWS 2.7 &amp; 2.8 WITH 3MM HEIRTAGE GLASS.</p> <p>CILL EXTENSION OF 25mm TO ACCEPT SECONDARY GLAZING.</p> <p>ALL REQUIRE MINOR REPAIRS INCLUDING REPLACEMENT OF IRONMONGERY AND SASH CORDS AND PULLYS. UNLESS REPLACEMENT IS SPECIFIED ALL OTHER REPAIRS WILL BE UNDERTAKEN BY STRIPPING AND SANDING TIMBER BACK TO SOUND TIMBER AND REPAIRCARE TWO PART EPOXY RESIN APPLIED. LIKE FOR LIKE TIMBER SPECIES WILL BE EMPLOYED FOR ANY SPLICING REPAIRS IDENTIFIED.</p> |

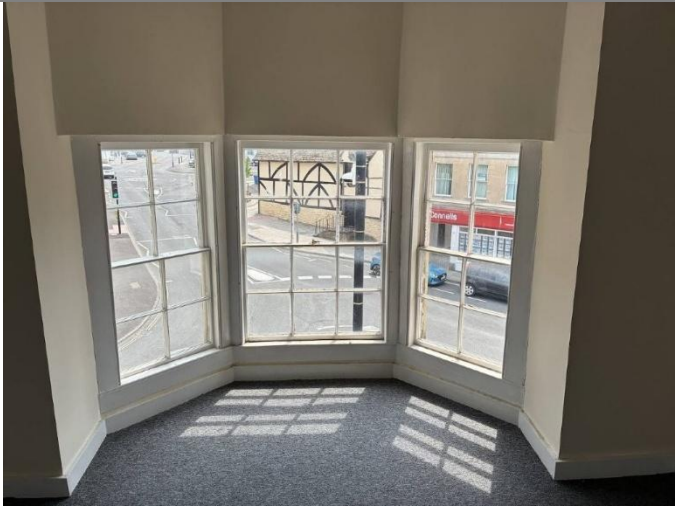
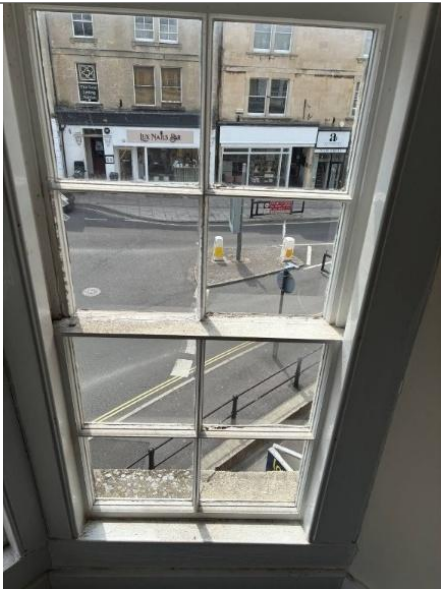
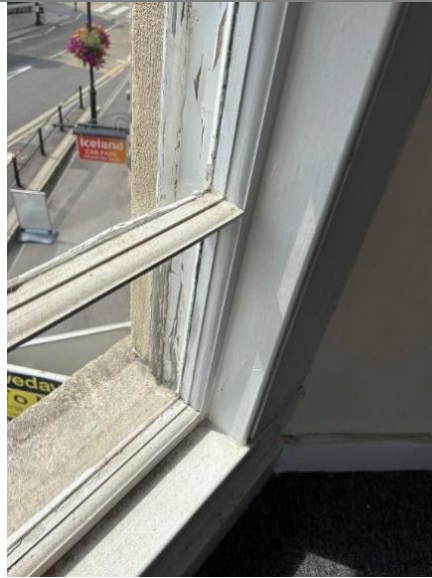
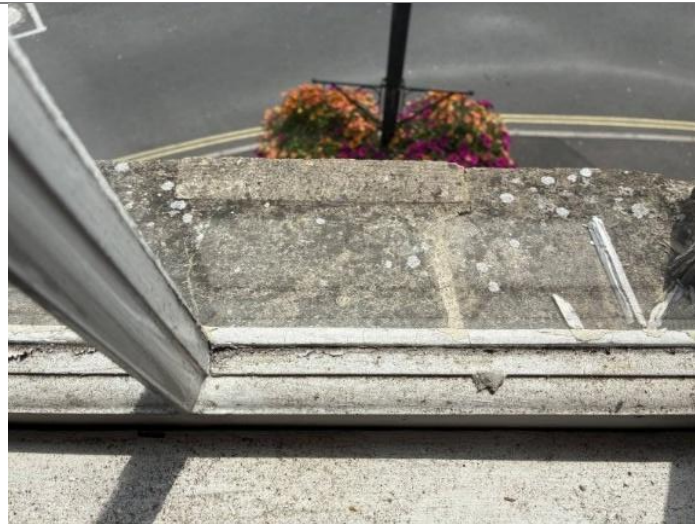
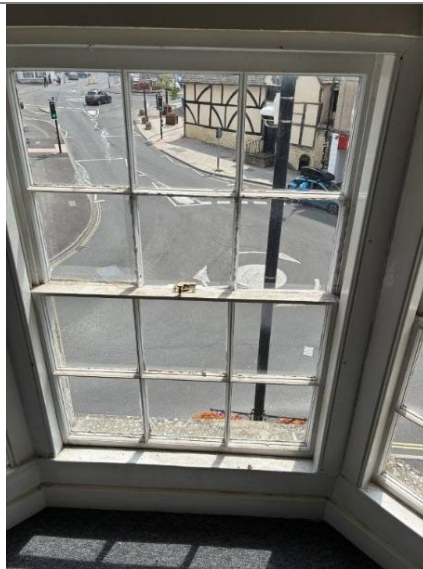
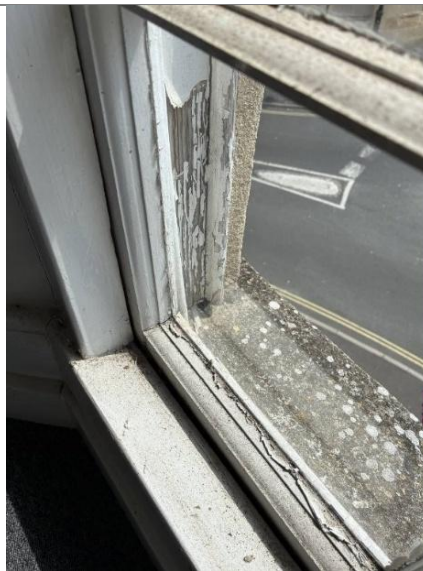
| <p>2.10-2.12</p> | | <p>MINOR REPAIRS.</p> <p>REMOVE POOR QUALITY PERSPEX GLAZING SURFACE FIXED TO SASHES. REPLACE WITH 3MM HERITAGE GLASS.</p> <p>ALL EXTERNAL STAFF BEADS AND SASH BOX COVERS ARE SHOWING DECAY.</p> <p>CILL EXTENSION OF 25mm TO ACCEPT SECONDARY GLAZING.</p> <p>ALL REQUIRE MINOR REPAIRS INCLUDING REPLACEMENT OF IRONMONGERY AND SASH CORDS AND PULLYS. UNLESS REPLACEMENT IS SPECIFIED ALL OTHER REPAIRS WILL BE UNDERTAKEN BY STRIPPING AND SANDING TIMBER BACK TO SOUND TIMBER AND REPAIRCARE TWO PART EPOXY RESIN APPLIED. LIKE FOR LIKE TIMBER SPECIES WILL BE EMPLOYED FOR ANY SPLICING REPAIRS IDENTIFIED.</p> |

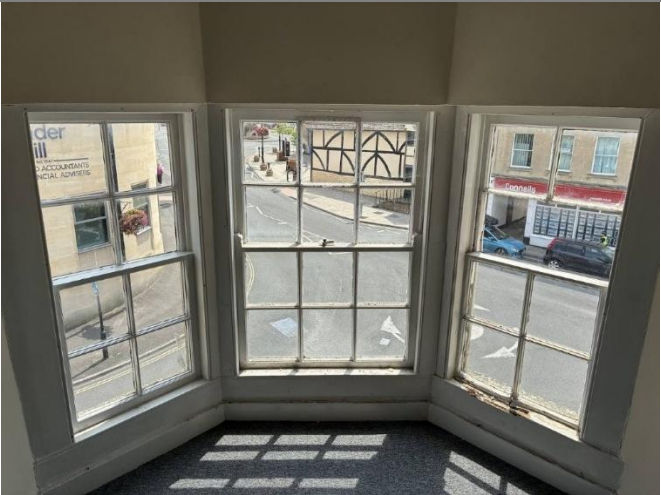
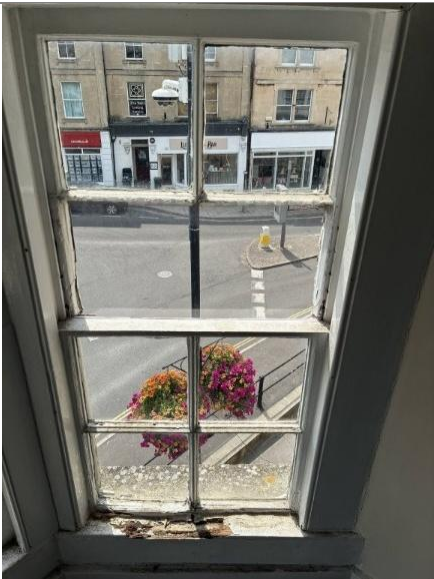
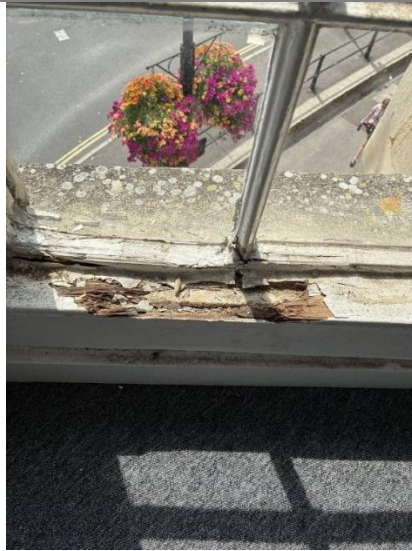
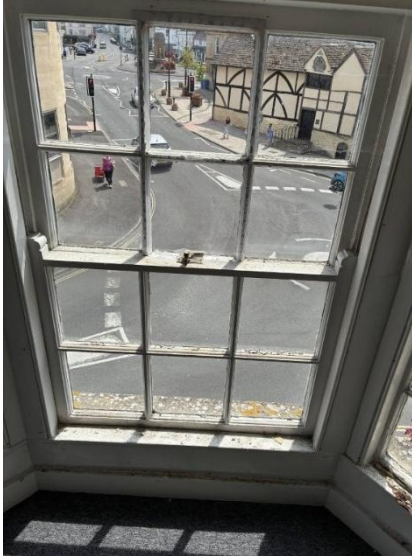
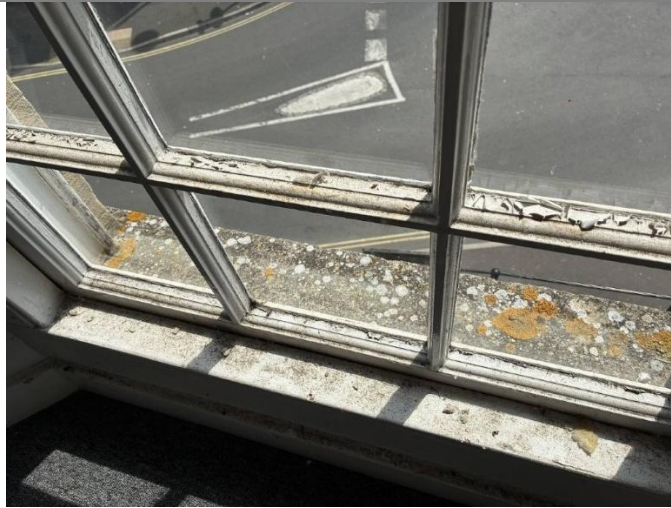
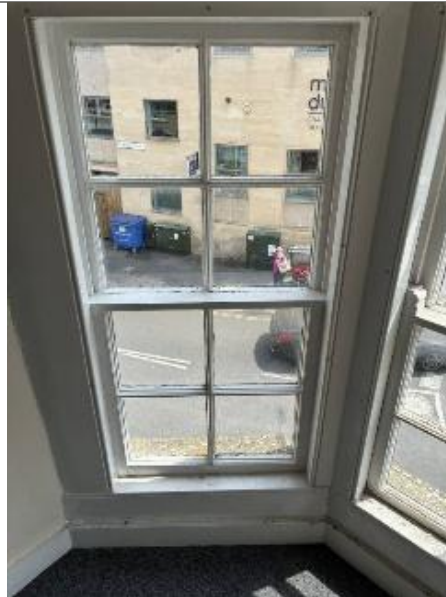
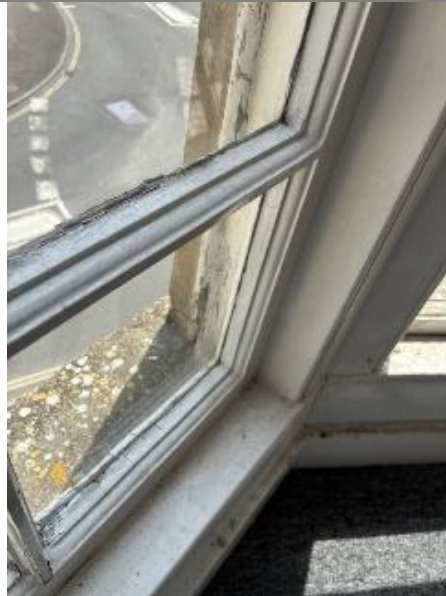
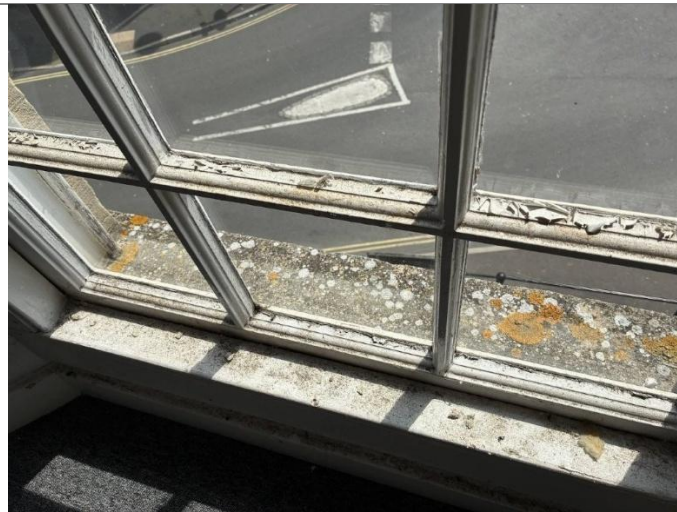
| <p>2.13-2.15</p> | | <p>2.13 - BOTTOM SASH AND CILL BADLY DECAYED. REPLACEMENT REQUIRED.</p> <p>2.14 - POOR QUALITY PERSPEX GLAZING ON UPPER SASH. REMOVE AND REPLACE WITH 3MM HERITAGE GLASS.</p> <p>2.15 - MINOR REPAIRS</p> <p>CILL EXTENSION OF 25mm TO ACCEPT SECONDARY GLAZING.</p> <p>ALL REQUIRE MINOR REPAIRS INCLUDING REPLACEMENT OF IRONMONGERY AND SASH CORDS AND PULLYS. UNLESS REPLACEMENT IS SPECIFIED ALL OTHER REPAIRS WILL BE UNDERTAKEN BY STRIPPING AND SANDING TIMBER BACK TO SOUND TIMBER AND REPAIR CARE TWO PART EPOXY RESIN APPLIED. LIKE FOR LIKE TIMBER SPECIES WILL BE EMPLOYED FOR ANY SPLICING REPAIRS IDENTIFIED.</p> |

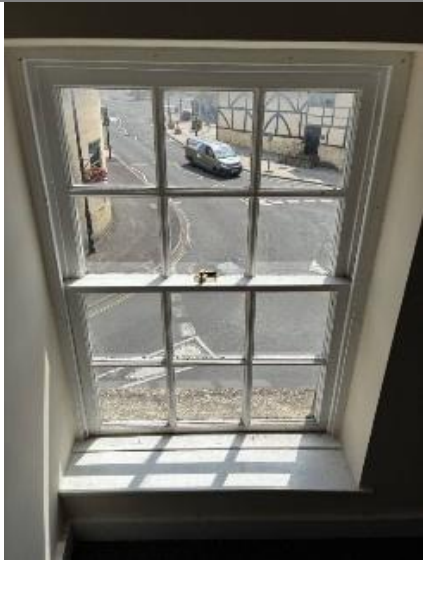
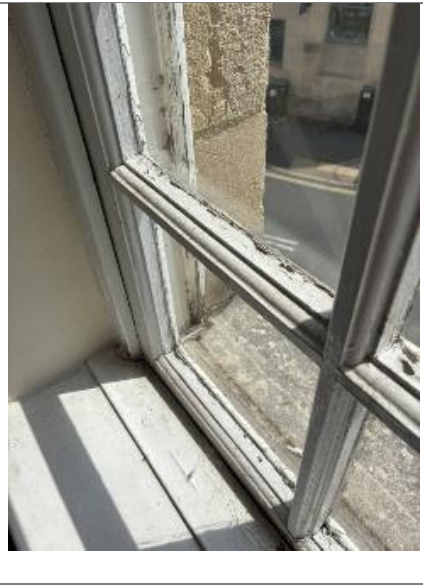
| 2.16 | | | | <p>CILL EXTENSION OF 25mm TO ACCEPT SECONDARY GLAZING.</p> <p>SASH WINDOW REQUIRES MINOR REPAIRS INCLUDING REPLACEMENT OF IRONMONGERY AND SASH CORDS AND PULLYS. UNLESS REPLACEMENT IS SPECIFIED ALL OTHER REPAIRS WILL BE UNDERTAKEN BY STRIPPING AND SANDING TIMBER BACK TO SOUND TIMBER AND REPAIRCARE TWO PART EPOXY RESIN APPLIED. LIKE FOR LIKE TIMBER SPECIES WILL BE EMPLOYED FOR ANY SPLICING REPAIRS IDENTIFIED.</p> |
