## Off Mains Drainage Survey Report Prepared For:

The School House, 30 Kingston Deverill  
Warminster  
BA12 7HE

**Date of Survey:** 30/10/2024

## Drainage Survey

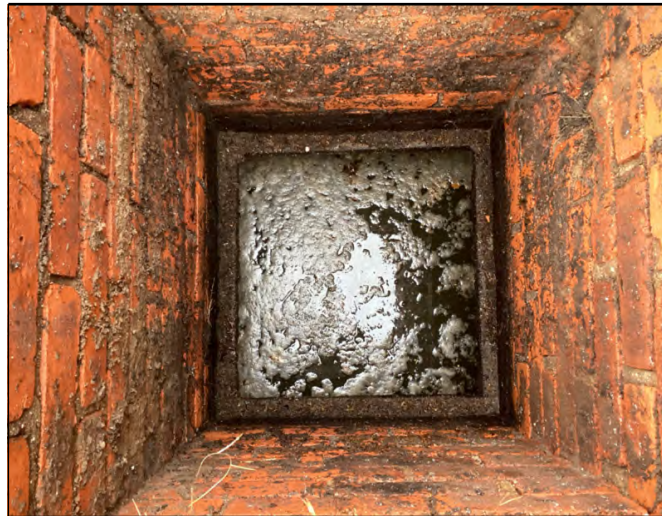
cesspit on arrival

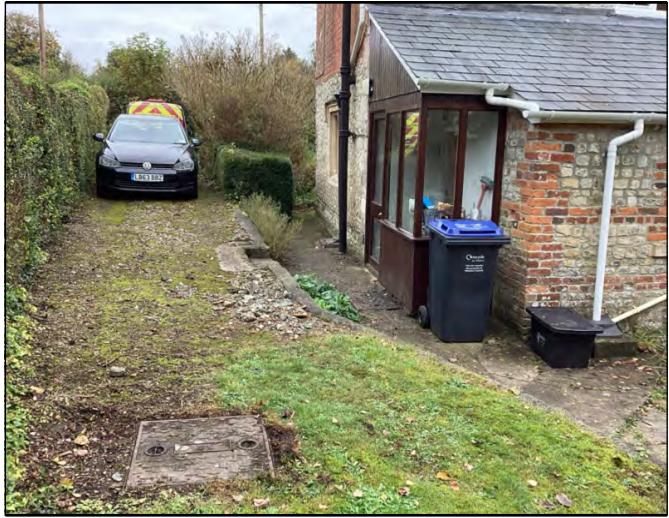
| Is there any removal of hedgerow or trees/shrubs necessary | Yes |
| If required, what is access like for plant to the area of the system for potential remedial works? | Poor |
| What works would be required to gain access to the area of the system if necessary? | There is a larger bush which will need to be removed for the new install |

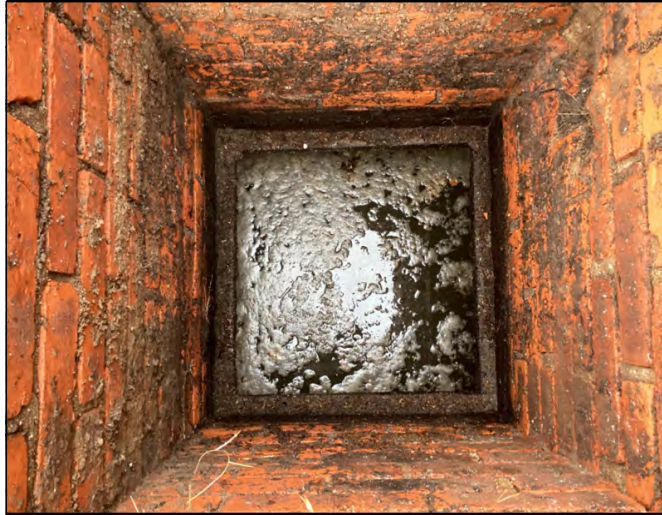
cesspit on arrival

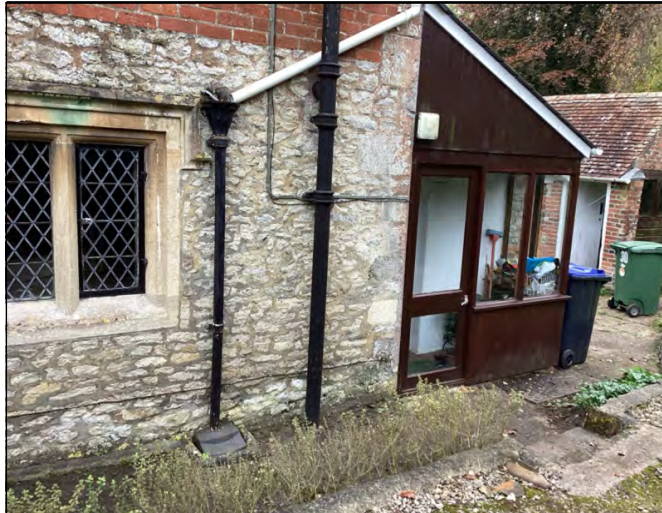
rain water cross connection at RWWG1

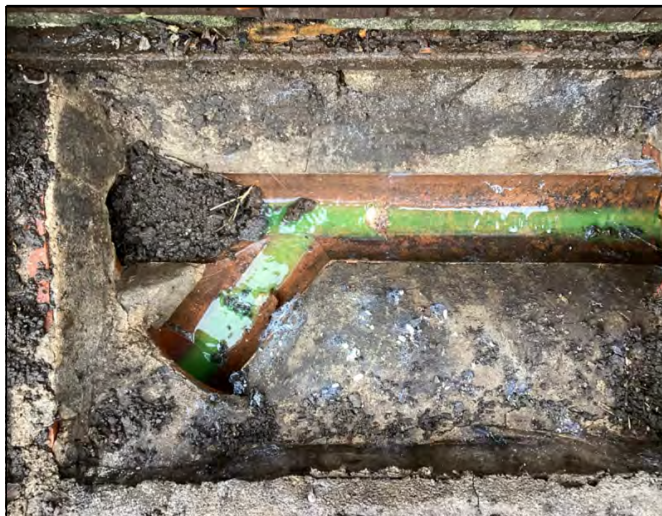
dye in manhole. 1 from  
RWWG1

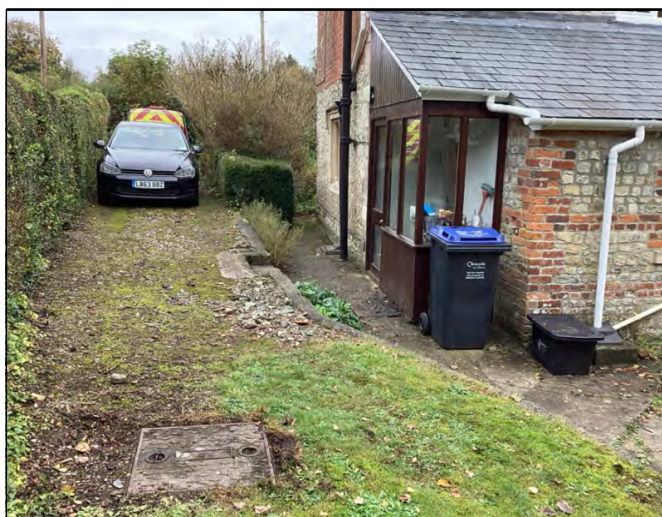
SVP1 goes directly into the cesspit with no access to the pipework.

cesspit location to SVP1

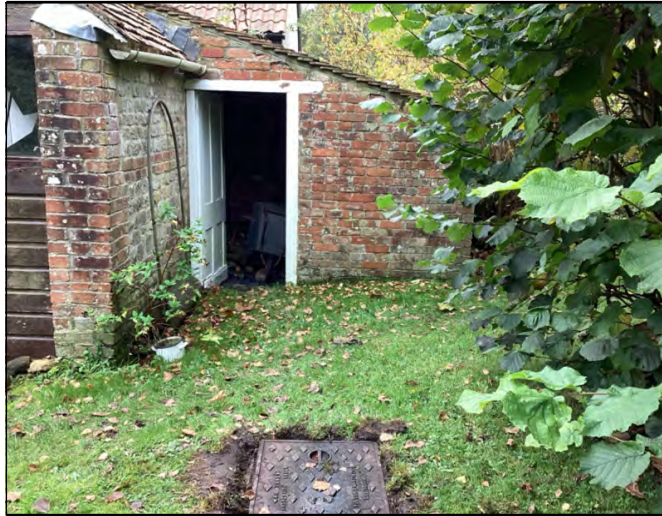
RWWG 1&2 appear to connect to the rain water system and from manhole 2 downstream runs towards a the rear left boundary into the neighbours.

manhole 2 location  
viewed downstream  
towards the left rear  
boundary

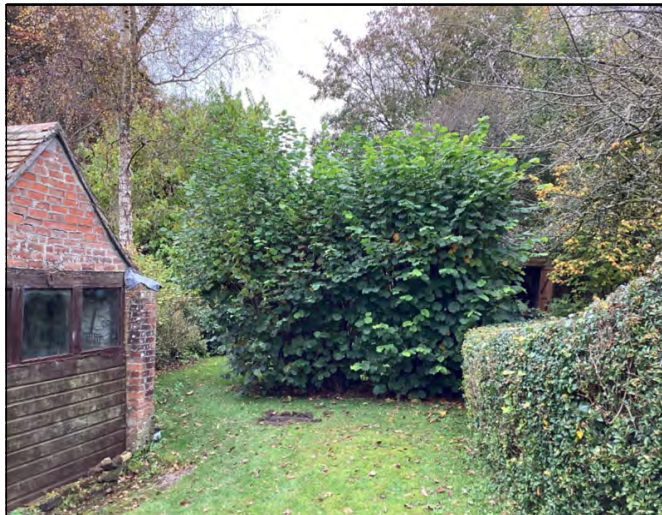
Two large bushes will need to be removed of the new install appt the end of the drive

large bushes to be  
removed

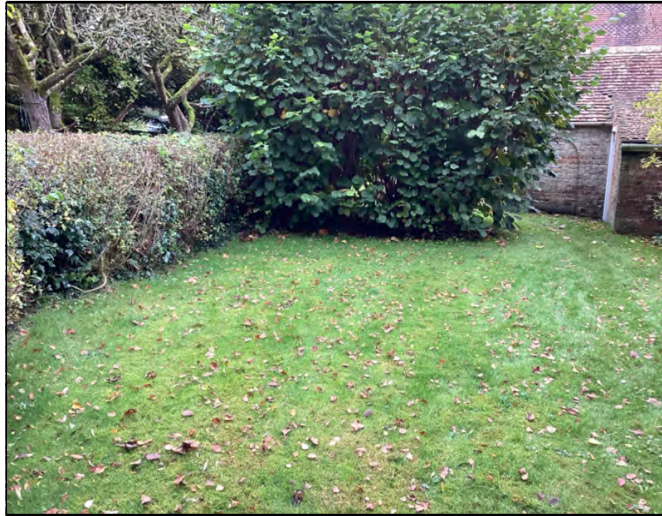
new STP location behind  
the large bushes that  
will need to be removed

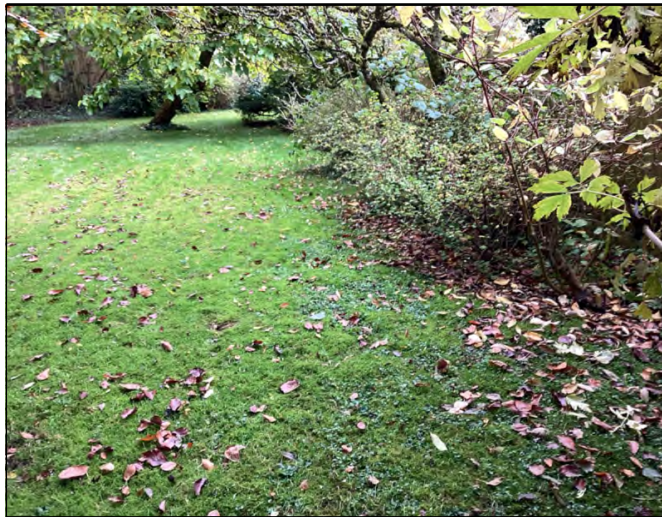
pumping main route  
from the new STP to the  
sample chamber

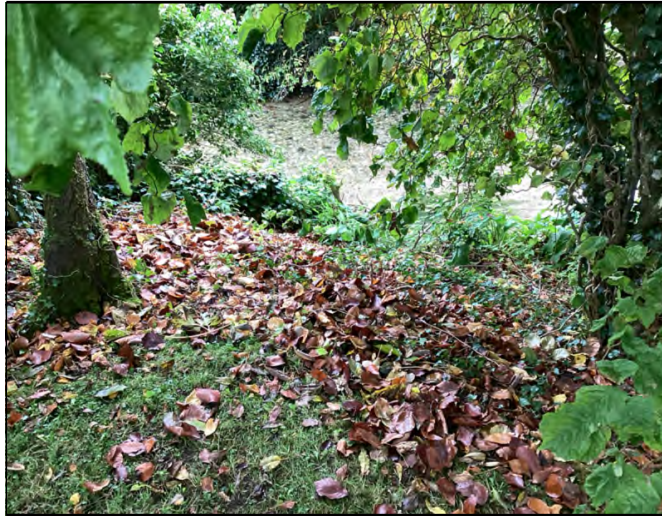
sample chamber  
location to the water  
course

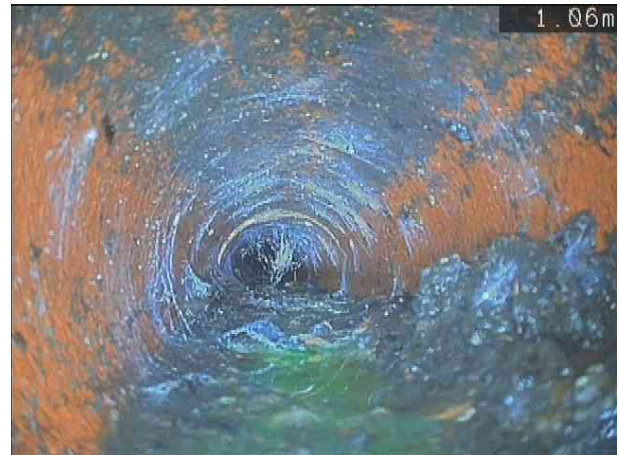
RWWG1X\_24ee1754-99c7-49c4-b9b0-5a0b47d49434\_20241106\_122018\_704.jpg, 00:00:36, 1.06 m  
Settled deposits, fine, 25% cross-sectional area loss, start

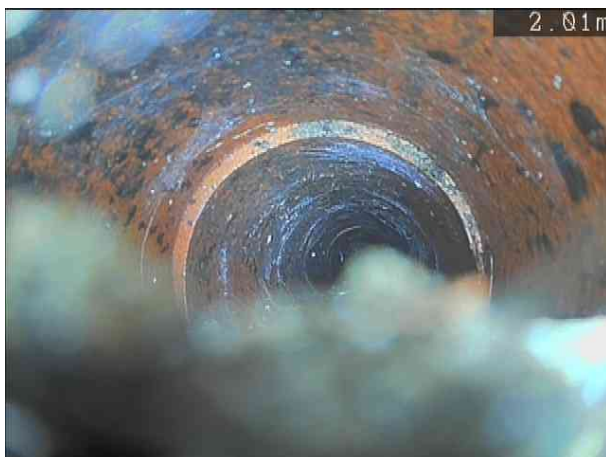
| Scale: | 1:50 | Position [m] | Code | Observation | MPEG | Photo | Grade |
|---|---|---|---|---|---|---|---|
| | | 2.01 | CC | Crack, circumferential from 4 o'clock to 11 o'clock | 00:00:49 | RWWG1X_ebeea0d1-1a22-45 | 2 / 2 |

RWWG1X\_ebeea0d1-1a22-453a-8d32-a98129a4e5da\_20241106\_122040\_552.jpg, 00:00:49, 2.01 m  
Crack, circumferential from 4 o'clock to 11 o'clock

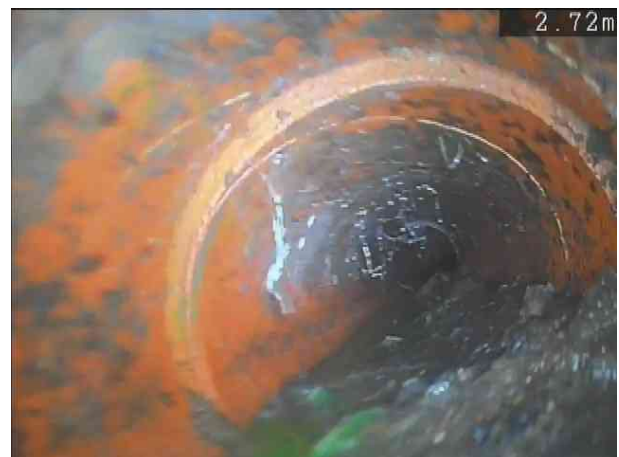
| Scale: | 1:50 | Position [m] | Code | Observation | MPEG | Photo | Grade |
|---|---|---|---|---|---|---|---|
| | | 2.72 | CS | Cracks, spiral from 9 o'clock to 5 o'clock | 00:00:56 | RWWG1X_86e6af7c-43b0-4f40 | 3 / 2 |

RWWG1X\_86e6af7c-43b0-4f40-9652-0ae3e08a8b3b\_20241106\_122100\_357.jpg, 00:00:56, 2.72 m  
Cracks, spiral from 9 o'clock to 5 o'clock

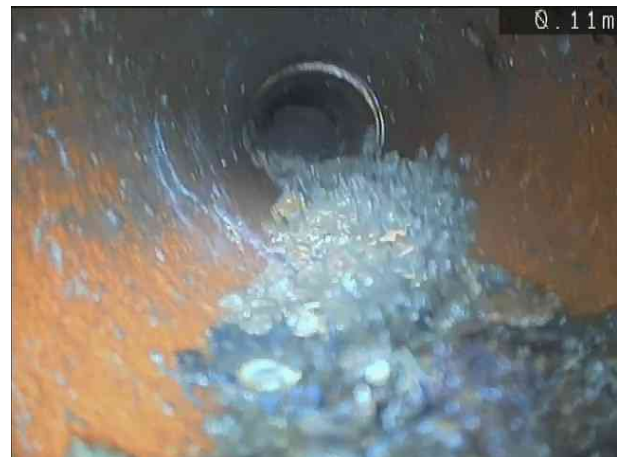
| Scale: | 1:50 | Position [m] | Code | Observation | MPEG | Photo | Grade |
|---|---|---|---|---|---|---|---|
| | | 0.11 | S01 | Settled deposits, fine, 15% cross-sectional area loss, start | 00:00:14 | UnknownX_aa392f14-f072-4e23 | |

UnknownX\_aa392f14-f072-4e23-8d57-0af68de4823c\_20241106\_122454\_667.jpg, 00:00:14, 0.11 m  
Settled deposits, fine, 15% cross-sectional area loss, start

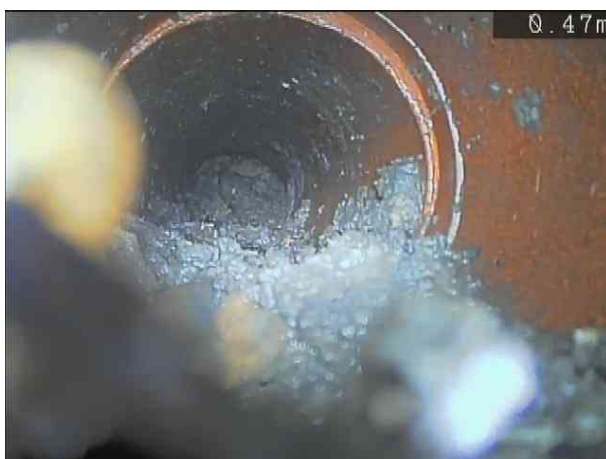
| Scale: | 1:50 | Position [m] | Code | Observation | MPEG | Photo | Grade |
|---|---|---|---|---|---|---|---|
| | | 0.47 | FC | Fracture, circumferential from 12 o'clock to 4 o'clock | 00:00:17 | UnknownX_a8f858ec-b9ad-429 | 3 / 2 |

UnknownX\_a8f858ec-b9ad-4292-a37d-4d0c5fb1dbe1\_20241106\_122508\_704.jpg, 00:00:17, 0.47 m  
Fracture, circumferential from 12 o'clock to 4 o'clock

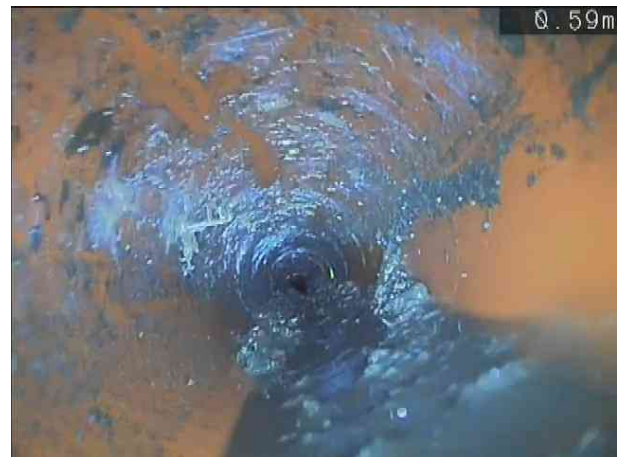
| Scale: 1:1836 | Position [m] | Code | Observation | MPEG | Photo | Grade |
|---|---|---|---|---|---|---|
| 0.59 S01 | DES | | Settled deposits, fine, 15% cross-sectional area loss, start | 00:00:14 | MH1X_e0<br>a5b025-16<br>50-4098-b | |

MH1X\_e0a5b025-1650-4098-ba8a-69178dd9b2d3\_20241106\_122746\_902.jpg, 00:00:14, 0.59 m  
Settled deposits, fine, 15% cross-sectional area loss, start

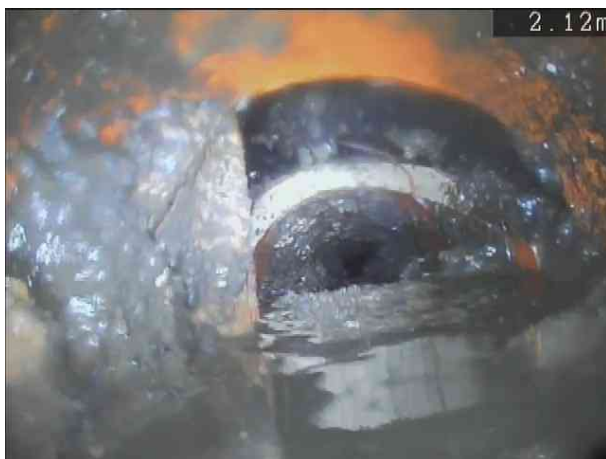
| Scale: 1:1836 | Position [m] | Code | Observation | MPEG | Photo | Grade |
|---|---|---|---|---|---|---|
| 2.12 | B | | Broken pipe from 9 o'clock to 3 o'clock | 00:01:00 | MH1X_14<br>7ddf87-d2<br>7d-45c7-b | 4 |
| 2.12 | SV | | Soil visible beyond defect | 00:01:00 | | |

MH1X\_147ddf87-d27d-45c7-b92f-d7a50c0d1b6e\_20241106\_122857\_182.jpg, 00:01:00, 2.12 m  
Broken pipe from 9 o'clock to 3 o'clock

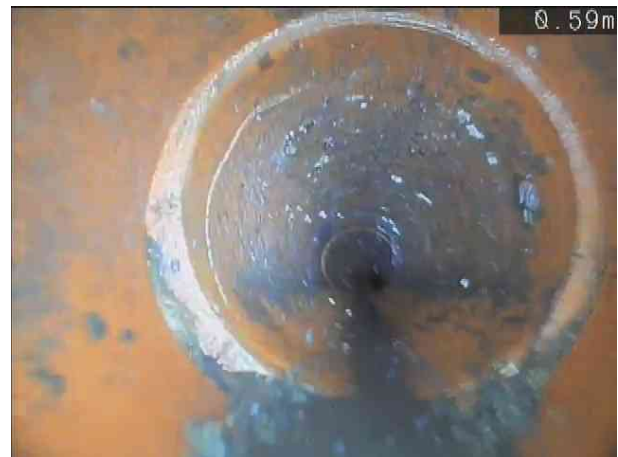
| Scale: | 1:58 | Position [m] | Code | Observation | MPEG | Photo | Grade |
|---|---|---|---|---|---|---|---|
| | | 0.59 | CC | Crack, circumferential from 8 o'clock to 12 o'clock | 00:00:16 | MH2X_49<br>3d89ce-f5<br>28-4eec-a | 2 / 2 |

MH2X\_493d89ce-f528-4eec-a012-1d1f96db270c\_20241106\_123134\_672.jpg, 00:00:16, 0.59 m  
Crack, circumferential from 8 o'clock to 12 o'clock

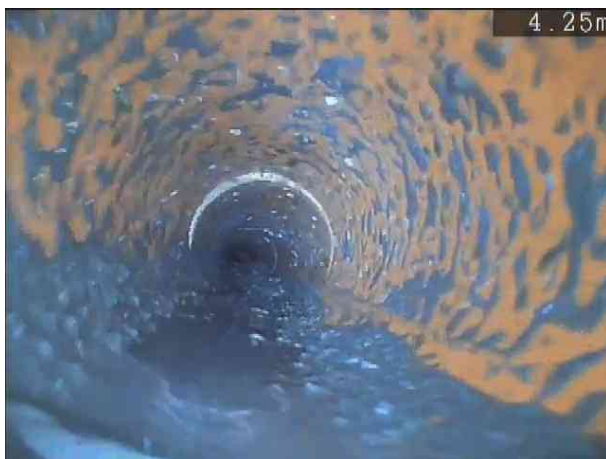
MH2X\_8dca36d0-ac9d-4d5f-a4de-f5b96a658363\_20241106\_123248\_012.jpg, 00:00:34, 4.25 m  
Settled deposits, fine, 15% cross-sectional area loss, start

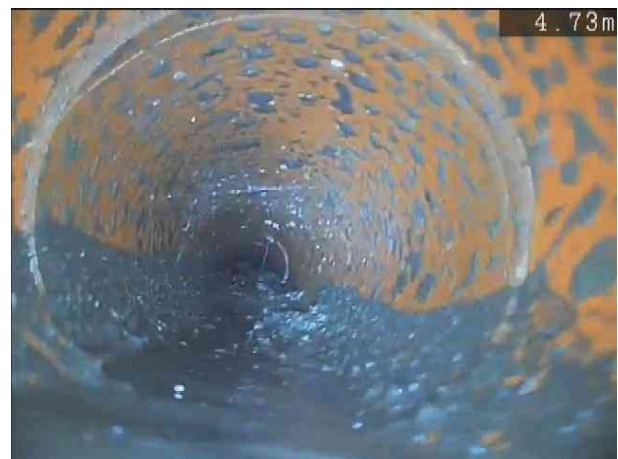
| Scale: | 1:58 | Position [m] | Code | Observation | MPEG | Photo | Grade |
|---|---|---|---|---|---|---|---|
| | | 4.73 | CC | Crack, circumferential from 10 o'clock to 5 o'clock | 00:00:35 | MH2X_1b<br>3c6750-1a<br>7d-4961-8f | 2 / 2 |

MH2X\_1b3c6750-1a7d-4961-8f1c-dcd46c15ad4a\_20241106\_123351\_921.jpg, 00:00:35, 4.73 m  
Crack, circumferential from 10 o'clock to 5 o'clock
