# Bratton House, Retaining Wall

## Structural Report

Project Reference: 2026-022

Document Reference: REPORT-01-001

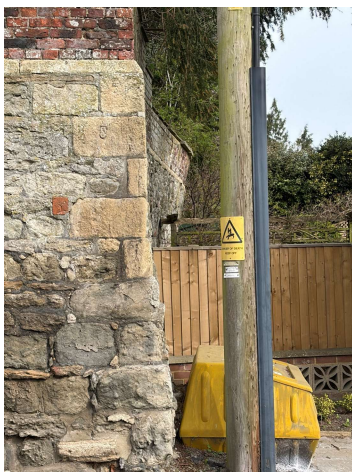
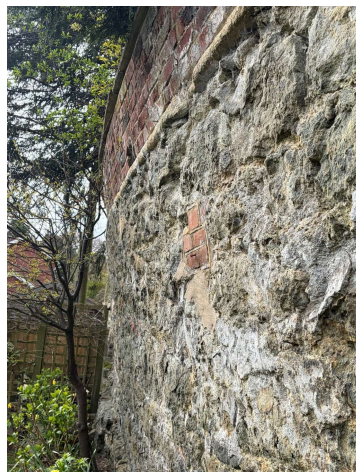
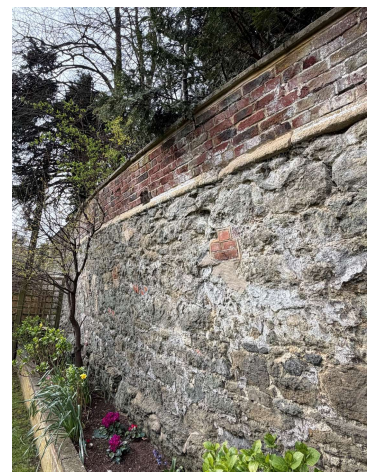
The lower portion of the wall, formed predominantly of irregular stone masonry, is observed to be leaning outward into the neighbouring garden. This lean is accompanied by a pronounced horizontal bowing along the length of the wall, indicating lateral displacement consistent with sustained earth pressure from the retained soil. The deformation appears to be progressive rather than localised, suggesting that the wall is acting as a flexible mass rather than a rigid element. While no major through-cracks or open fractures were identified within this section, the absence of cracking should not be taken as an indication of stability, as movement in mass masonry walls can often occur through joint deformation and internal rearrangement rather than discrete cracking.

The inspection findings indicate that the primary structural concern relates to the stone masonry section of the retaining wall, which is exhibiting outward lean and pronounced bowing. This behaviour is characteristic of a retaining structure that is no longer adequately resisting lateral earth pressures and is undergoing progressive deformation.

Demolish and reconstruct the affected stone section of the retaining wall.

Rebuild using either mass masonry or reinforced concrete backing with a masonry facing to match existing appearance.

Incorporate proper drainage (weep holes, land drain, granular backfill).

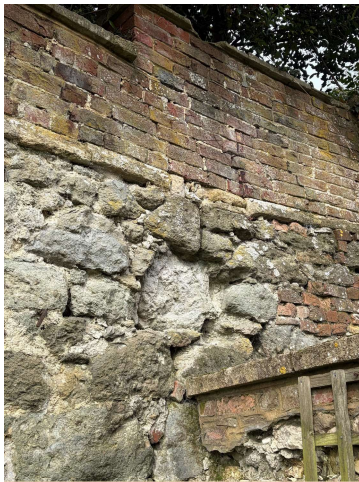
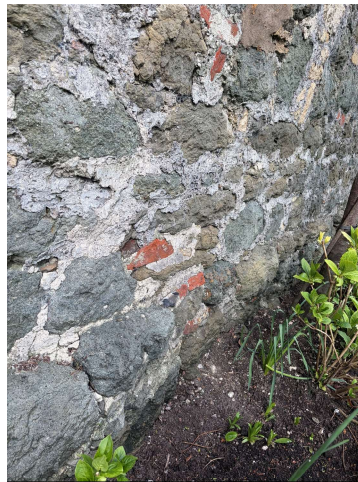
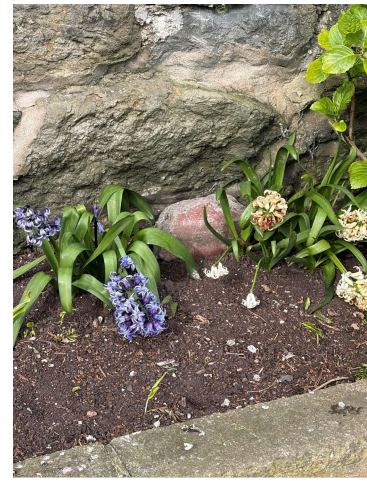
There are several areas within the stonework where the masonry appears loose and poorly bonded, with mortar joints significantly deteriorated or missing altogether. Individual stones appear to have become dislodged or are at risk of displacement, particularly in zones where previous failures have occurred. Evidence of historic localised repairs is visible, with sections of stonework having been replaced or infilled with brickwork. These repairs appear to have been undertaken in an ad hoc manner and do not provide uniform structural continuity with the surrounding stone masonry. The interface between original stonework and later brick infill may represent planes of weakness within the wall. It was reported to Conley that the outward movement and deformation of this section have increased over time, which is consistent with the observed condition and suggests an ongoing mechanism of instability, potentially exacerbated by factors such as poor drainage, increased surcharge loading, or seasonal moisture variation.

Vegetation growth is also noted within joints of the stone and brickwork, including small plants and rooted material. This vegetation can contribute to further deterioration by widening joints, retaining moisture, and introducing root action that may displace masonry units over time.

The historic repairs observed within the stone section, where brickwork has been used to infill areas of lost masonry, may also be contributing to the current condition. These repairs are likely to have different stiffness and bonding characteristics compared to the original stonework, creating zones of differential behaviour and potential weakness. Such inconsistencies can lead to uneven load distribution and localised instability.

Remove or manage vegetation directly behind the wall, particularly smaller trees and shrubs.

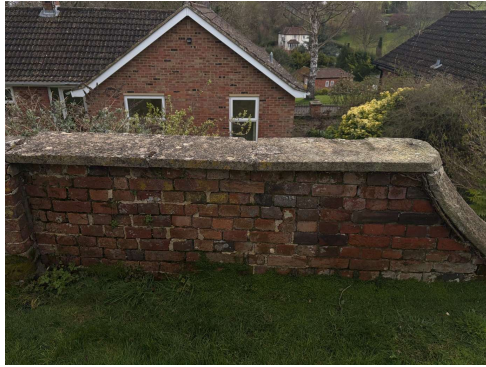
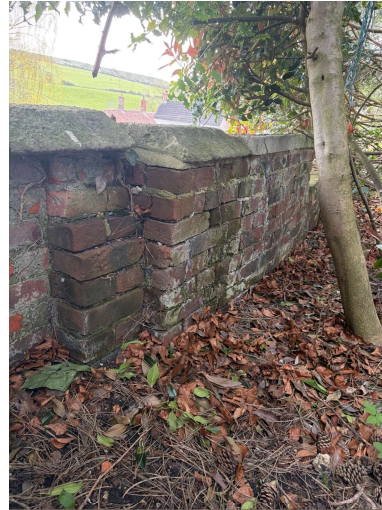
In contrast, the upper section of the wall, comprising approximately 0.5m of brickwork above the retained ground level, appears to be in generally good condition. The brick courses are relatively uniform, and the masonry shows no significant signs of distortion, bowing, or structural cracking. Mortar joints in this section are generally intact, with only minor weathering observed. The coping detail along the top of the wall appears continuous and largely undisturbed, providing an element of protection against direct water ingress into the wall core. No significant displacement or failure of the coping units was observed.

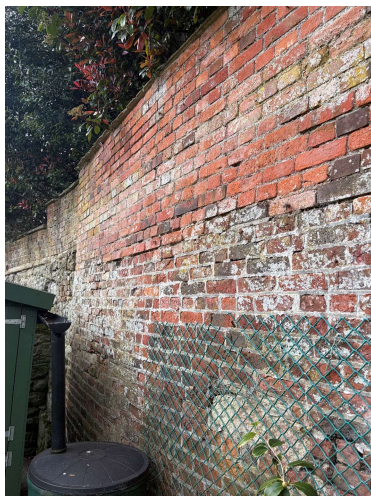
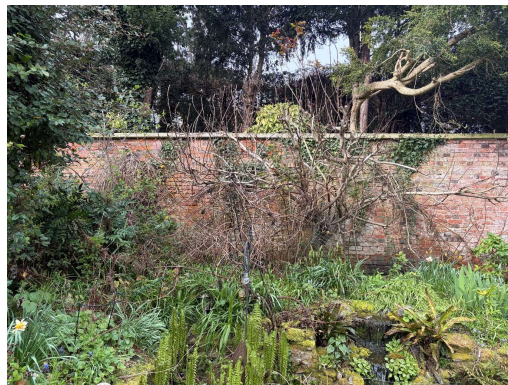
The main retaining section constructed in brickwork (below the upper stone transition and extending toward ground level on the exposed face) is also observed to be in comparatively sound condition. This section does not exhibit the same degree of deformation as the stonework, and no notable bowing or structural cracking was identified. The wall face appears relatively plumb in this area. However, there are isolated zones where mortar joints have deteriorated, receded, or “blown.” This is likely attributable to long-term weathering and freeze-thaw cycles, particularly in areas exposed to moisture ingress. While these defects are currently minor and localised, they may allow increased water penetration into the wall, which could contribute to longer-term deterioration if not addressed.

Staining, biological growth (including lichen and moss), and general weathering are evident across much of the wall surface, indicating prolonged exposure to moisture. No obvious drainage provisions, such as weep holes, were observed within the inspected sections, which may contribute to the build-up of hydrostatic pressure behind the wall, particularly within the more deforming stone section.
