Mann Williams  
Consulting Civil and  
Structural Engineers

# Quemerford Gate Cottage

## Roof Inspection

Job Number: 13179

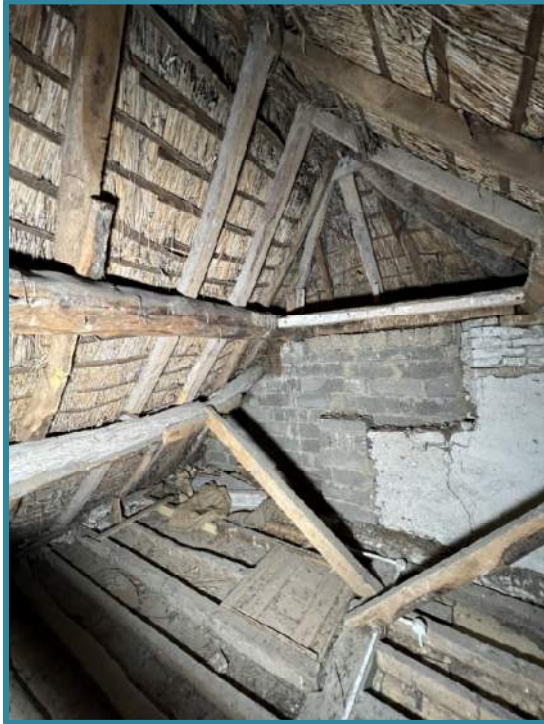
*East Cell - Looking East*

- 2.1.3 In the east cell there is a central ceiling support beam that runs from the east gable through to the central chimney wall. At each end angled props have been inserted off this beam to give support to the purlins either side.

- 2.1.4 The lower purlin on the north roof slope has some decay in the length of the timber which would benefit from some additional support [Item 01]. The bearing end of this same purlin also appears to have decayed and it would be prudent to insert a prop off the masonry in this location [Item 02].

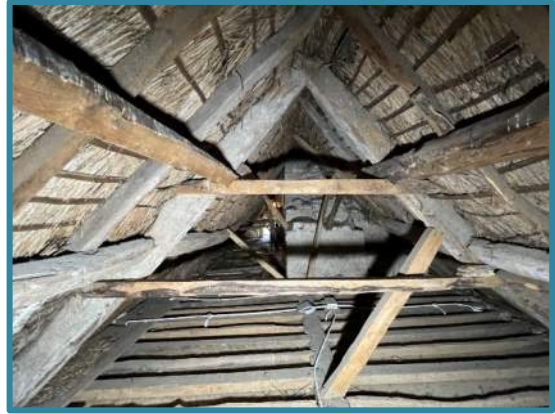
*Truss TR1 – Looking West*

- 2.1.6 In the middle of the east cell there is a timber frame that supports the roof (TR01). This comprises a pair of large section rafters with 2no. high level tie members. There is however no tie present at ceiling level. The rafter to the north roof slope has failed at the purlin mortice hole and an angled prop is in place, propped off the central ceiling beam. The central ceiling beam is not designed to carry roof load but the structural configuration appears to be working at present. We would recommend some enhancements though.

- 3.1.2 The main areas of concern centre around the trusses and the purlins. Truss TR01 has a fractured principal rafter and no formal tie beam at ceiling level. The introduction of a tie structure will both provide lateral restraint to the base of the principal rafters but also provide a medium to introduce an additional prop to the principal rafter where it is fractured.

- 2.1.7 Our recommendation would be to introduce a couple of timbers at low level to both provide a sound horizontal tie to the foot of the rafters and also to allow an additional prop to be installed to secure the fractured principal rafter on the north side [Items 04 & 05].

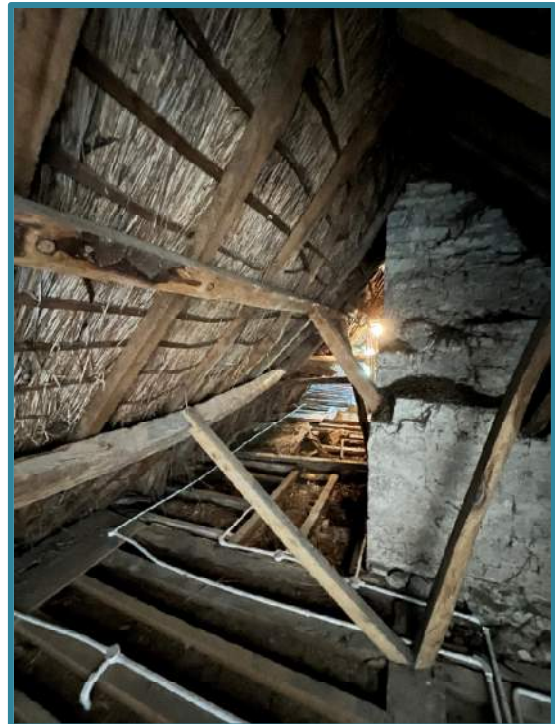
*Central Chimney - Looking West*

- 2.1.5 A long purlin extends past the central chimney wall on the south elevation which would benefit from some intermediate support [Item 03].

- 2.1.11 A rafter and ceiling beam give support to the roof purlins on the south roof slope where they run past the central chimney wall. It is not clear how these timbers are secured into the chimney wall and we feel it would be prudent to install a metal tie between the ceiling beam and the masonry to ensure any lateral thrust from the rafter is resisted by a good connection with the central masonry wall [Item 08].

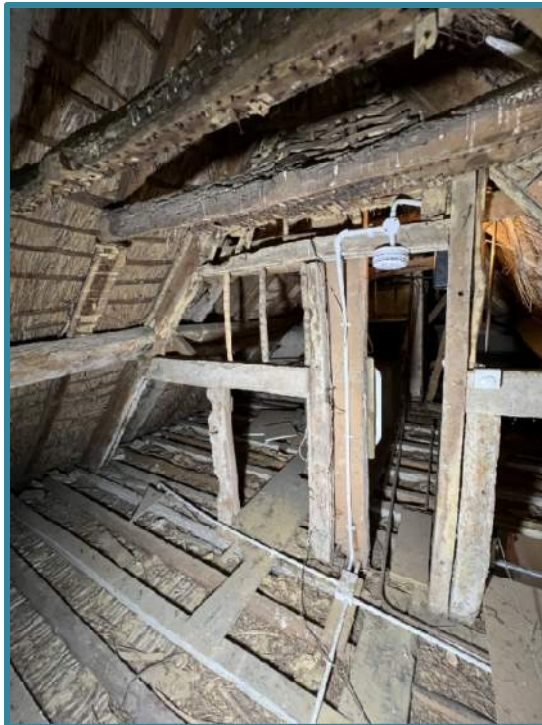
West Cell – Truss TR2

- 2.1.8 There is a truss (TR02) located in the middle of the west cell which appears to have formed a space divider as, what appears to be a doorway, has been created in the timber truss framing. On the east side of the truss there are 2no. lines of purlins and on the west side just a single run of purlins. There are however high level ties between the rafters in the area to the west of the truss.

- 2.1.9 The tie beam to the truss is set at ceiling level and carries 2no. slightly offset ceiling beams down the centre of the area (refer roof plan). The tie beam appears to sit on a masonry wall beneath but is significantly decayed in areas. The debris around the beam needs cleaning out to give a better visual inspection of this beam but we would recommend a new tie is installed as suggested on truss TR01 to secure the base of the rafters to the truss against lateral outwards movement [Item 06].

- 3.1.3 Similarly on truss TR02 the existing tie beam is suffering from decay and a new tying structure is required to retain the truss principal rafters in position.

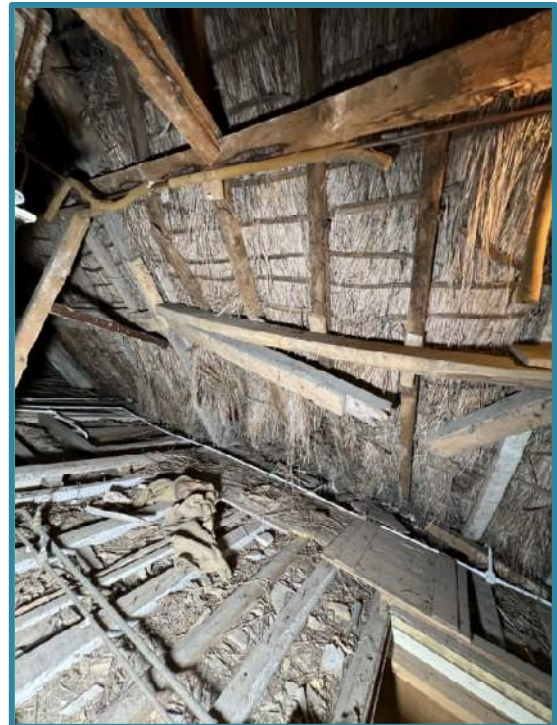
West Cell - Failed Purlin

- 2.1.10 On the south roof elevation the original lower purlin in the east section of this part of the roof has failed and a new very thin timber has been put in its place. This timber is not securely fixed each end and we would recommend a new purlin is installed on hangers to introduce an adequate support to the rafters in this location [Item 07].

**Strengthening:** provide new 125x200 C24 purlin on proprietary truss hangers bolted to rafters
