Our Ref: 14084.4/ADW/JW

**RE: 47 BLUE BOAR ROW, SALISBURY – PROPOSED STRUCTURAL REPAIR WORKS TO THE EXISTING FABRIC FOR PHASE 1**

47, BLUE BOAR ROW  
SALISBURY - PHASE 1

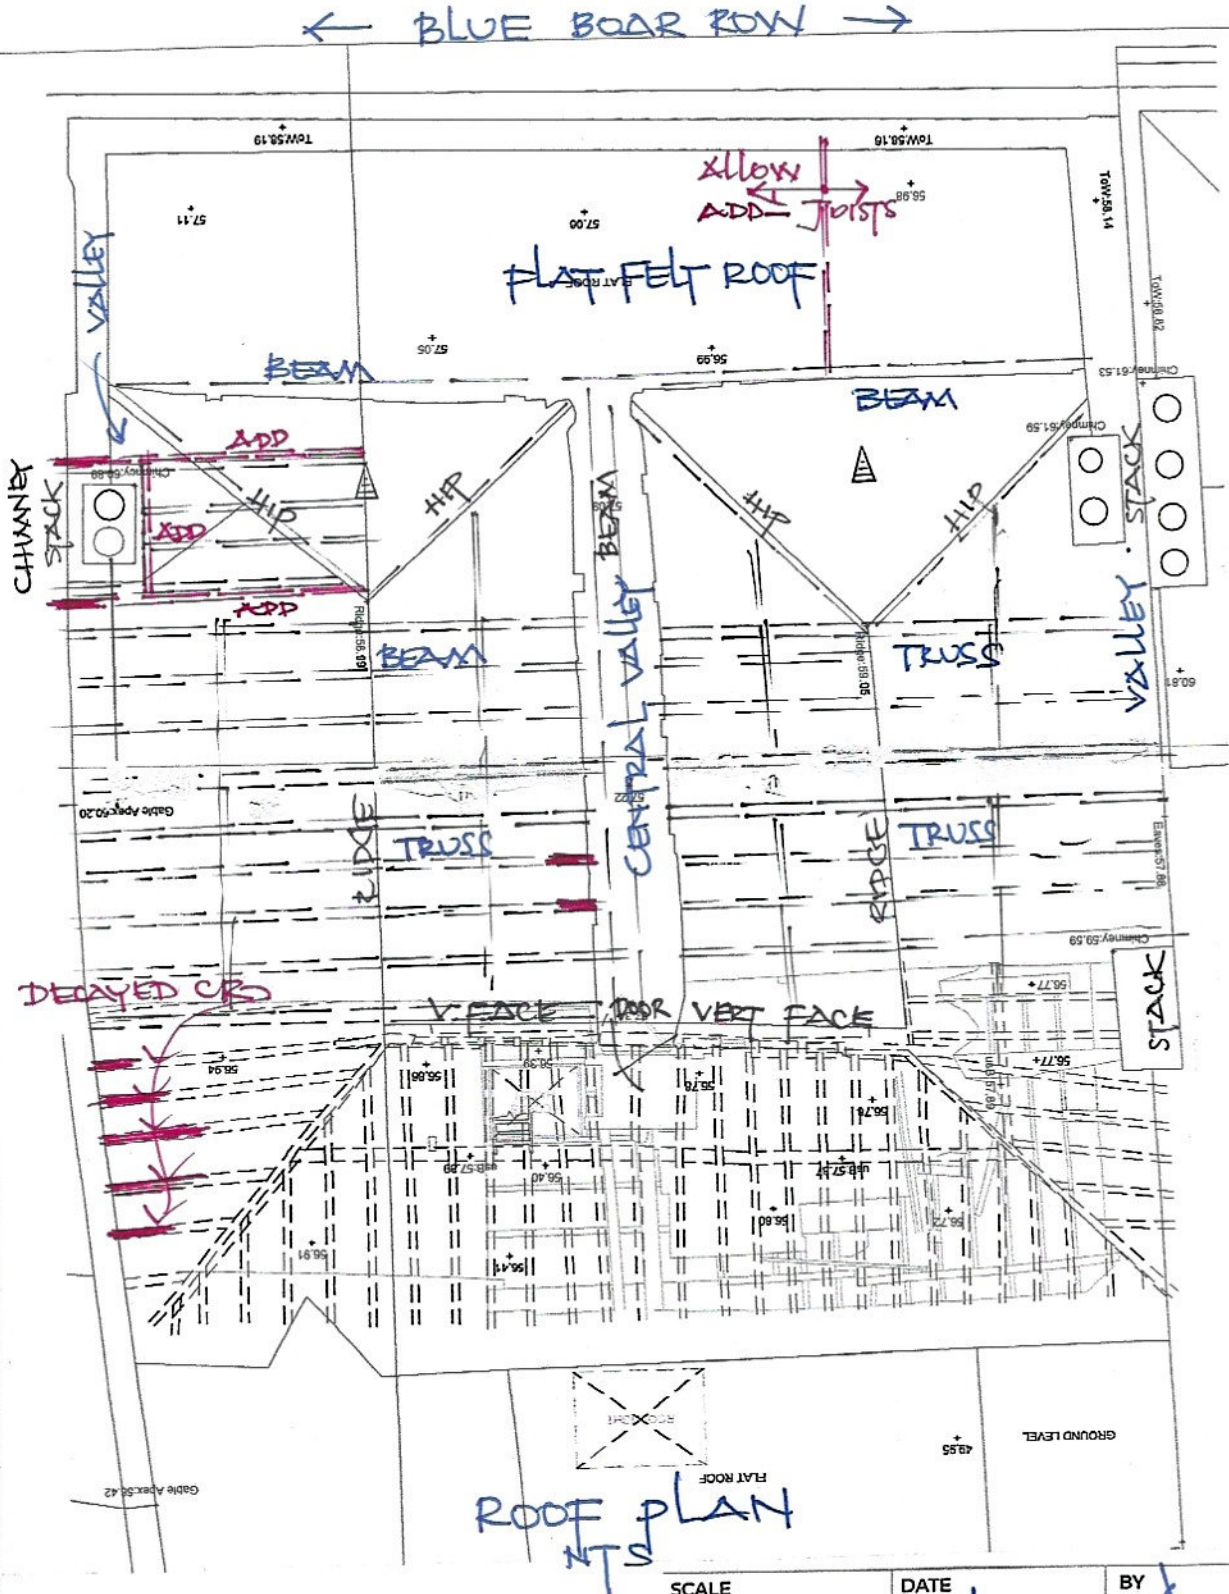
ROOF REPAIRS  
PLAN

I had reported that the roof had been previously repaired and that there is evidence of water penetration through finishes causing both staining and decay of timber elements and damage to lath & plaster ceilings.

The roof form comprises two pitched roof areas with a central valley and edge valleys abutting the existing building on either side. The rooves are linked via valley rafters to a pitched roof to the rear, with a vertical face towards Blue Boar. The roof is plain clay tiled with both valleys and the flat margin to the Blue Boar elevations both covered in torched roofing felt.

The pitched roof structure comprises trusses spanning to a primary beam under the central valley. The trusses support purlins and common rafters with the front elevation flat roof, supported on a beam spanning the same direction as the trusses. The ceilings are independent timber joists.

Water ingress has caused historic damage to structure, and there are some modern softwood repairs, particularly around the ceiling access hatch.

Most of the damage has occurred in these valley areas and the common rafter ends are most affected. The attached sketch shows common rafters which need strengthening and this will be achieved by augmenting the original ones with new treated softwood alongside, leaving the external fabric in place.

It is not possible to access the flat roof zones, but the same principal can be followed once opened up: namely, to augment the existing joists with new.

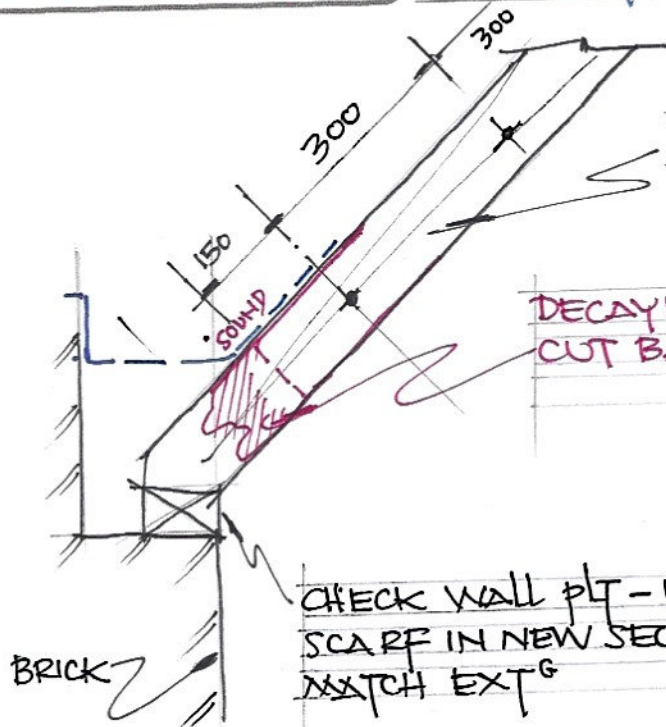
AUGMENTING DETAIL  
1:10

DECAYED COMMON RAFTER  
CUT BACK TO SOUND

PARTER DECAYED C.R. WITH  
NEW 50x100 C24. MIN  
3 M10 BOLTS @ 300% +  
150 END DISTANCES

CHECK WALL PLT - IF DECAYED  
SCARF IN NEW SECTION TO  
MATCH EXT'G
