## Job Sheet & SSRA

| Job | <b>The Old Cottage, Ogbourne St Andrew, Marlborough, SN8 1SB</b> |
| Date / Time of inspection | <b>18/08/2026 11:22</b> |
| Enquiry Description | <b>Prune trees</b> |

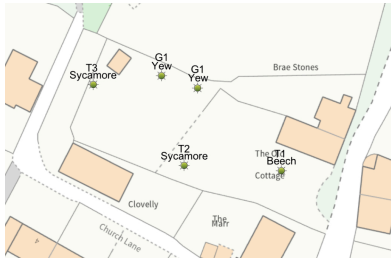
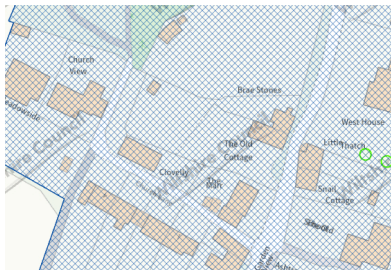
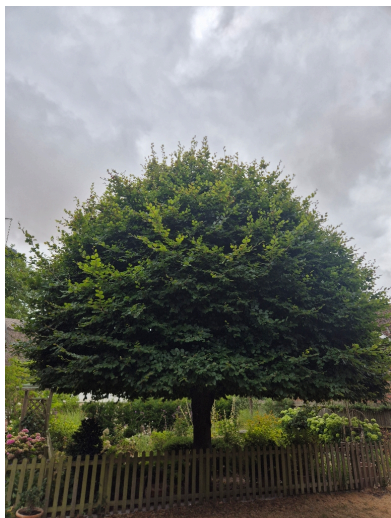
| Work | | | | |
|---|---|---|---|---|
| T1 | Beech (Fagus sylvatica) | <p><b>Physiologically good</b><br/><b>Structurally good</b></p> <p>Small, mature beech located to the side of the property, approximately 5m in height. The tree has historically been annually hedge-trimmed to maintain an umbrella-shaped crown.</p> <p>The client requests that the tree is pruned back harder than usual to reduce the crown to a more manageable size.</p> <p><b>Recommendation:</b><br/>Reduce the crown by approximately 1.5m, maintaining a balanced and suitable branch structure.</p> <p>Road speed N/a<br/>Traffic N/A<br/>Phone signal medium</p> | | <p>///solids.c<br/>orrode.s<br/>werving</p> |

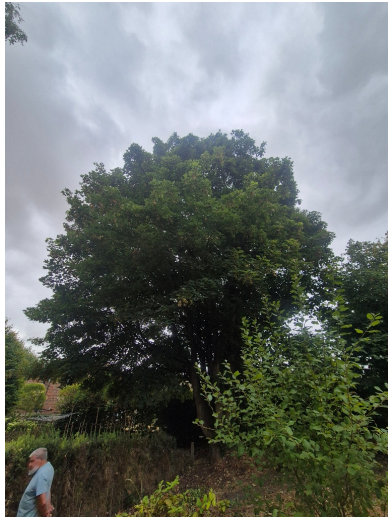
| Work | | | | |
|---|---|---|---|---|
| T2 | Sycamore (Acer pseudoplatanus) | <p>Physiologically good<br/>Structurally good</p> <p>Large, mature tree located within the rear garden. The tree is multi-stemmed, developing into a symmetrical scaffold framework supporting a dense, symmetrical crown extending approximately 12m radially, resulting in an overall tree height of approximately 18m.</p> <p>Multiple crossing and rubbing branches are present throughout the crown, along with several branches exhibiting squirrel damage. A number of limbs also carry significant end weight, increasing the potential for limb failure.</p> <p>The client has requested that all damaged branches within the crown are removed and that the overall crown is reduced to help mitigate the potential for limb failure.</p> <p>Recommendation:<br/>Remove all crossing/rubbing and squirrel-damaged branches throughout the crown. Reduce the overall crown by approximately 3m, while retaining a balanced and natural crown shape and</p> | | ///lance.emporium.hats |

| Work | | | | |
|---|---|---|---|---|
| | | <p><b>maintaining suitable branch structure.</b></p> <p><b>Road speed N/A</b><br/> <b>Traffic N/A</b><br/> <b>Phone signal medium</b></p> | | |

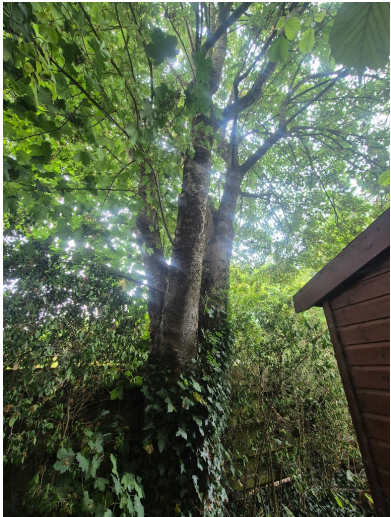
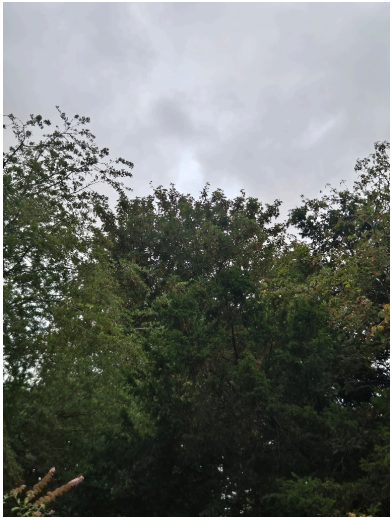
| Work | | | | |
|---|---|---|---|---|
| T3 | Sycamore (Acer pseudoplatanus) | <p>Physiologically good<br/>Structurally good</p> <p>Semi-mature Sycamore located to the rear of the garden. The tree is single-stemmed up to approximately 3.5m, where it develops into a multi-way compressed union, dividing into three co-dominant stems. These stems extend a further 5m before reaching the first crown break, then develop into a dense foliage scaffold framework with a crown spread of approximately 10m radially, resulting in an overall height of approximately 19m.</p> <p>The client is concerned that the compressed unions may be susceptible to failure due to the significant end weight of the upper crown, with potential targets including a shed, neighbouring vehicles and the boundary fence.</p> <p><b>Recommendation:</b><br/>Reduce the tree by approximately 7m, leaving an overall height of approximately 11.5m. This will significantly reduce the end weight and leverage acting on the compressed unions, helping to mitigate the potential for failure at the first main union</p> | | ///quiz.ag<br>reeing.pr<br>ominent |

| Work | | | | |
|---|---|---|---|---|
| | | <p>while retaining an appropriate and balanced crown structure.</p> <p>Road speed N/A</p> <p>Traffic N/A</p> <p>Phone signal medium</p> | | |

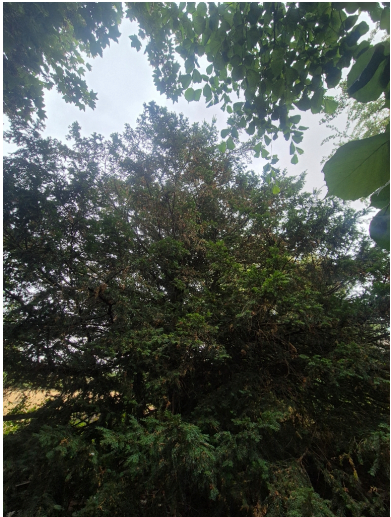
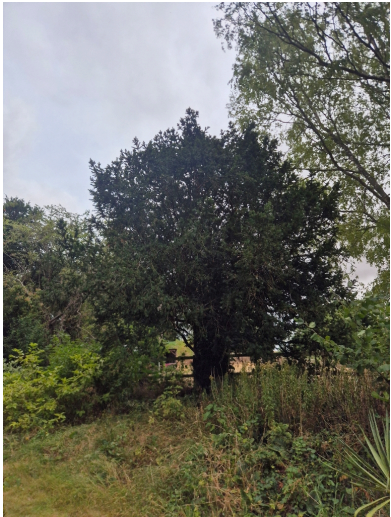
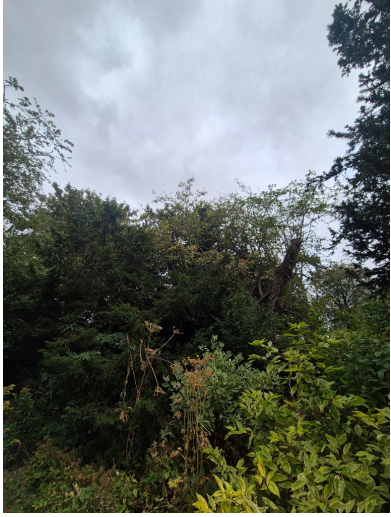
| Work | | | | |
|---|---|---|---|---|
| G1 | Yew (Taxus baccata) | <p>Physiologically good<br/>Structurally good</p> <p>Two mature, small trees located to the eastern side of the rear garden. Both trees are single-stemmed up to the first crown break at approximately 1m, developing dense, multi-branched crowns comprising numerous upright and lateral branches arising directly from the main stem, resulting in an overall height of approximately 6m.</p> <p>The client would like both trees reduced to a more manageable size, with the intention of maintaining them as hedges themselves in the future.</p> <p><b>Recommendation:</b><br/>Reduce both crowns by approximately 2m, leaving the trees at a more manageable height and size suitable for future maintenance as hedging.</p> <p>Road speed N/A<br/>Traffic N/A<br/>Phone signal medium</p> | | <p>///unlimit<br/>ed.garag<br/>es.simula<br/>tor and<br/>///sums.h<br/>eadlight.<br/>destined</p> |
