# NEIL **MARSDEN** ASSOCIATES INDEPENDENT DAMP & TIMBER CONSULTANTS

## Timber Survey

| <b>Property Address</b> | Chippenham Borough Lands Charity Bank House<br>Bath Road Chippenham Wiltshire SN15 2SA |
| <b>Inspection Date</b> | 29 <sup>th</sup> of June 2026 |

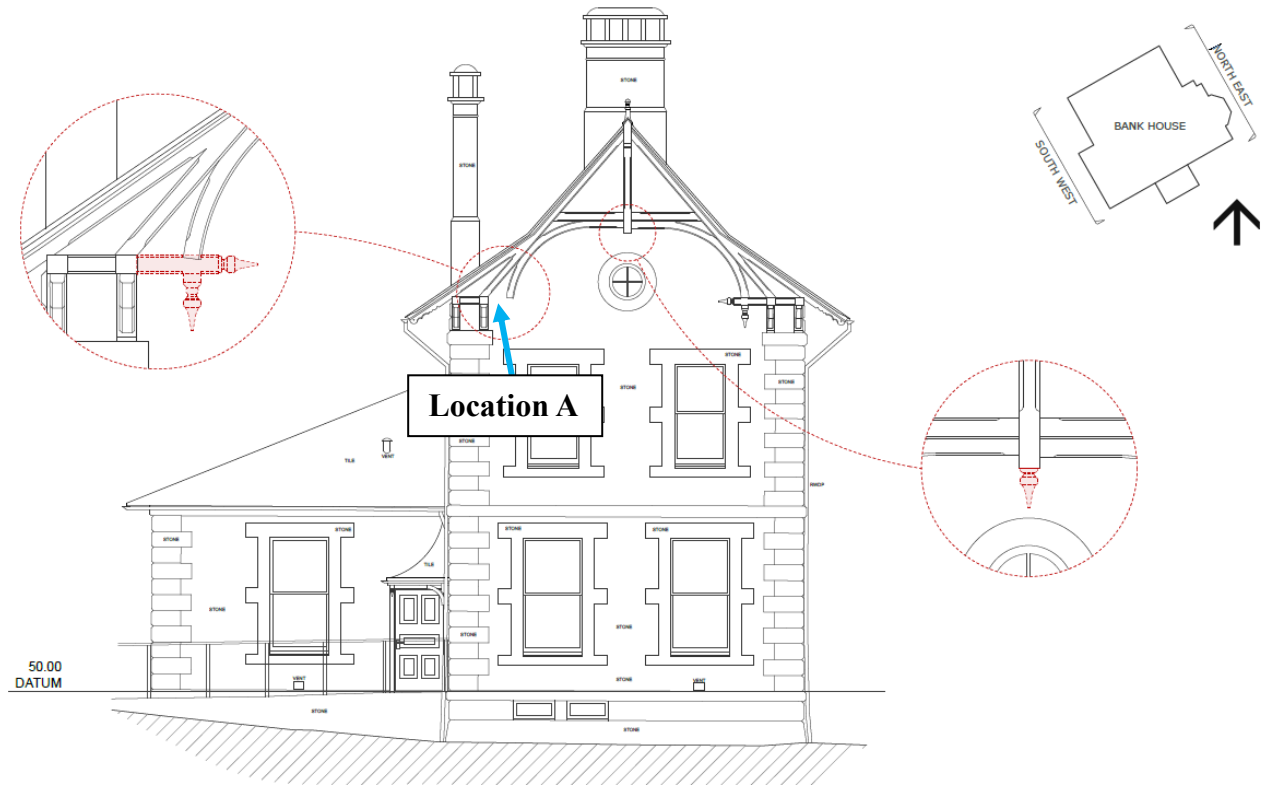
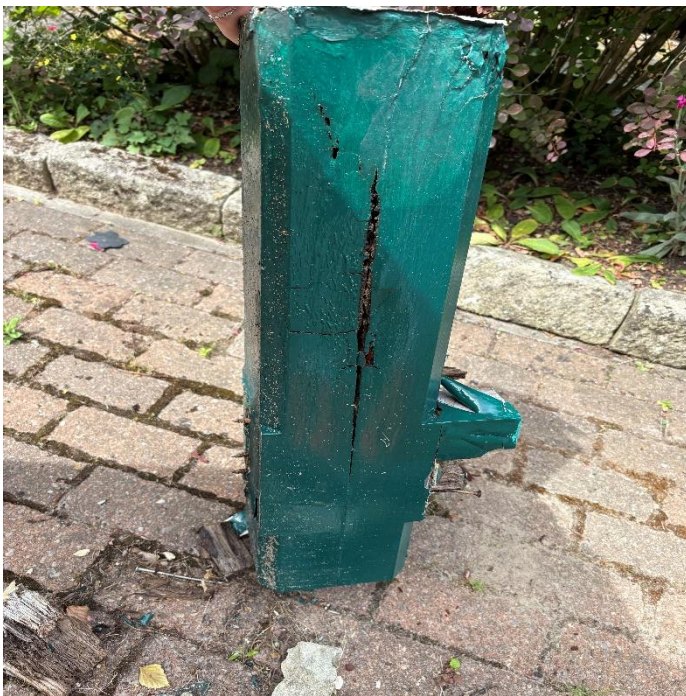
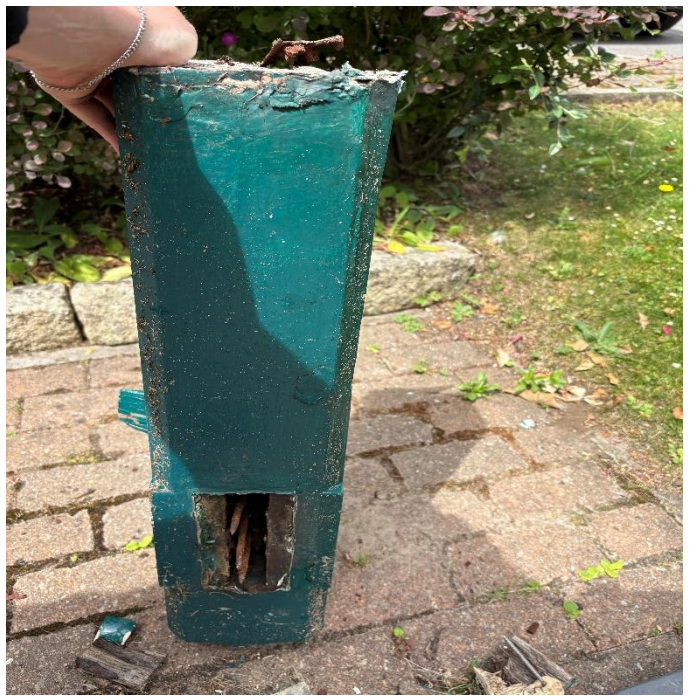
**Locations identified as 'A' on the plan.**

As shown in the photos below, this particular detail has decayed due to water ingress from wind-driven rain and timber joints opening over time, inviting unwanted moisture, resulting in the development of wet rot decay that has affected at least 30-40 per cent of the core of the main horizontal timber. *Wet Rot was the main rot type on all affected timbers.*

**It is recommended that this detail be fully replaced with like-for-like timber (solid, if achievable; if not, well-laminated) and installed using hidden stainless steel screws, external glue/adhesive, accompanied by domino joints. All to be signed off by your consulting structural engineer.**

**The timber should be well primed and finished with oil-based paint or a similar external paint finish. A reputable joinery company versed in creating like-for-like period joinery is recommended to complete all required external timber repair works at this property.**

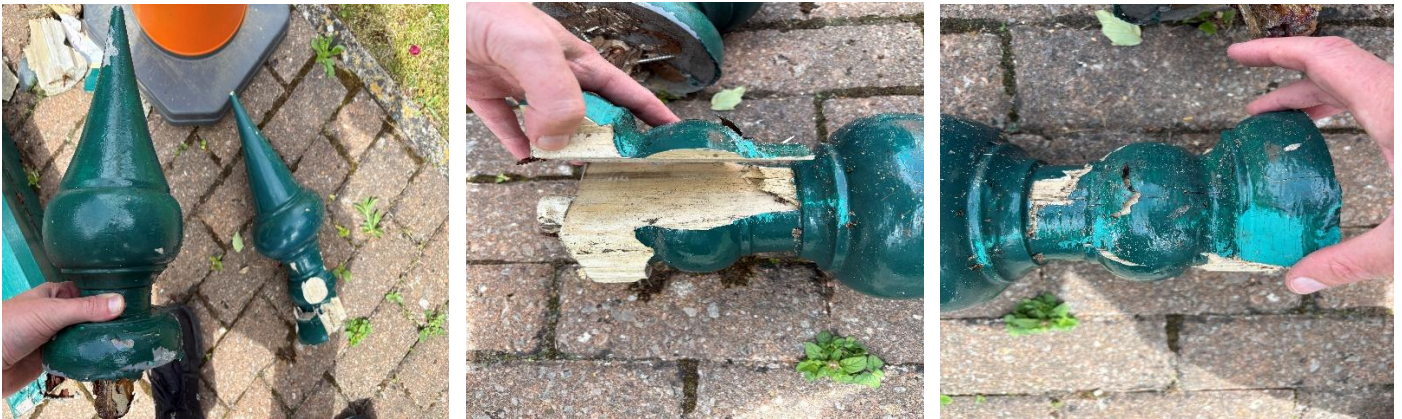
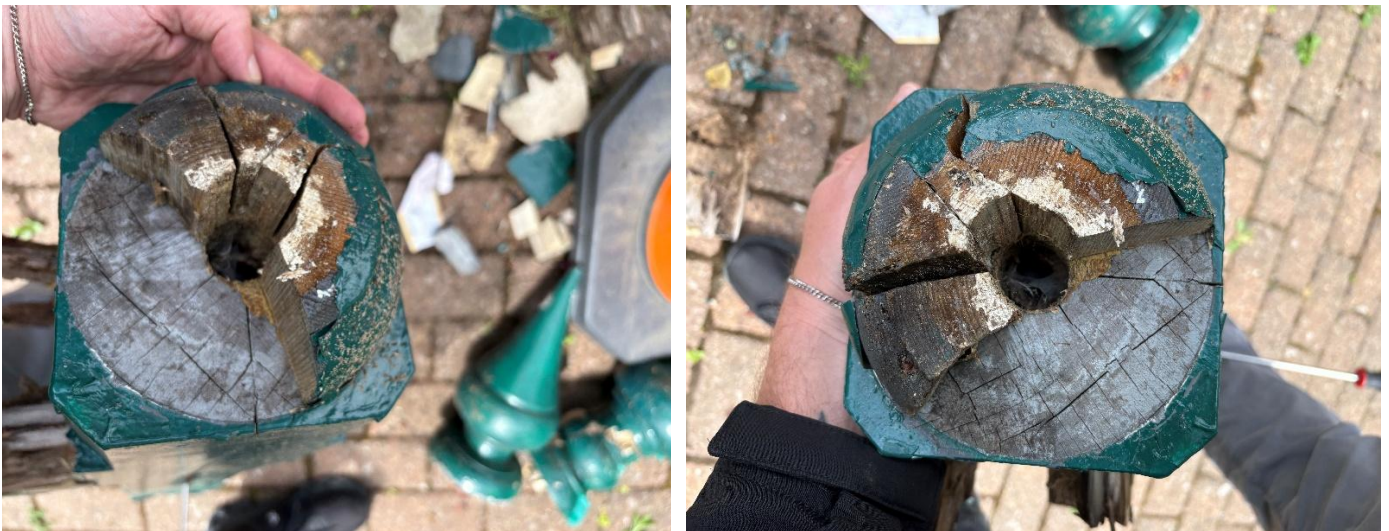
The finials can be repaired by a joinery company (as mentioned). They will likely need to form a new cutter for their table routers to create a matching profile.

The missing pieces below can be formed with new cutters and put back together with external adhesive/glues, likely polyurethane, as this glue is stronger than the timber itself when cured.

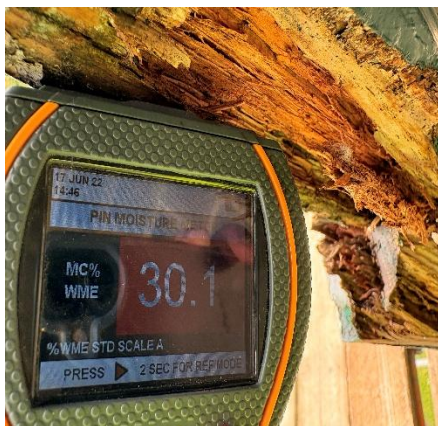
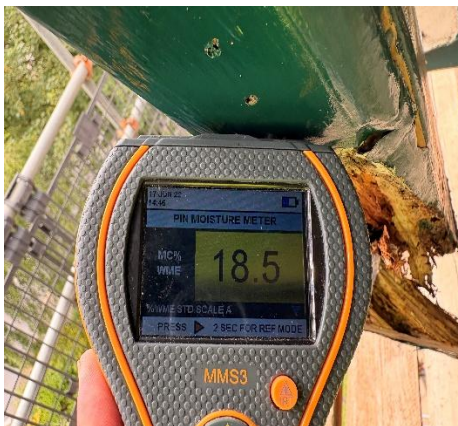
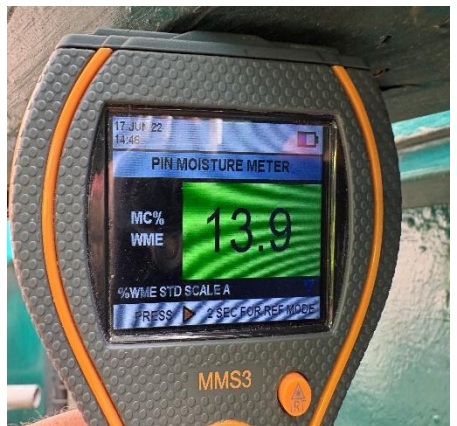
For context, I undertook localised moisture readings, with mostly low-moderate values recorded, and localised pockets of elevated values adjacent to affected timbers.

*The elevated readings should be reduced once the remedial timber repair works are fully completed.*

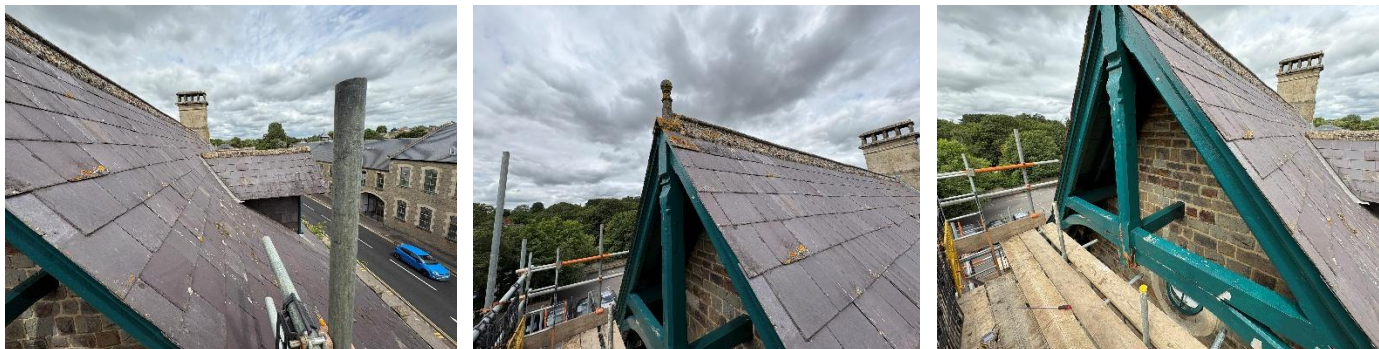
*The slate roof is in satisfactory condition; however, a periodic property of this nature always requires seasonal maintenance/inspection on the external envelope.*

**Regular maintenance of the property's exterior is essential to ensure that it remains watertight. Failure to address defects allowing rainwater to penetrate the building fabric will increase the risk of fungal decay affecting the internal structural timbers.**
