## PICKETT'S YARD, BERWICK ST JOHN.

### Arboricultural Impact Assessment and Method Statement.

**Report by:** Steve Russell BSc (Hons). **Date:** 8th August 2026.

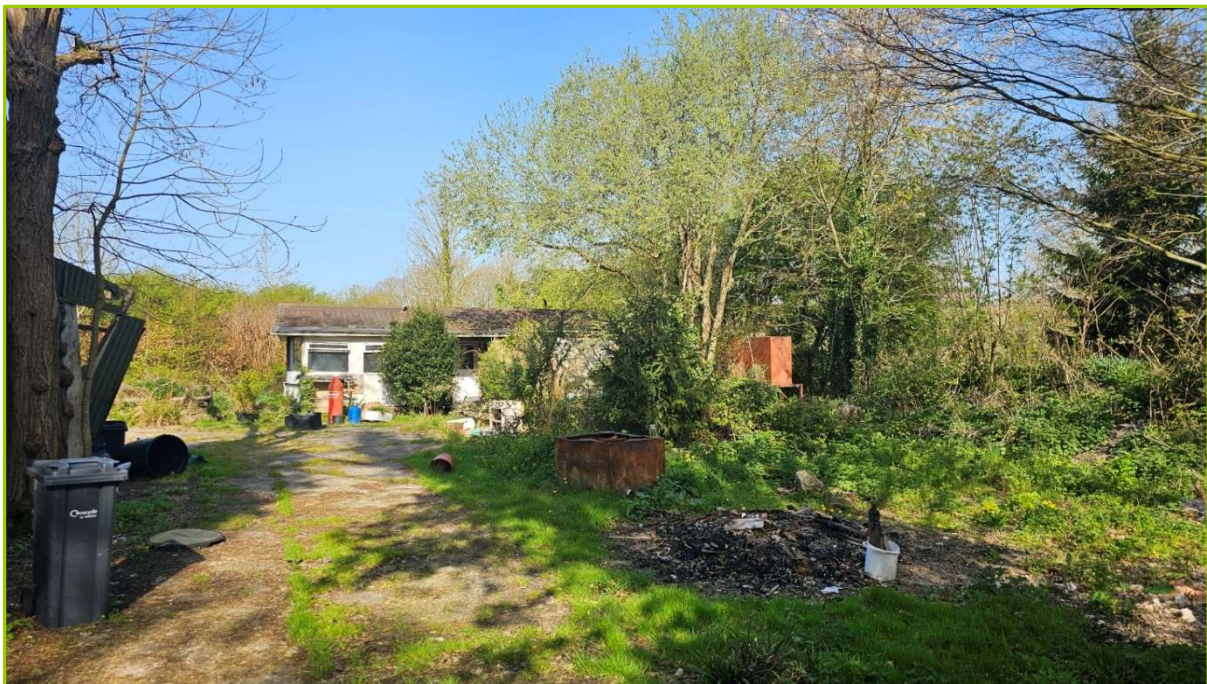
Photo 1 - View looking west towards existing bungalow.

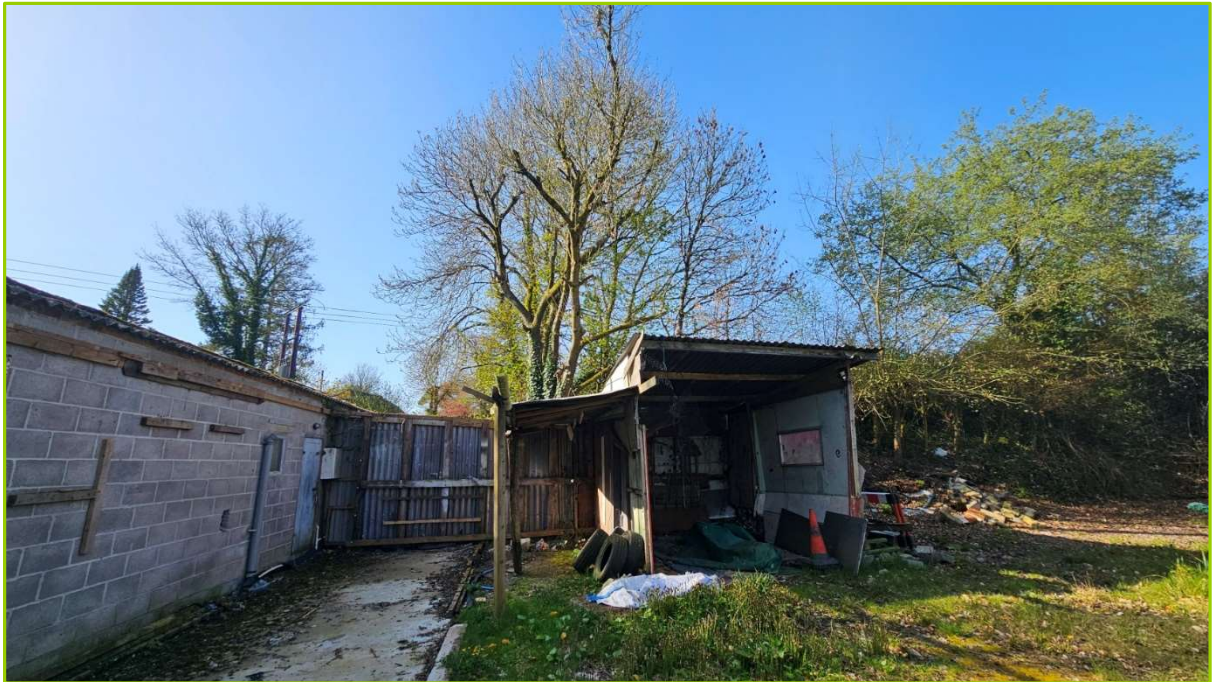
Photo 2 - View looking south towards barns.

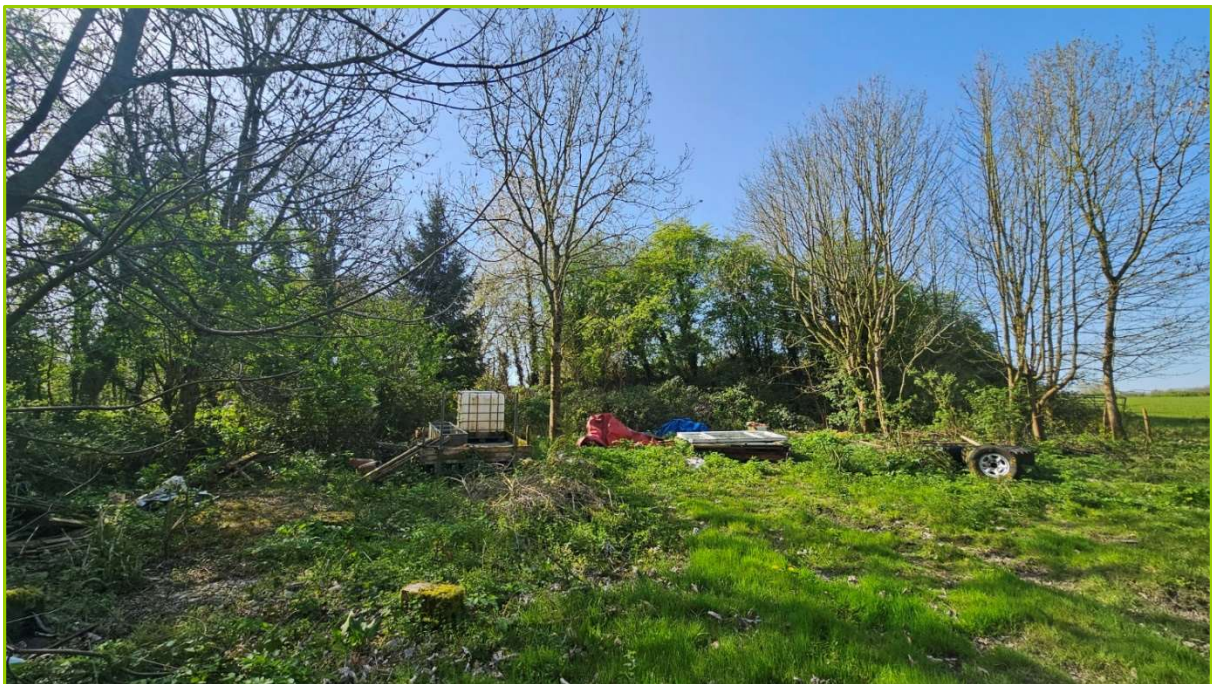
Photo 3 - View looking southwest from the northern end of the site.

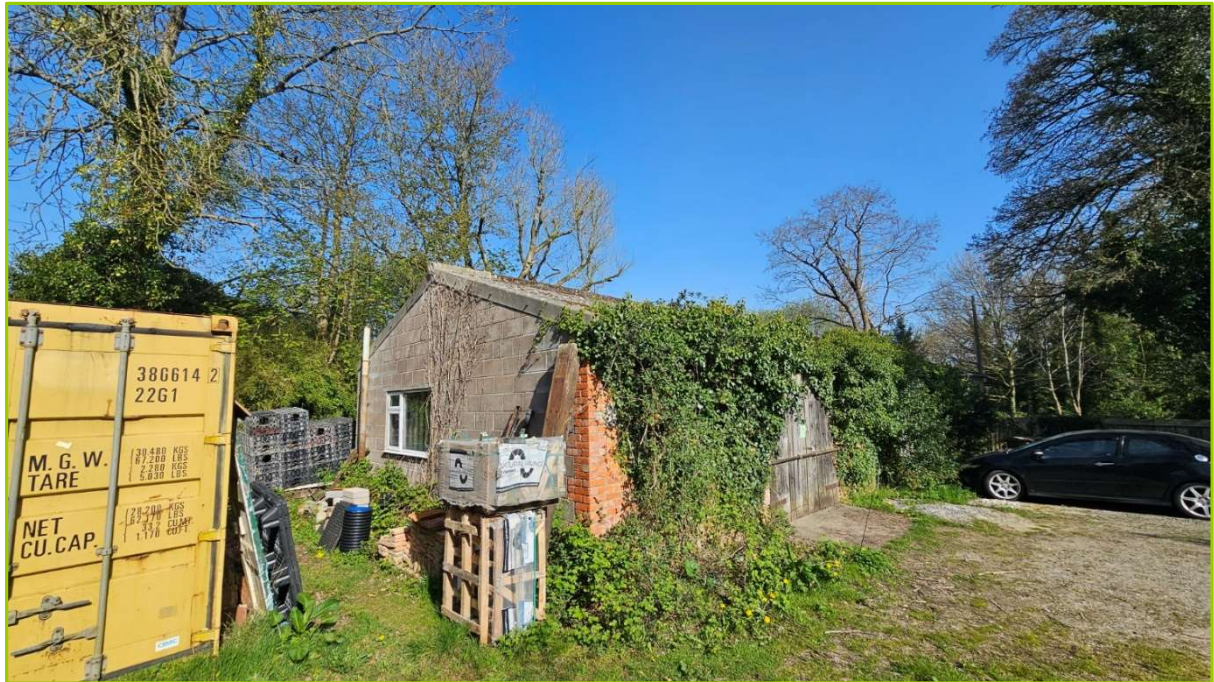
Photo 4 - View looking north showing frontage and workshop.

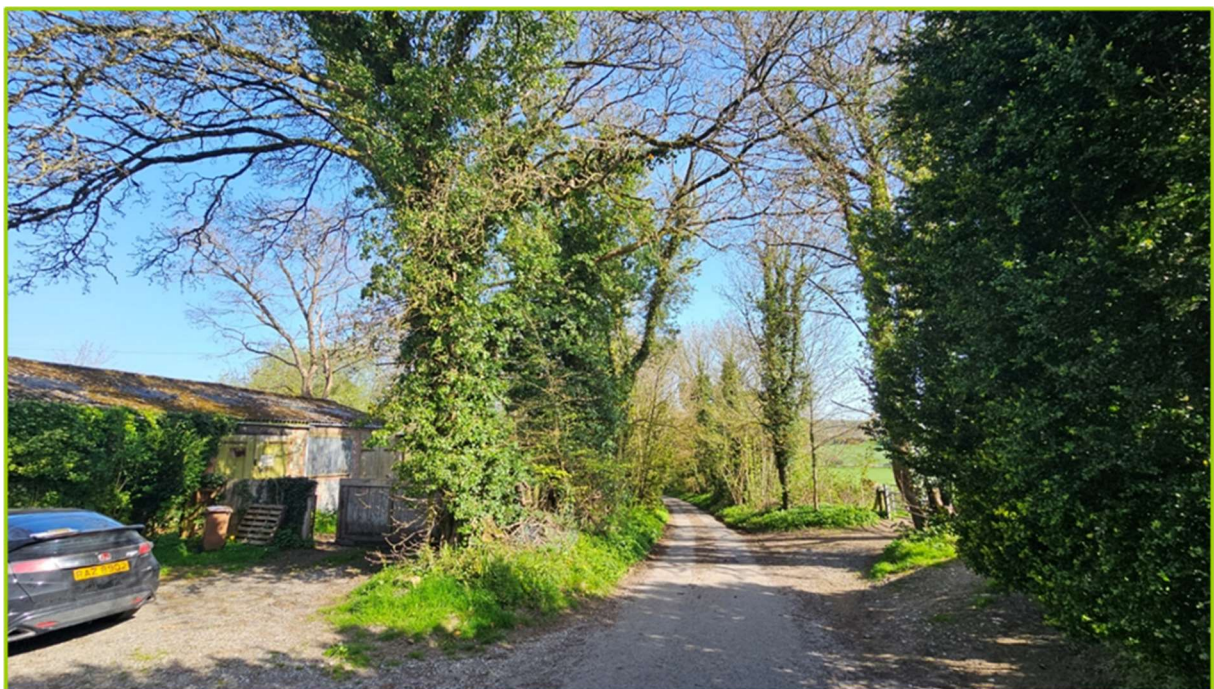
Photo 5 - View looking north along Woodlands Lane.

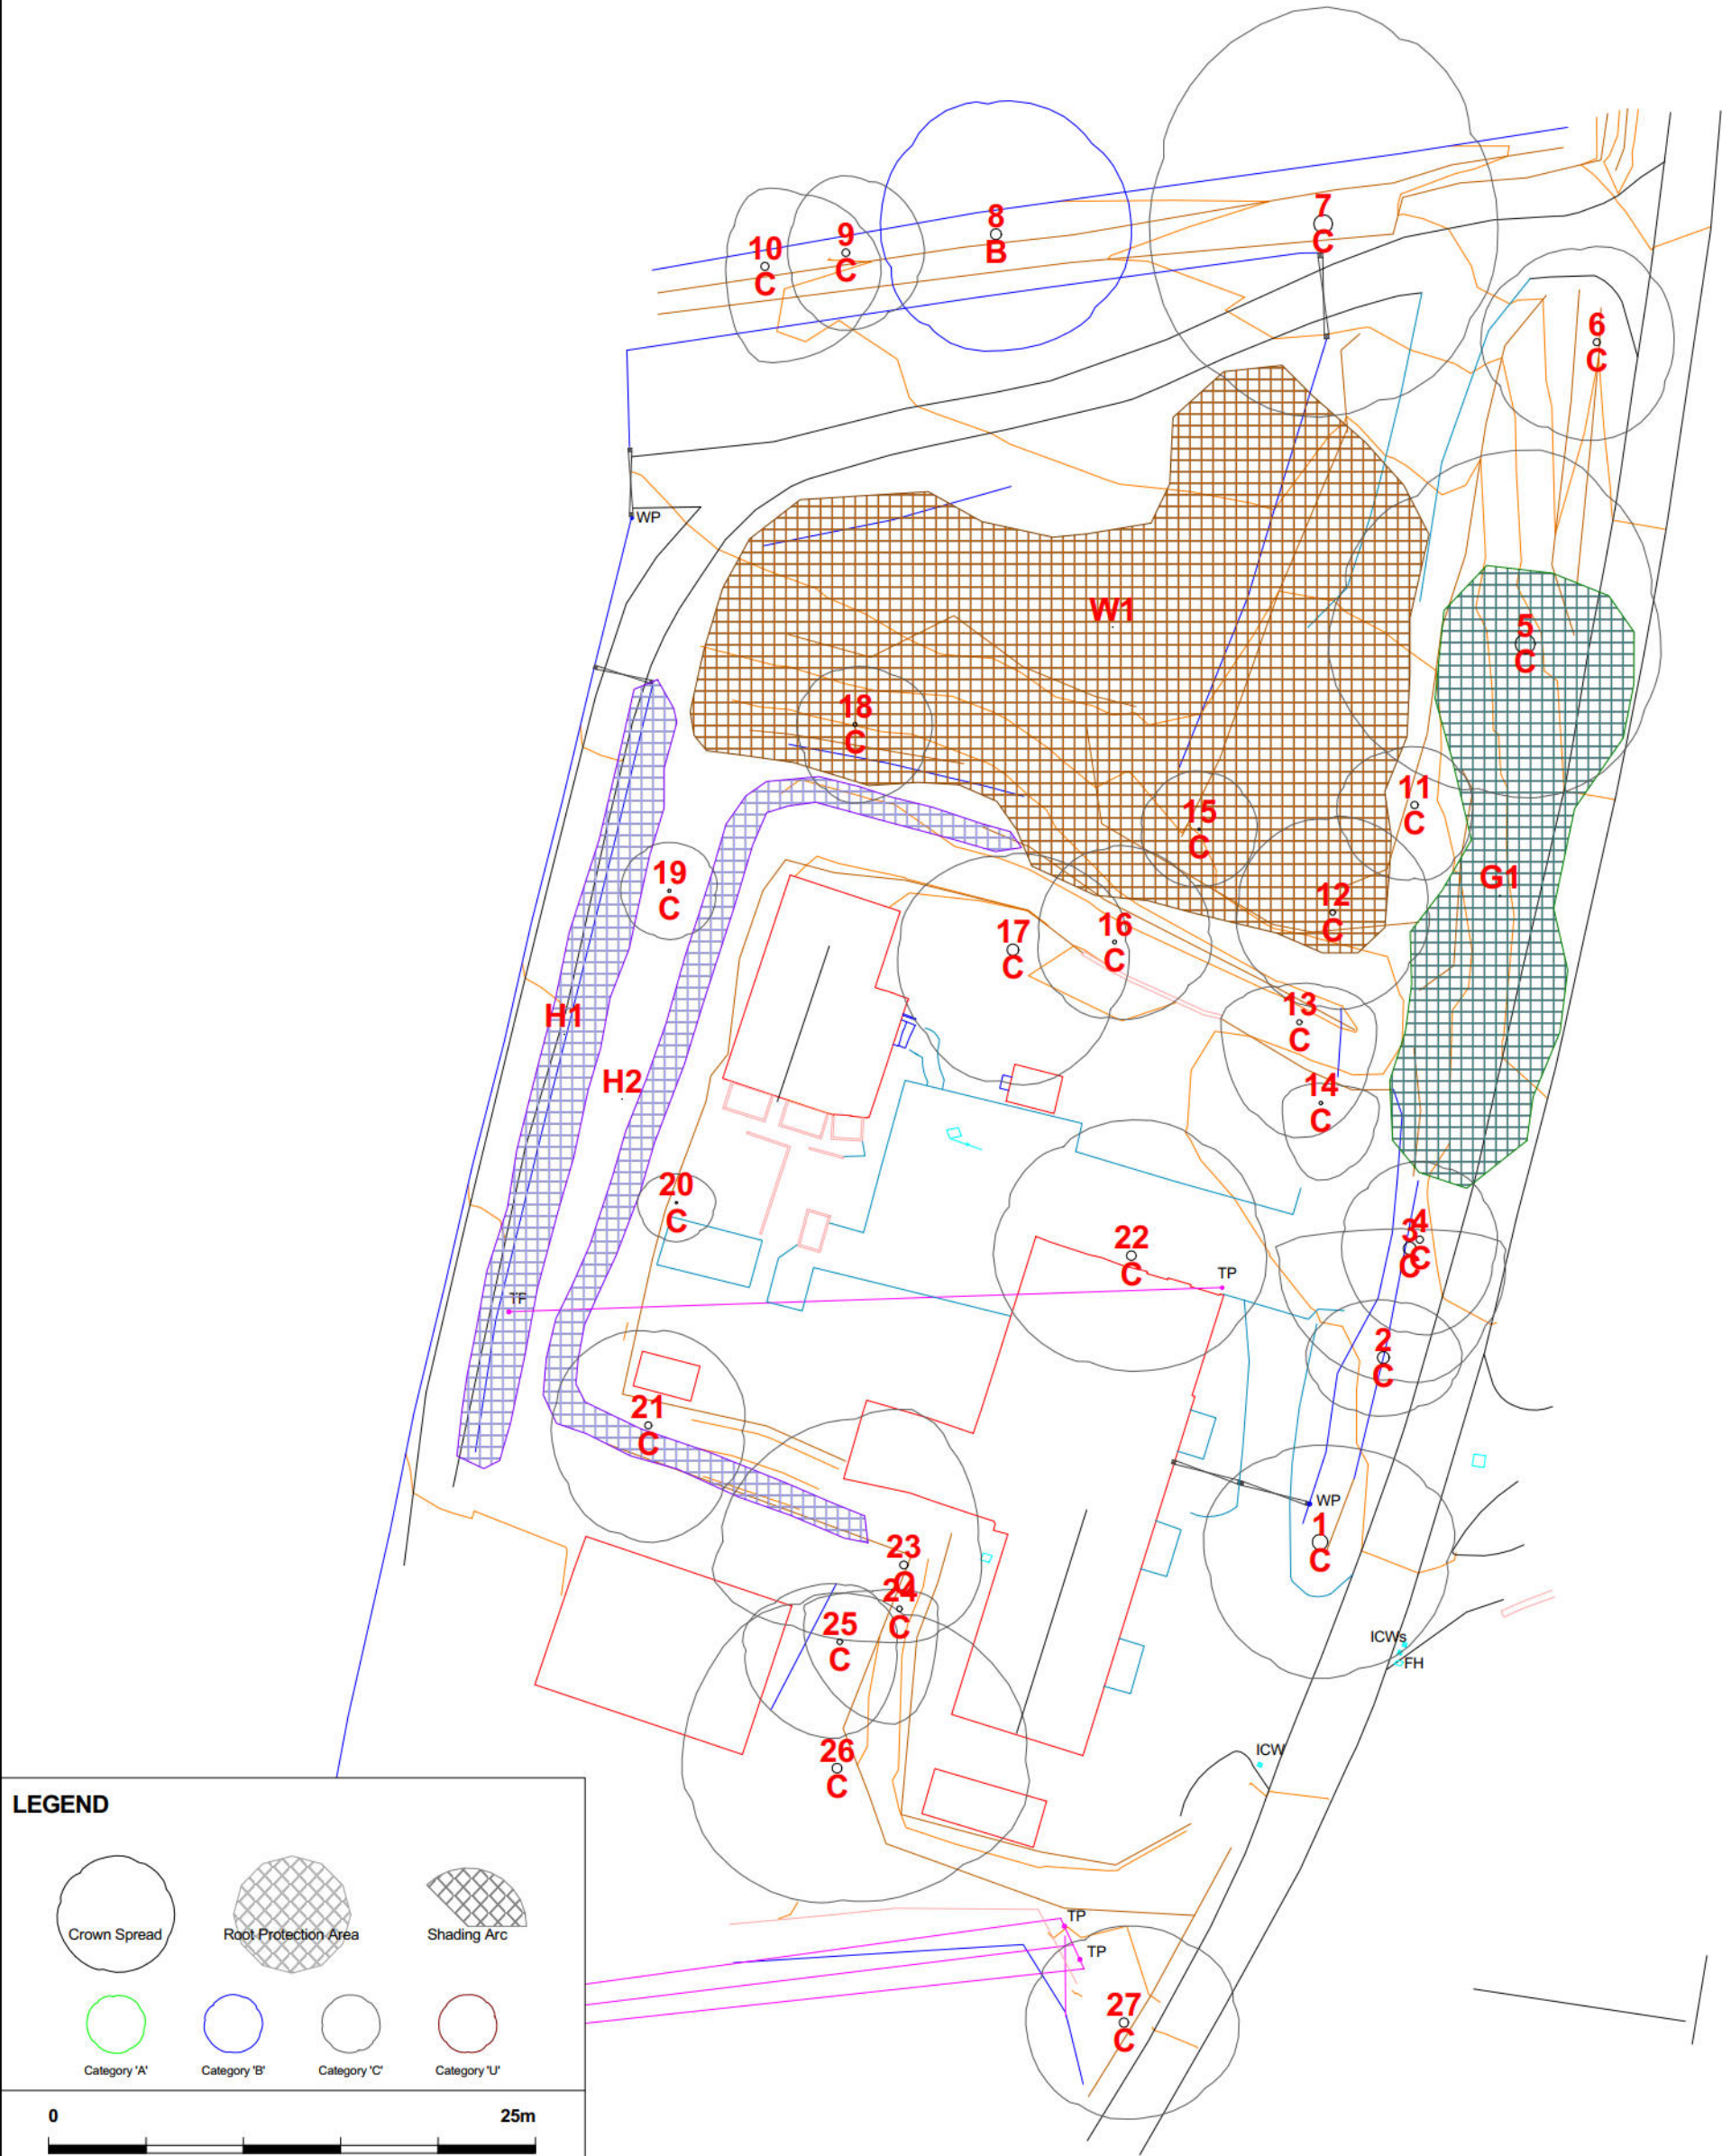
PLAN TITLE: TREE SURVEY  
PLAN REF: WCM/SSR/TR/PY/TSP/1

| Tree ID | Common Name | Latin Name | Maturity | Height (m) | Number of Stems | Stem 1 (mm) | Stem 2 (mm) | Stem 3 (mm) | Stem 4 (mm) | Stem 5 (mm) | Spread (m) | | | | Canopy Height (m) | | | | Crown | Stem | Basal Area | Category | Life Expectancy | Physiological Condition | Comment |
|---|---|---|---|---|---|---|---|---|---|---|---|---|---|---|---|---|---|---|---|---|---|---|---|---|---|
| 1 | Sycamore | Acer pseudoplatanus | Mature | 16.5 | 1 | 810 | | | | | 5 | 7 | 7 | 6 | 8 | 6 | 7 | 8 | Good | Ivy | Poor | C | 20 to 40 yrs | Fair | Heavy Ivy into crown. Cavity in base. Hollow. |
| 3 | Common Ash | Fraxinus excelsior | Mature | 19 | 1 | 670 | | | | | 1 | 5 | 7 | 7 | 16 | 16 | 15 | 16 | Poor | Ivy | Fair | C | <10 yrs | Poor | 90% dead. Heavy Ivy into crown. |
| 5 | Common Ash | Fraxinus excelsior | Mature | 19 | 1 | 1030 | | | | | 10 | 7 | 8 | 10 | 6 | 8 | 5 | 5 | Fair | Ivy | Fair | C | 10 to 20 yrs | Fair | In decline. Cavities in stem. Sycamore regen growing from base into crown. |

| Tree ID | Common Name | Latin Name | Maturity | Height (m) | Number of Stems | Stem 1 (mm) | Stem 2 (mm) | Stem 3 (mm) | Stem 4 (mm) | Stem 5 (mm) | Spread (m) | | | | Canopy Height (m) | | | | Crown | Stem | Basal Area | Category | Life Expectancy | Physiological Condition | Comment |
|---|---|---|---|---|---|---|---|---|---|---|---|---|---|---|---|---|---|---|---|---|---|---|---|---|---|
| 22 | False Acacia | Robinia pseudoacacia | Mature | | 1 | 500 | | | | | 7 | 7 | 6 | 7 | 8 | 8 | 8 | 7 | Good | Fair | Fair | C | >40 yrs | Fair | Not certain of ID, Possibly a thornless variety. Close to building. Concrete all round. Damage and wounding in crown. Dead wood in crown. |

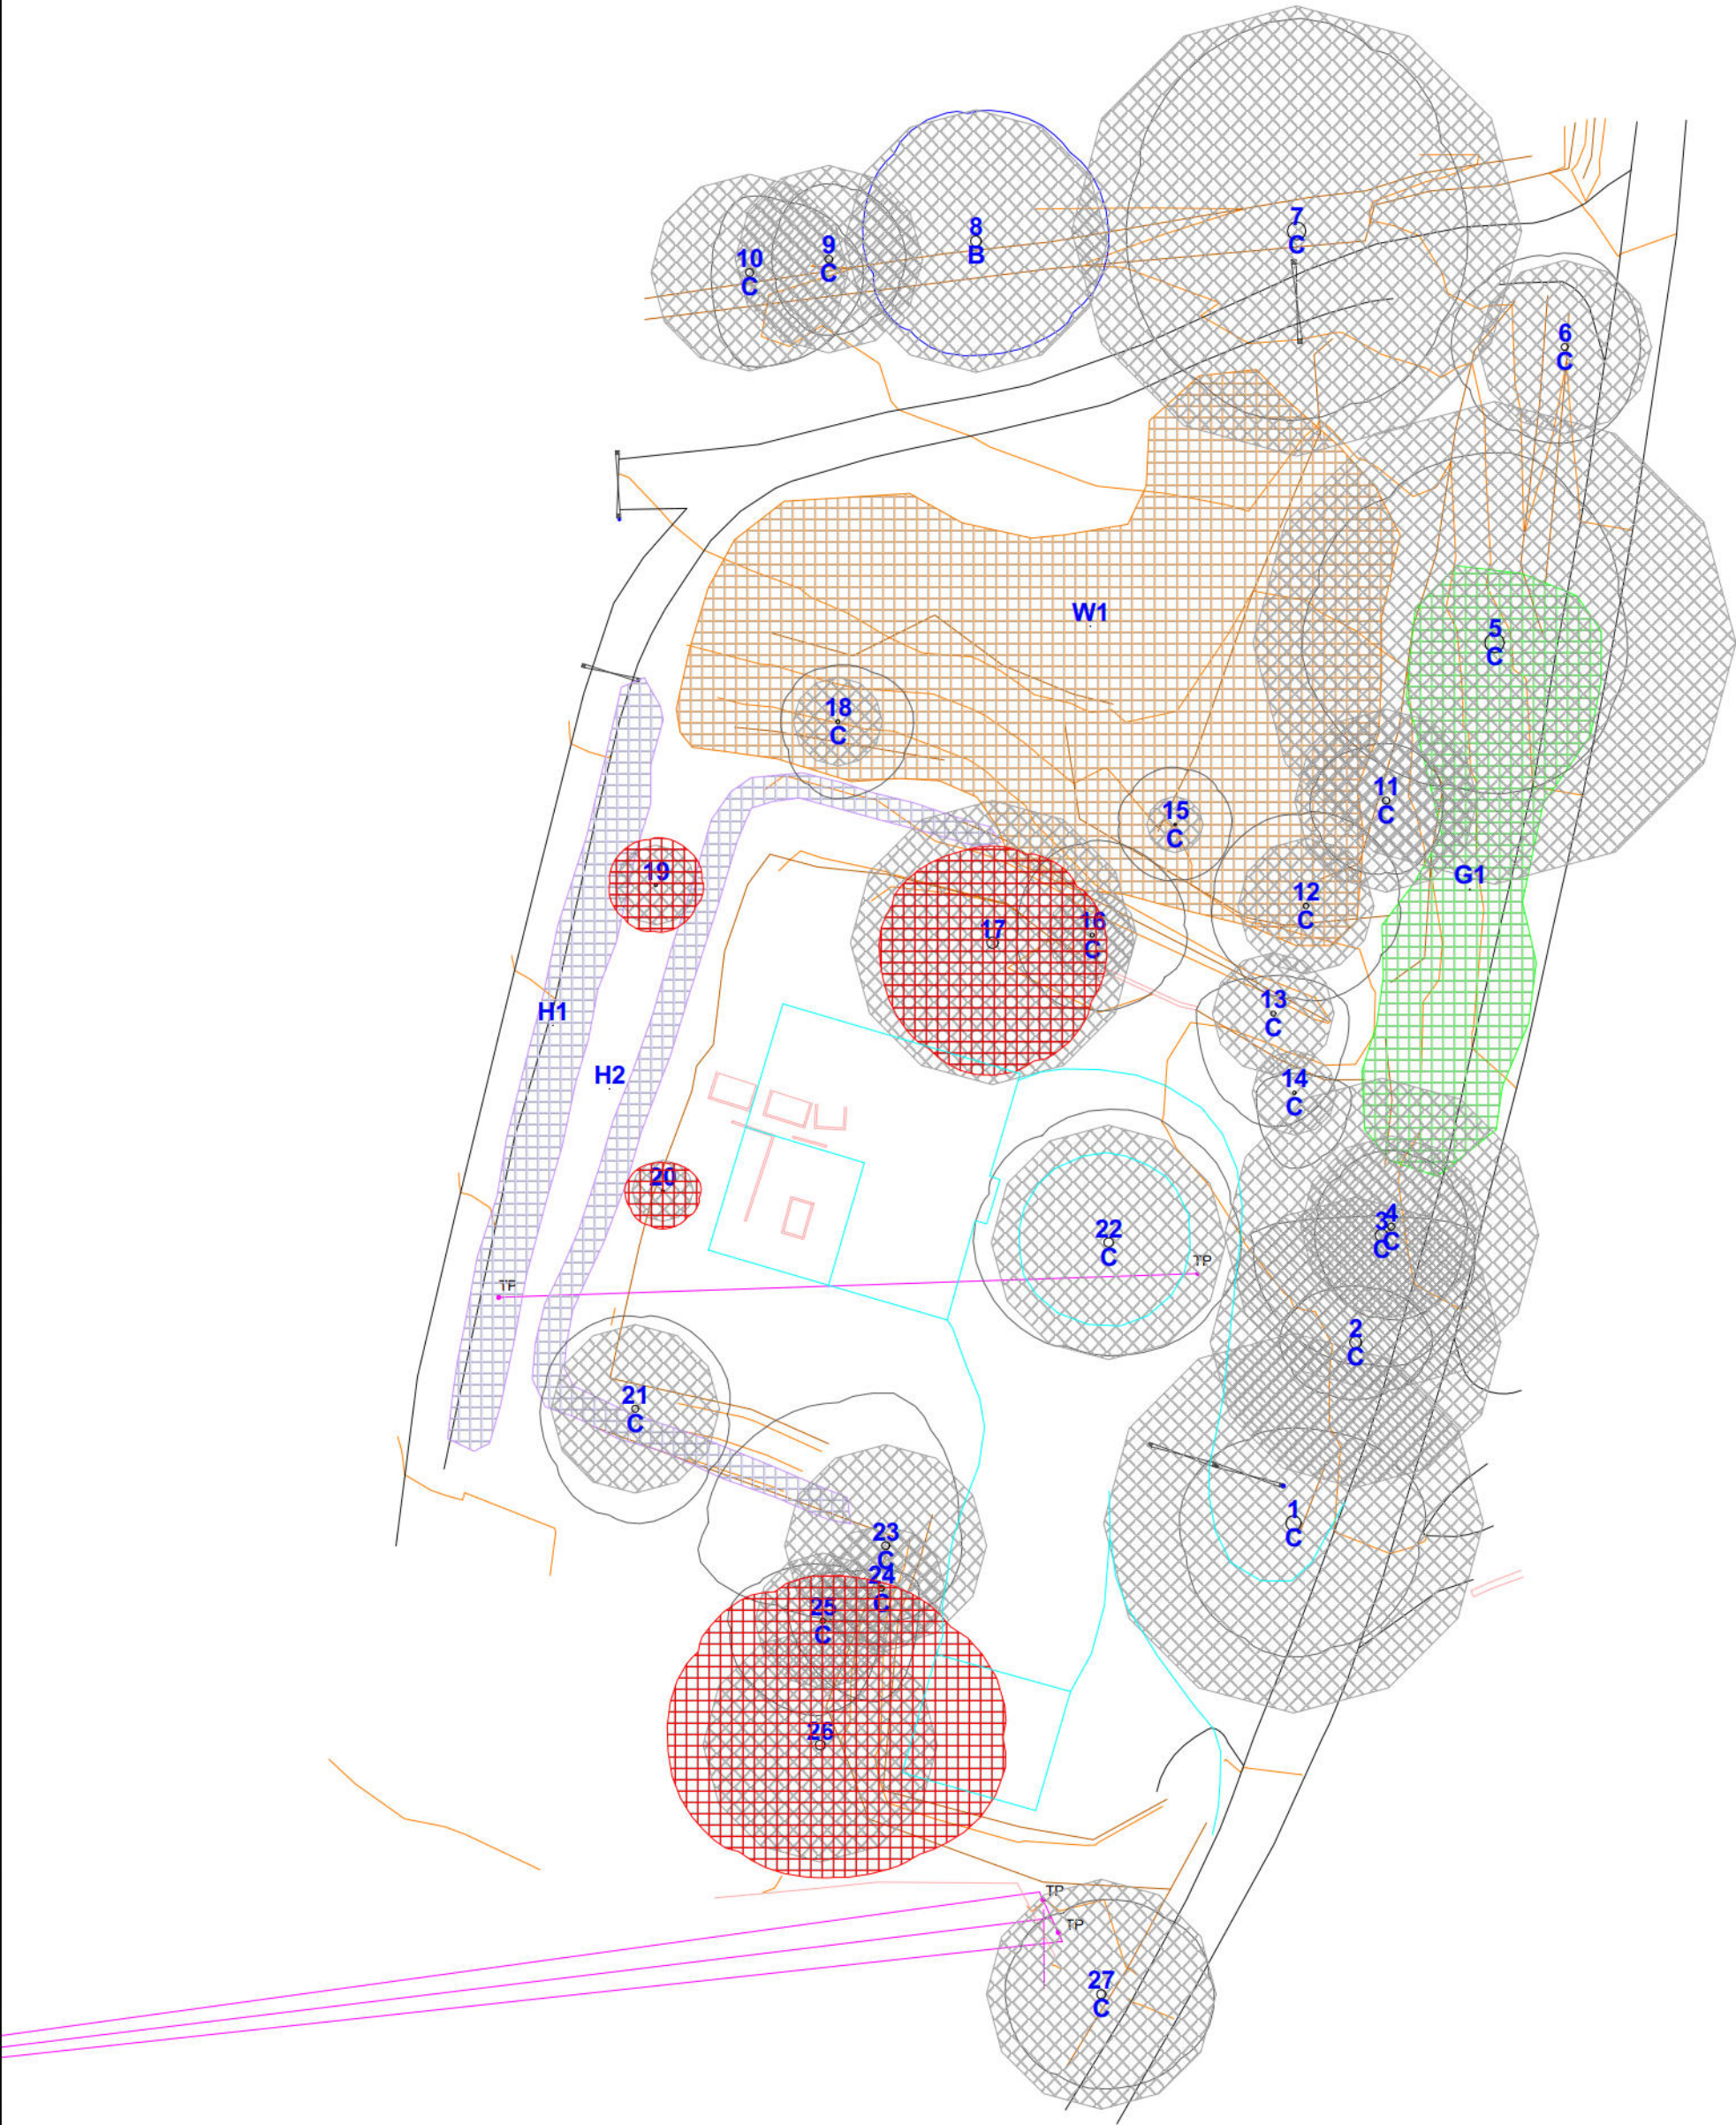
PLAN TITLE: TREES REMOVED  
PLAN REF: WCM/SSR/TR/PY/TSP/1

To carry out the redevelopment as proposed will require the removal of four trees, a mature Goat willow, a mature Ash, a semi-mature Sycamore and a semi-mature Ash. All of which are Category C. A number of tree RPAs will be impacted by the access/driveway, in particular the False acacia, which although only in fair condition, is to be retained within the driveway.

Other than the removal of the four trees, the impact from the proposals on the overall visual importance in the local landscape will be minimal. All trees bar the four identified trees are being retained. The trees for removal are shown in the Tree Removal Plan (Appendix 6).

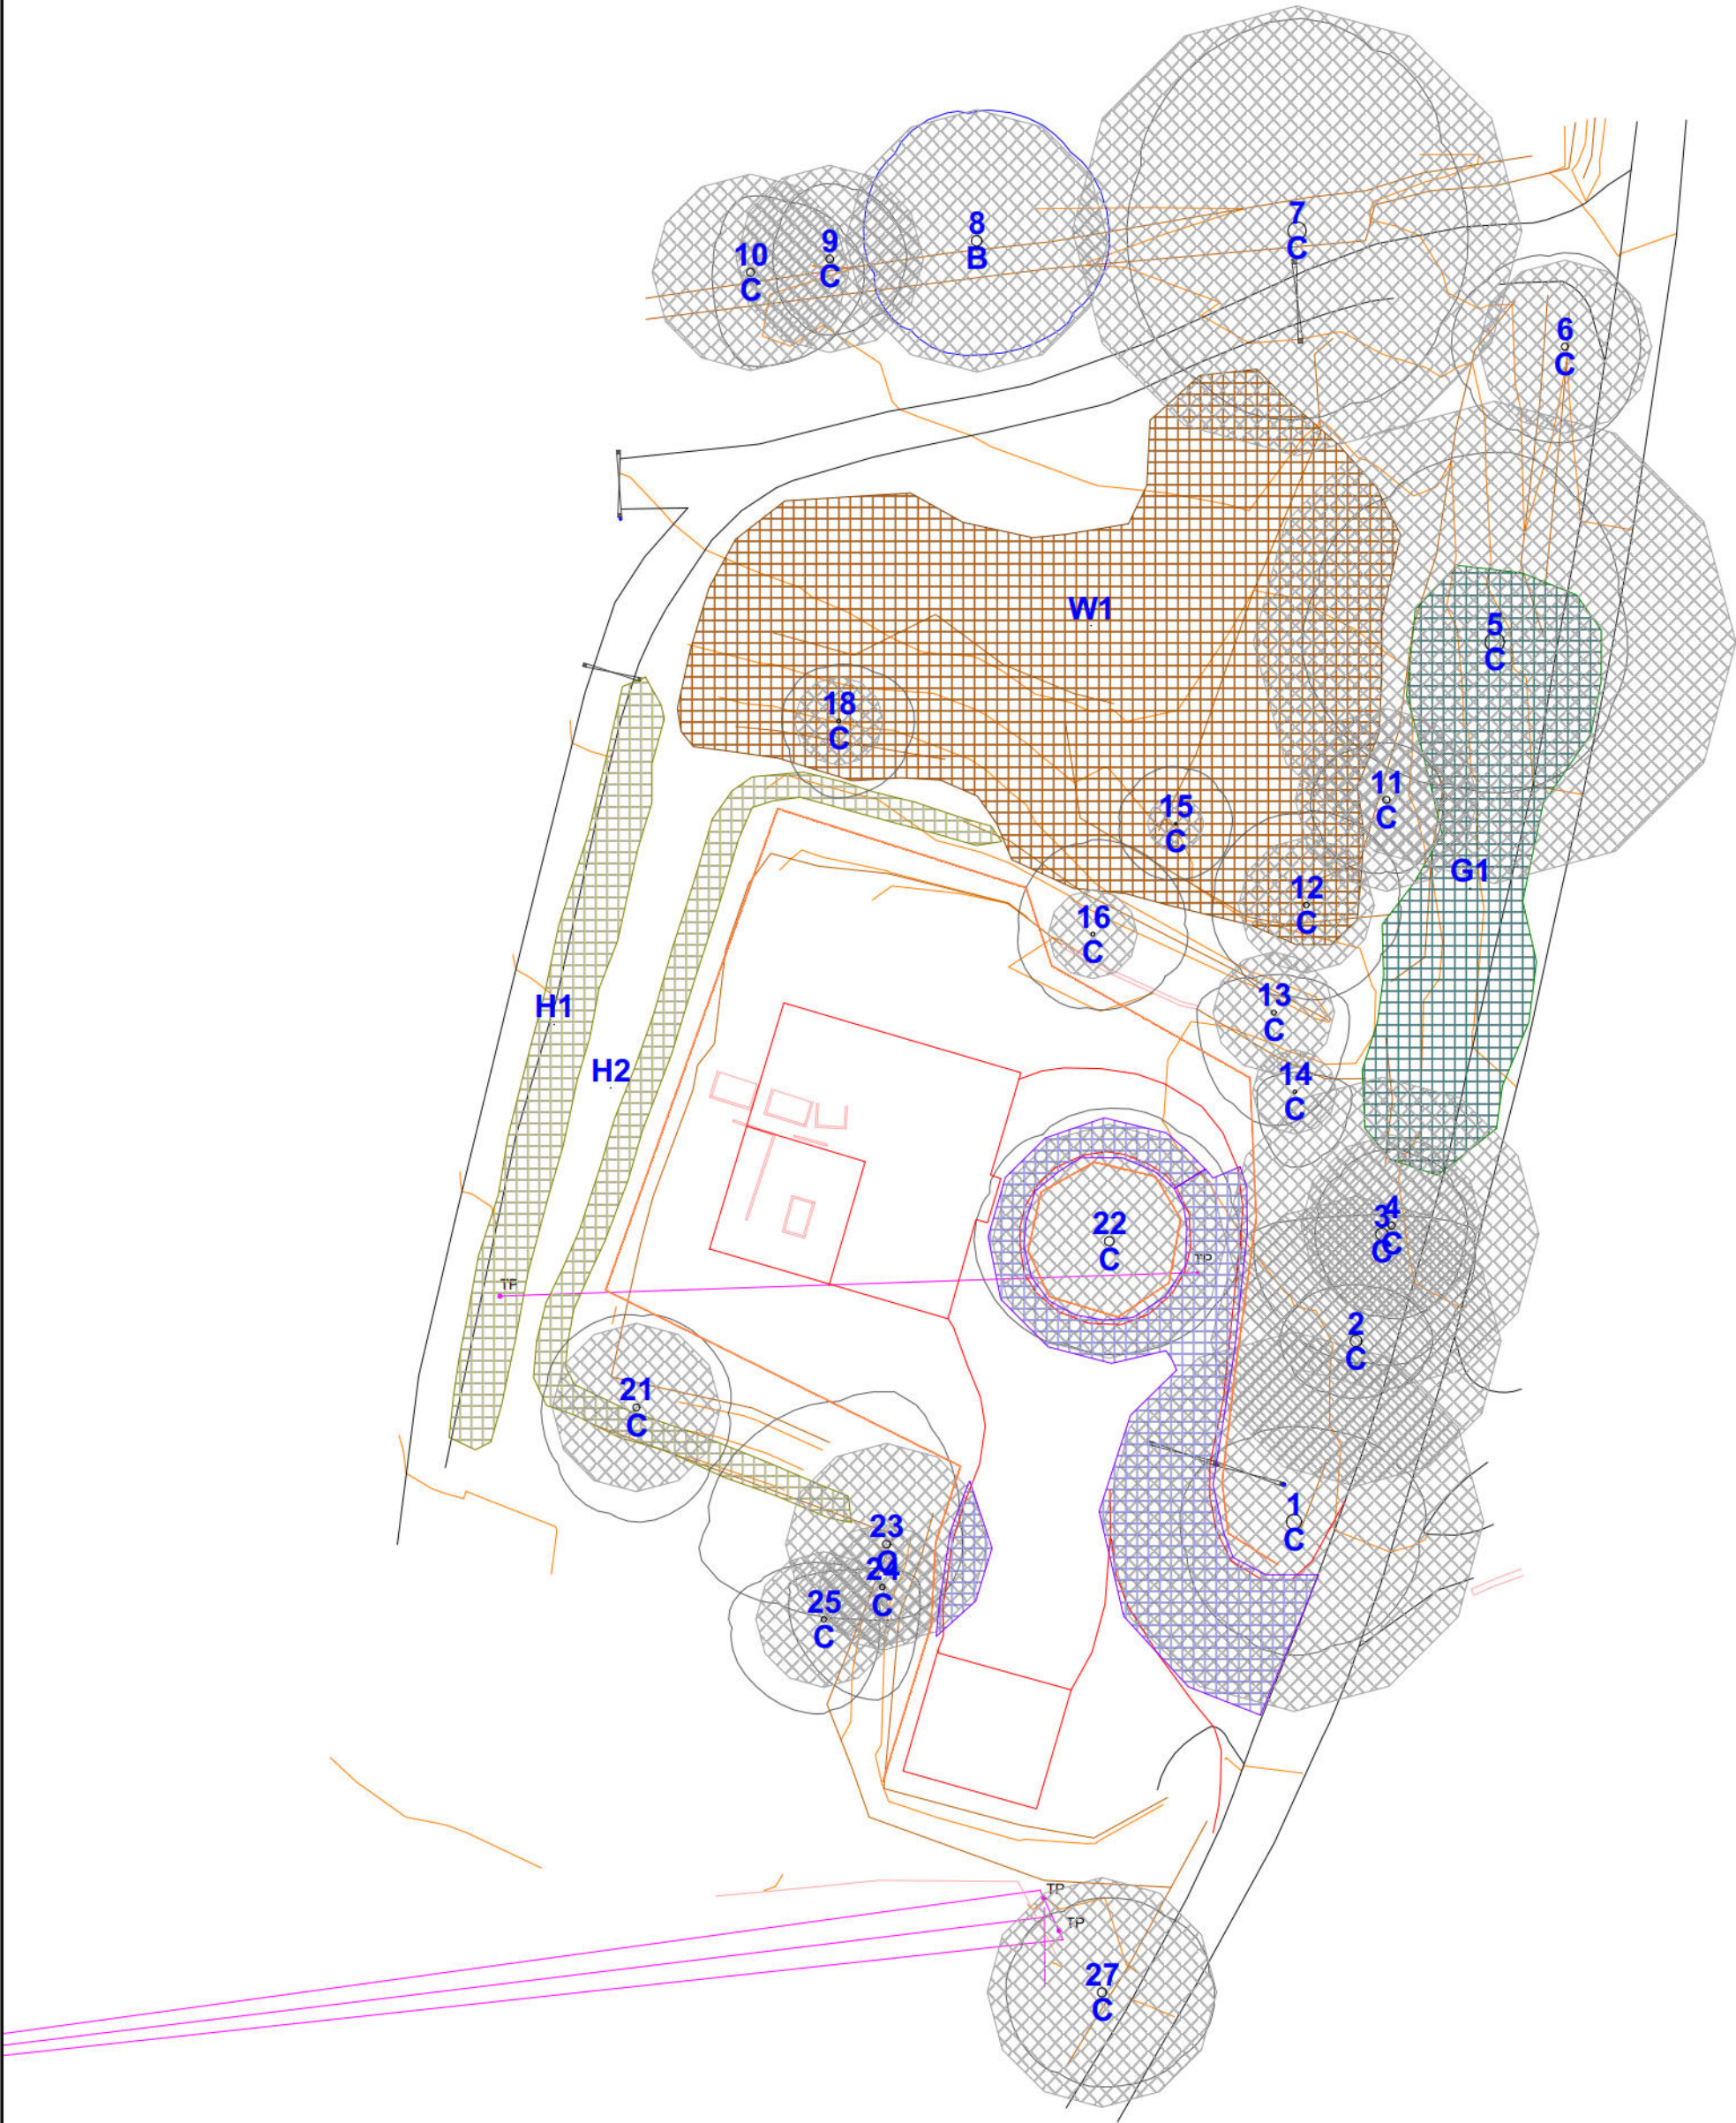
PLAN TITLE: PROTECTION PLAN  
PLAN REF: WCM/SSR/TR/PY/TPP/1

A number of the retained trees within the site will require protection during the development of the site with Temporary Protection Fencing, the construction of the new access although following existing ground levels in the most part will require care in excavation and construction. The area of woodland to the north will be fenced off completely with Temporary Protection Fencing. Where the access/driveway extend over the RPAs, a non-dig permeable surface will be required.

Construction of the final access to protect the RPA, will be of a proprietary cellular confinement system that will allow water and gas movement, will provide load spreading to avoid compaction and will require no excavation to the existing surface e.g. the Cellweb TRP® Cellular Confinement System. Effective edge retention will be custom designed to avoid any significant excavation into existing soil levels being pre-formed edging secured by metal pins. Details of the construction will be supplied by the selected system engineer if and when required. The areas where this will be required is shown in Purple on the Tree Protection Plan (Appendix 7).
