# **BS 5837 Tree Survey Report with Tree Survey/Tree Constraints Plan**

**'All-Boxed'  
Bath Road Industrial Estate  
Chippenham  
SN14 0AB**

**Ref: 7506  
Survey Date: 20<sup>th</sup> November 2025**

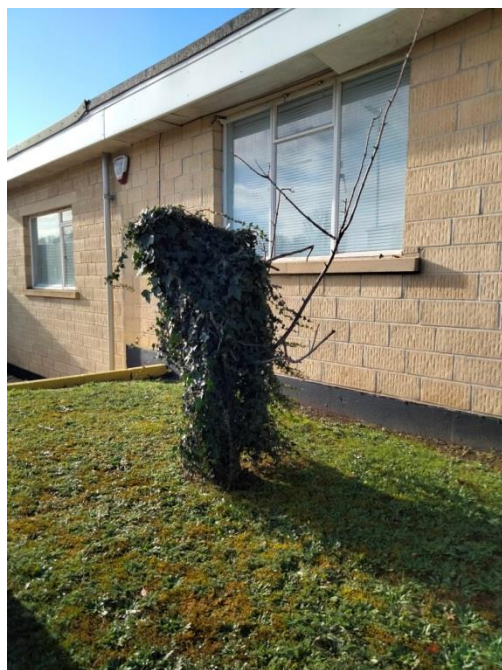
| R<br>e<br>f | Species | Ht<br>m | Trunk<br>Diam at<br>1.5m ht<br>mm | a .Crown Spread m.<br>b Canopy fringe ht m.<br>c. 1 <sup>st</sup> branch ht m.<br>d. 1 <sup>st</sup> branch diam mm. | M<br>a<br>t | V<br>ig | E<br>R<br>C | Notes | BS<br>5837<br>Cats. |
|---|---|---|---|---|---|---|---|---|---|
| - | STUMP | 1 | Est 150 | N/A | Dead | Dead | Dead | <p><b>Position:</b> All-Boxed' Bath Road frontage approx. 6m South of T1 within grass strip alongside building, between building and pavement/road</p> <p>Small dead stump approx. 1m tall x 150mm diameter at base : dense ivy cover</p> | N/A |

**1) Dead stump**

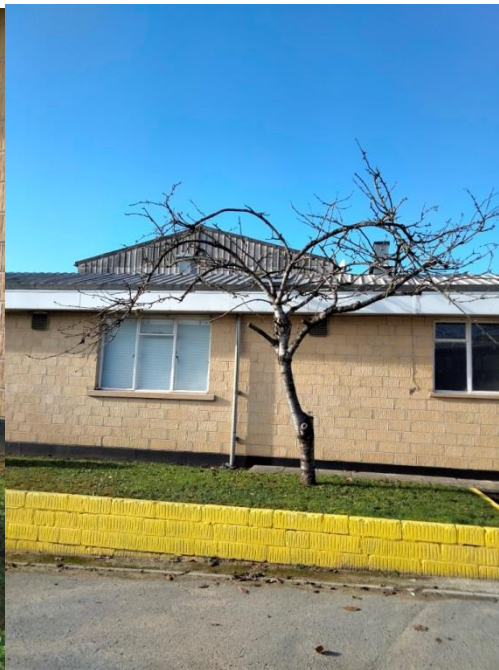
| R<br>e<br>f | Species | Ht<br>m | Trunk<br>Diam at<br>1.5m ht<br>mm | a .Crown Spread m.<br>b Canopy fringe ht m.<br>c. 1 <sup>st</sup> branch ht m.<br>d. 1 <sup>st</sup> branch diam mm. | M<br>a<br>t | V<br>ig | E<br>R<br>C | Notes | BS<br>5837<br>Cats. |
|---|---|---|---|---|---|---|---|---|---|
| T1 | Japanese<br>cherry | 3.5 | 130 | N a) 2.5 b) 2<br>c) 1.5 d) 75<br>S a) 2.5 b) 1.2<br>c) 2 d) 50<br>W a) 1.75 b) 2<br>c) 1.8 d) 50<br>E a) 1.5 b) 1.5<br>c) 2 d) 50 | FM | Moribund | Nil | <b>Position:</b> 'All-Boxed' Bath Road frontage within raised grassed linear area alongside building, between building and pavement/road<br><b>Observations:</b> Poor quality small moribund ornamental cherry cultivar, top grafted at ca. 0.9m height<br>Small, open, sparse crown from 1.6m ht,<br>Much of the crown is dead. Large old canker wound at 2m height (W)<br><b>Summary:</b><br>Small tree in an advanced state of decline | U |

**2) T1 - sparse, moribund crown**

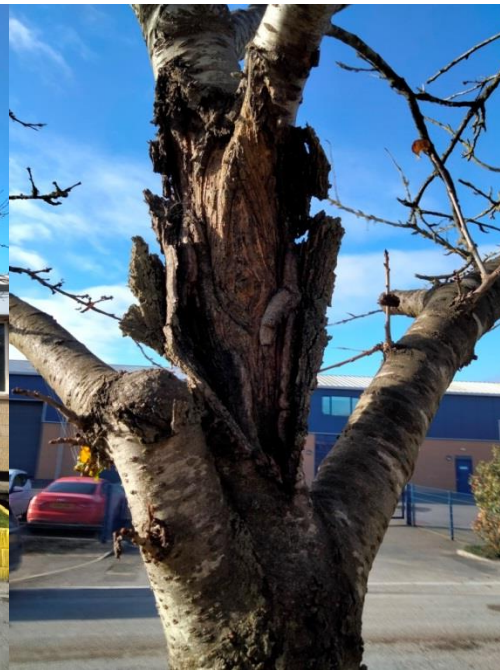
**3) T1 – major stem canker**

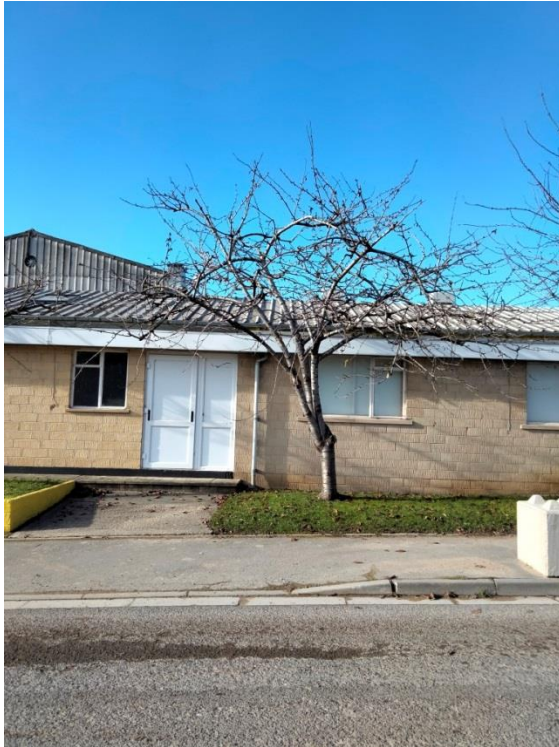
4) T2

| R<br>e<br>f | Species | Ht<br>m | Trunk<br>Diam at<br>1.5m ht<br>mm | a .Crown Spread m.<br>b Canopy fringe ht m.<br>c. 1 <sup>st</sup> branch ht m.<br>d. 1 <sup>st</sup> branch diam mm. | M<br>a<br>t | V<br>ig | E<br>R<br>C | Notes | BS<br>5837<br>Cats. |
|---|---|---|---|---|---|---|---|---|---|
| T2 | Japanese<br>cherry | 4.5 | 130 +<br>110 ( x2)<br><br>Agg dbh<br>200 | N a)3.5 b)1.6<br>c) 2 d) 75<br>S a) 3 b)1.6<br>c) 2 d) 75<br>W a) 3 b)2.25<br>c) 2 d) 50<br>E a) 3 b) 1.2<br>c) 2 d) 75 | FM | Mod | <10 | <b>Position:</b> All-Boxed' Bath Road frontage within grass strip alongside building, between building and pavement/road<br><b>Observations:</b> Poor quality small ornamental cherry cultivar, top grafted at ca. 0.9m height .<br>Tightly congested poor quality compressed fork at base of three fanning light framework stems arising from a swollen top-graft region. Crown fans mostly N- S alongside building, with laterals from ca. 2m ht.<br>Large (ca. 200mm x 100mm opening) old water-filled wound- cavity on N face of top-graft region from branch removal many years ago. Manual probing of wet wound-cavity indicates hollowing/decay reaches down into main stem by >300mm.<br>Small (ca. 75mm x 50mm opening) old pruning wound hollow (NE) reaches into trunk alongside larger cavity.<br><b>Summary:</b><br>Presence of large decay cavity and poor quality principal forks about region of top-graft compromise structural strength and reduce estimated remaining contribution to <10 years | U |

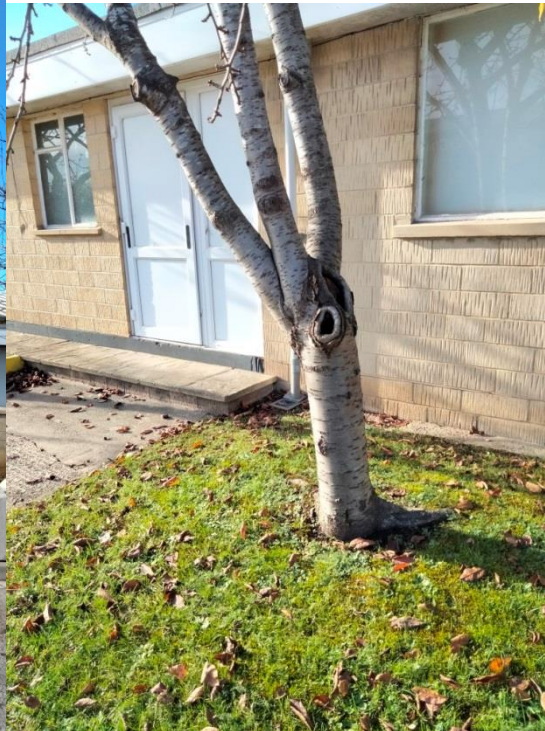
5) T2 – poor quality fork structure

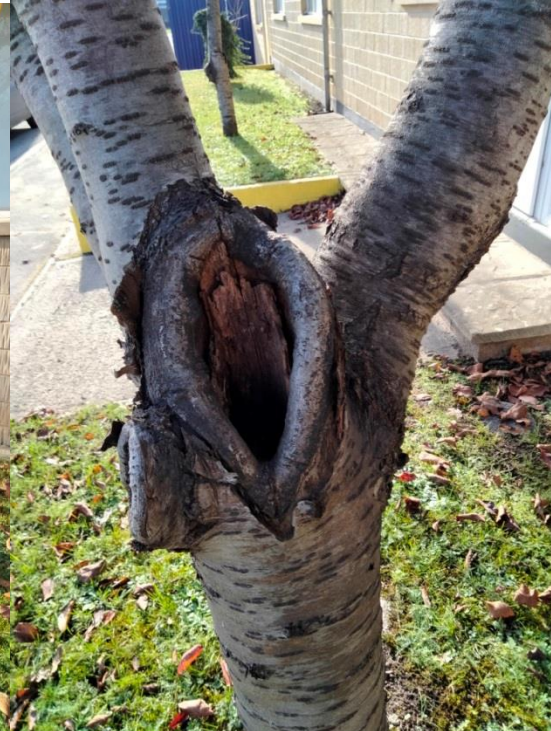
6) T2 – large decay hollow at base of crown

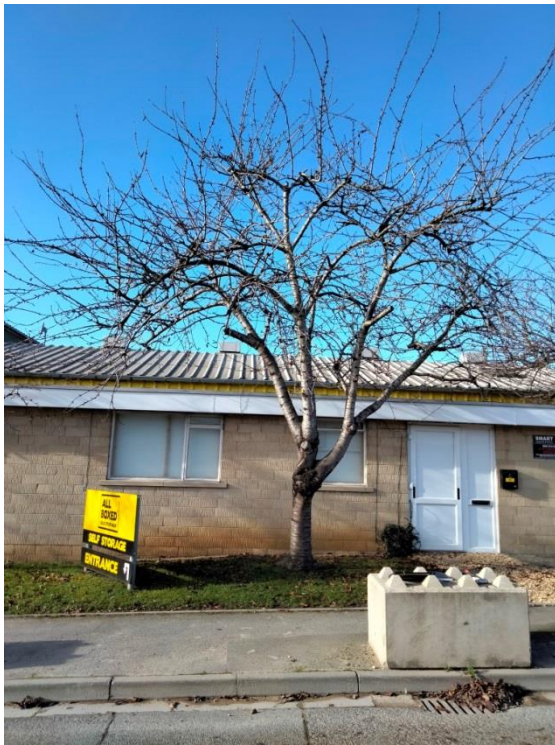
7) T3

| R<br>e<br>f | Species | Ht<br>m | Trunk<br>Diam at<br>1.5m ht<br>mm | a .Crown Spread m.<br>b Canopy fringe ht m.<br>c. 1 <sup>st</sup> branch ht m.<br>d. 1 <sup>st</sup> branch diam mm. | M<br>a<br>t | V<br>ig | E<br>R<br>C | Notes | BS<br>5837<br>Cats. |
|---|---|---|---|---|---|---|---|---|---|
| T3 | Japanese<br>cherry | 6 | 220 + 190<br><br>Agg dbh<br>290<br><br>Main stem<br>230 dim<br>at 0.9m ht<br>(at base of<br>top graft<br>swelling) | N a)4 b) 2<br>c)2 d)120<br>S a)3.5 b)1.75<br>c)2 d) 180<br>W a)2.5 b) 2.3<br>c)2.3 d)75<br>E a)3 b) 2<br>c)4 d)100 | FM | Mod | <10 | <b>Position:</b> All-Boxed' Bath Road frontage within grass strip towards N end of building, between building and pavement/road<br><b>Observations:</b> Medium-small ornamental cherry cultivar, top grafted at ca. 0.9m height. Tightly congested poor quality compressed fork at base of two main framework stems arises from swollen top-graft region.<br>Two old partly occluded wounds (E ) with internal decay reach into region of top-graft at base of crown framework from earlier stem removals (manual probe penetrates downwards by c 150mm into top-graft swelling). Additional large old stem wound present (W) at ca. 2m ht on main upright stem with incipient decay and insect bore-holes – wound directly above poor quality main fork and at base of slightly higher 2° crown framework fork.<br>Mod. Vigorous crown with canopy over unit & pavement by < 1.5m ; lower tips rest on roof<br><b>Summary:</b><br>Notwithstanding apparently moderate crown vitality, the poor quality main stem attachment and old wounds with decay at base of crown about the region of the top-graft and shortly above, compromise structural strength & reduce estimated remaining contribution to <10 years | U |

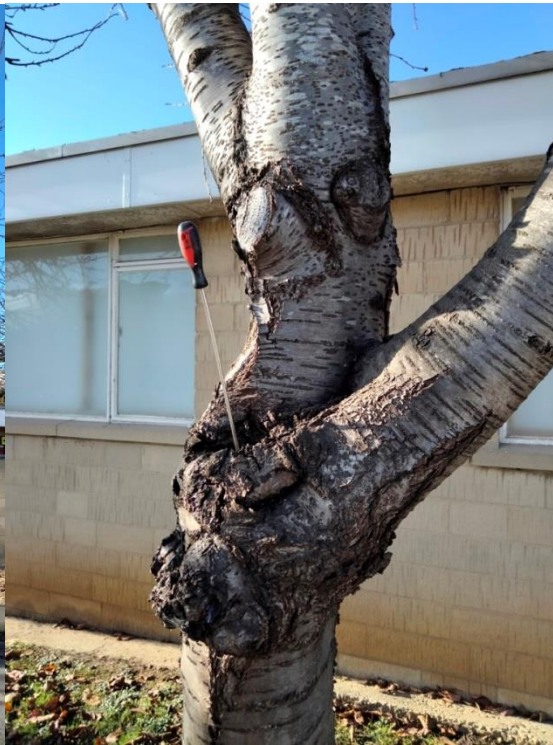
8) T3 - poor quality fork with old stem-removal wounds housing decay in region of graft union at base of crown framework

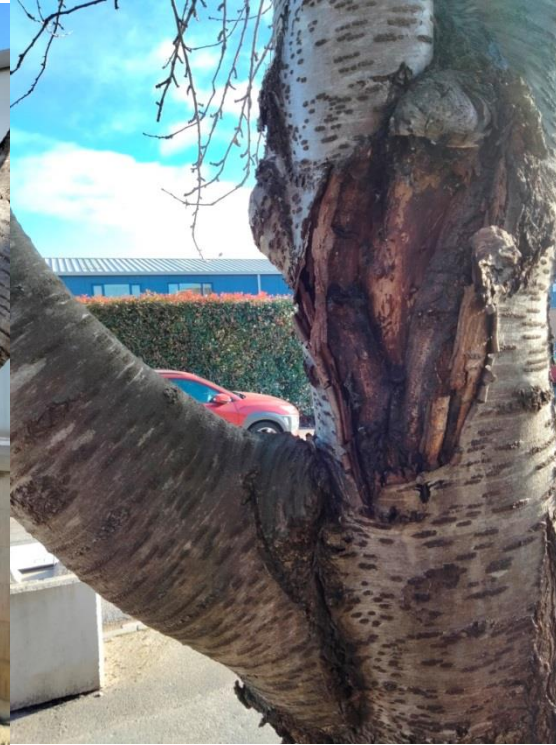
9) T3 - large old stem wound with incipient decay in region of poor quality forks

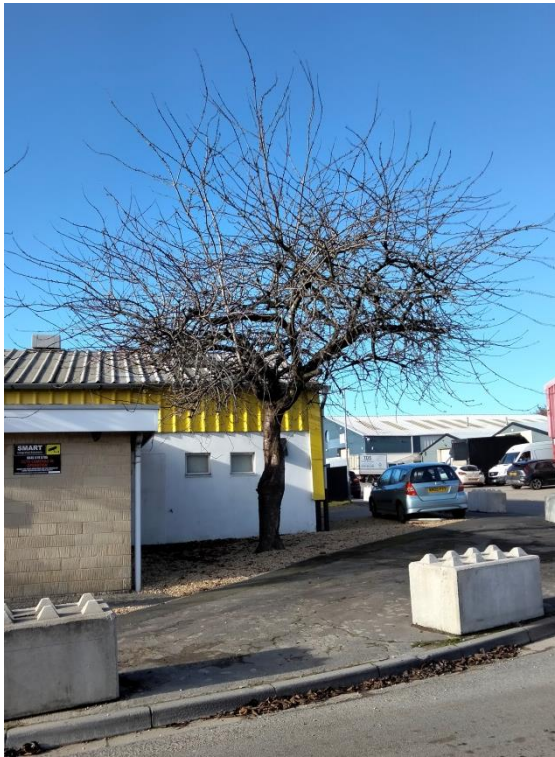
10) T4

| R<br>e<br>f | Species | Ht<br>m | Trunk<br>Diam at<br>1.5m ht<br>mm | a .Crown Spread m.<br>b Canopy fringe ht m.<br>c. 1 <sup>st</sup> branch ht m.<br>d. 1 <sup>st</sup> branch diam mm. | M<br>a<br>t | V<br>ig | E<br>R<br>C | Notes | BS<br>5837<br>Cats. |
|---|---|---|---|---|---|---|---|---|---|
| T4 | Japanese<br>cherry | 7 | 320 | N a) 5    b) 2<br>c) 3.5   d) 200<br>S a) 4    b) 1.8<br>c) 3    d) 200<br>W a) 4.5   b) 1.5<br>c) 3    d) 200<br>E a) 6    b) 2<br>c) 3    d) 250 | FM | MH | <10 | <p><b>Position:</b> Bath Road corner frontage ; N end of All-Boxed' unit within corner gravel area between building and pavement/road</p> <p><b>Observations:</b> Medium-sized ornamental cherry cultivar. Fairly heavy lateral branching is present from around 3m ht to form a dense weighty crown with outer canopy over-reaching the wide pavement corner- area by &lt;3m down to 2.5m ht and on other aspects extending over the unit to S and W by &lt;2m; some low growth brushes the unit's façade and roof .</p> <p>There are a number of old branch stubs about the crown from past rough pruning</p> <p>There is a large swelling at the head of the stock about the top-graft union at ca. 1.2m height. Secondary branches have been removed from this region in the past leaving a single upright stem rising from the graft region.</p> <p>The singling of the main stem has left the remains of an old partly occluded horizontal pruning wound within a recess on the S face of the swollen graft union. Old and recent perennial fruiting bodies of decay fungus (provisionally identified from outward features as <i>Phellinus pomaceus</i>) are attached about the wound recess</p> <p>Mallet-tapping of the lower region of the main stem, from below the graft swelling, down to ca. 30cm above ground-level produced audible resonance response, that I interpret with a high level of confidence to be characteristic of advanced decay and hollowing within a thin-walled trunk shell. This was in contrast to distinctively solid-type resonance produced from about the stem shortly above the graft swelling, when mallet-tapped for comparison.</p> <p><b>Summary:</b></p> <p>Notwithstanding apparent crown vitality , the presence of fruiting bodies of decay fungus and hollow-type response to mallet-tapping about a large proportion of the lower main trunk, are considered to be strongly indicative of impaired structural strength and unacceptable tree-safety .</p> | U |

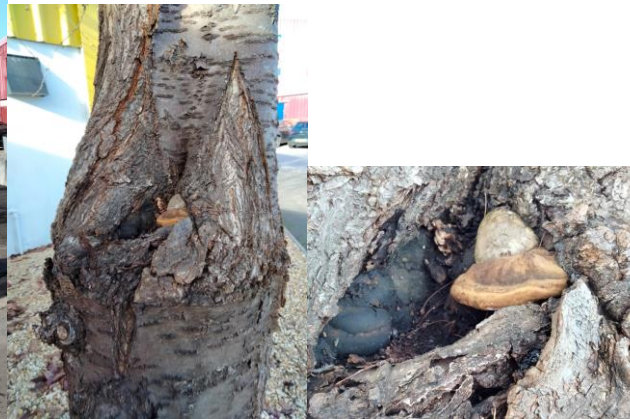
11) and 12) T4 - old stem removal wounds housing decay in region of graft union at ca 1.2m ht .  
Perennial fruiting bodies of decay-fungus present (provisionally identified as *Phellinus pomaceus* from external features )

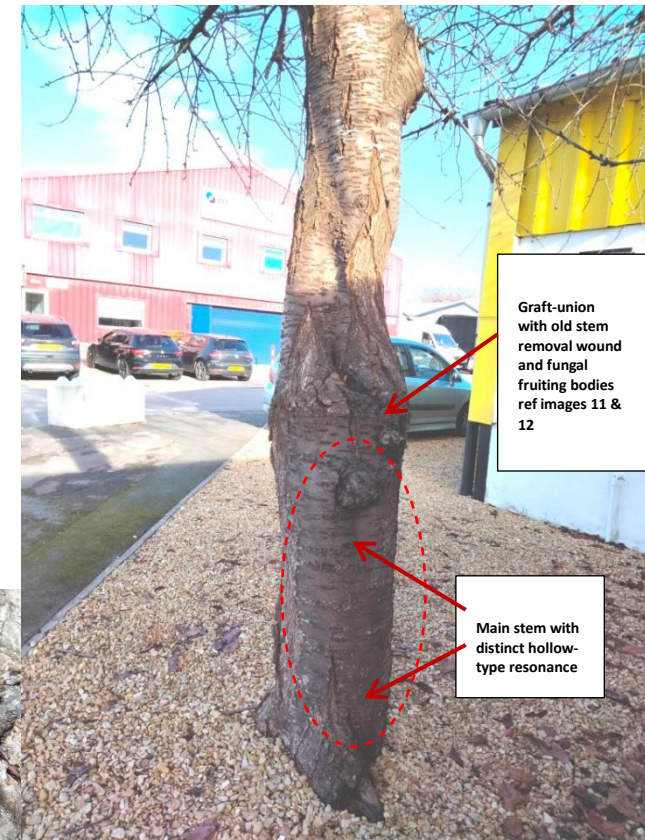
13) T4 - main stem with hollow-type resonance when mallet-tested below graft union, approx. within area described by red-dashed outline

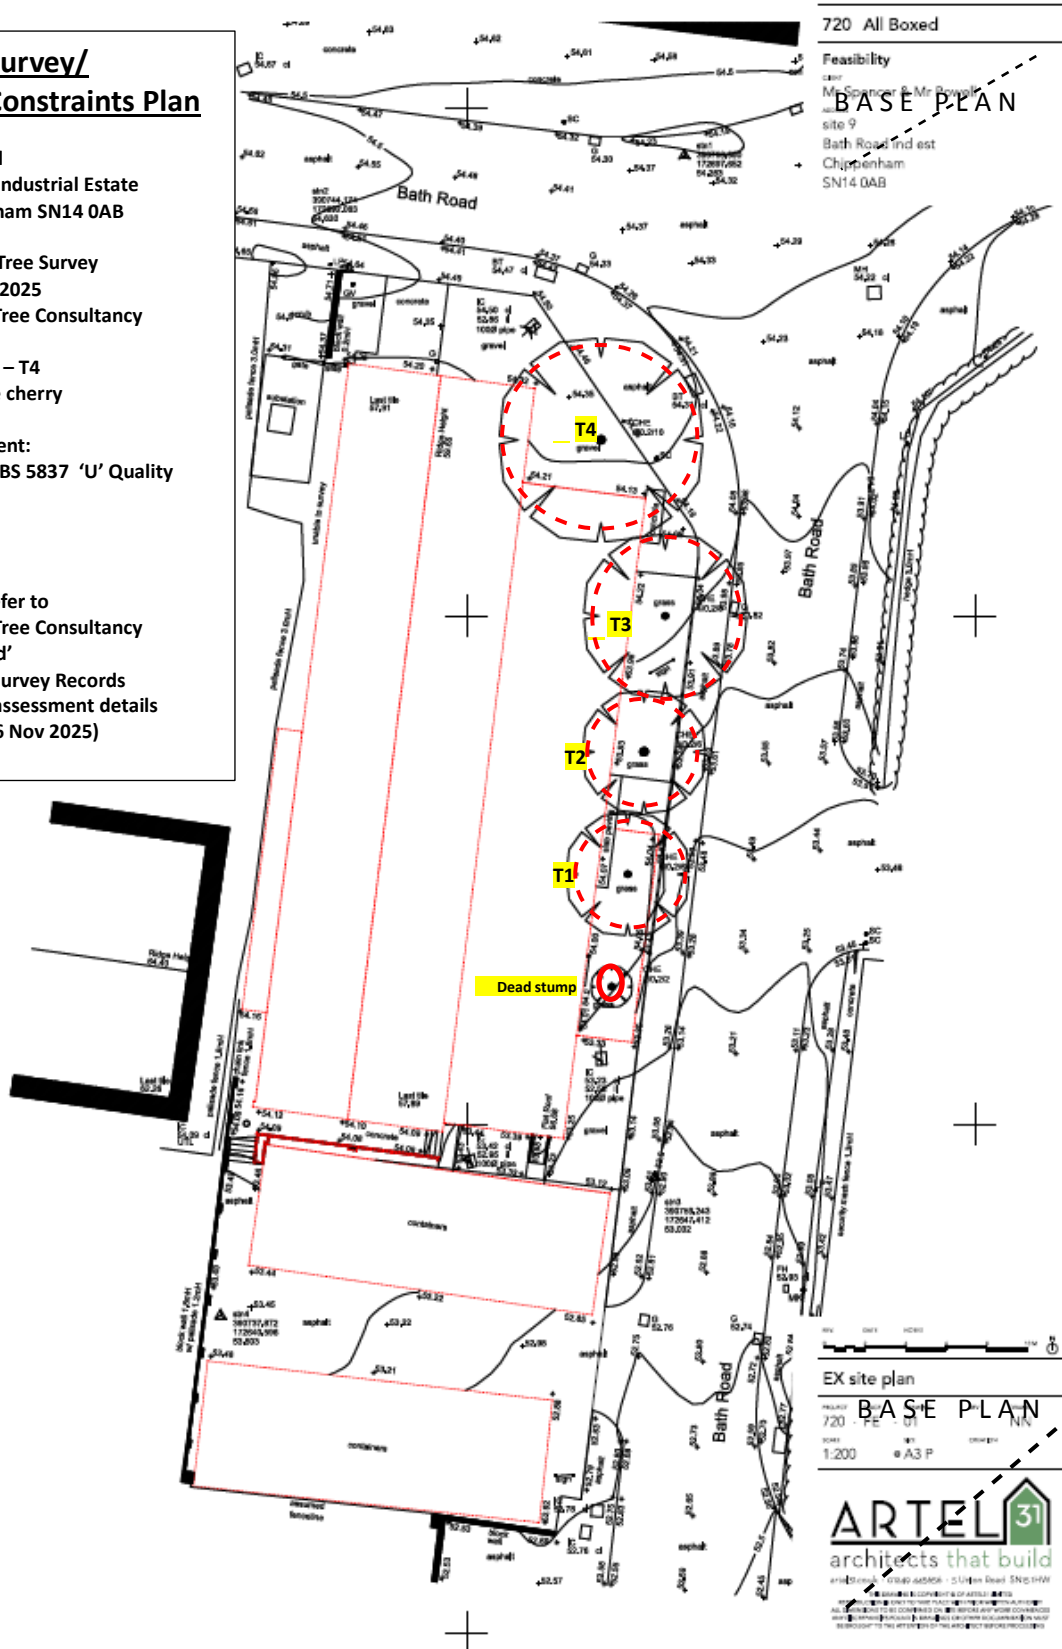
## Tree Survey/Tree Constraints Plan

Assessment:  
T1 – T4 : BS 5837 'U' Quality
