**PHOTOGRAPHIC SCHEDULE OF WORKS  
FOR  
137 High Street Marlborough, Wiltshire, SN8 1HN**

**Tenant:** *Nova Fine Art*

**Date of inspection:** Thursday 26<sup>th</sup> September 2024

**For the attention of:** James Hay Pension Trustees Ltd

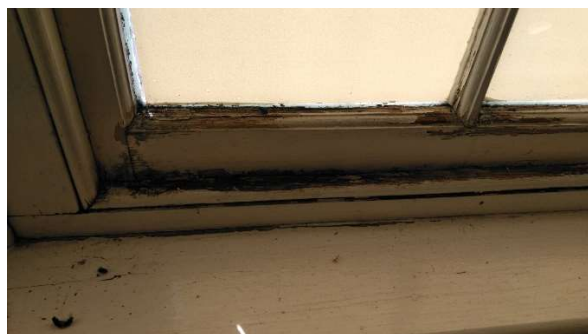
**1.**

At all levels of the property, the windows are in a chronic state of disrepair. The wooden frames are now all but defective, showing clear signs of rot and decay. Many when touched and examined crumble.

At the third-floor level, the window frames are literally disintegrating on touch from very light probing. In picture 2, the window has shifted outwards, meaning the window can no longer be secured and at some point, the window could fall out. All the window frames, sills, soffits and fascia are rotten or buckling due to damp and water penetration. The wood has just about absorbed all the water it can, and water is now finding its way into the bitumen roof of the bay windows, see picture 3 or it is leaking through the gaps in the tiles at the front elevation and tile over hangs.

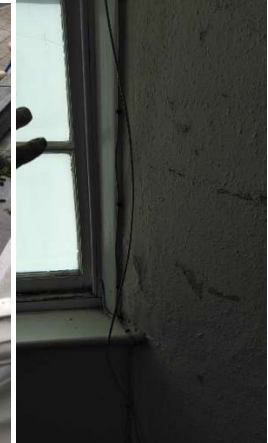
It was also observed that the property's gutters are clogged with moss, leaves and grass, and with the gutters blocked, the water is spilling out and charting its course down into the fabric of the building. Many of the internal walls around or in close proximity to the windows, gutters or gullies are showing decay and patches of increasing damp/water penetration. See picture 4 on the next page. There are areas of the roof where tiles have become dislodged and vegetation has taken root, again causing issues of water to build up and soak down into the structure of the building, see picture 5 and 6. Water is also pitching on the roof of the bay windows where the water has nowhere to go, owing to the gutters blocked see picture 7. Some of the windows now have glass that is visibly insecure on touch, see picture 8. Between the adjoining properties there is a roof gully, and this is

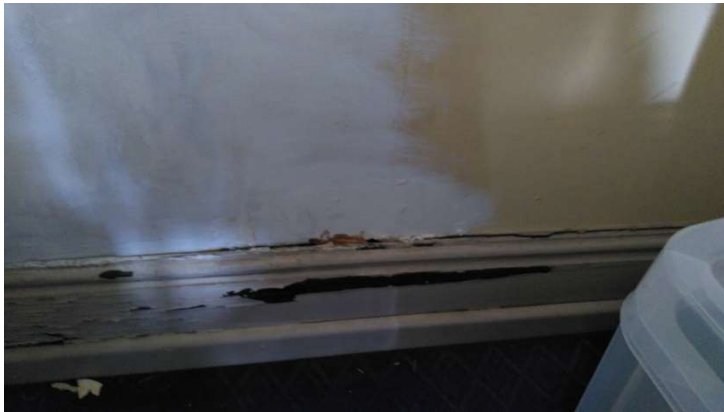
9.

believed to be either blocked with moss/debris or the lead work of the gully has cracked, and water has now saturated down into the wall, which is causing the internal wall to crack and visibly shift in and out of place. See picture 9 and 10.

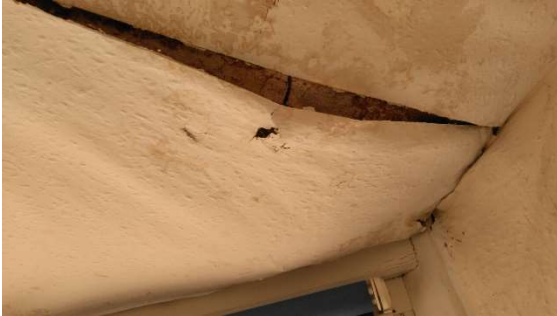
**11.**

Due to the amount of water and damp that is penetrating the building, the walls throughout the third and second floors are struggling to maintain their structure. From pictures 11 to 15, you can clearly see the effect the water ingress has had on the interior of the property. If this is not tackled

within the next six months or so, this issue will worsen and begin to affect the gallery that is seen by the public on the ground and first floors. The electrics will also be compromised throughout if no action is taken promptly.

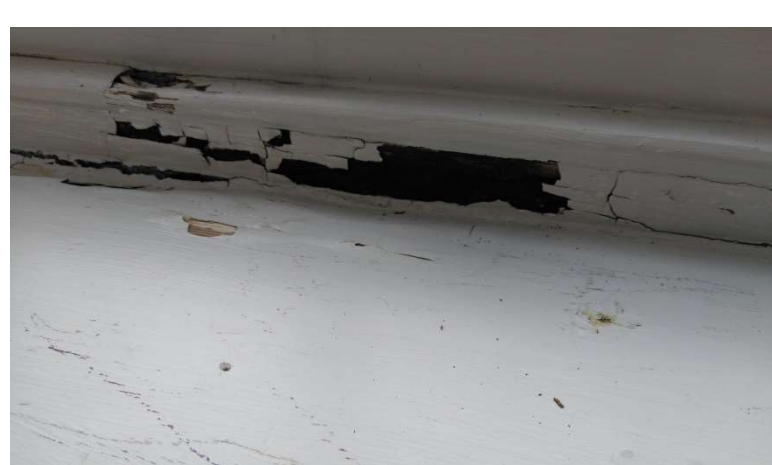
**18.**

Picture 18 reflects the current general state of condition of the windows throughout the property and unless they receive a complete overhaul, the problems will only multiply. Damp and mould is common throughout the upper floors and this will surely spread to the areas of the property that house the gallery.

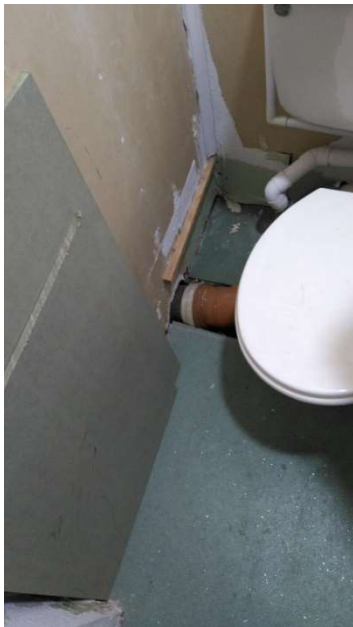
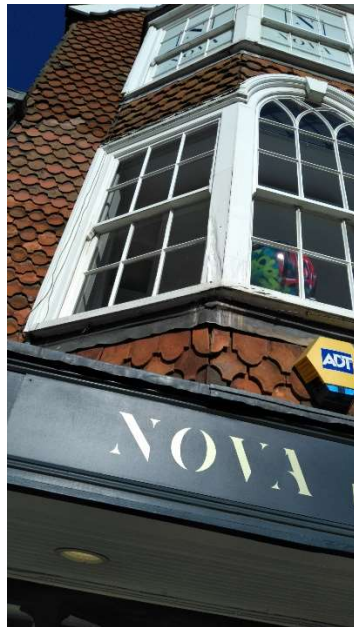
Like the second-floor landing, the first-floor rear toilet is unusable due to the floor that has visibly shifted inwards and gave an almighty crack when walked across on inspection. The plumbing by previous tenants has been done to a poor standard and this should be improved when the flooring is renovated, with the soil pipe and fittings to be moved/adjusted and properly boxed in.

The windows on this level cannot be opened, except the middle window and even this takes some force and is not often attempted due to safety issues. Externally the tiles above the ground floor have become cracked and dislodged which is allowing water to penetrate down into the wall.

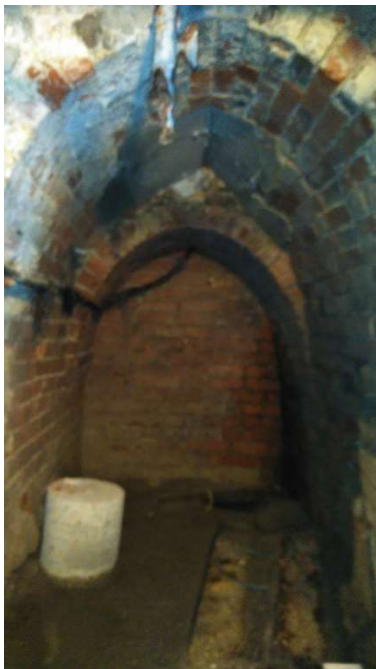
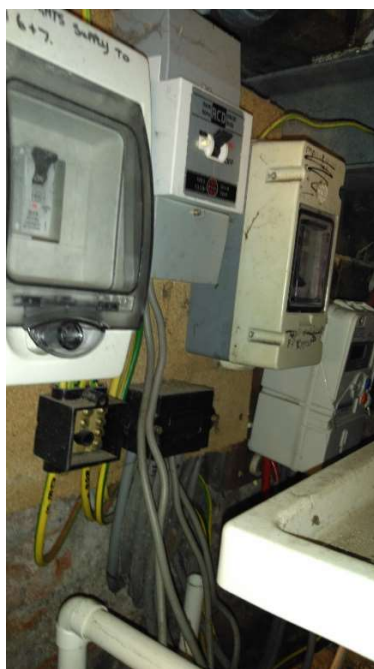
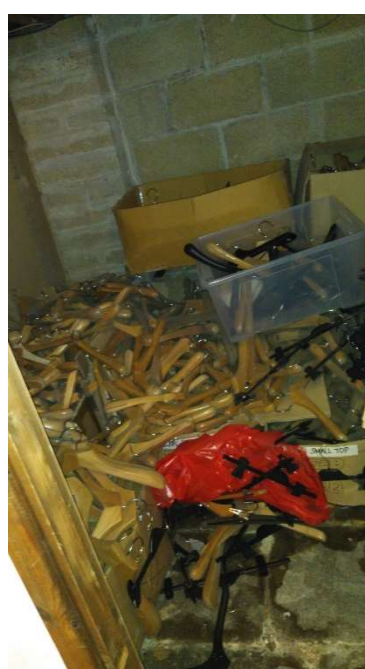
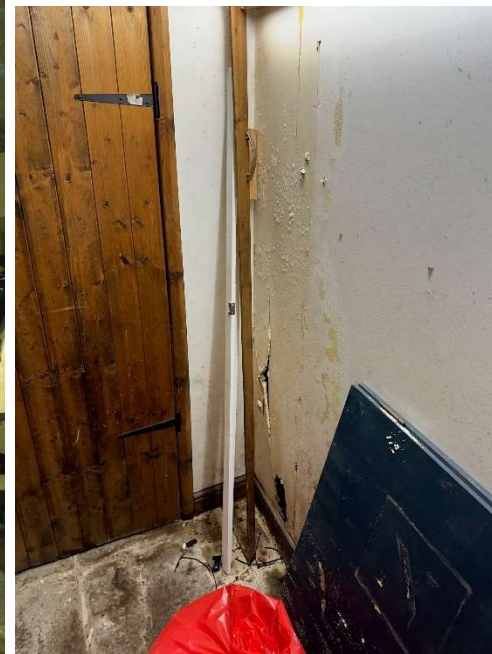
The basement has been a major cause of concern after an inspection by *Dorset and Wiltshire Fire and Rescue (DWFR)*. The inspection found a number of issues making the property non-compliant. These included the lack of fire wall and barriers and electric issues with clips to the basement.
