## PHOTOGRAPH SCHEDULE

**Property Address:** 27 High Street, Royal Wootton Bassett, Wilts, SN4 7AF

**Document Ref:** 26-018-PS

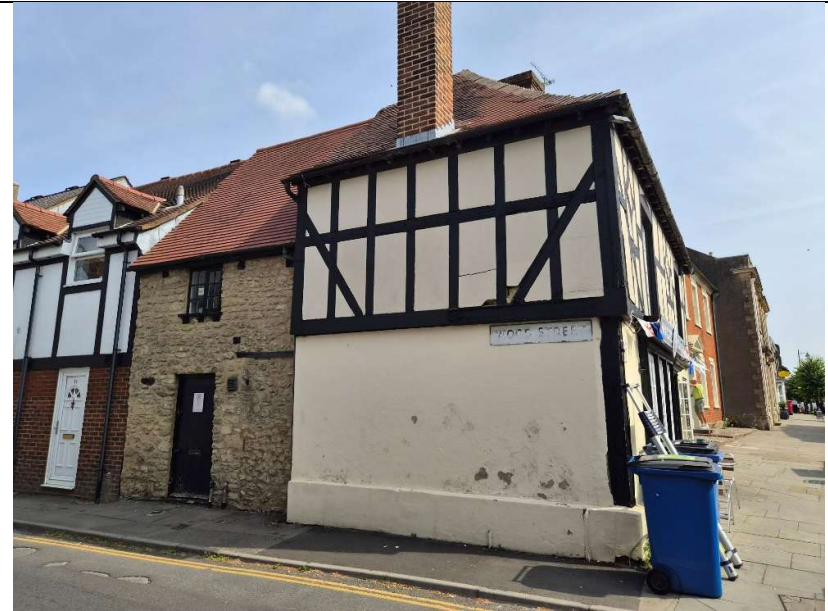
2. Gable end elevation, showing frontmost part of the building, together with the rear 'extension'.

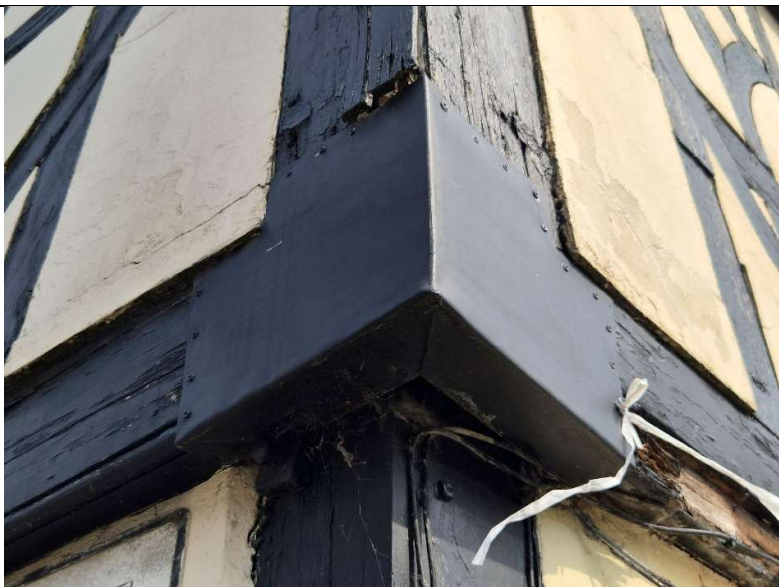
3. uPVC cover strip to south corner of building

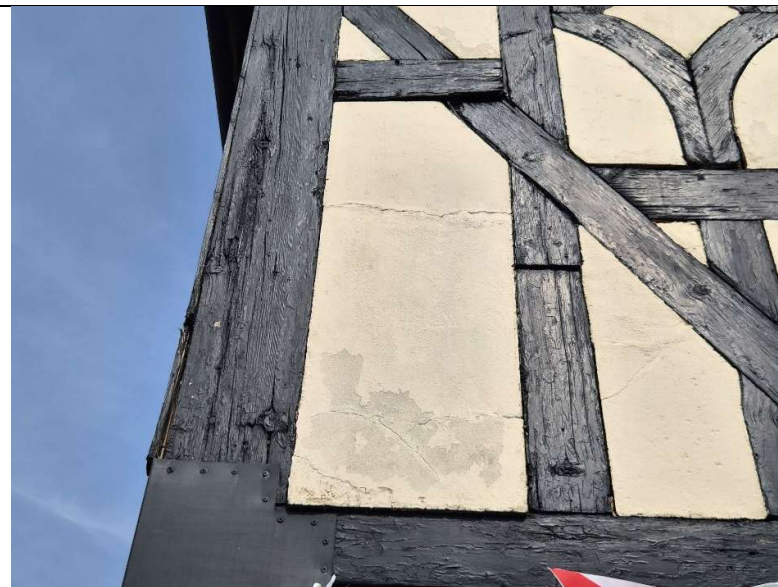
4. Split corner post. Defective render panels and open joints to front (south) corner of building. Note evidence of some historic splice repairs.

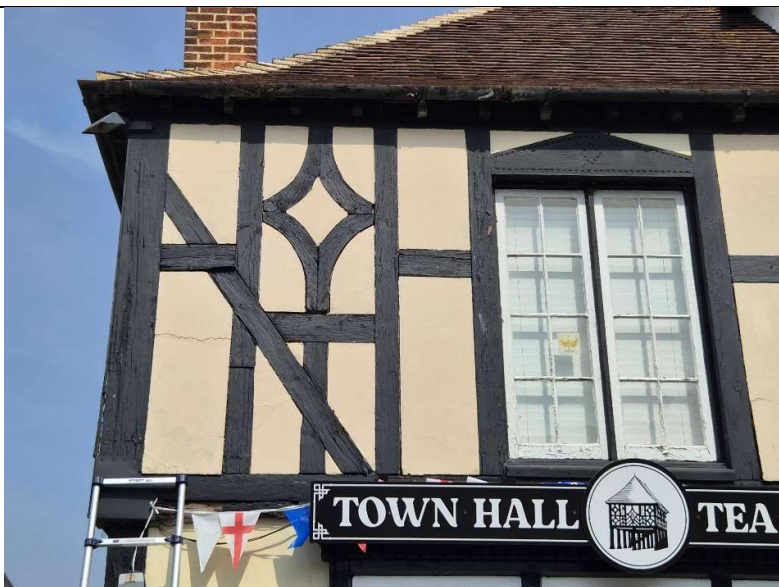
5. View of front part of the building note open joints to frame and cracks to render panels.

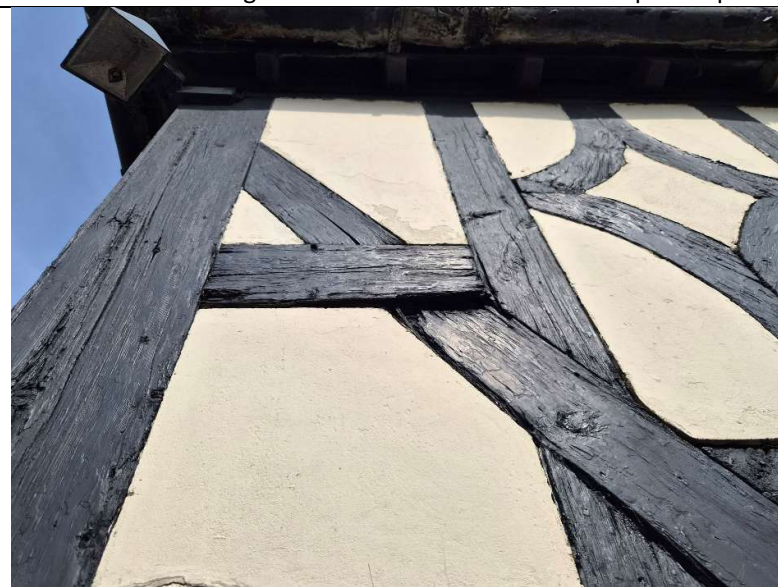
6. Open joints in frame and between timber and render panels – requires repair

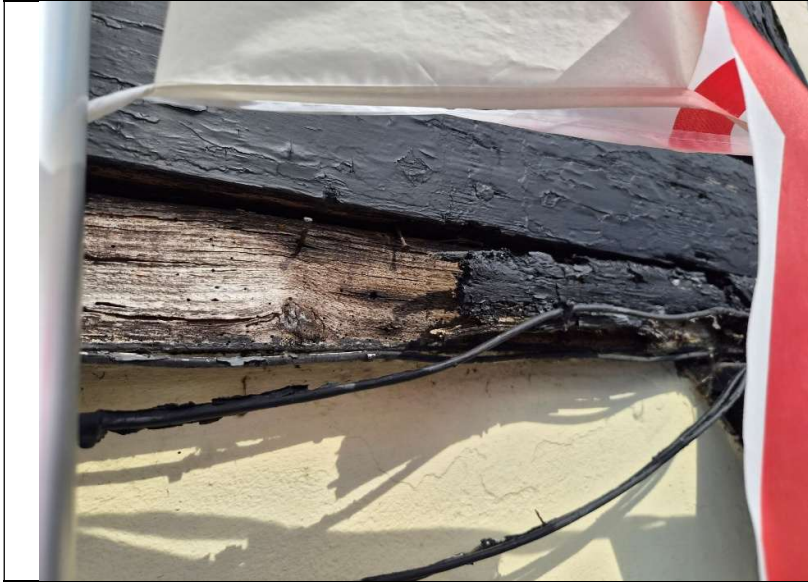
7. Decay noted on bottom member, to left of bay window. Joint indicates some historic repair.

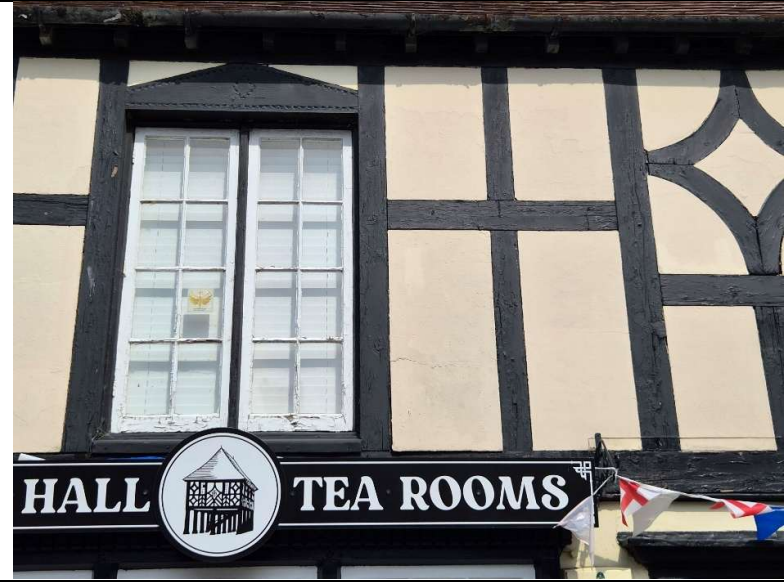
8. View of timber frame and render panels to front elevation. Note cosmetic deterioration to first floor windows.

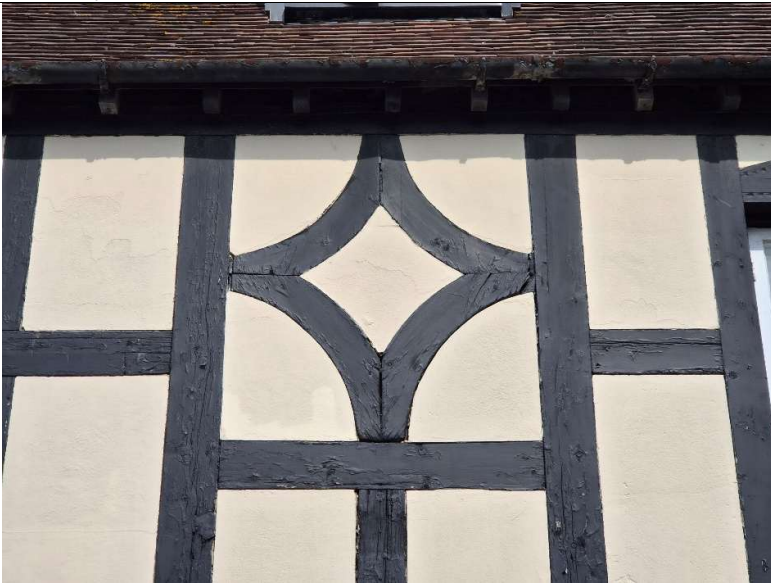
9. Open joints in timber framing to front elevation

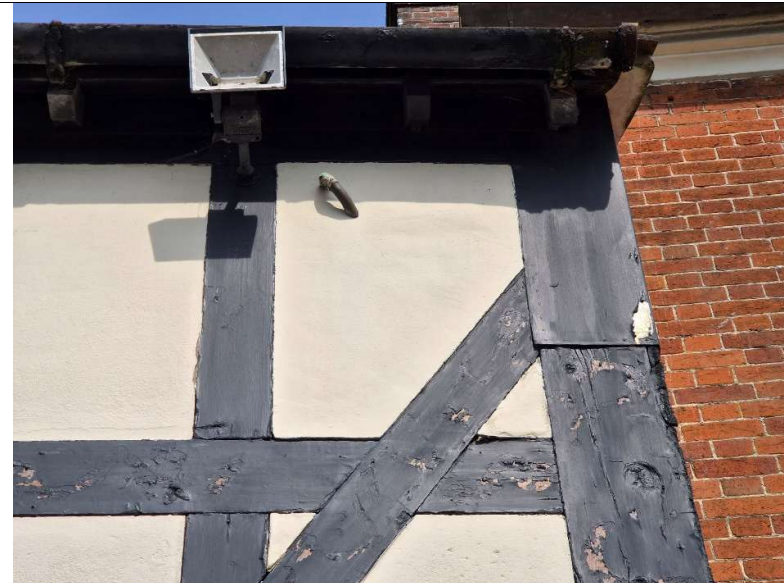
10. Flaking paint and open joints to timber framing. uPVC cover strip to corner post. Open joints around render panels.

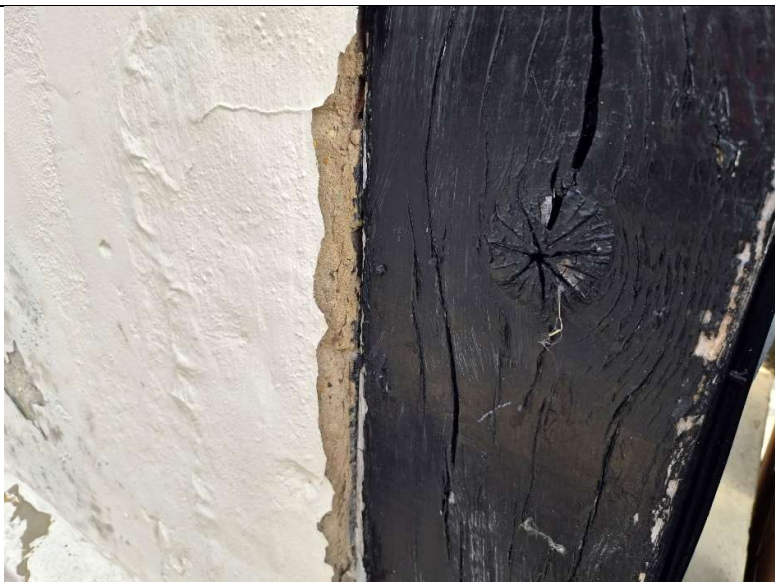
11. Render junction to corner post on southernmost corner of building.

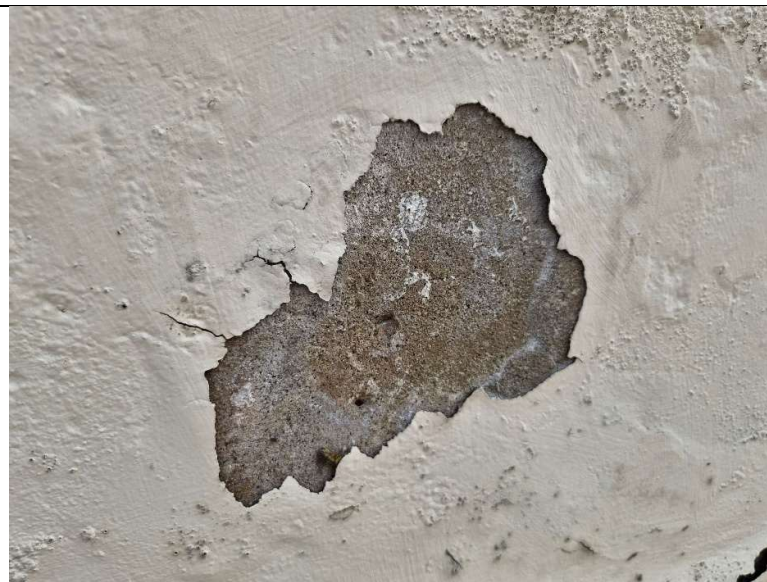
12. Peeling/flaking pant to gable wall, caused by tracking ground moisture

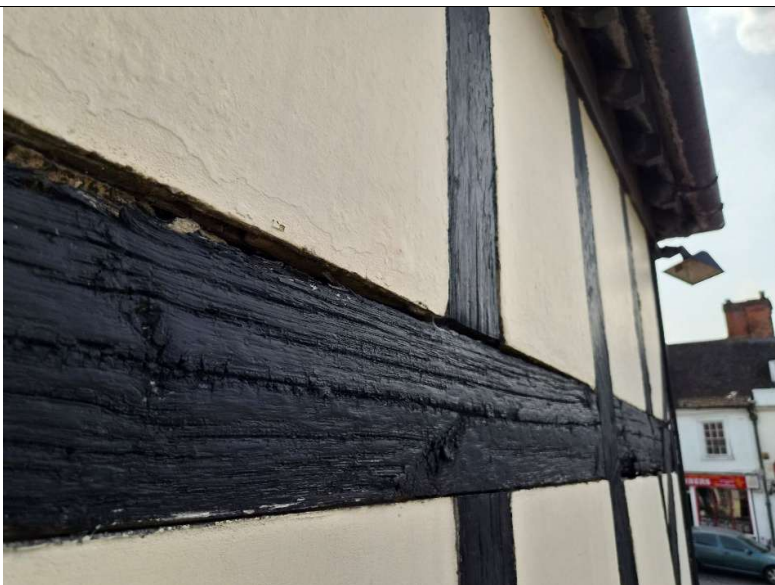
13. Open joints to timber frame and between frame and render panels to gable end.

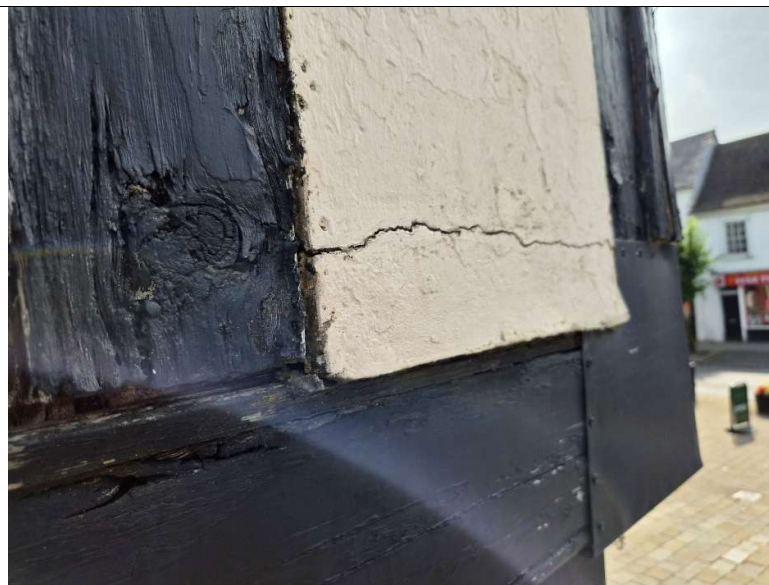
14. Cracked timber and open joints. Note cracked and loose render panel at risk of falling out

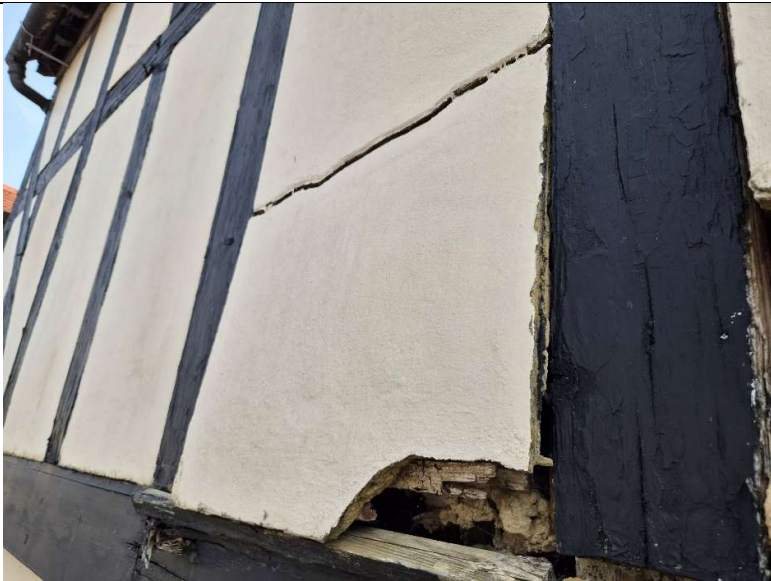
15. Missing section of render to gable end. Note exposed joints to framework

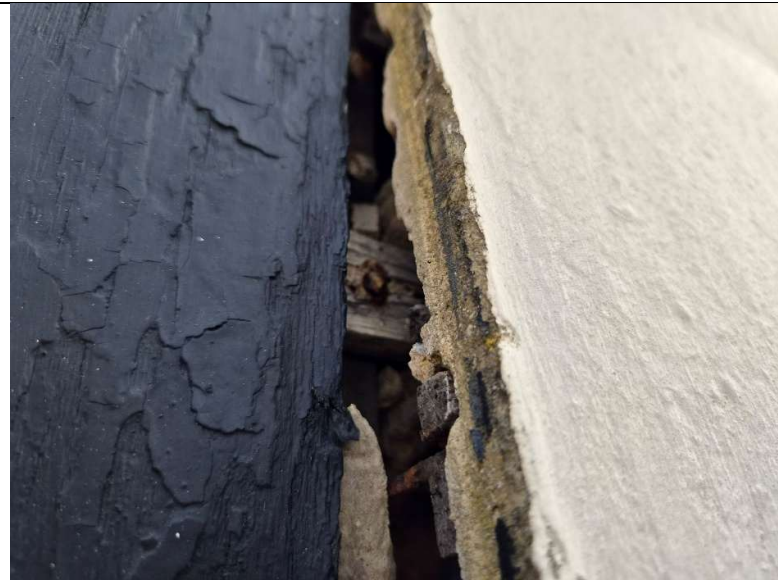
16. Render panel detached from timber laths and at severe risk of falling out. Laths and timber frame now exposed to the elements.

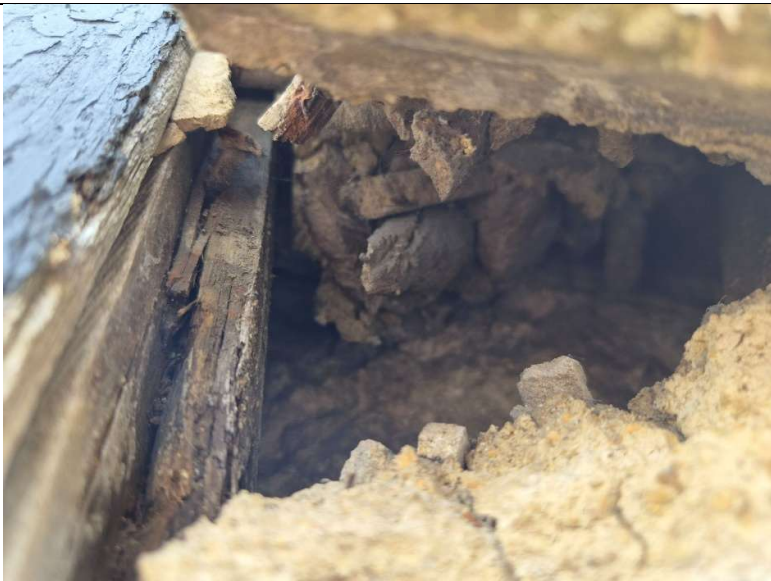
17. Render panel detached from timber laths and at severe risk of falling out. Laths and timber frame now exposed to the elements.

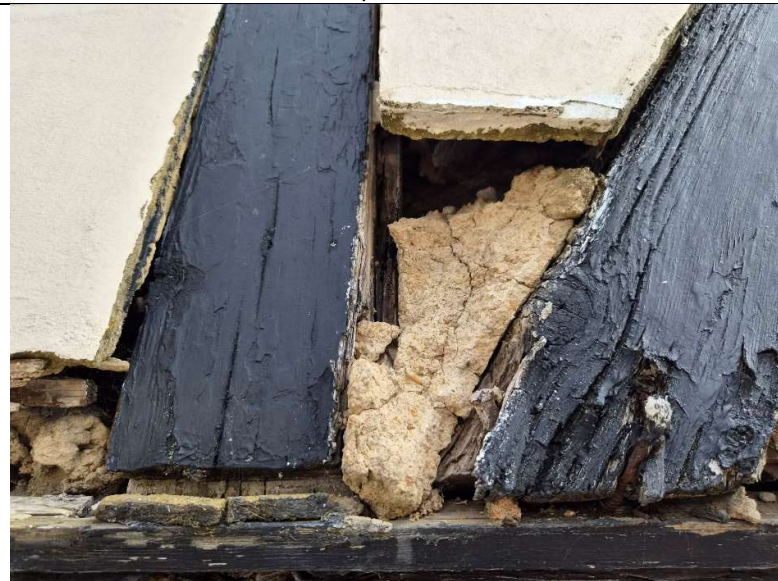
18. Render panel detached from timber laths and at severe risk of falling out. Laths and timber frame now exposed to the elements.

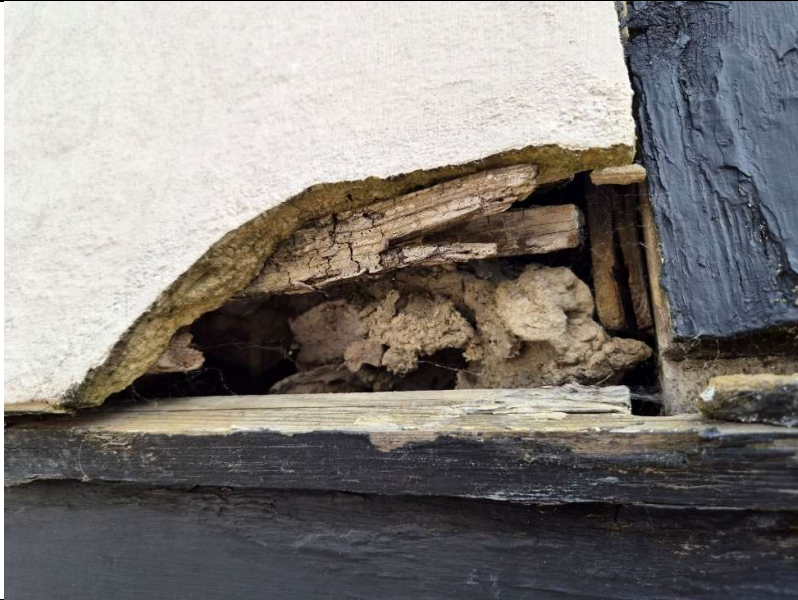
19. Render panel detached from timber laths and at severe risk of falling out. Laths and timber frame now exposed to the elements.

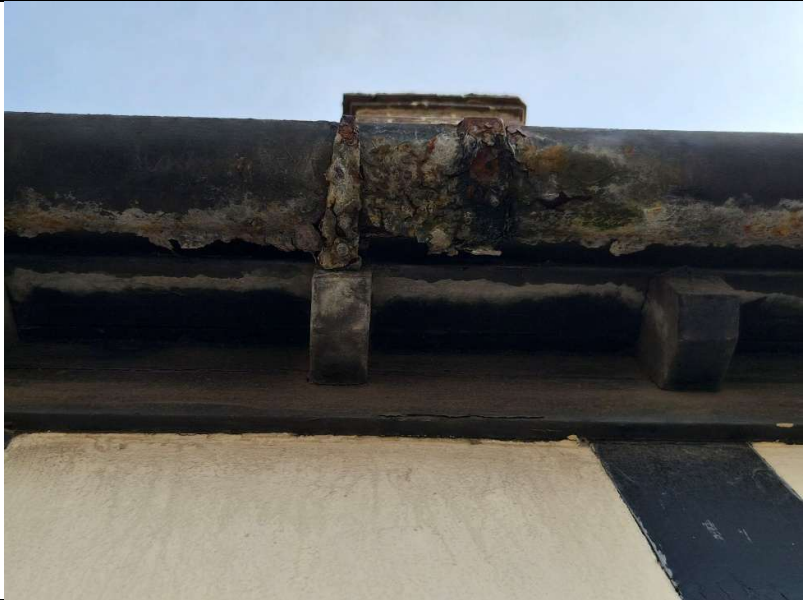
20. Extensive decay of rainwater goods to gable end elevation. Note run-off staining on render panel below, confirming gutter leaks.
