# St Lawrence Chaple – Warminster

## Masonry condition survey

20<sup>th</sup> October 2025-- Nigel Goodenough for Albion Stonemasons

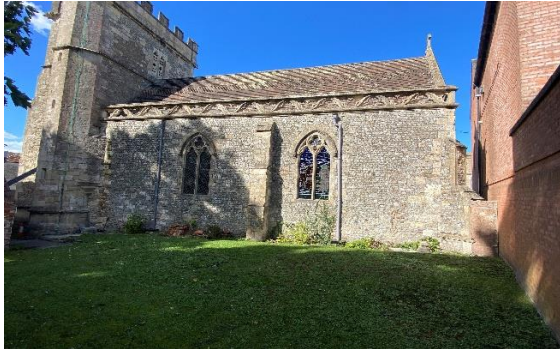
The masonry of St Lawrence Chaple is in excellent condition with very few recommendations for repair or replacement.

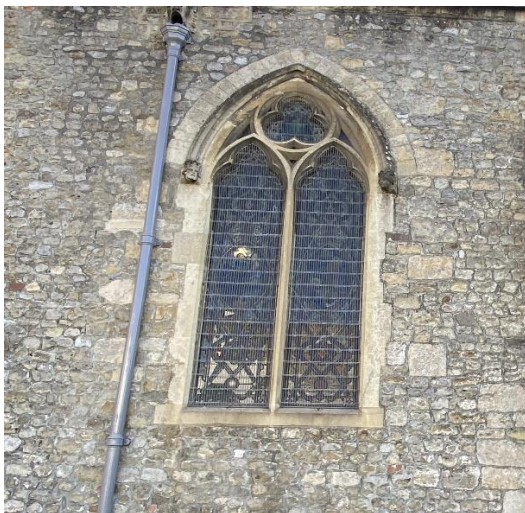
It is constructed of varying beds and sources of Oolitic stone from the Bath area for the dressings and carvings with the wall faces being finished with small modules of Greenstone as is the local vernacular.

All elevations have, over various times, been repointed with hard cementitious mortar, which is not ideal, however there are little signs of erosion around the edges of the softer dressings as would be expected with this practice.

All elevations would benefit from a light conservation clean, subject approval, which may uncover some minor repointing. If this was to be undertaken consideration would be needed for the dark sooty deposits around the weather dressing particularly string courses, copings and hood mouldings that will require poulticing to remove this discolouration.

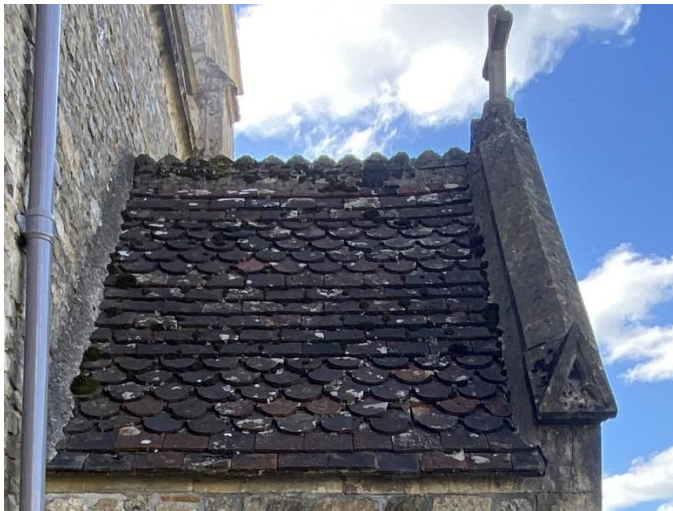
Moss on some surfaces, minor open joint repointing and defrassing of a few Bath stone dressings to windows.

Some minor rust staining from ferrous fixings of the window guards.

Some open joints to high level and porch copings.

The porch roof tile abutment with the nave and the porch gable is a mortar fillet not leadwork which may cause issues in the future, but water ingress staining was not apparent.

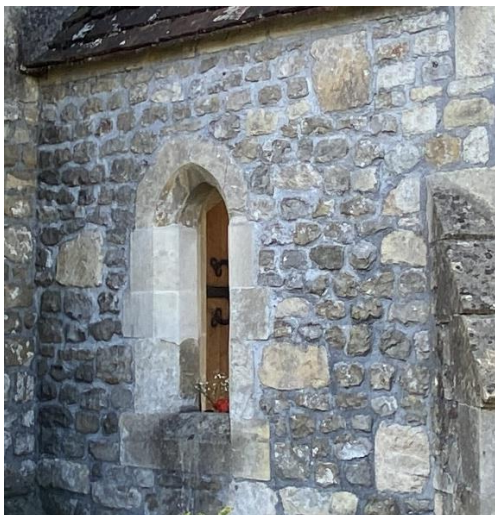
The west side of the porch and a smaller area of the east side appear to have been recently repointed in grey cement which stands out from other areas.

Some lower stones to the tower quoins and buttresses are showing wear but are still functioning.

Porch requires guttering (noted elsewhere) by specialist.

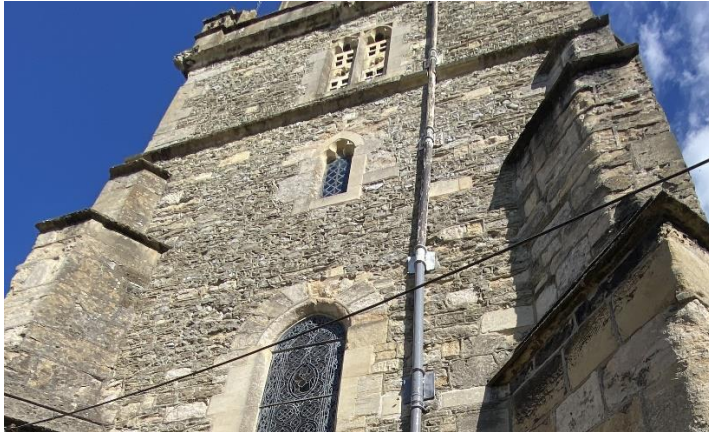
This elevation mainly of the tower has been repointed in a style called ribbon pointing where the mortar stands proud of the stones that it surrounds. There appears to be erosion of stones, particularly to the central voussoirs to the lower window and second offset areas to the N/W and S/W buttresses. This material should be removed to arrest this decay.

There are possibly redundant electrical fittings and wires attached to the N/W buttress.

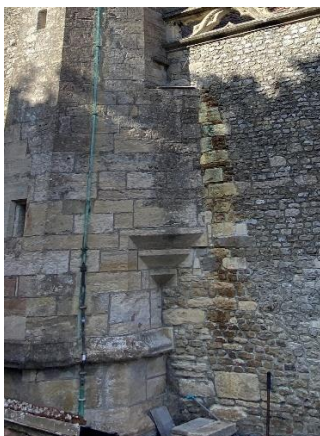
Leaded bell rope cover to be inspected by lead work specialist.

Minor pointing works required to stair wall ashlar.

Generally, the south elevation is in a similar good condition to the north with a few joints requiring pointing only.

There is a water stain running down the wall where the tower masonry abuts the nave and is caused by the discharge of water from the surface of the offset, this is does not appear to be causing damage.

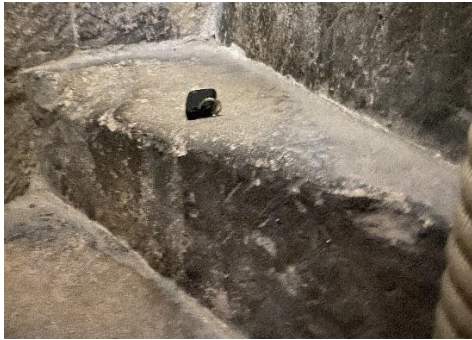
**Tower staircase** There are 7 nr stone treads leading up to the clock chamber that are considered boarder line candidates for indent replacement, as has been previously undertaken further up, due to worn surfaces.

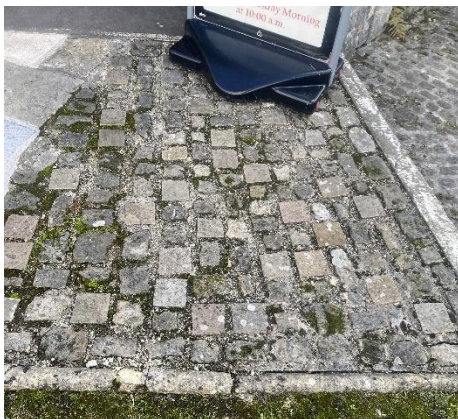
The mortar between the cobles to the sides of the paved path leading up to the porch has decayed to the point of needing to be replaced. Approximately 10m2.

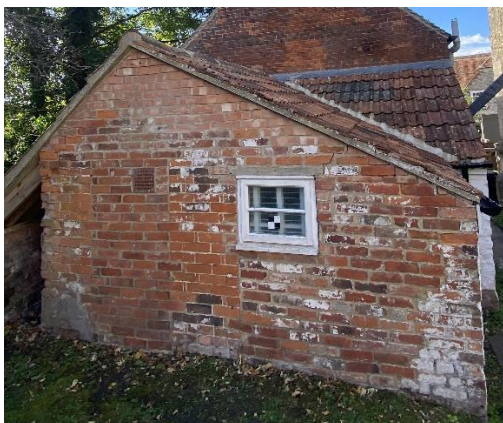
There are some minor pointing works mainly to the low-level east elevation required.
