An illustration of the Chapel dating to shortly after the Nave was rebuilt in 1855

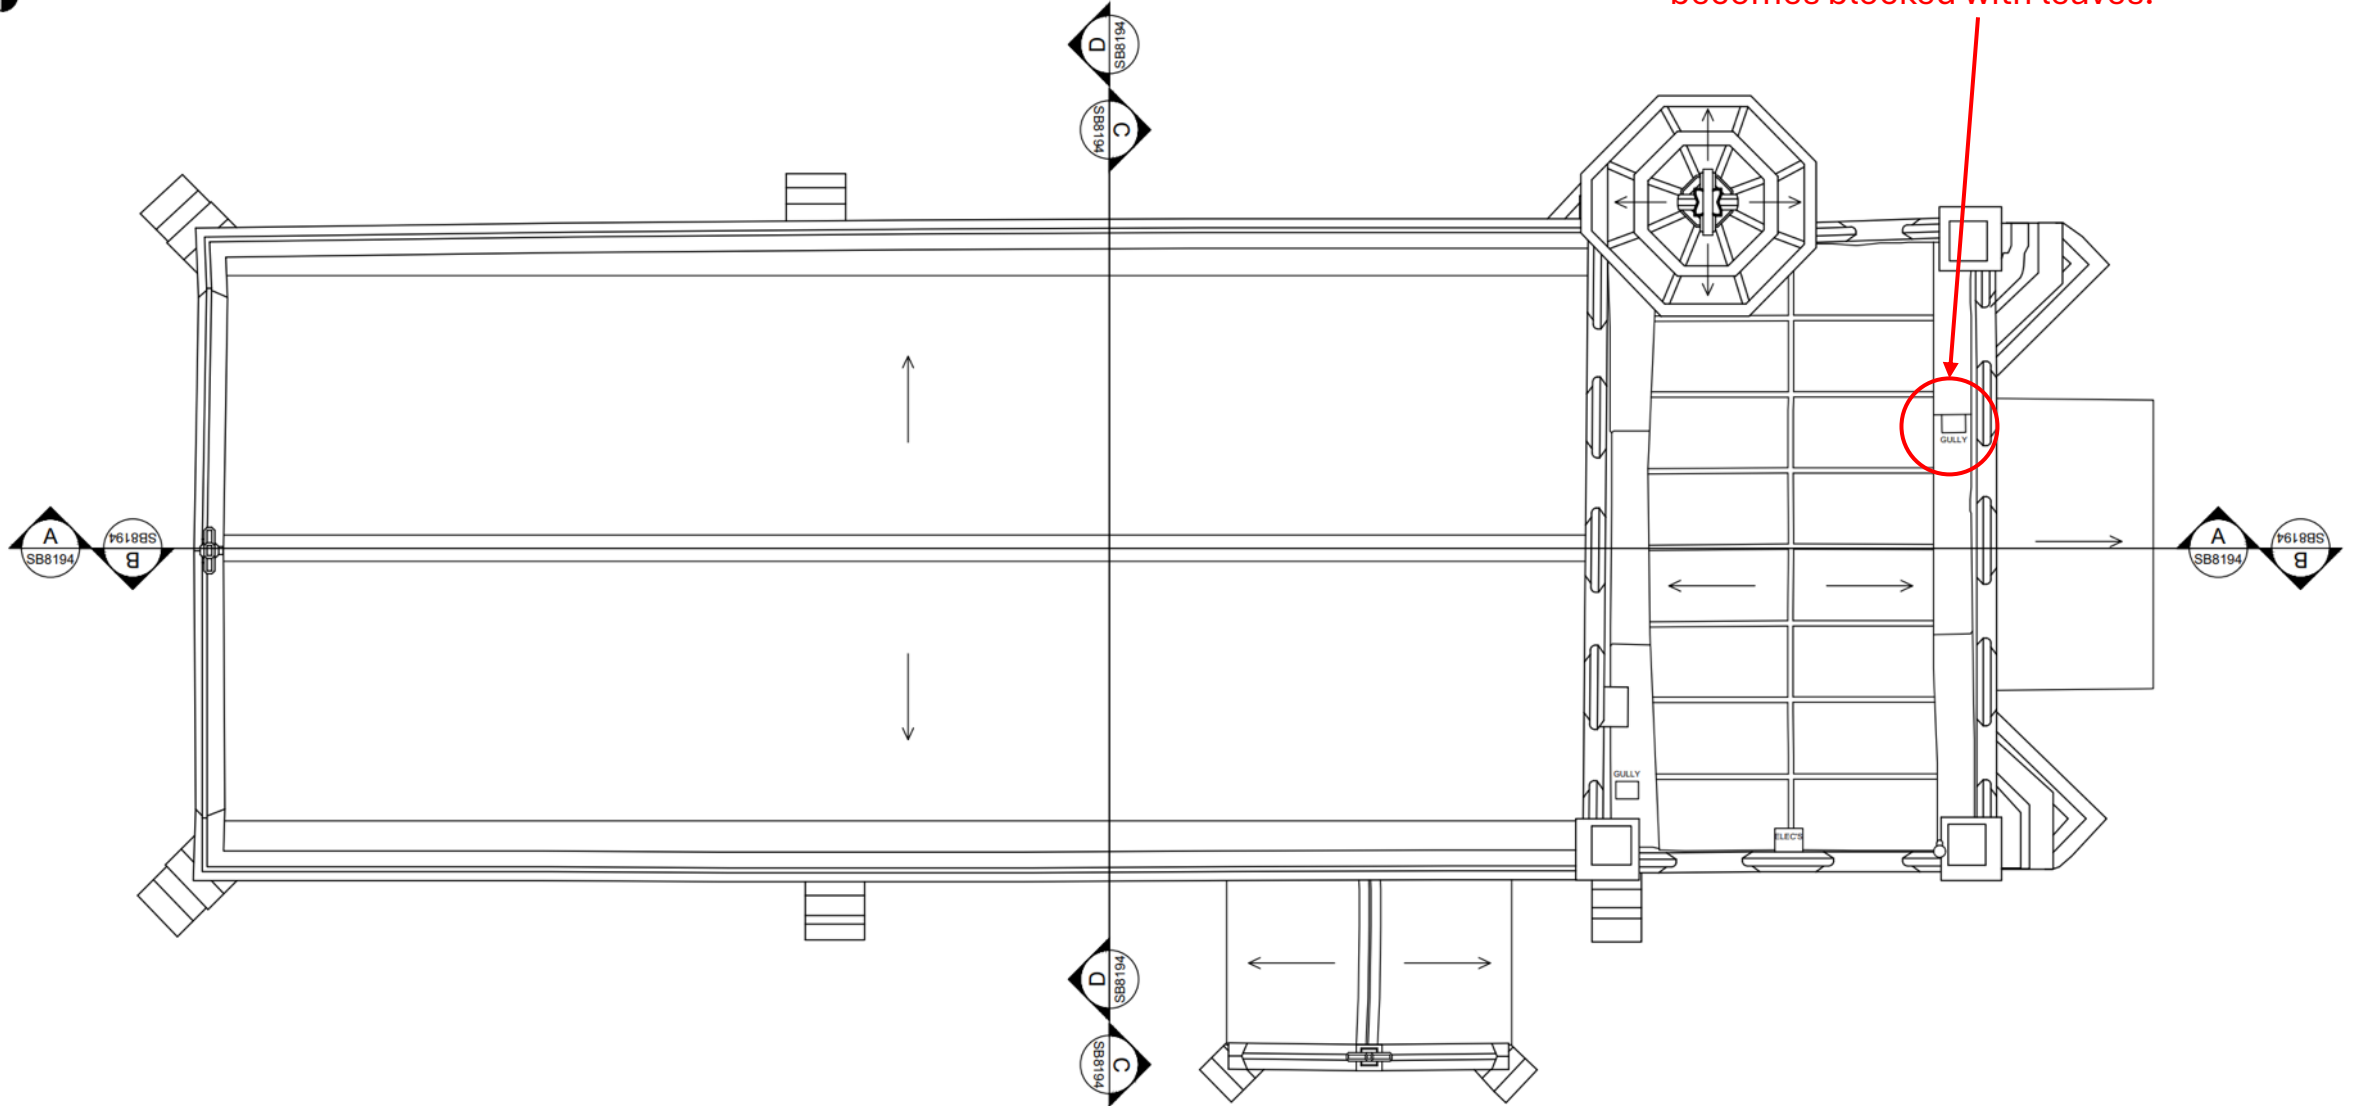
Roof gully

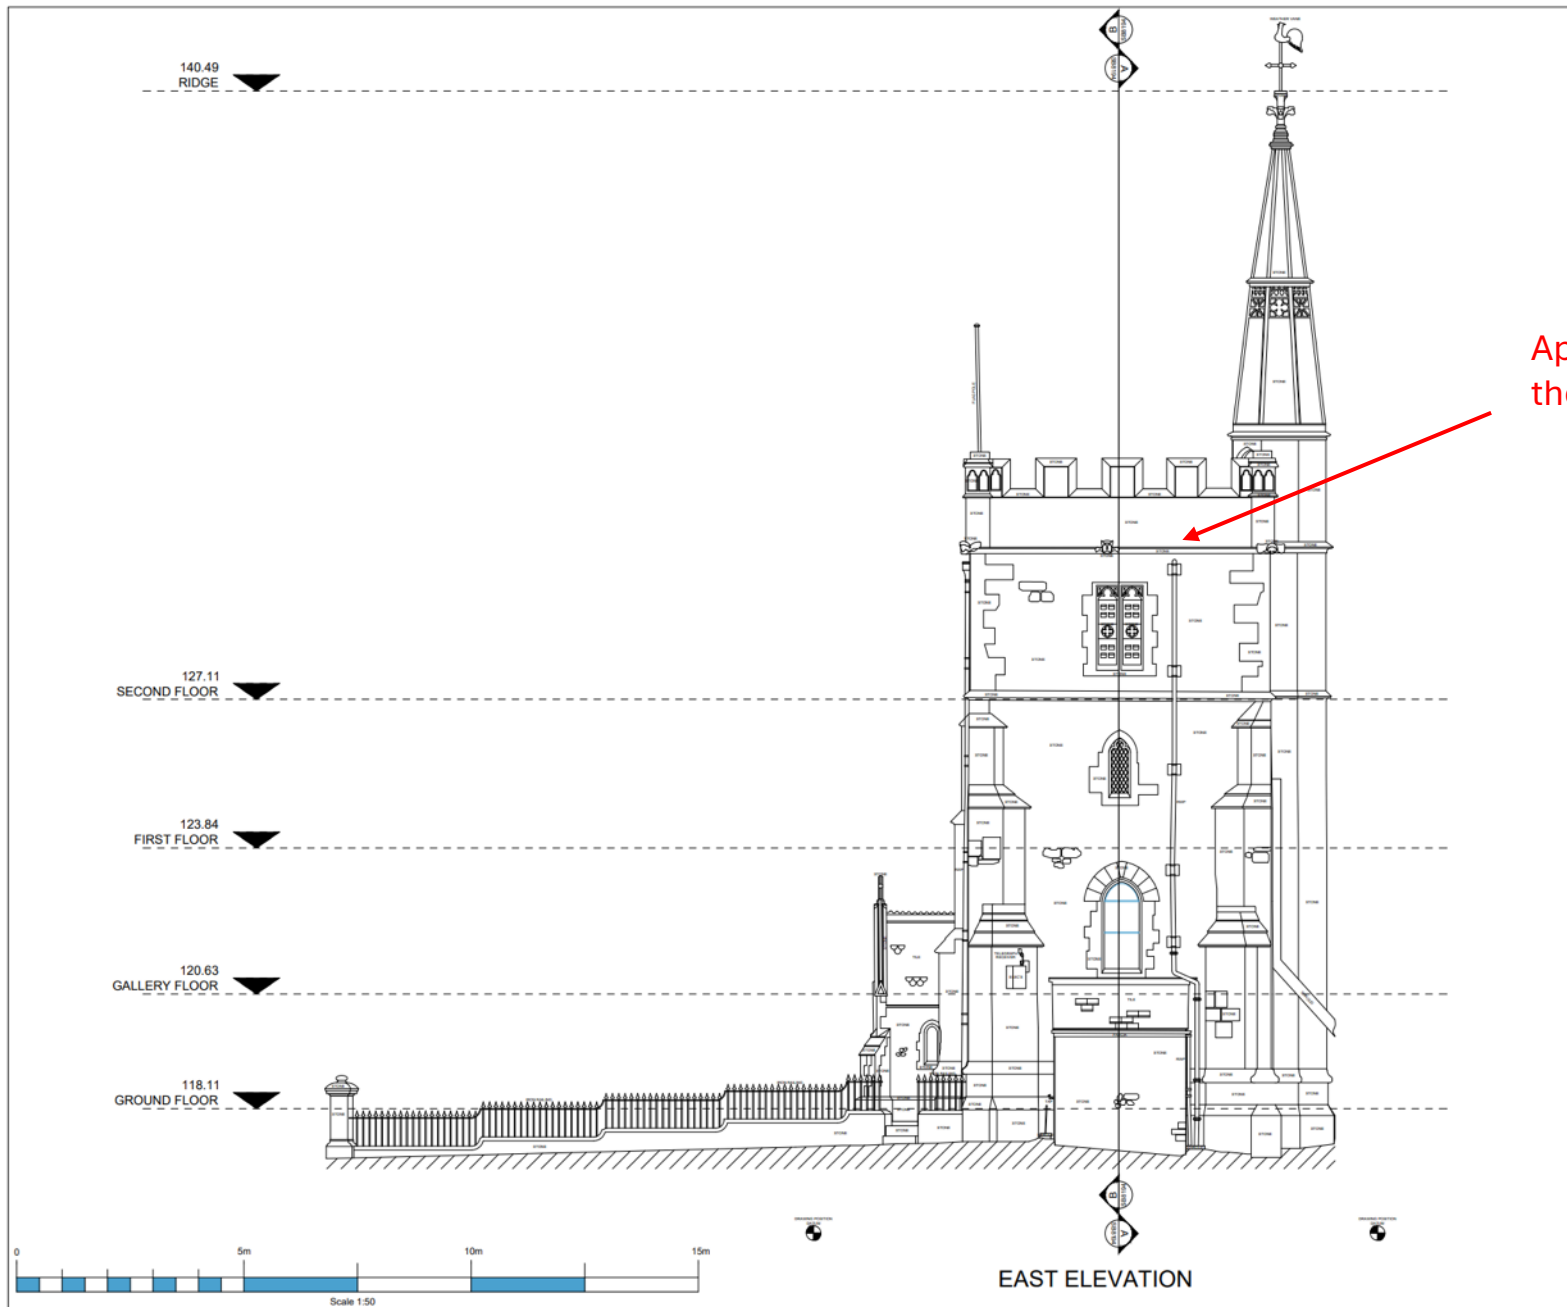
Approximate position of  
the new lead overflow pipe

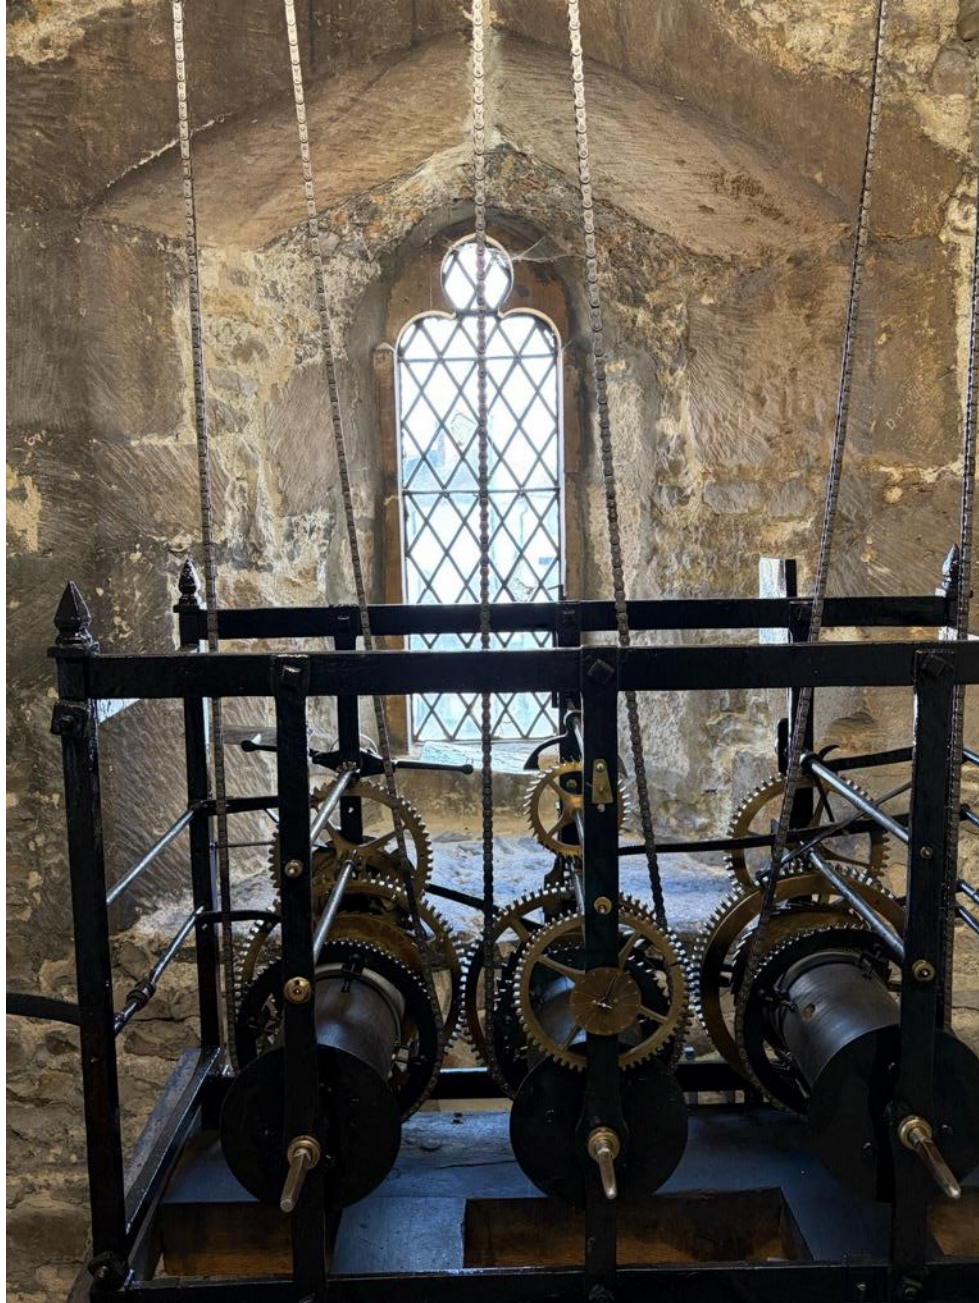
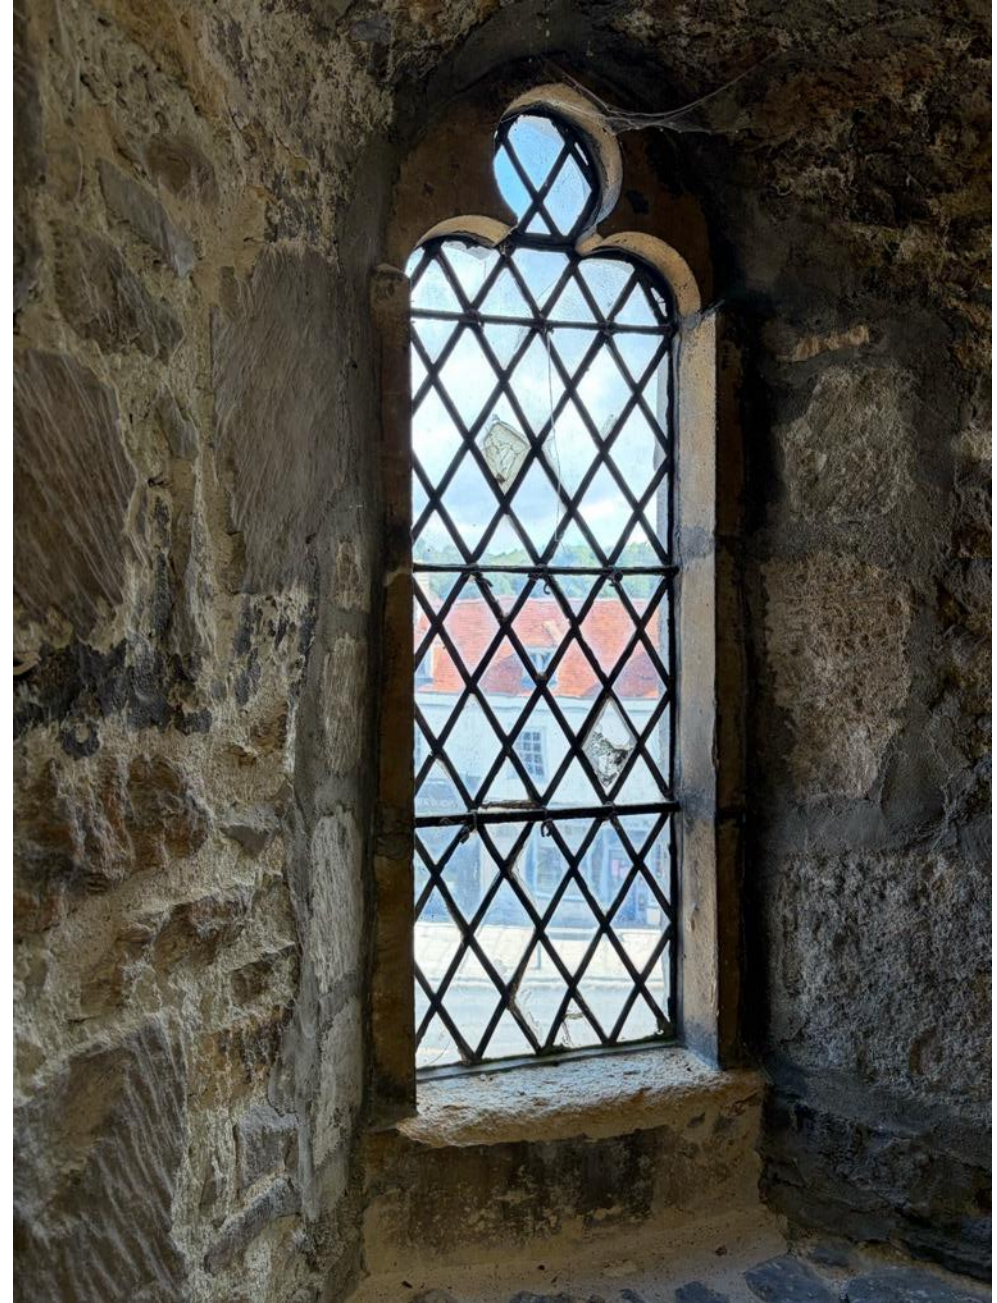
Removal, repairs and reinstallation of the tower Northside window in the clockroom

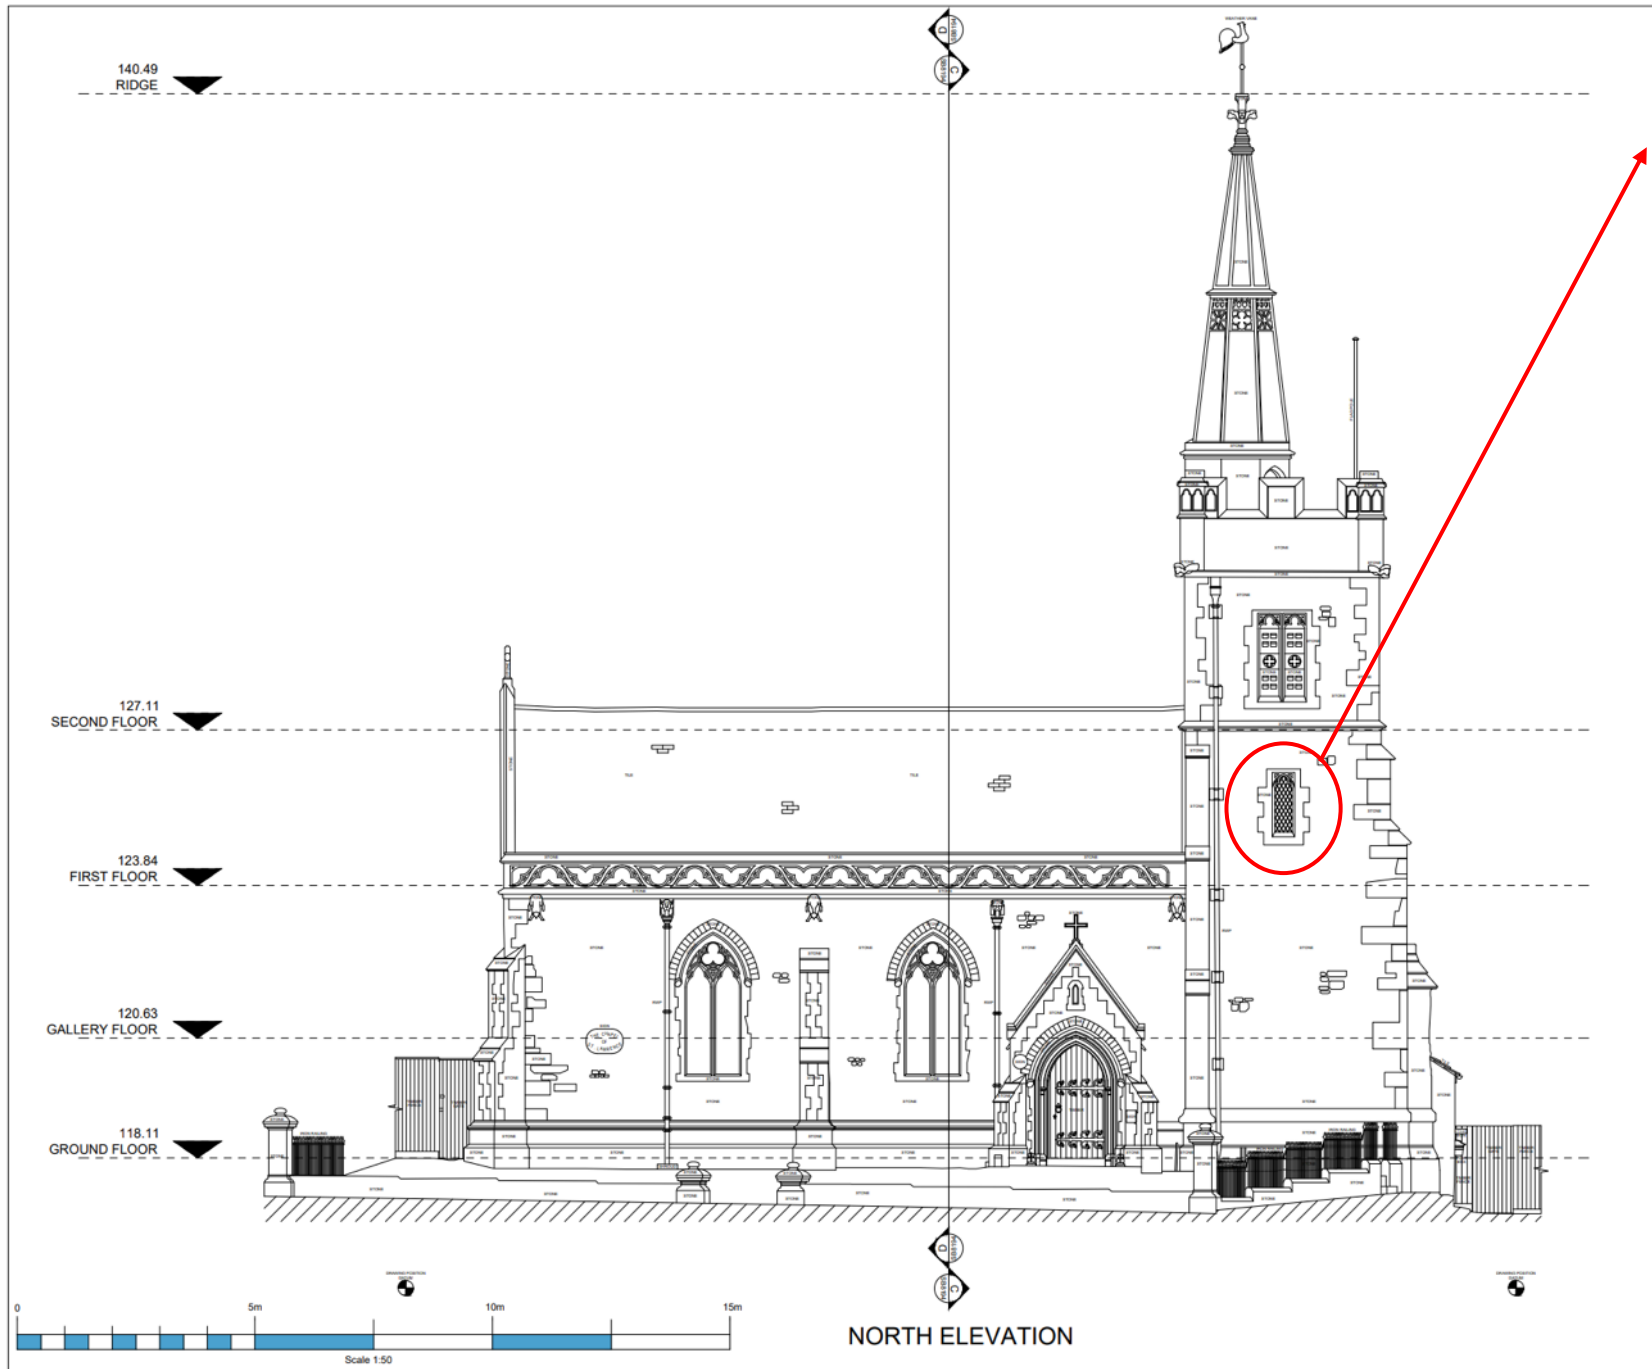
Removal, repairs and reinstallation  
of the tower Northside window in  
the clock room

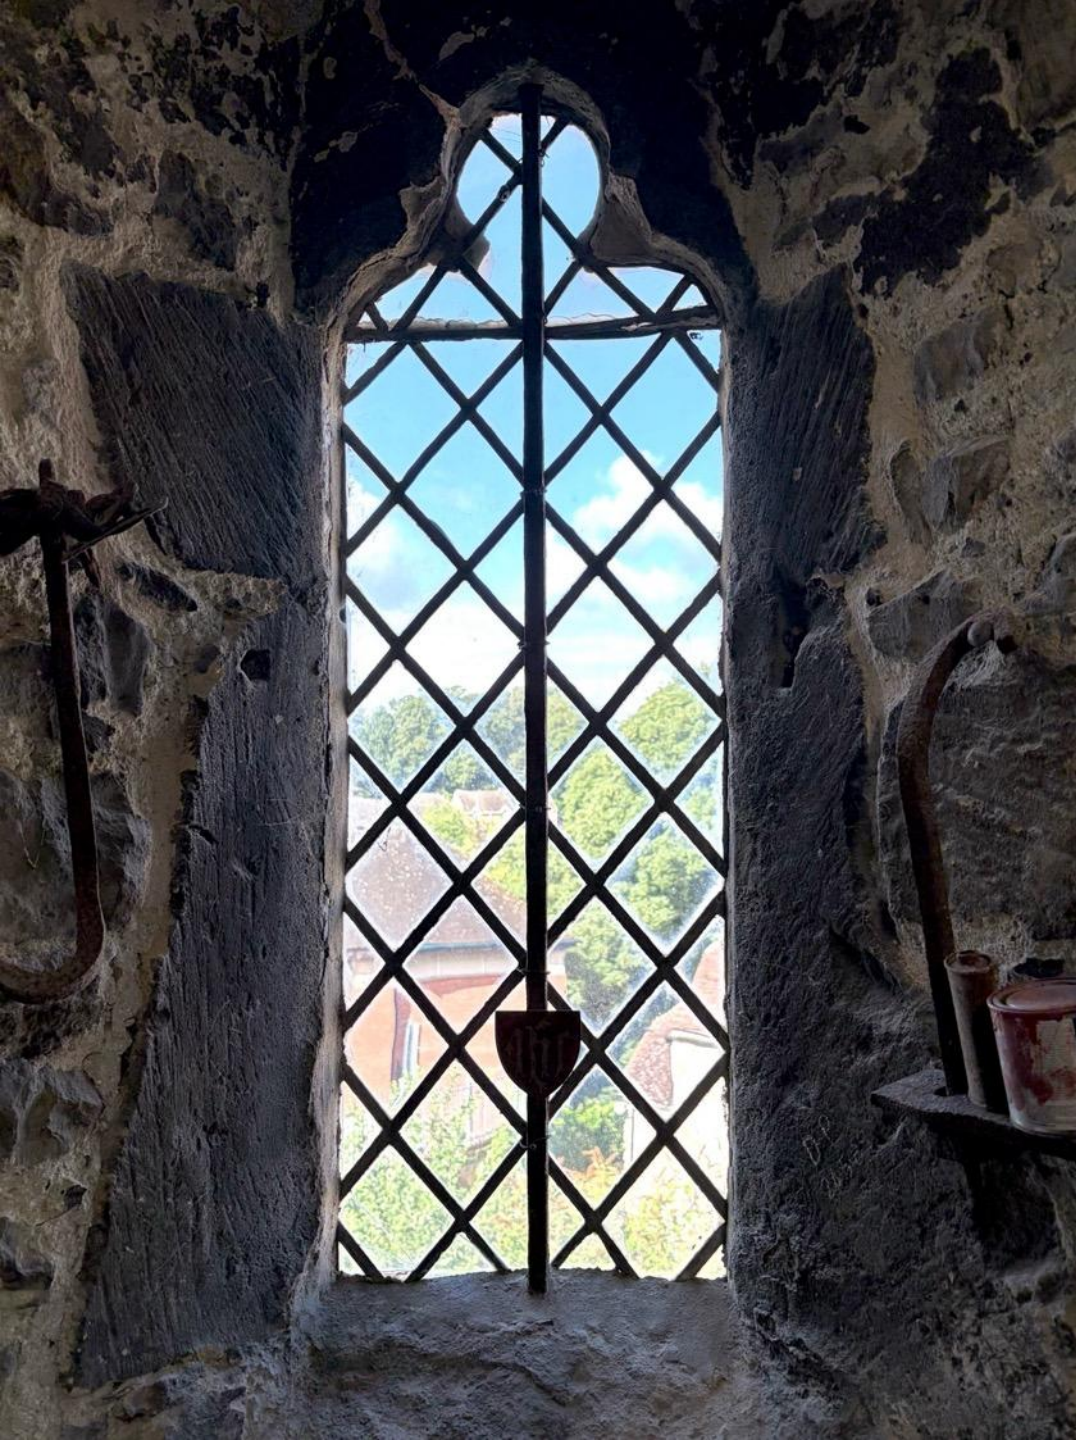
## Removal, repairs and reinstallation of the tower Westend window in the clock room

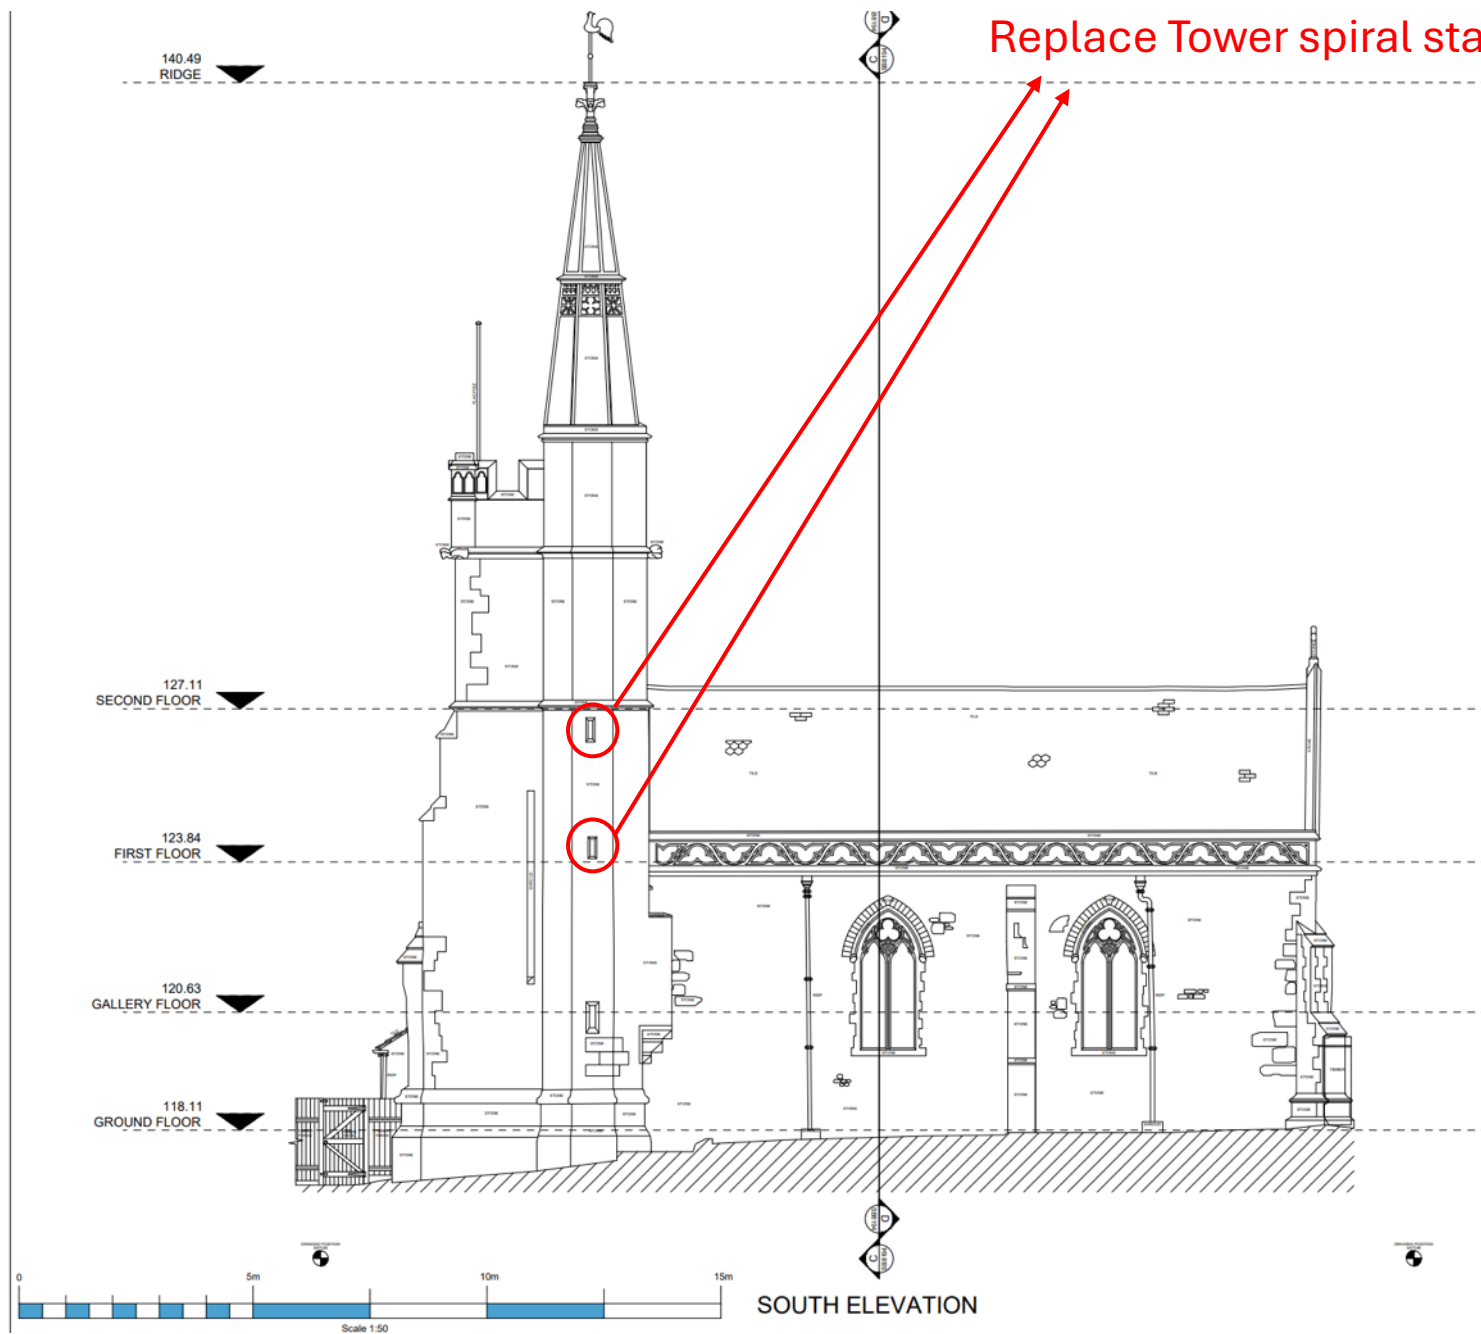
Replace Tower spiral staircase glass

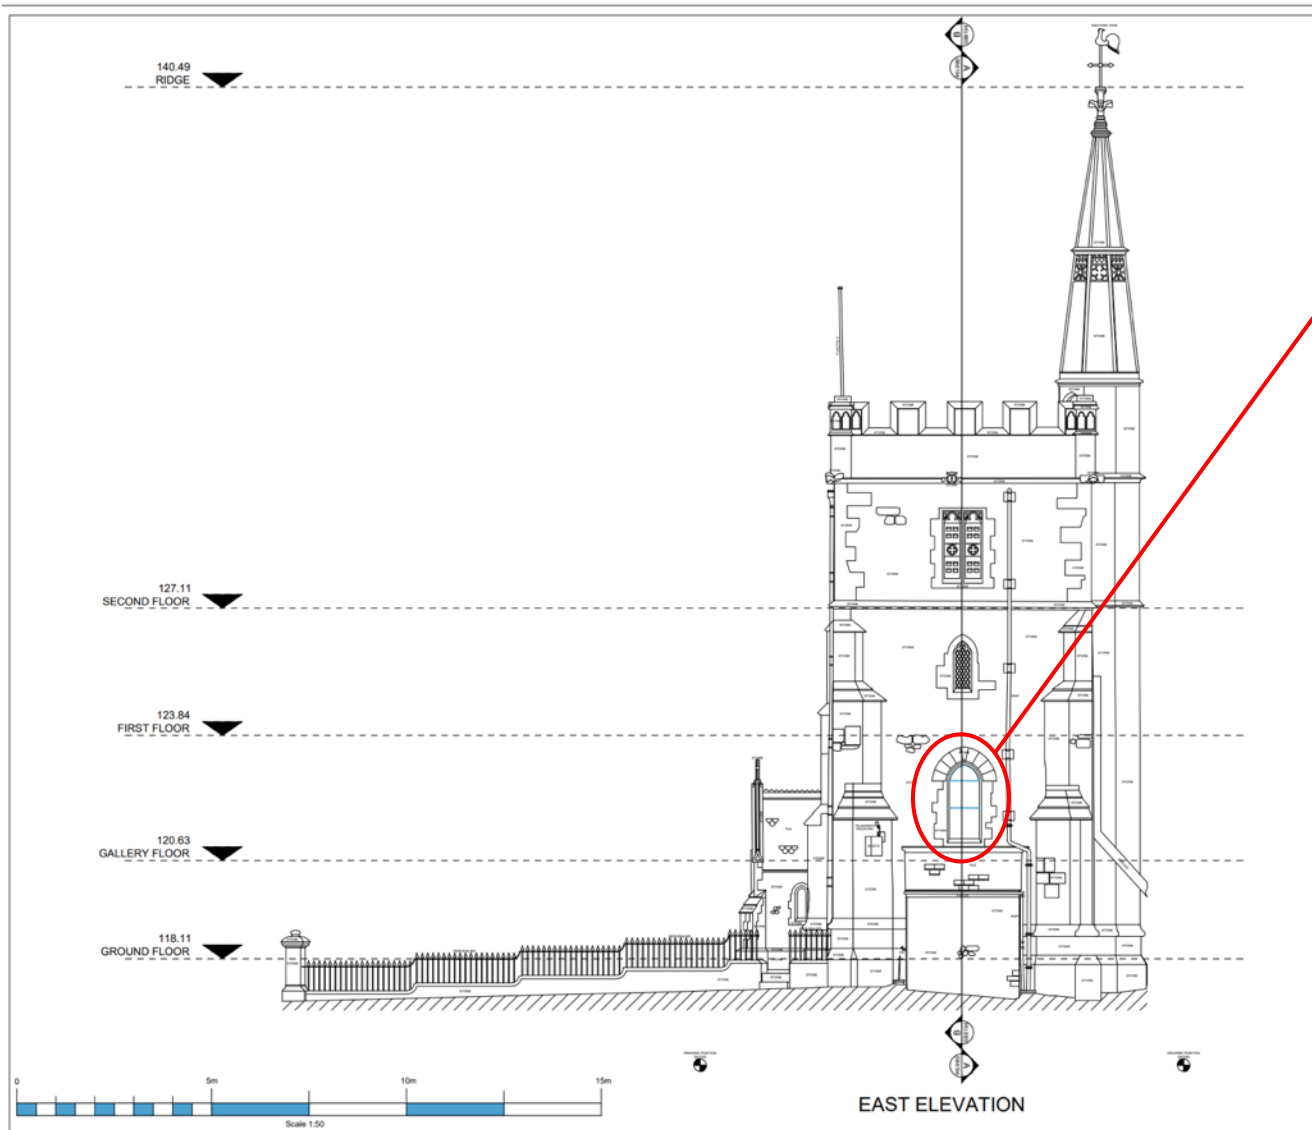
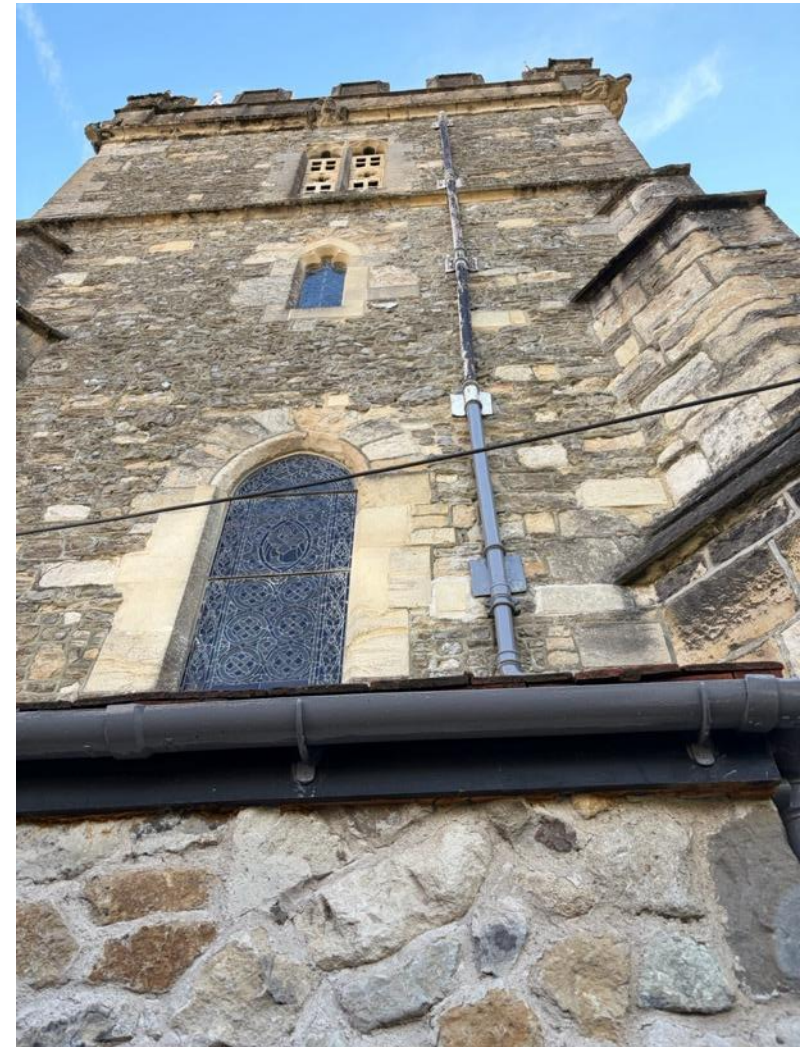
Westend stained-glass window mesh

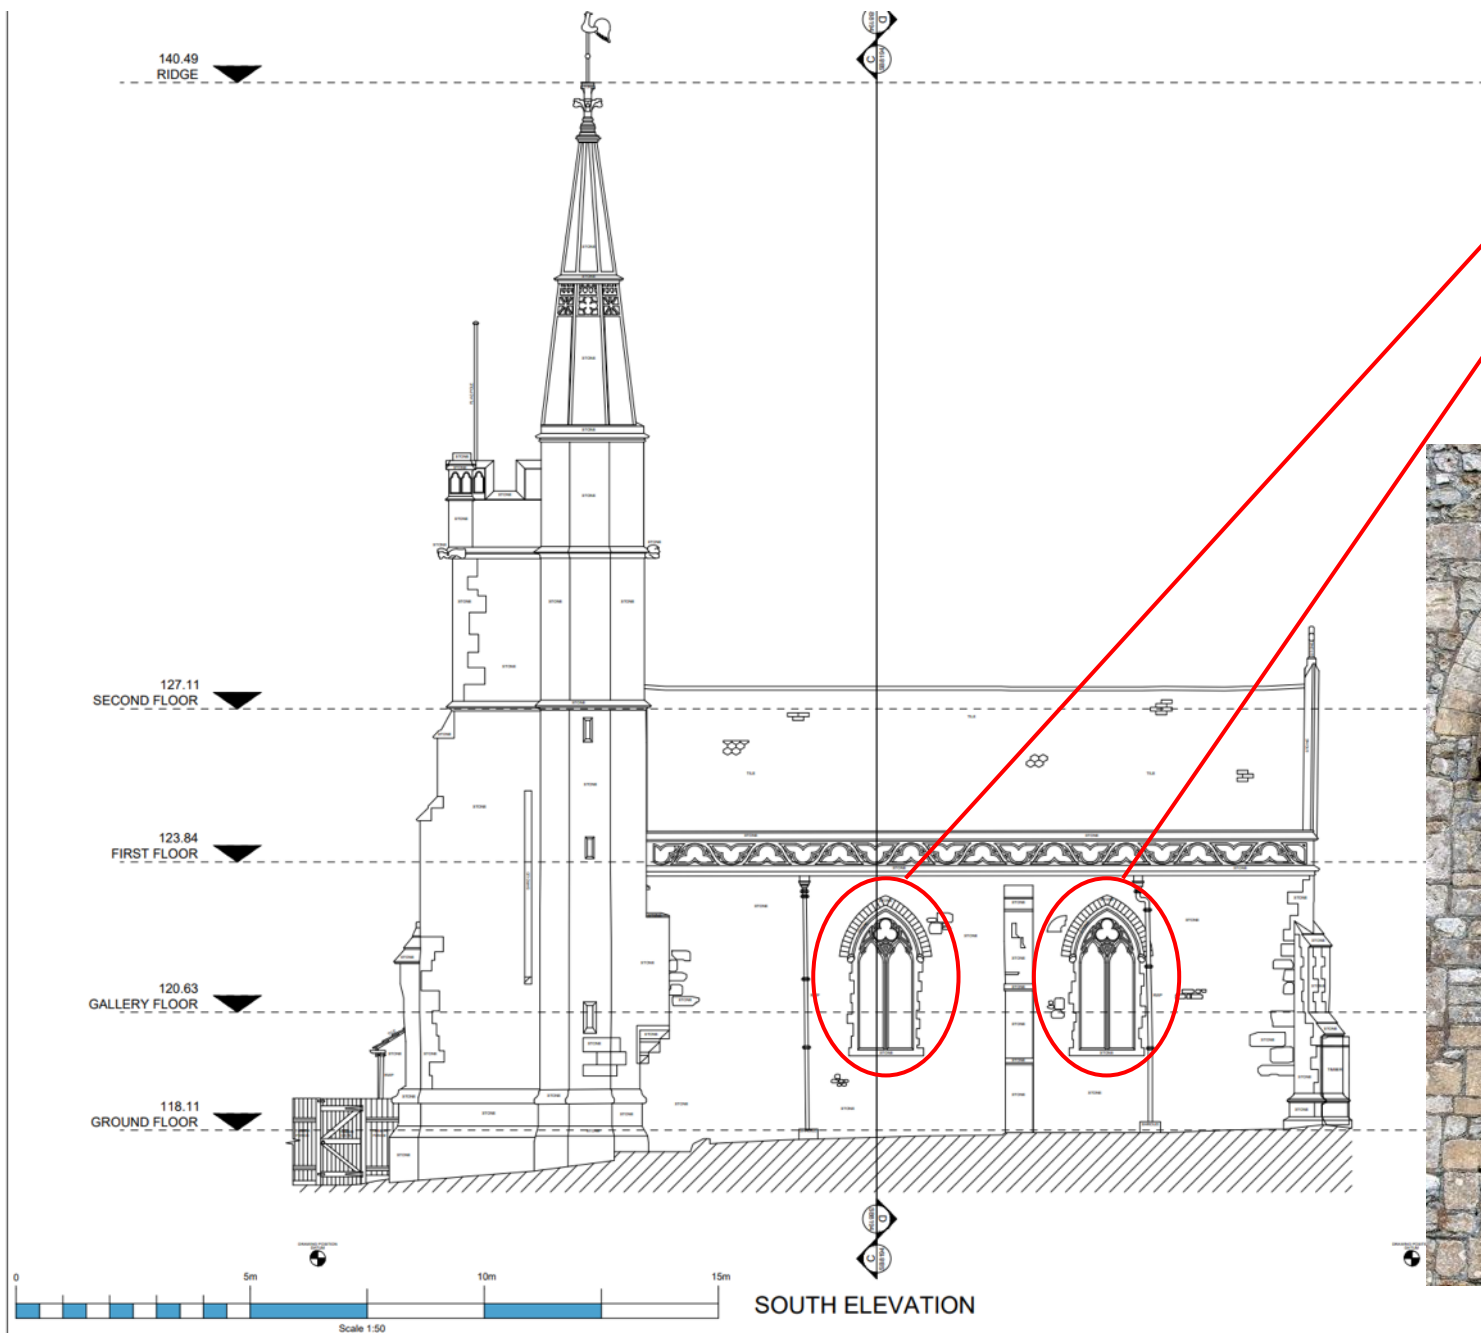
Southside stained-glass window mesh

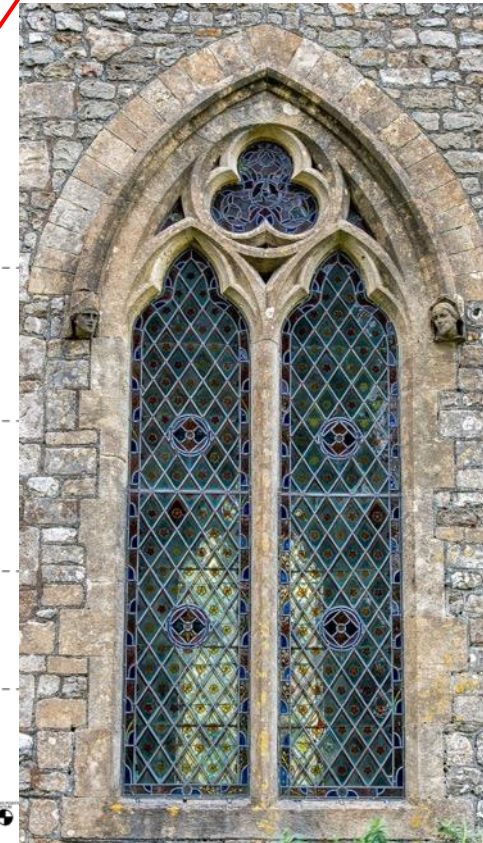
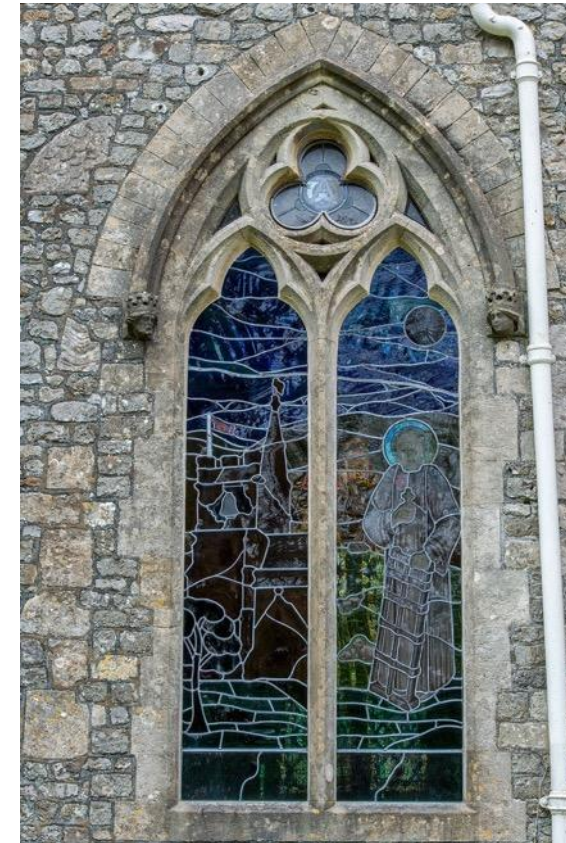
Cleaning of moss and lichen

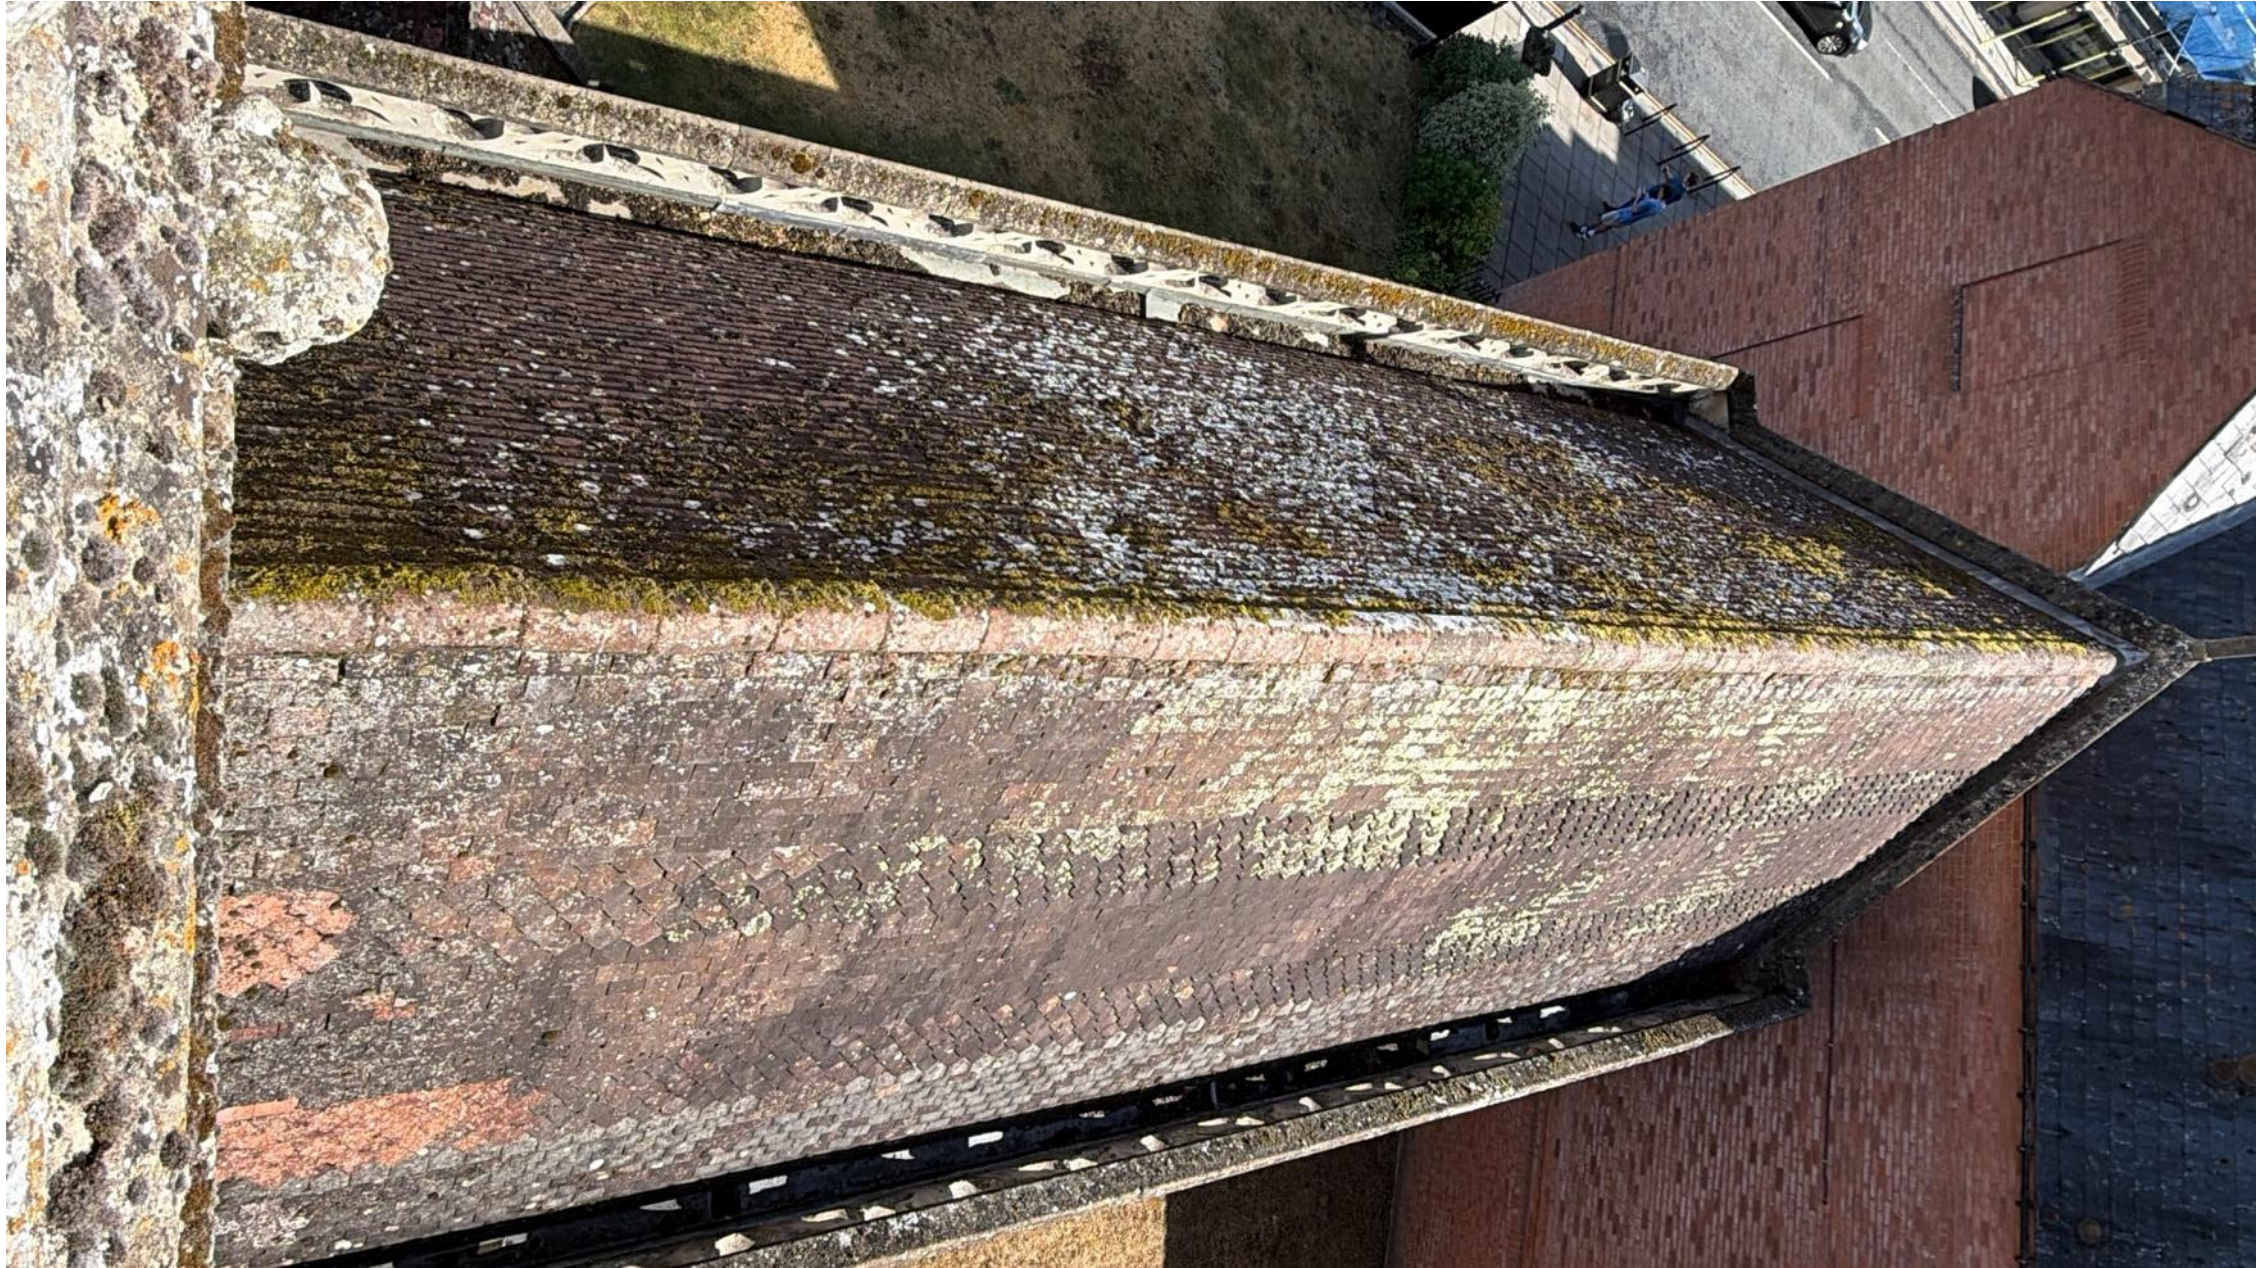
## Cleaning of moss and lichen
