An illustration of the Chapel dating to shortly after the Nave was rebuilt in 1855

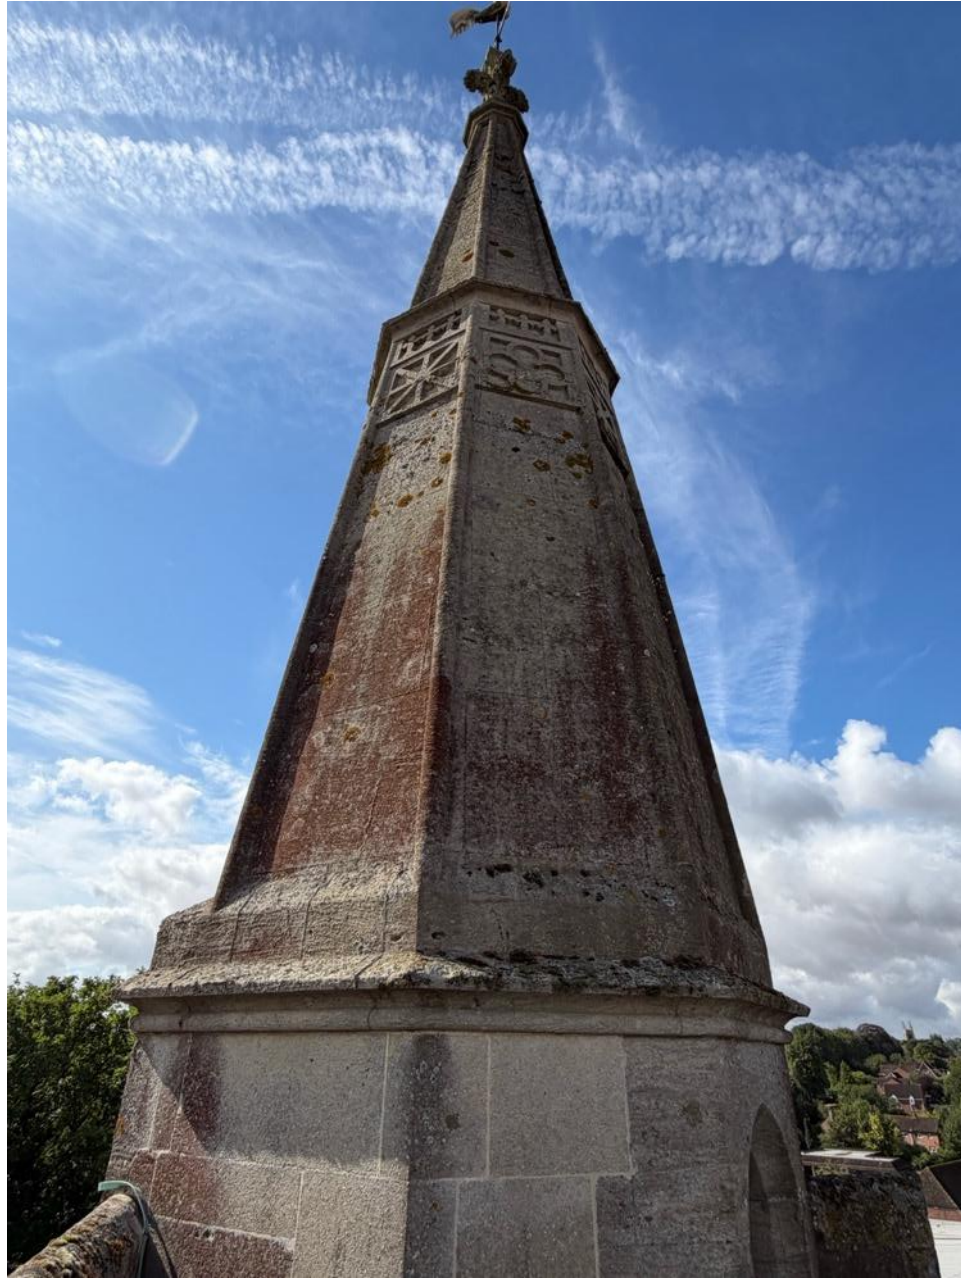
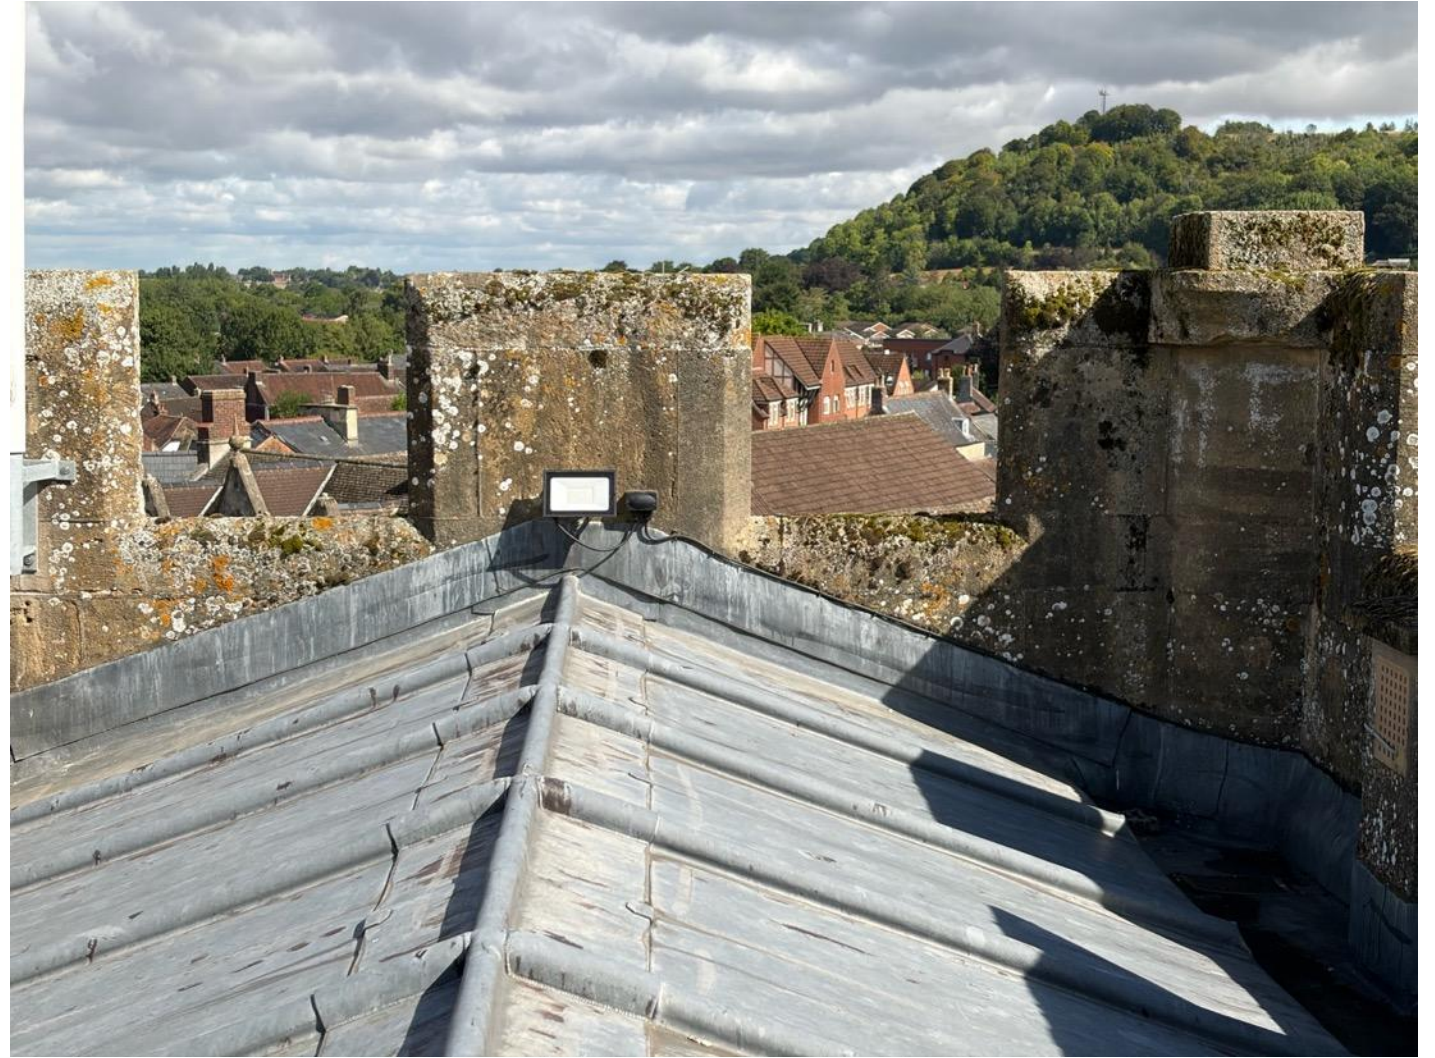
Cleaning of moss and lichen

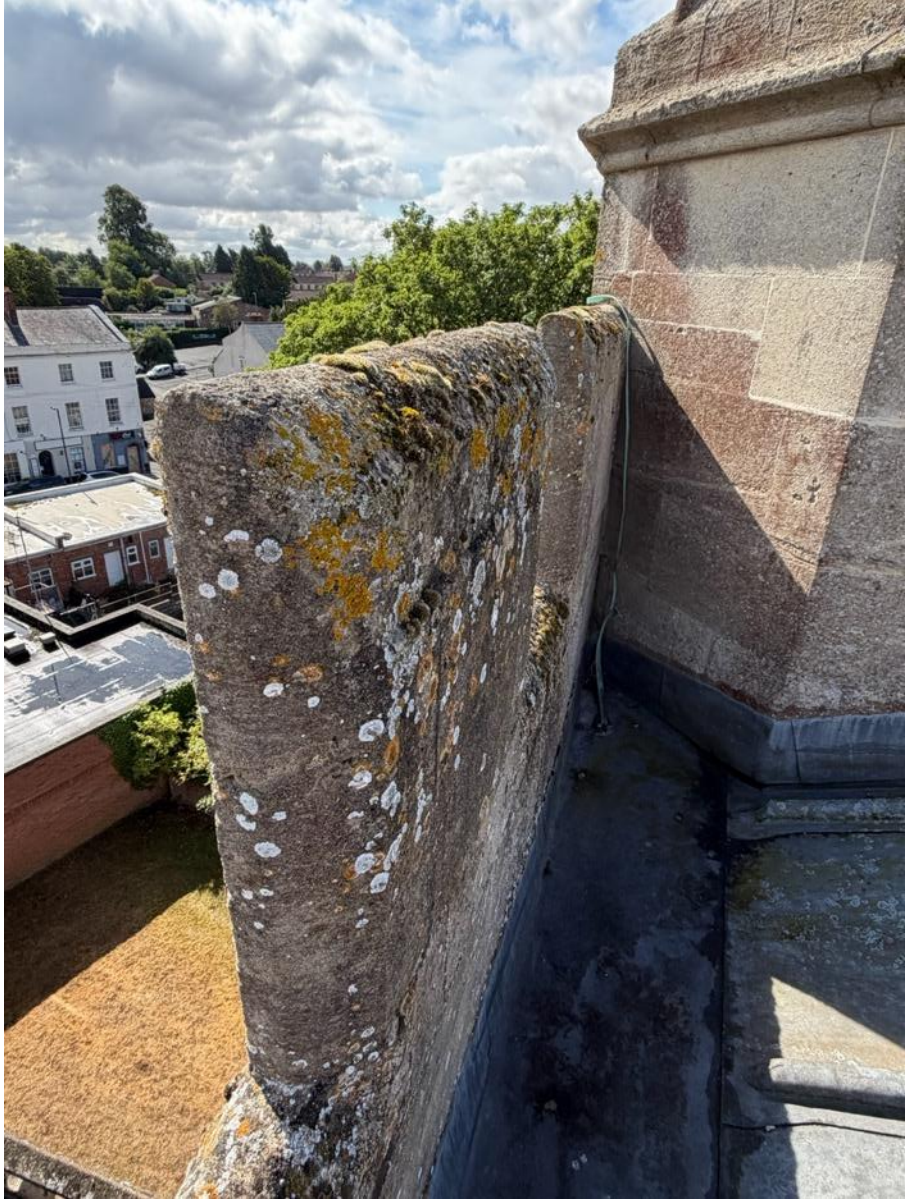
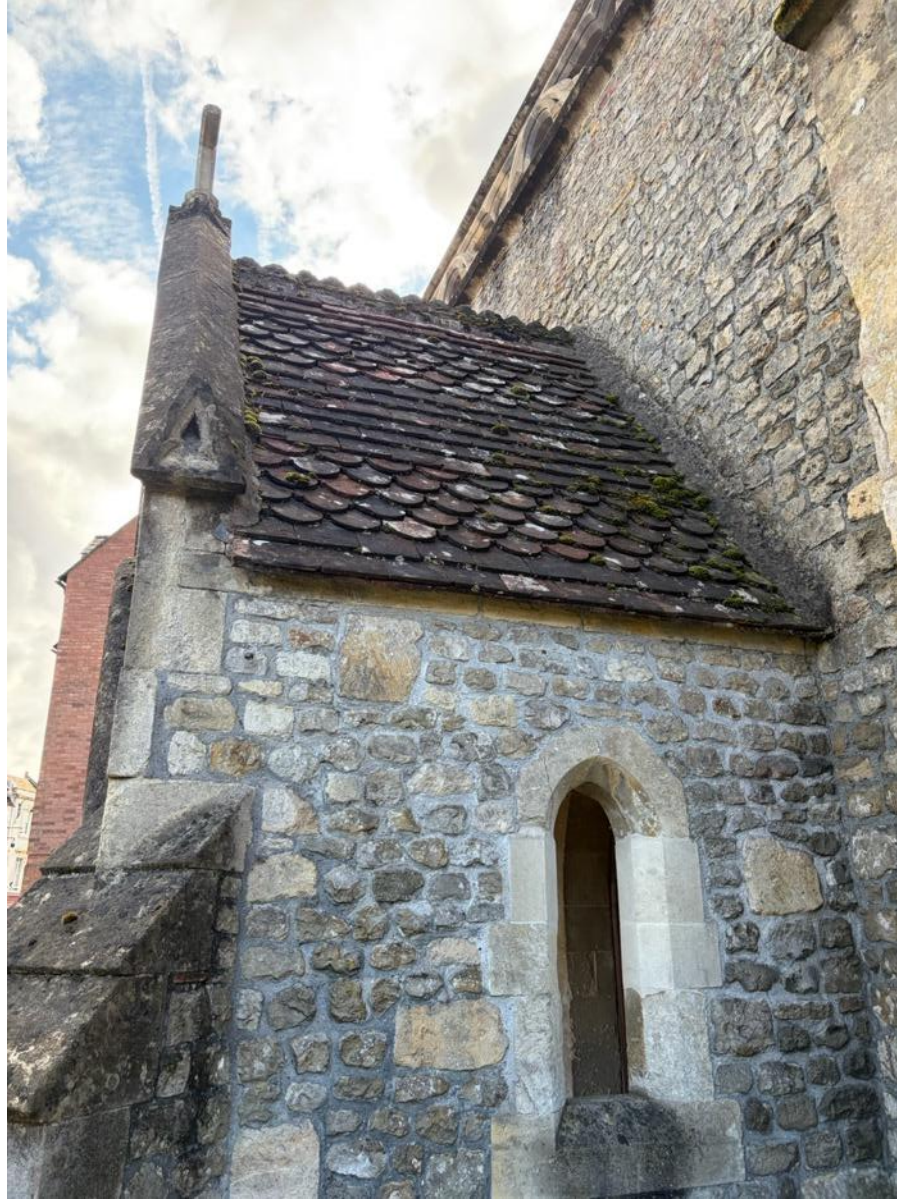
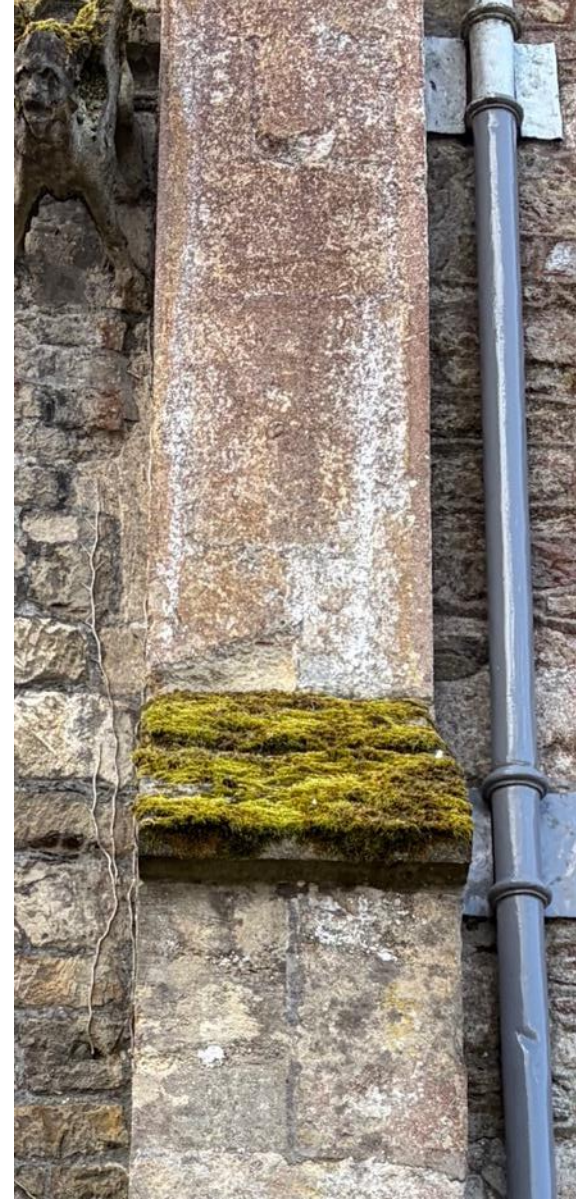
Cleaning of moss and lichen

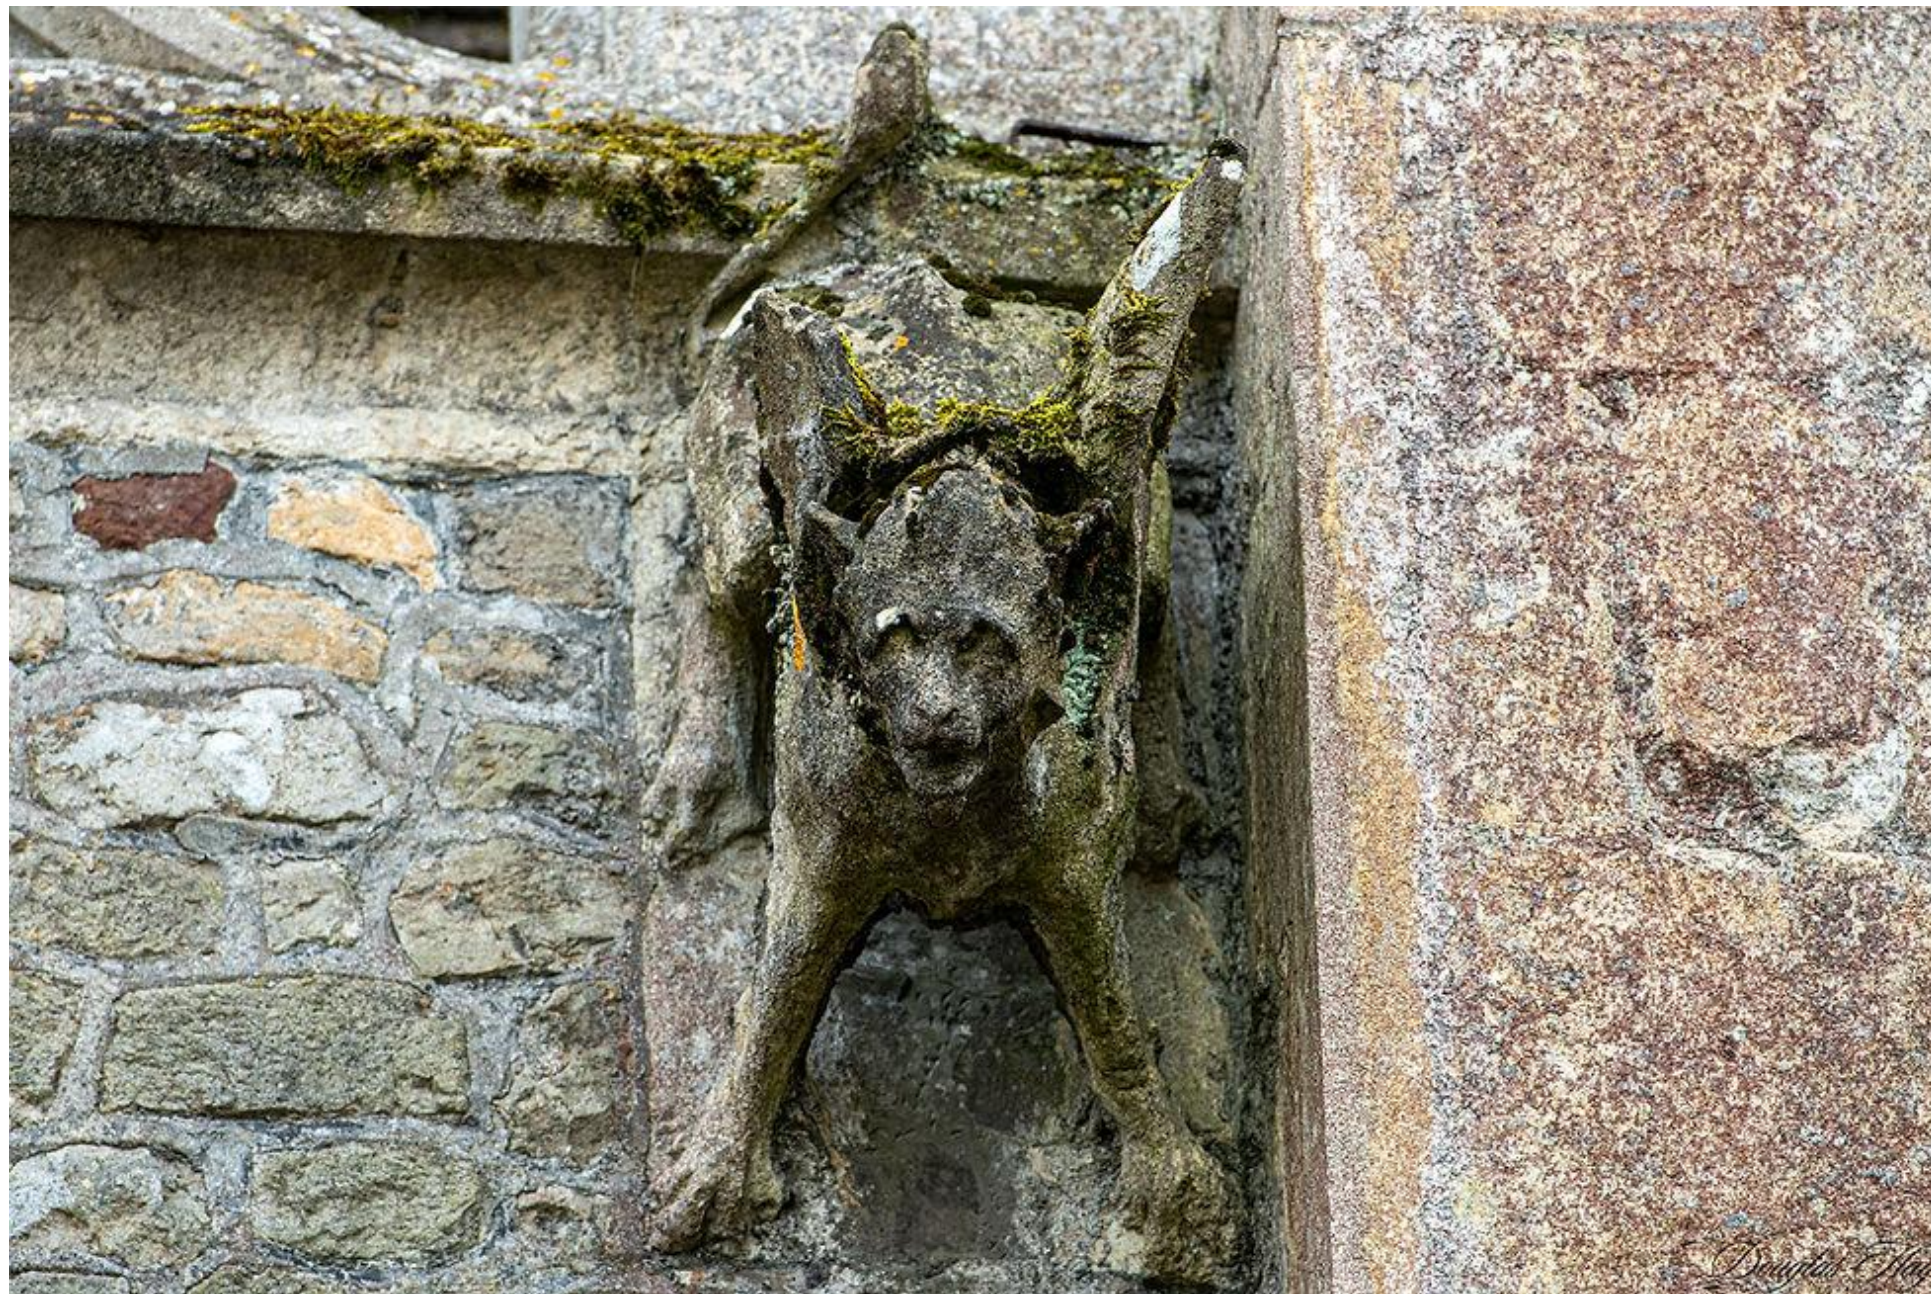
Cleaning of moss and lichen

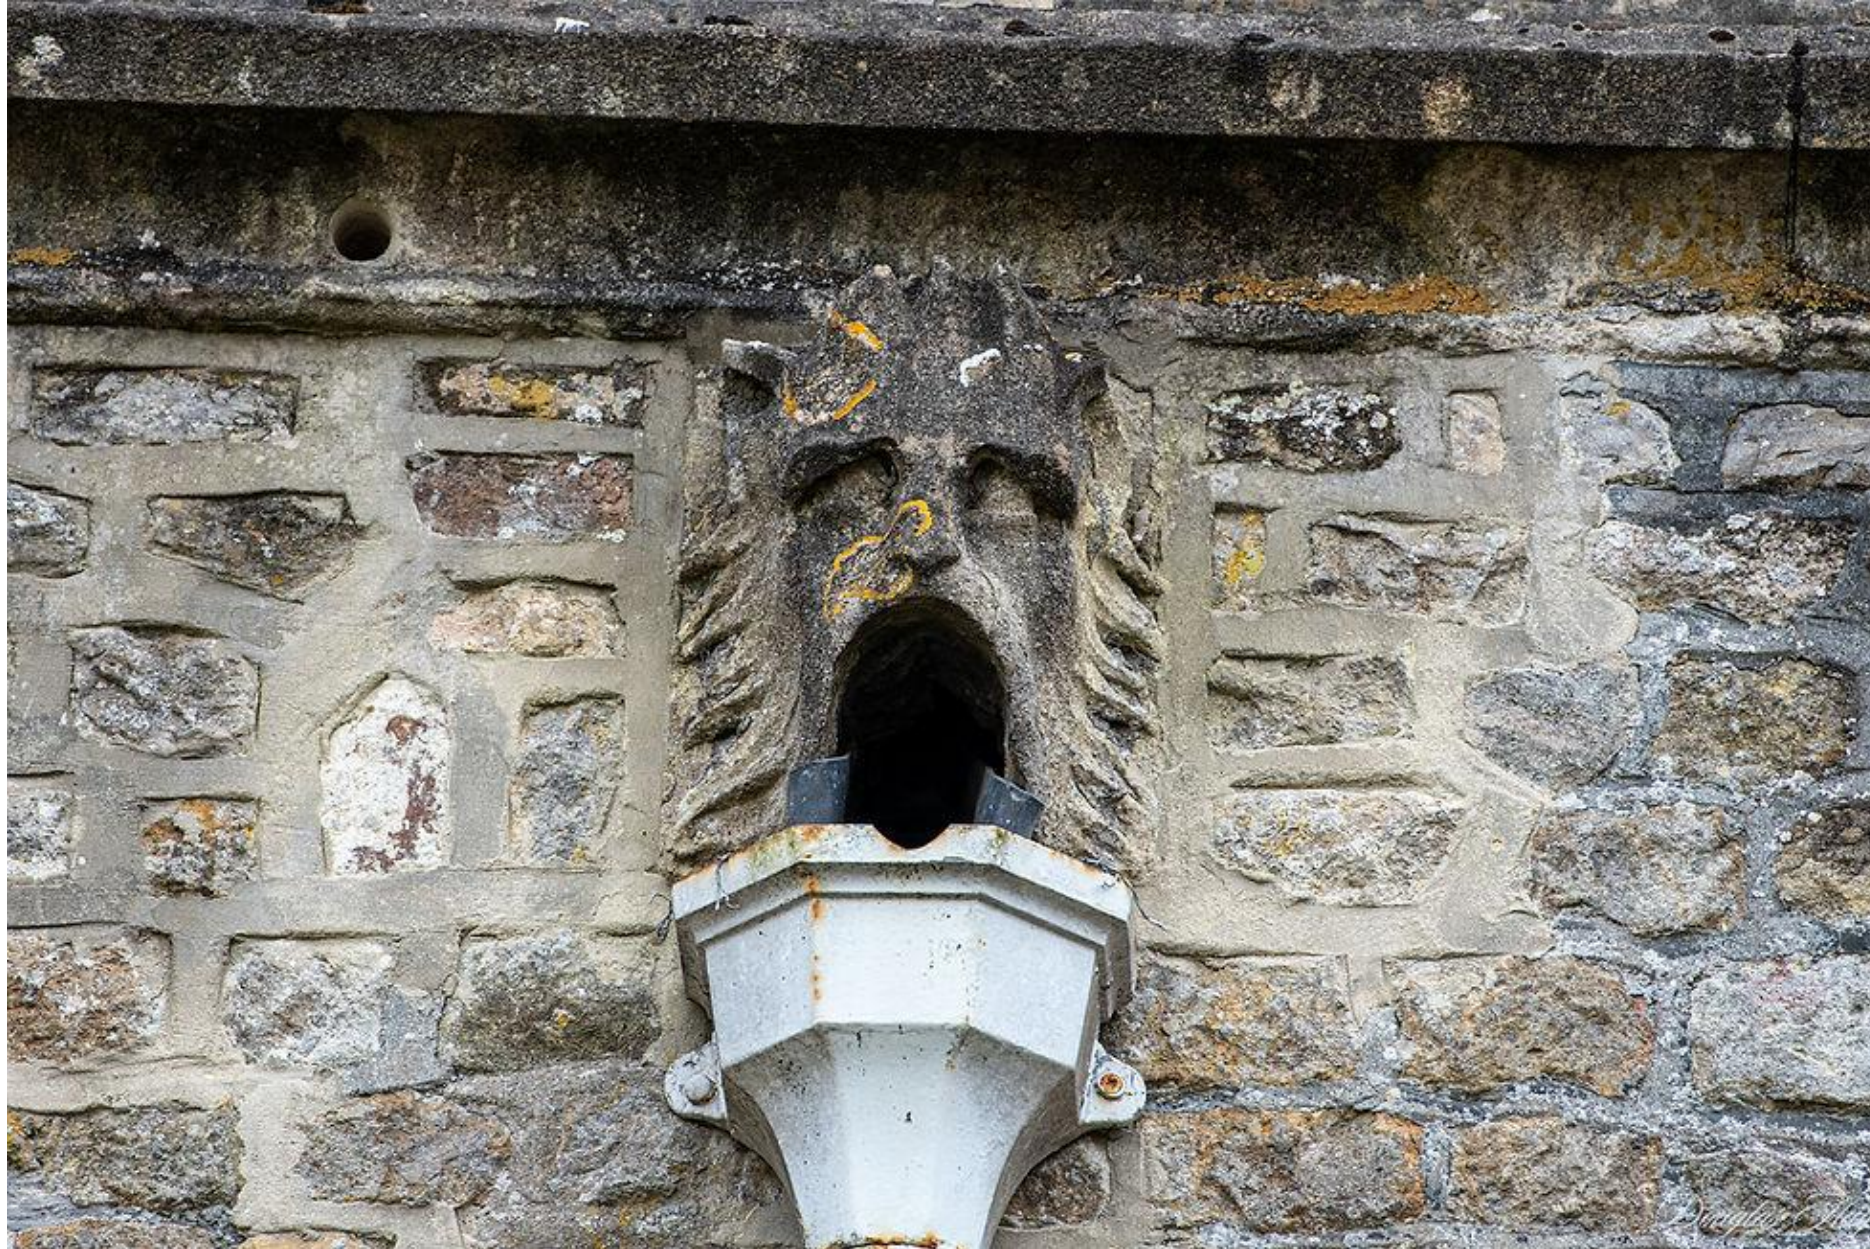
Cleaning of moss and lichen

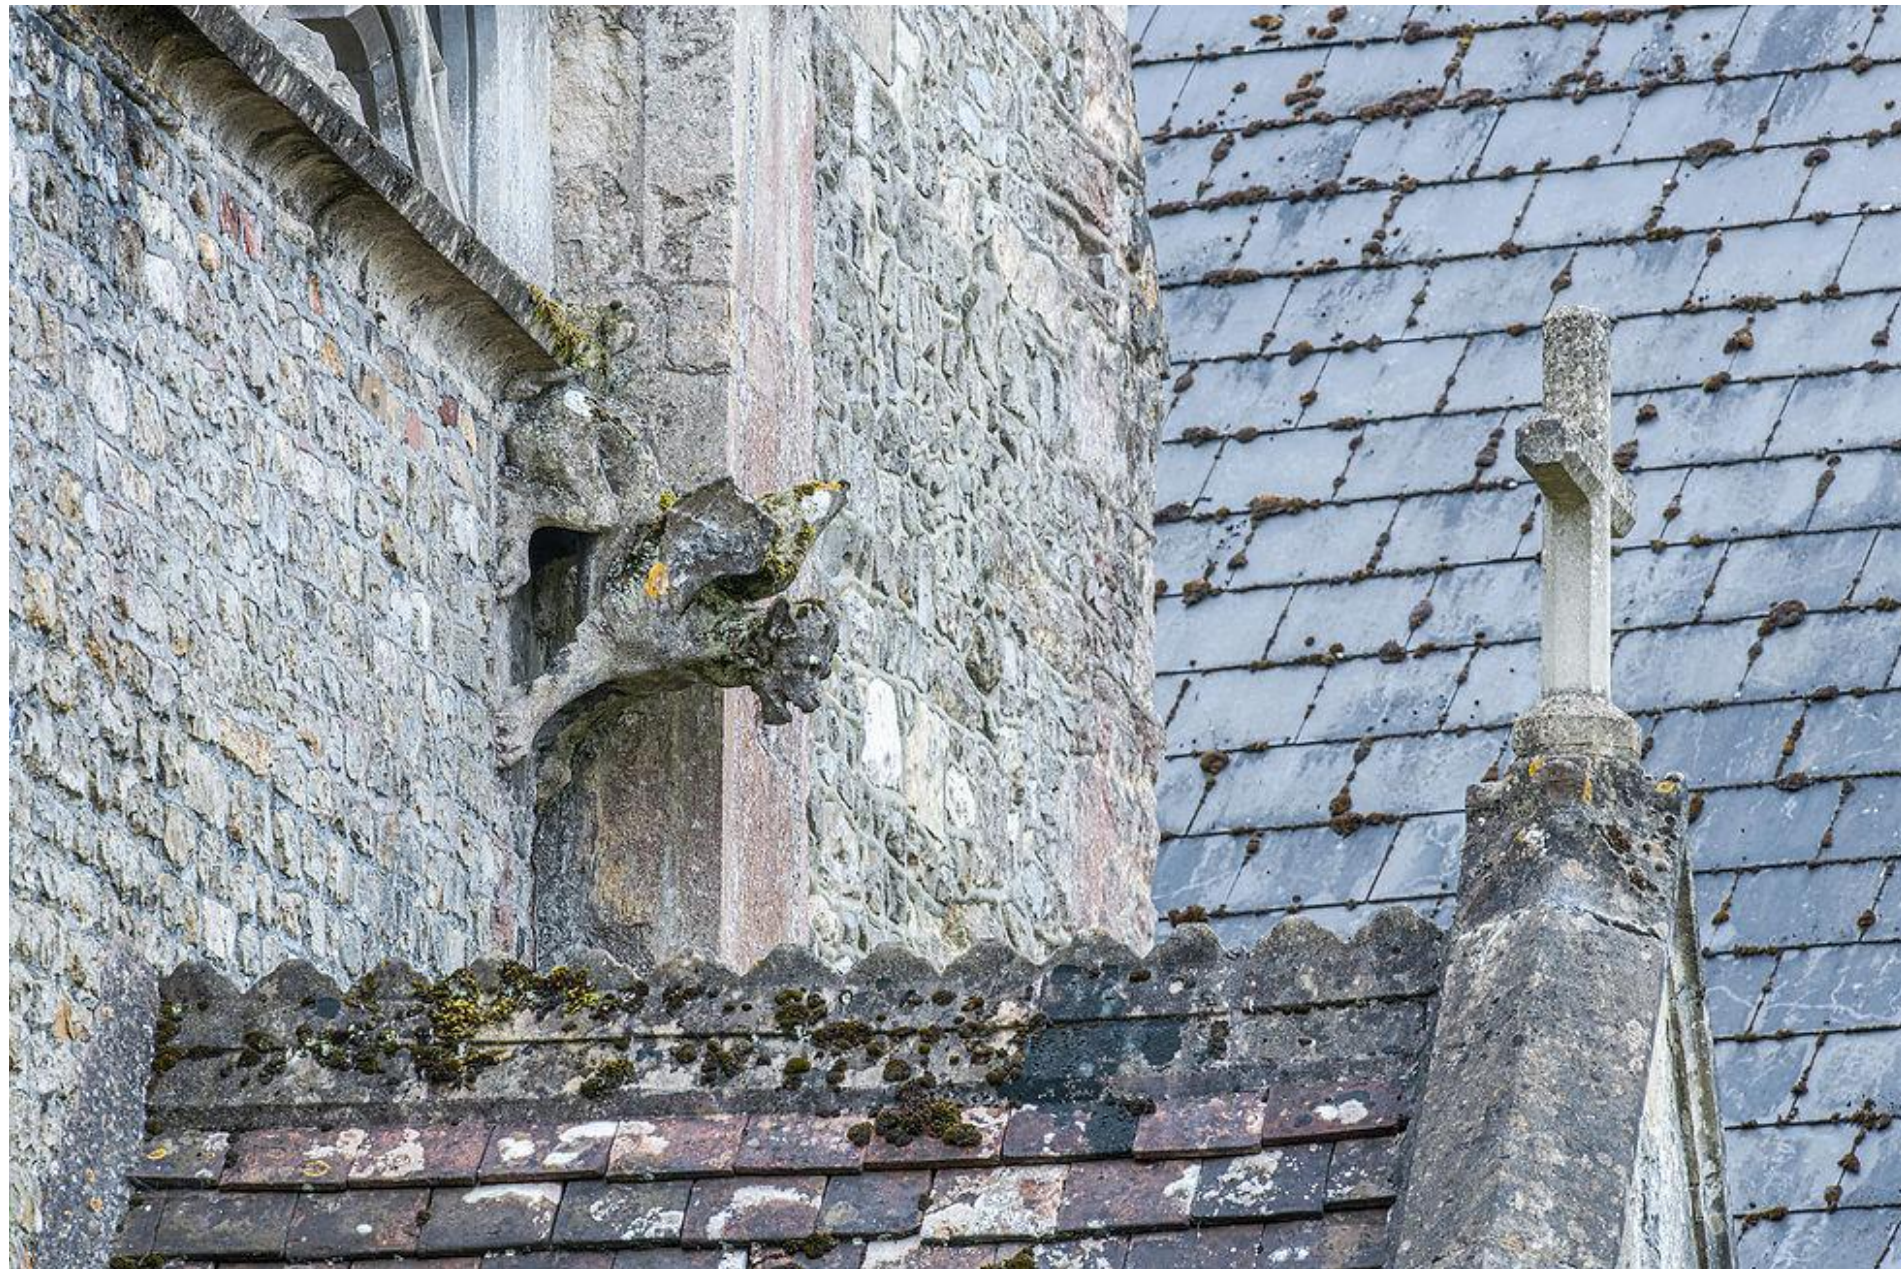
## Cleaning of moss and lichen

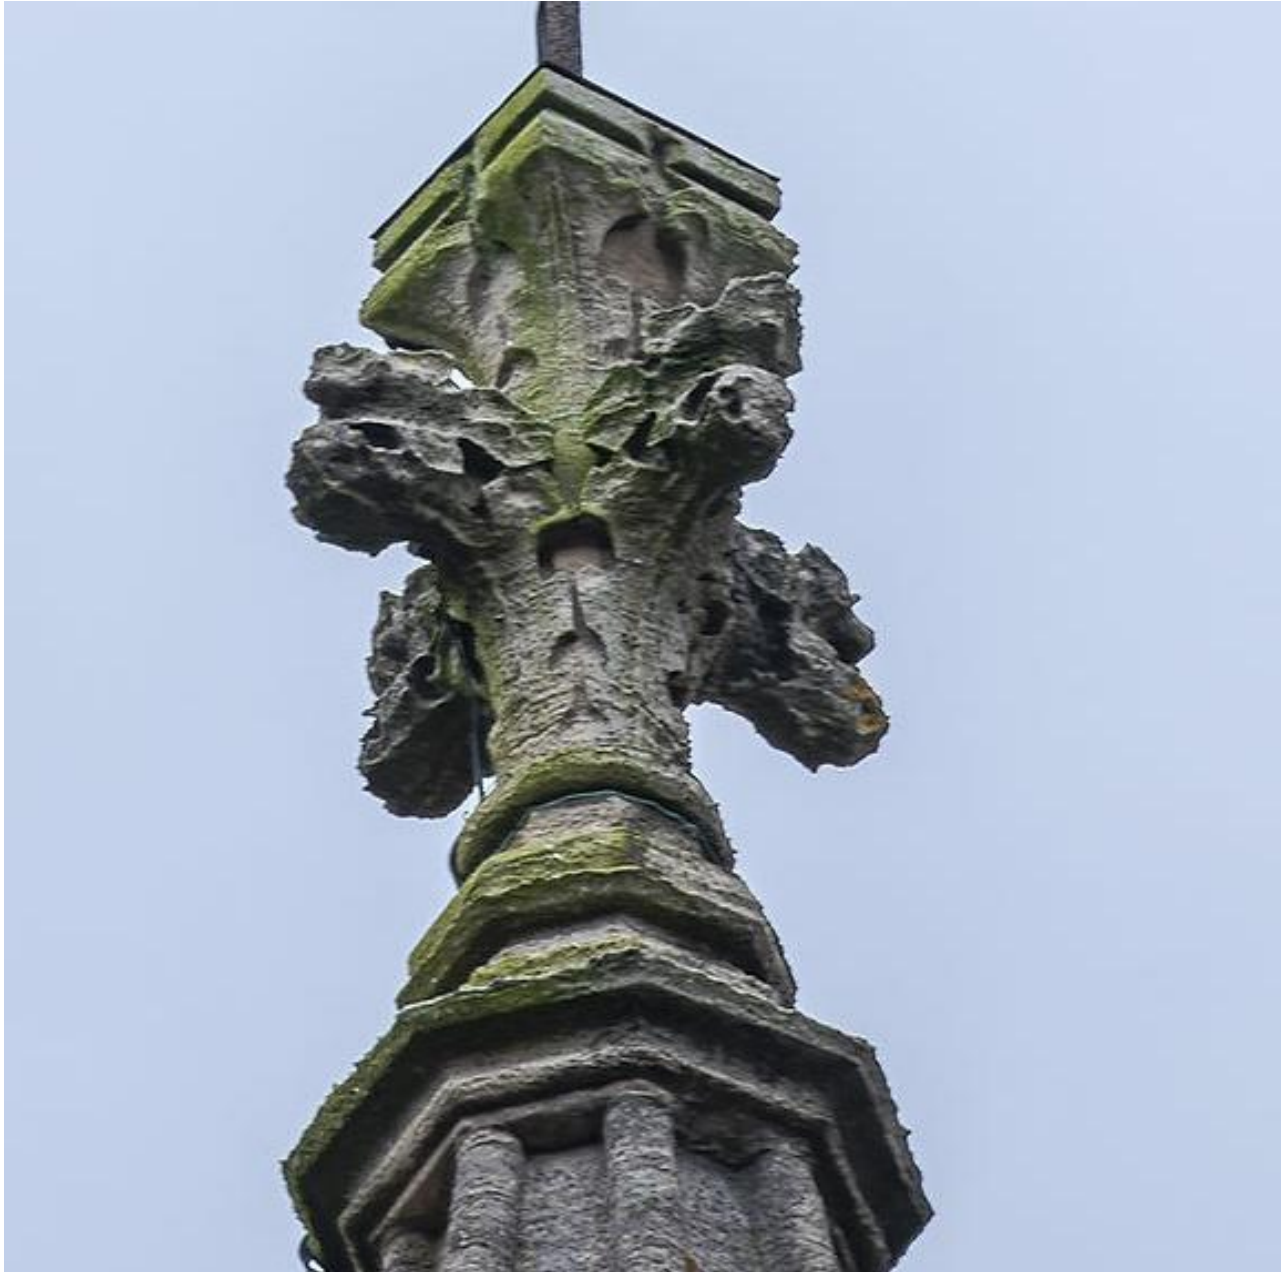
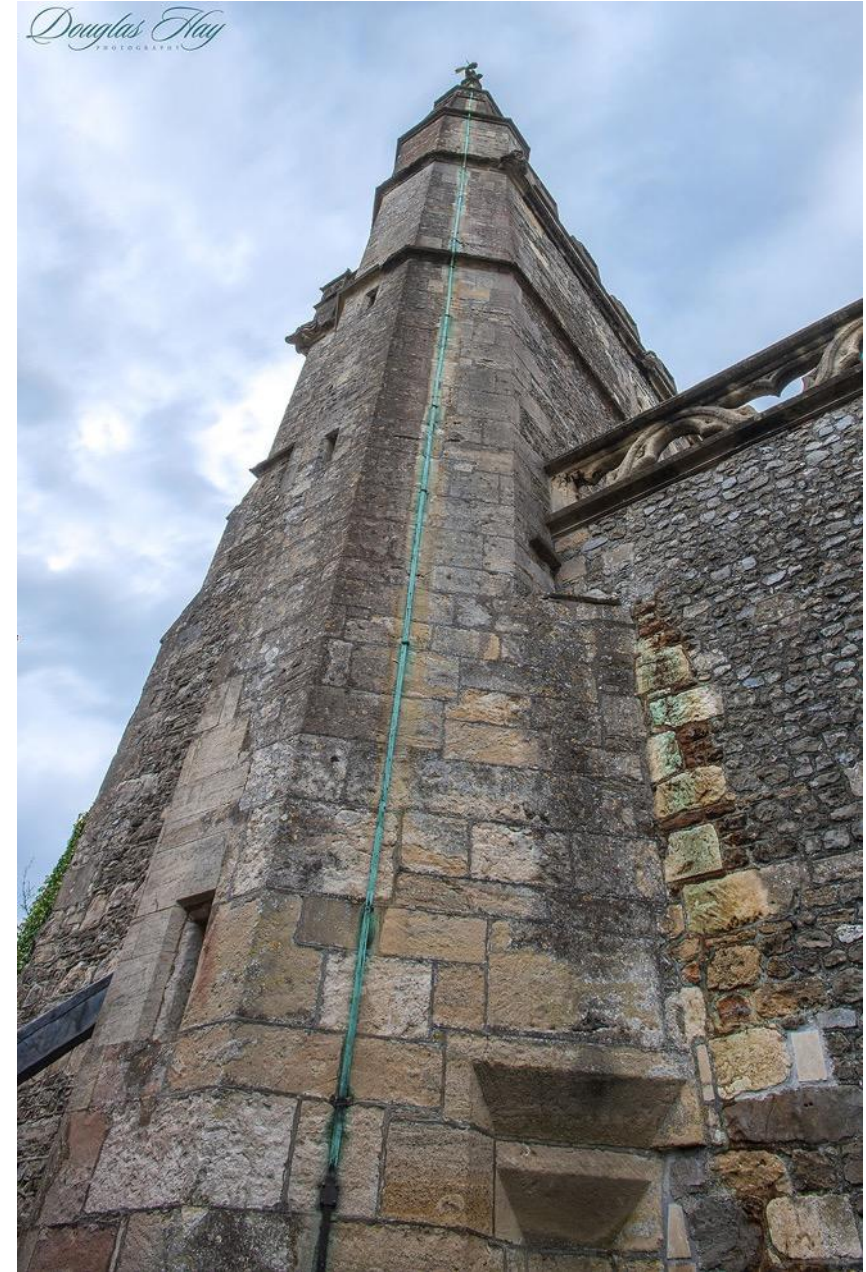
## Cleaning of moss and lichen

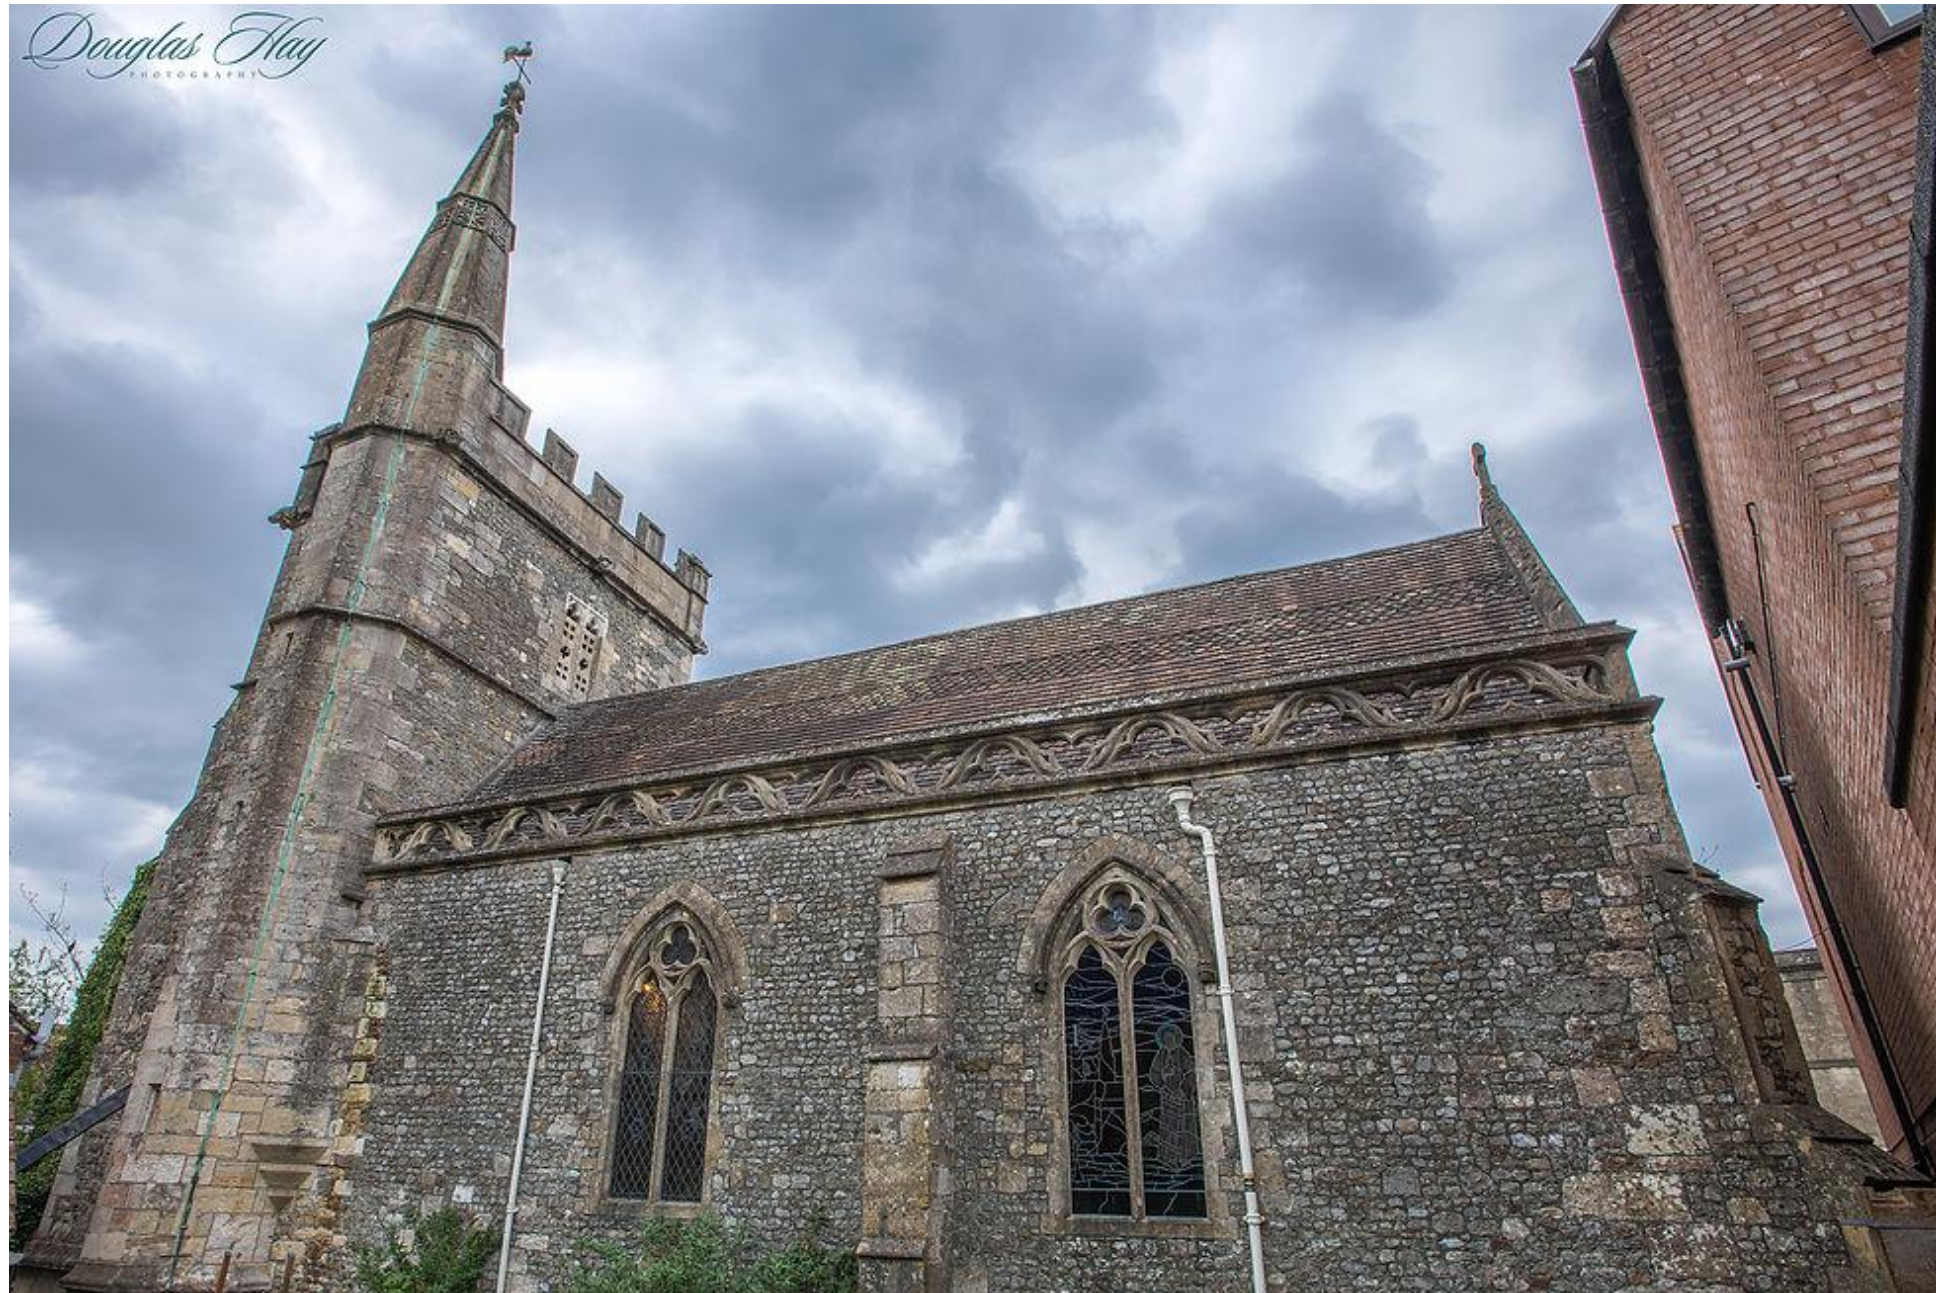
## Cleaning of moss and lichen

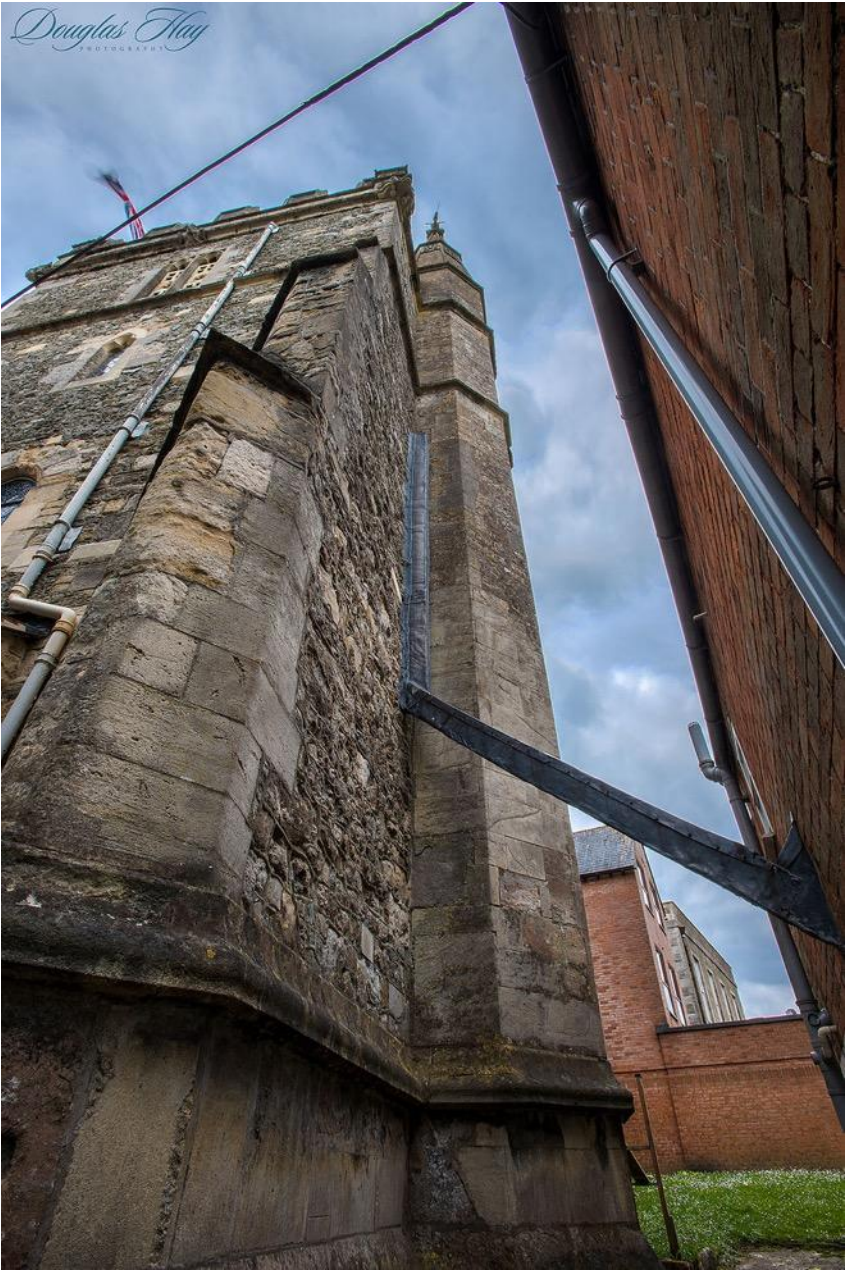
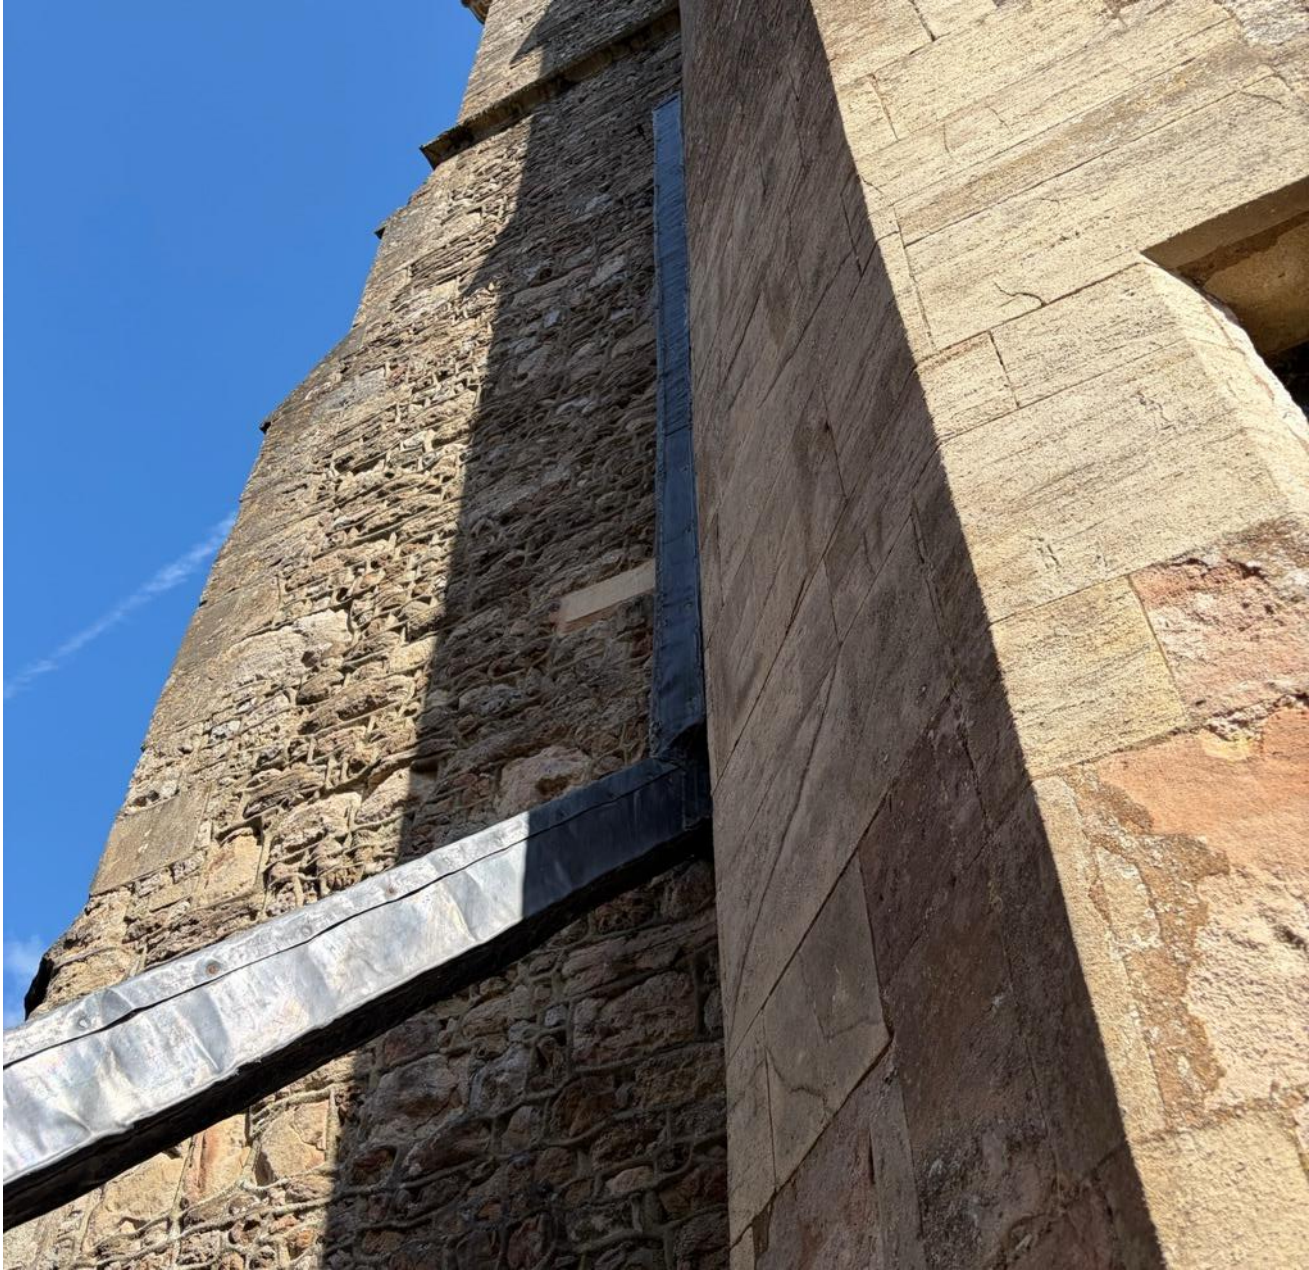
Repairs to the lead bell rope shoot

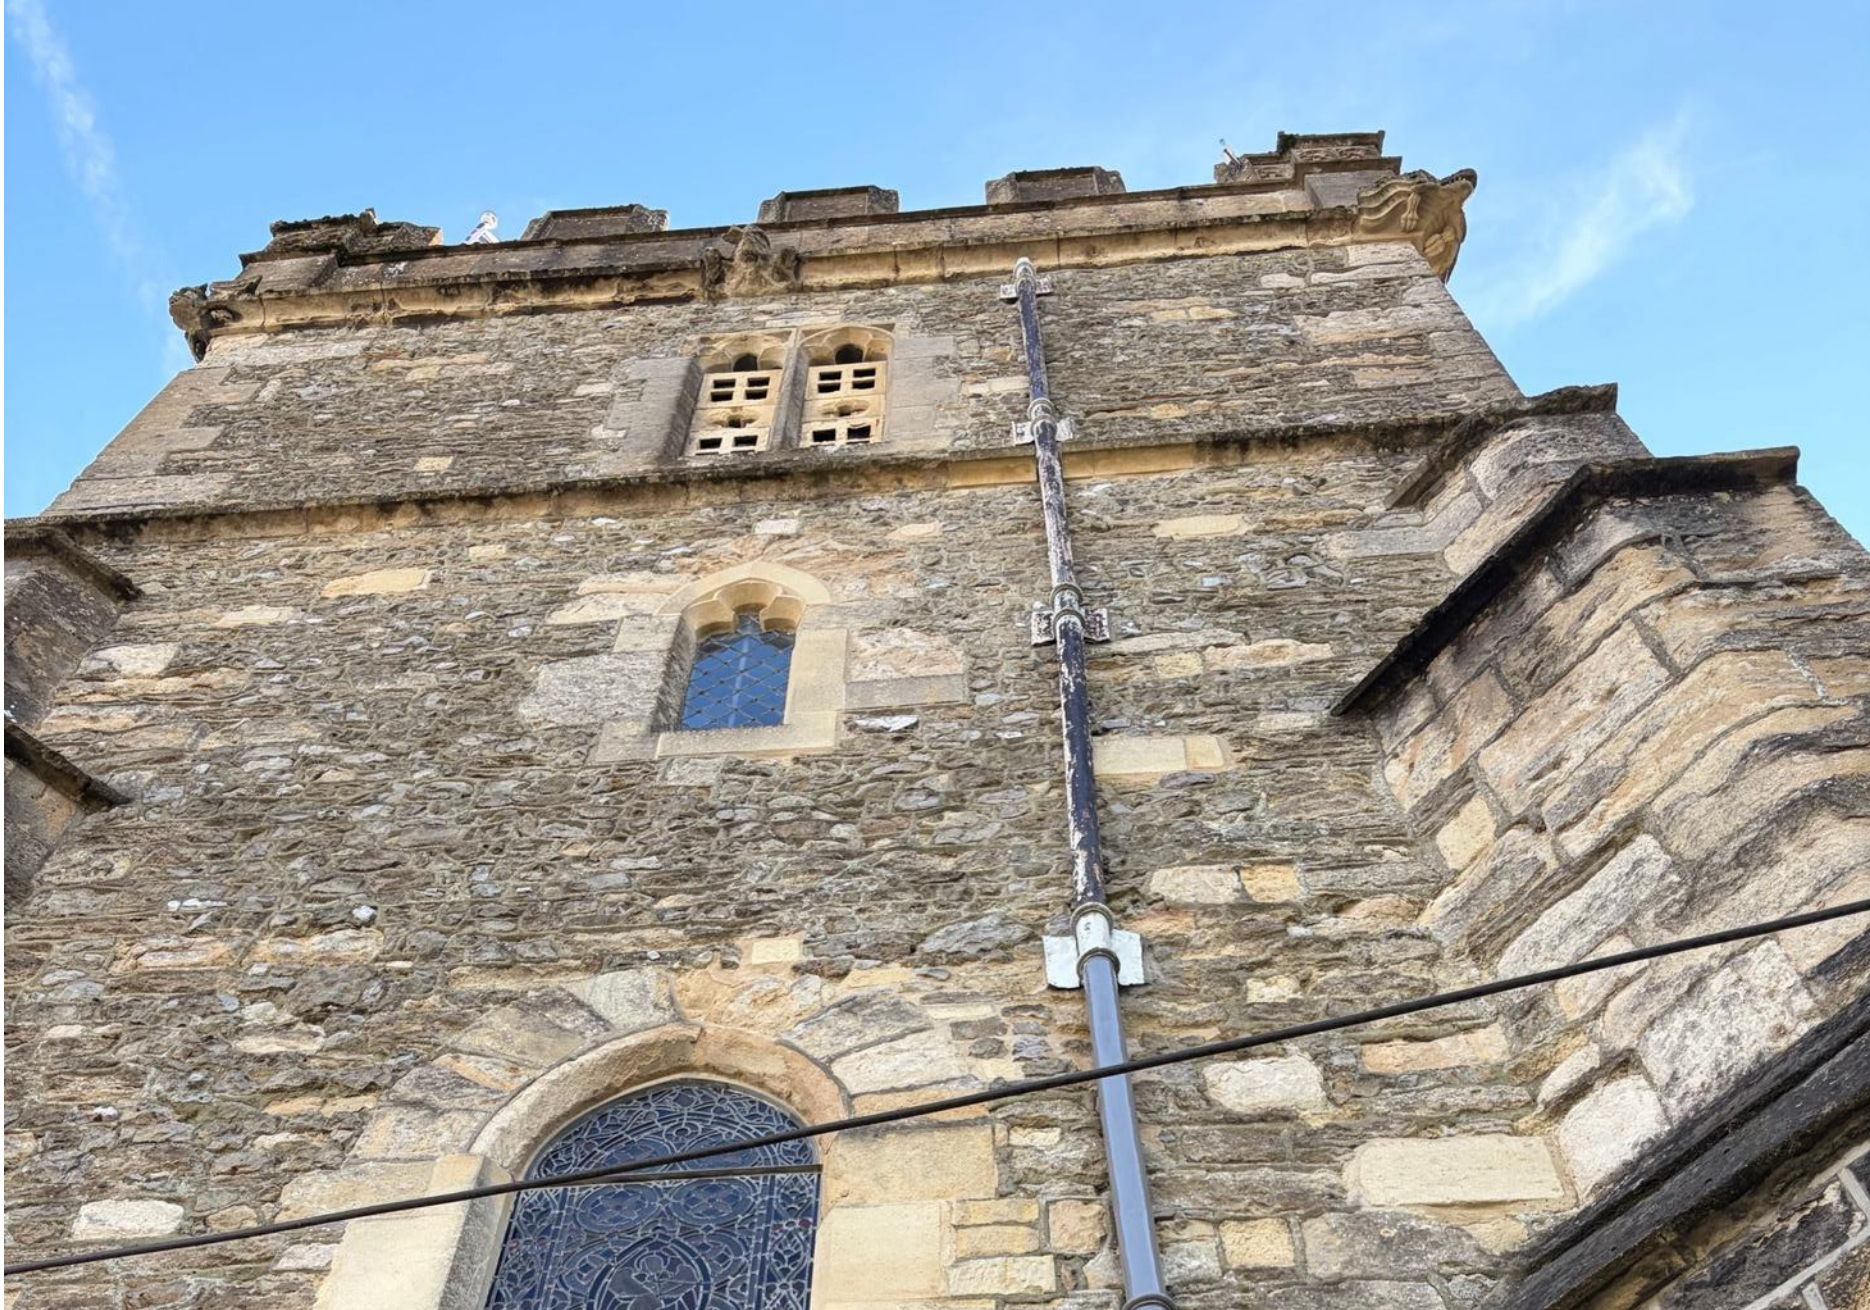
Continued repainting of the downpipes
