An illustration of the Chapel dating to shortly after the Nave was rebuilt in 1855

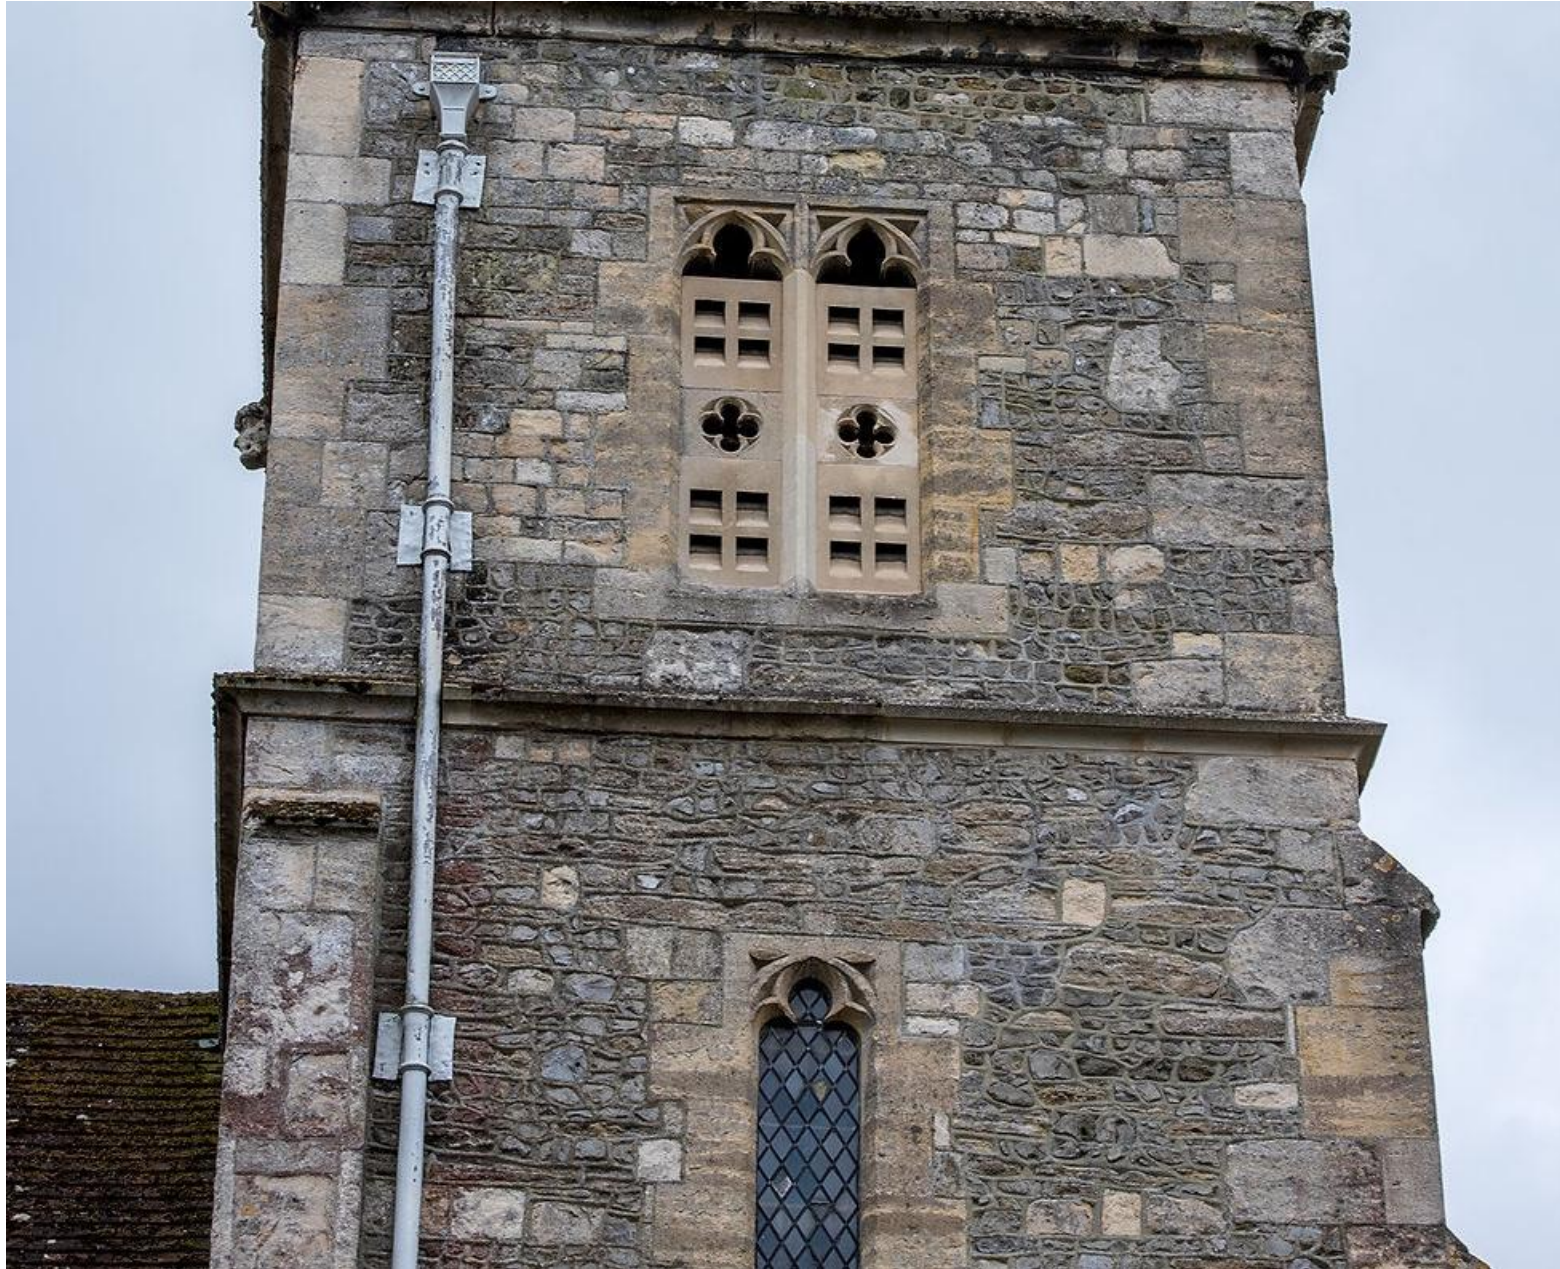
## Porch Gutters and down pipes

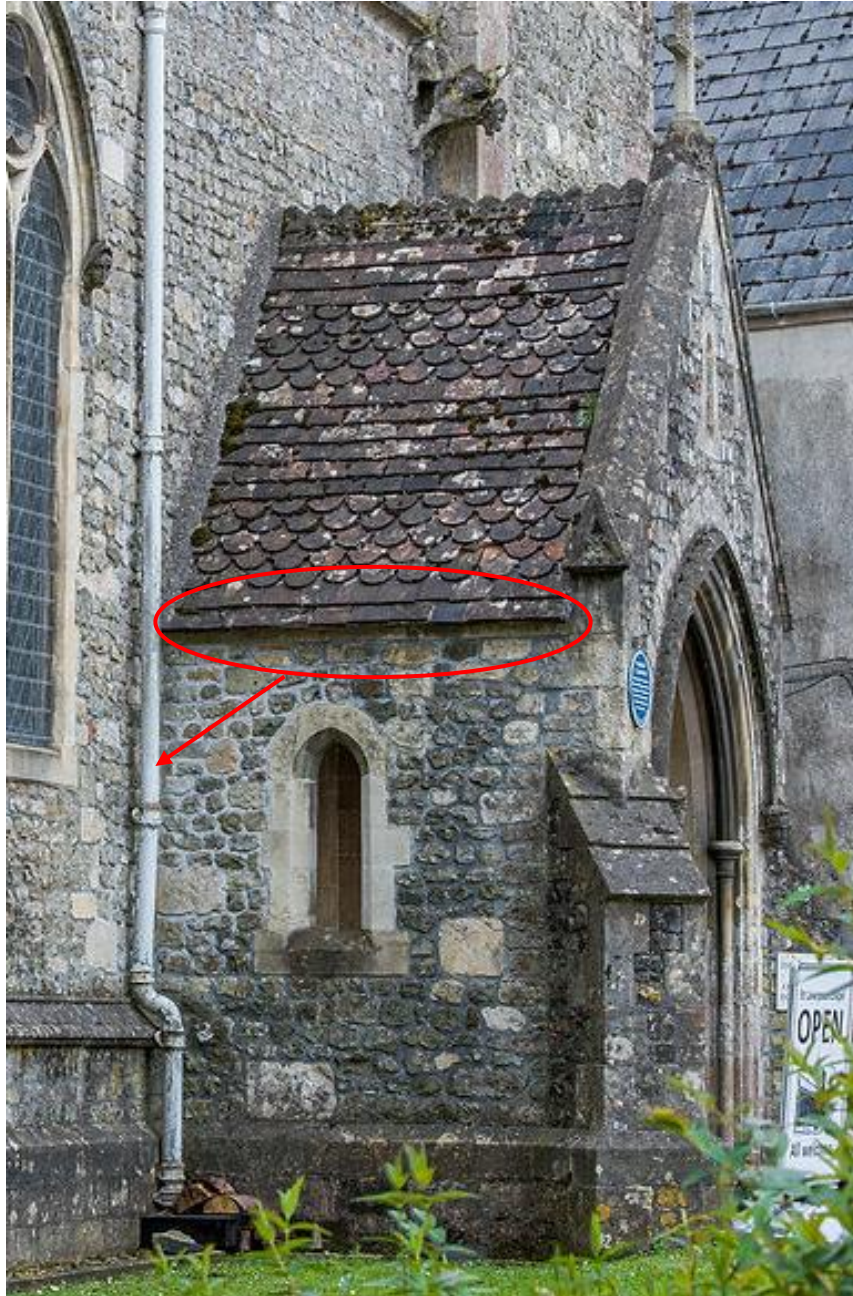
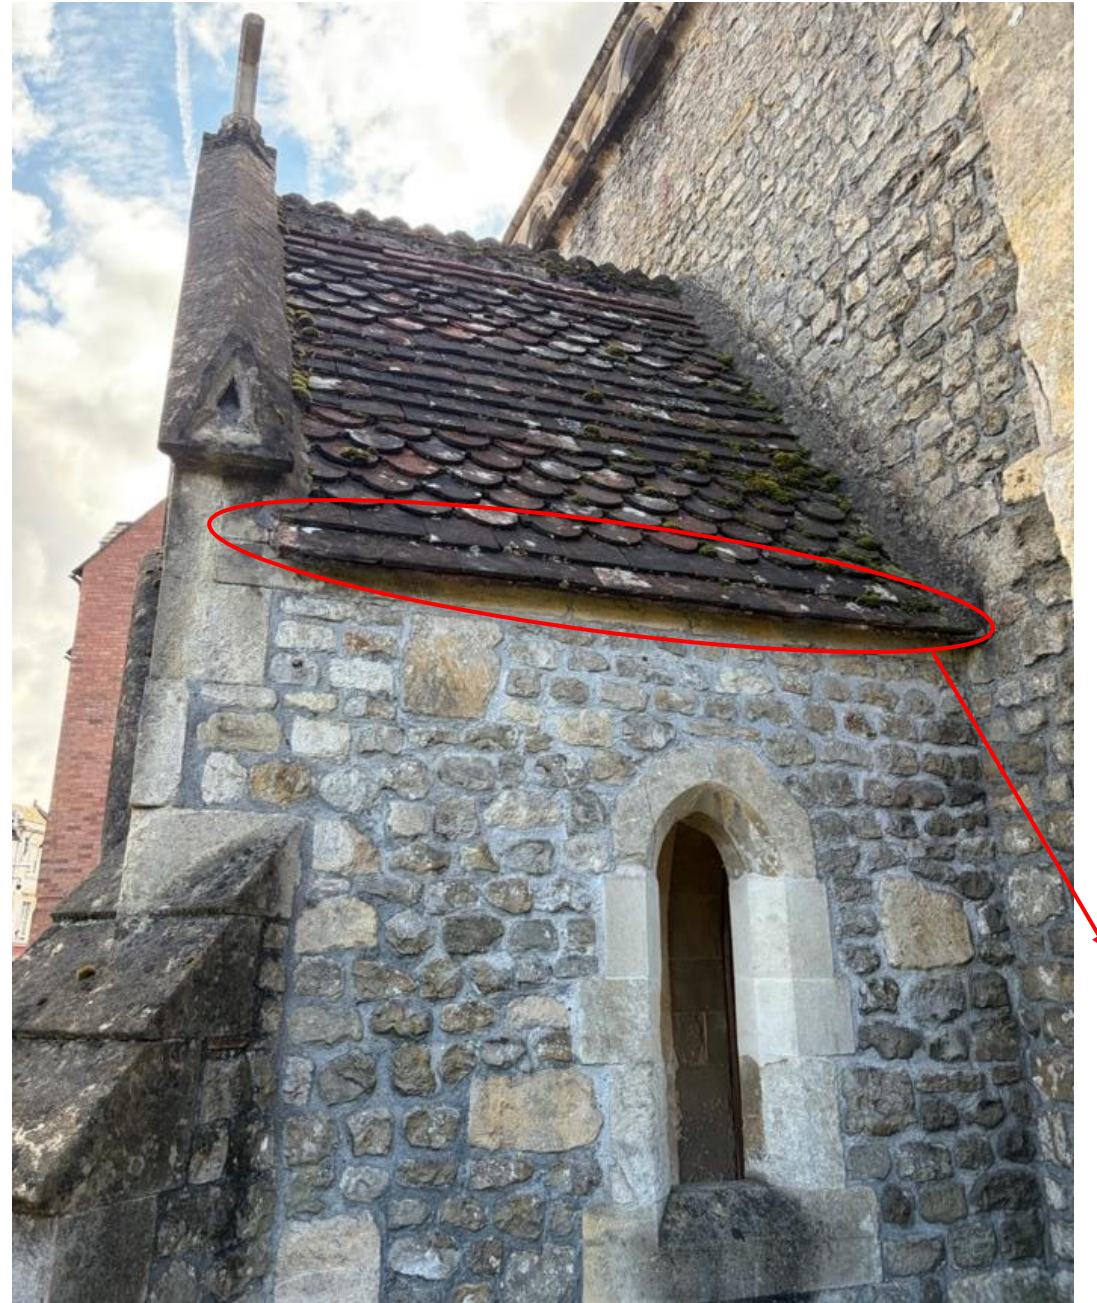
New porch  
gutters  
connect to the  
cast iron Nave  
downpipes

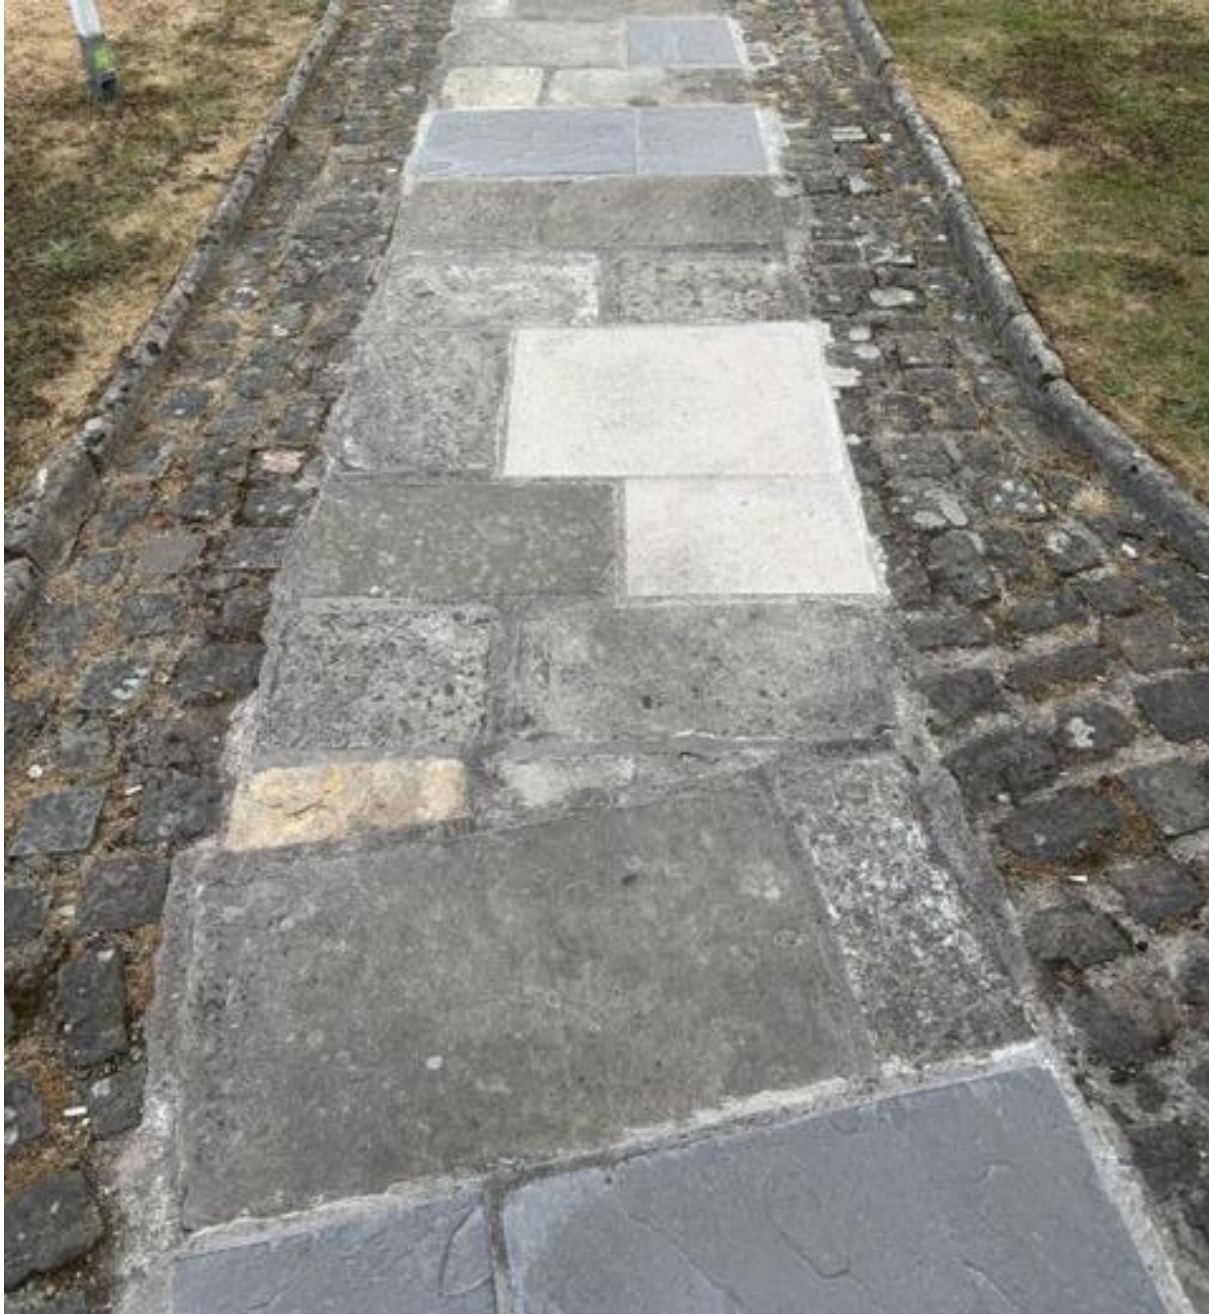
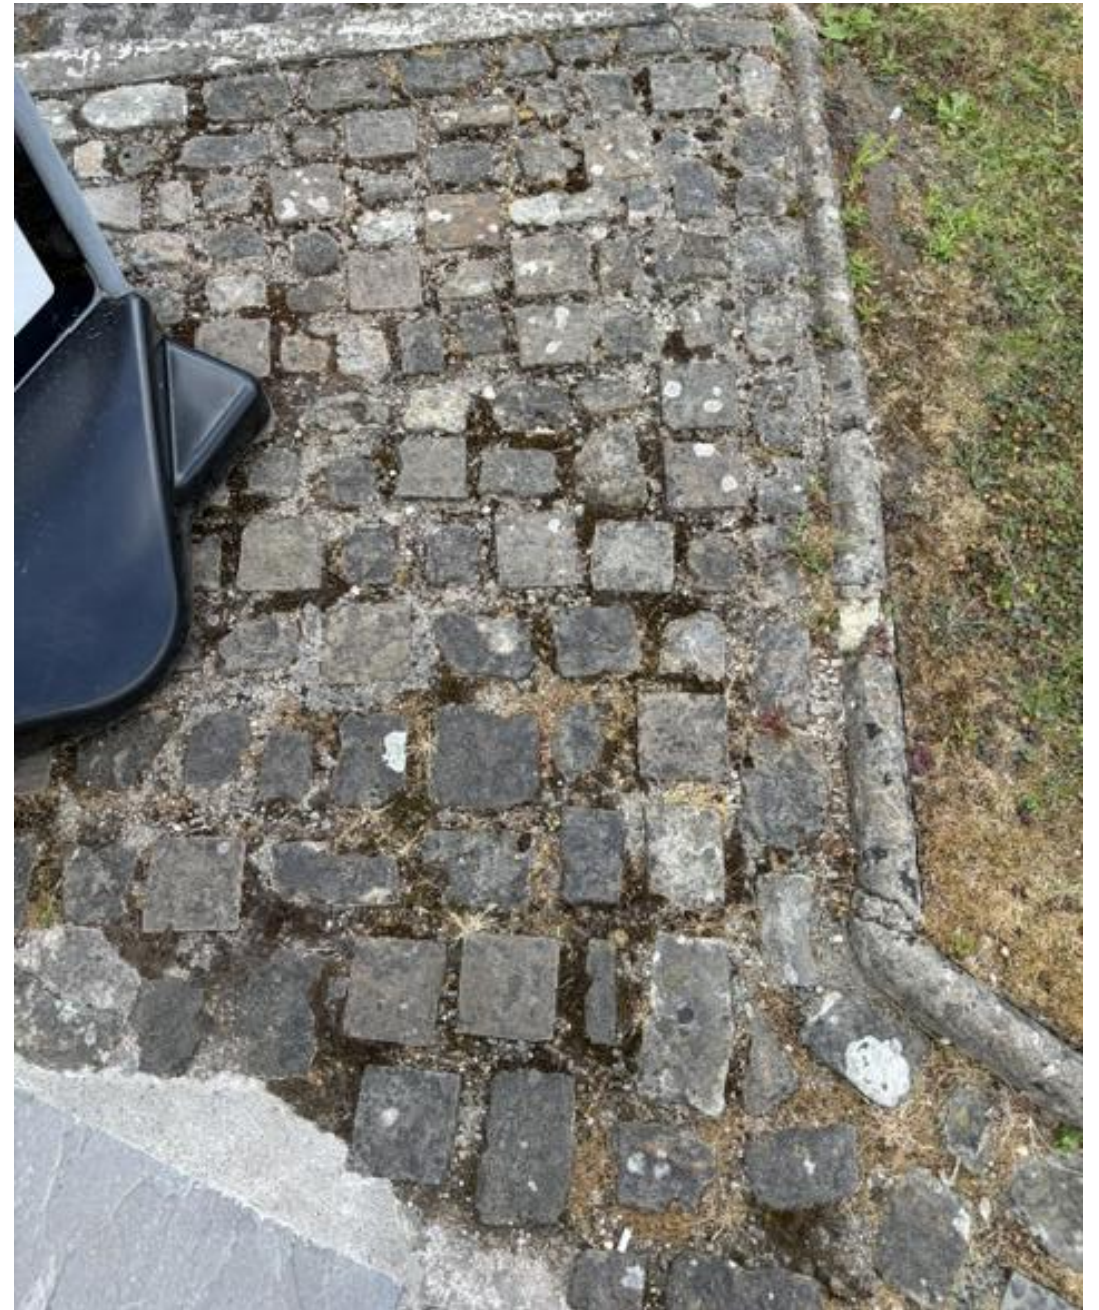
Chapel path repointing

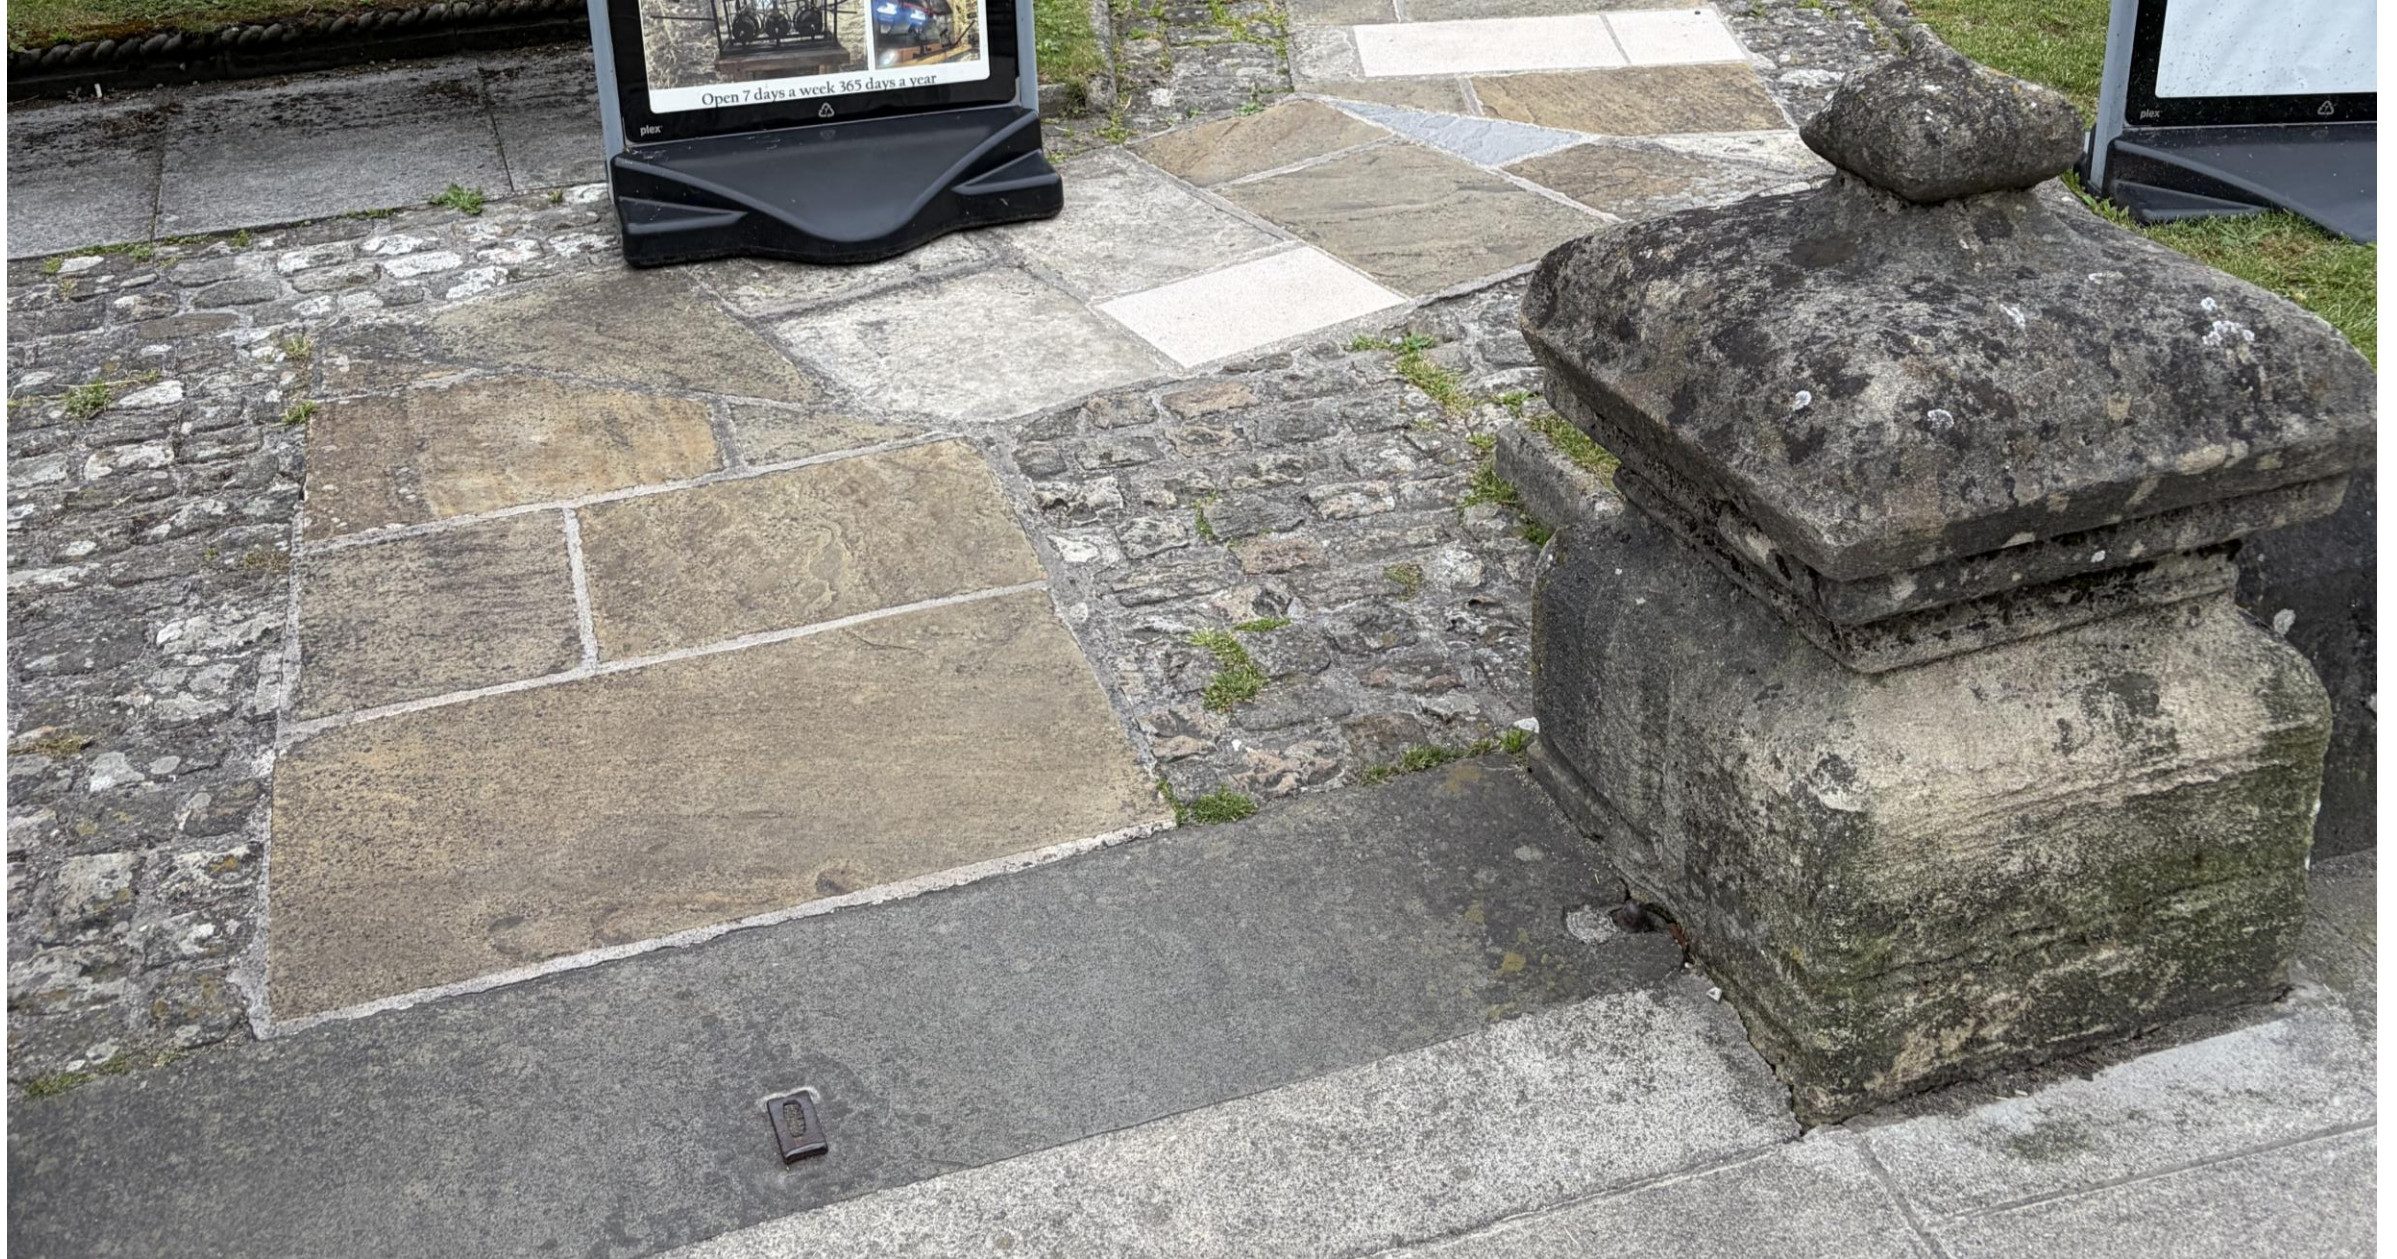
## Chapel path repointing

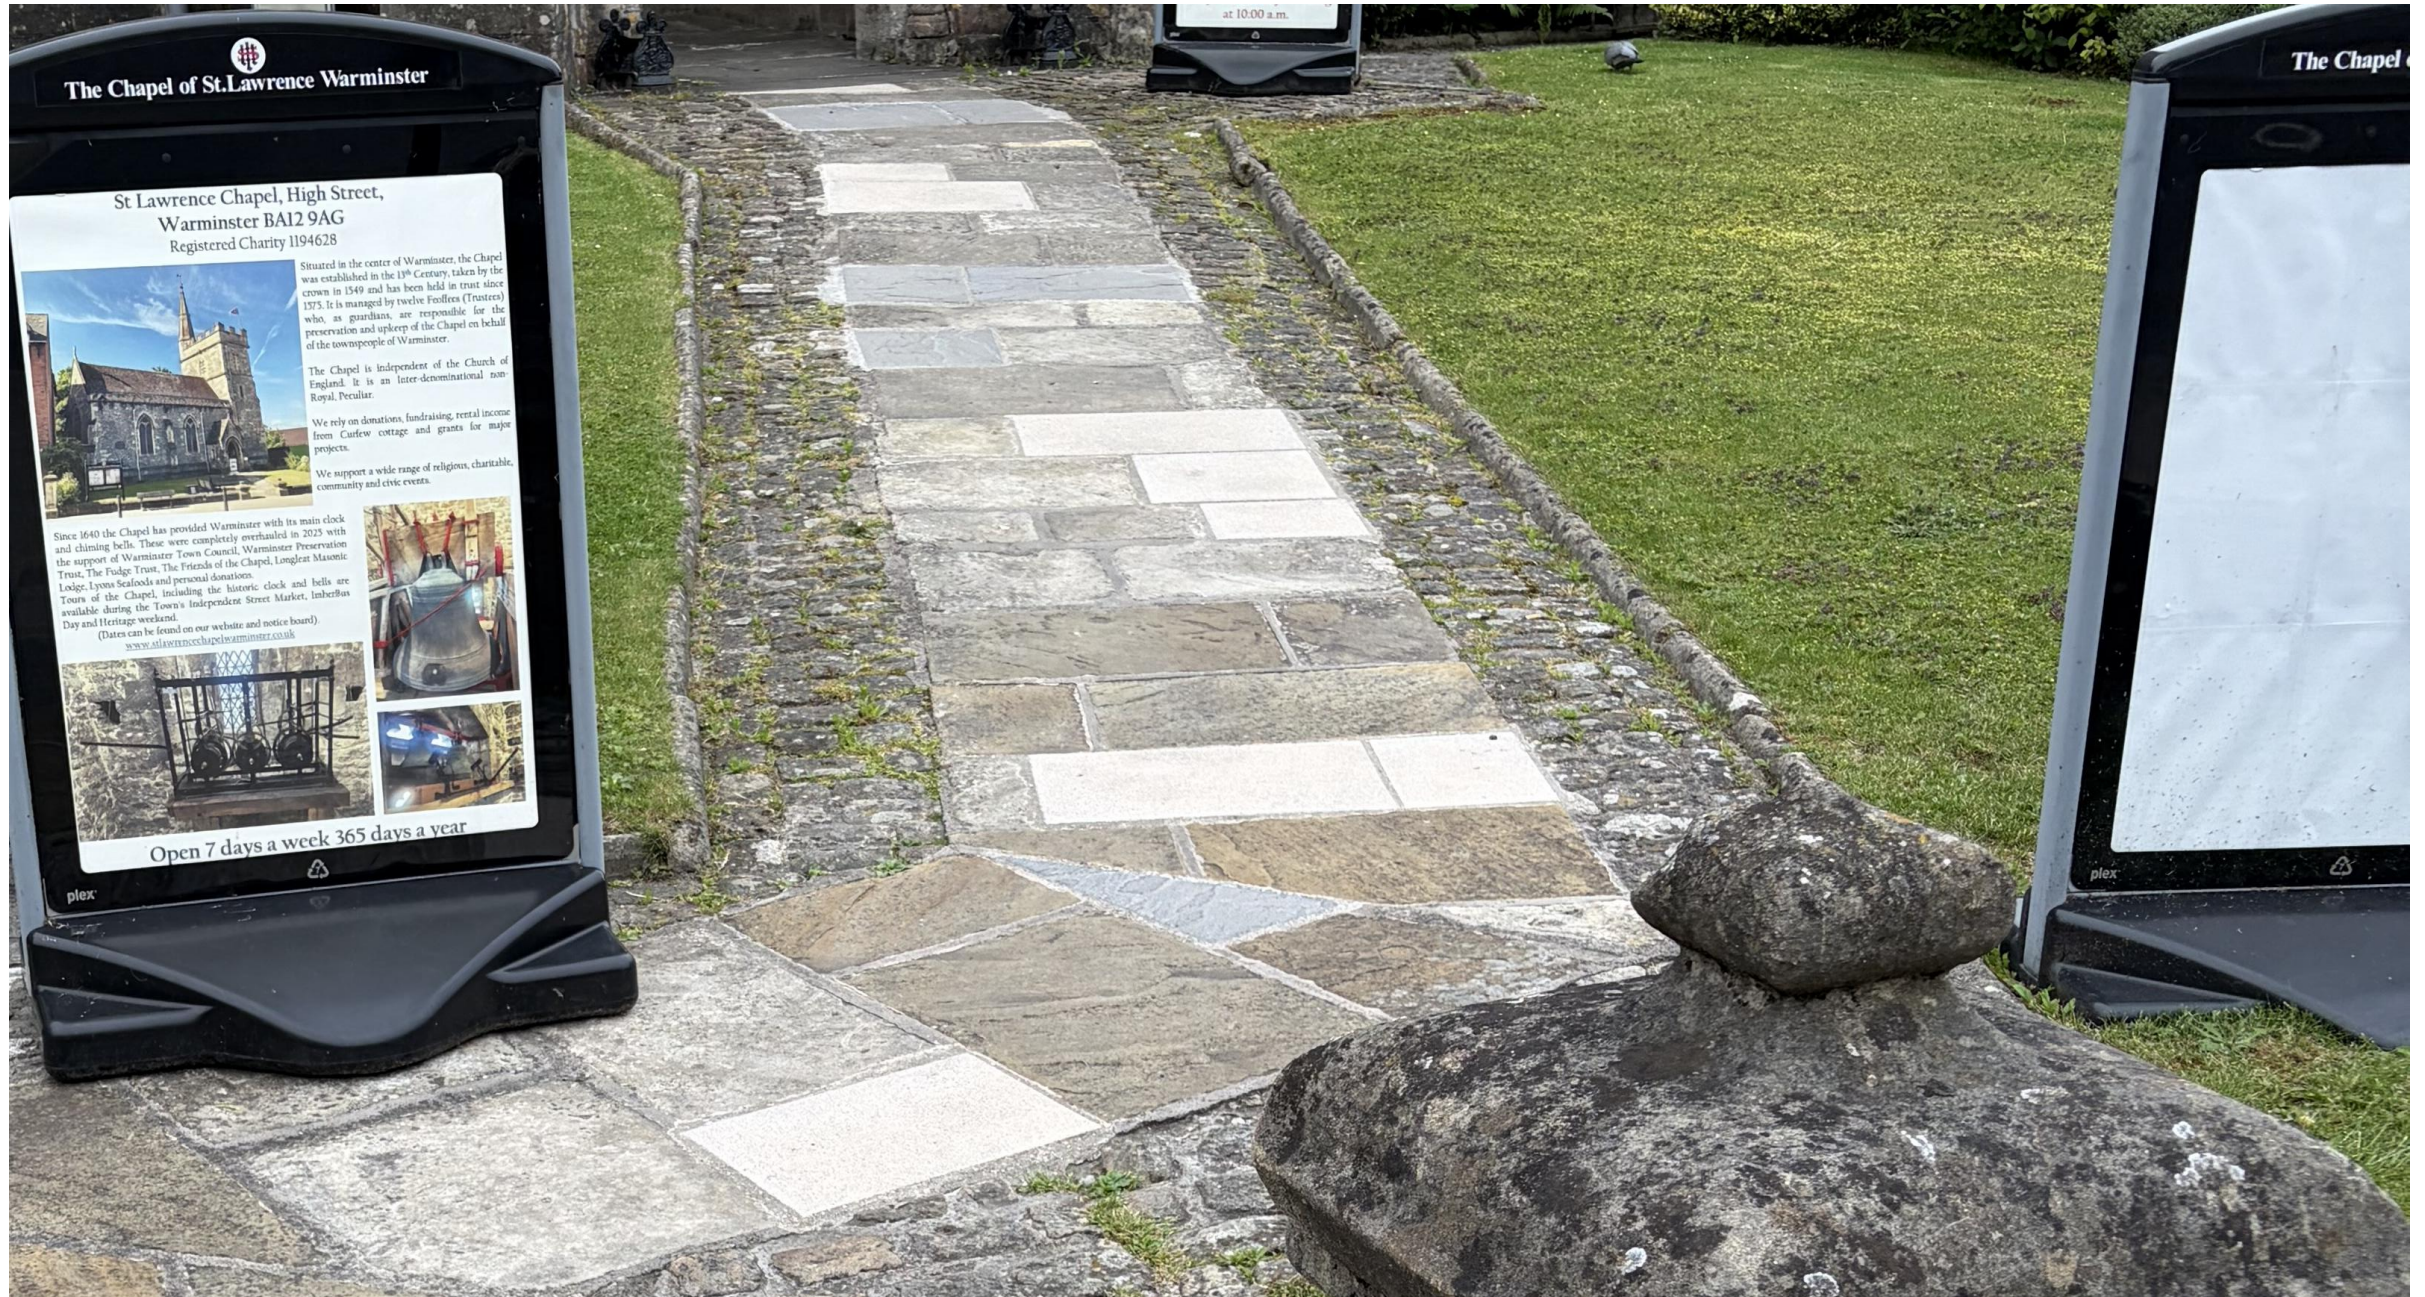
# Chapel path repointing
