1302/03/CJK

## St Lawrence Chapel, Warminster: Fabric Repairs & Improvements

BACKGROUND DOCUMENT in support of a listed building application to Wiltshire Planning Department, including a design statement, a statement of need and a statement of significance.

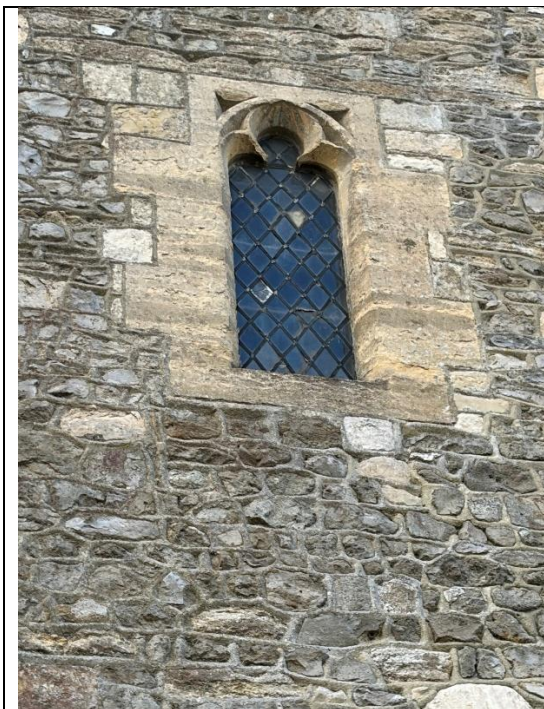
- **General stone conservation to the Chapel's external masonry.** This is to include the removal of hard cementitious pointing mortar where practical and without damage to the surrounding stonework. Most of the Chapel's external masonry was repointed in a hard cementitious mortar in the 1970's, often in the form of raised 'Ribbon' pointing popular at that time: see fig 2 & 3 below. Also, a small number of proposed stone repairs, the defrassing of damaged stone, the careful removal of redundant fixings and a small number of new stone indents to match the existing stone: see fig 4. Only lime-based mortar (3.5 NHL) to be used to match existing. This work is all to be done by Albion Stonemasons, and the details of the proposed works are contained within their quotation and associated specification: refer to appendix C. The proposed masonry repairs are to include an amount of repointing to the adjacent Curfew Cottage.

Fig 2. Photo of the raised 'ribbon' hard cementitious pointing to most of the tower elevations.

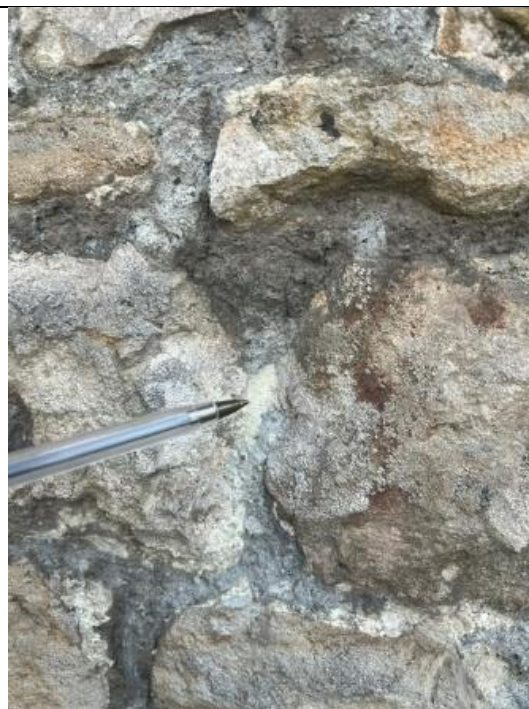
Fig 3. Close up of area of pointing where original pointing mortar is visible beneath the later hard mortar.

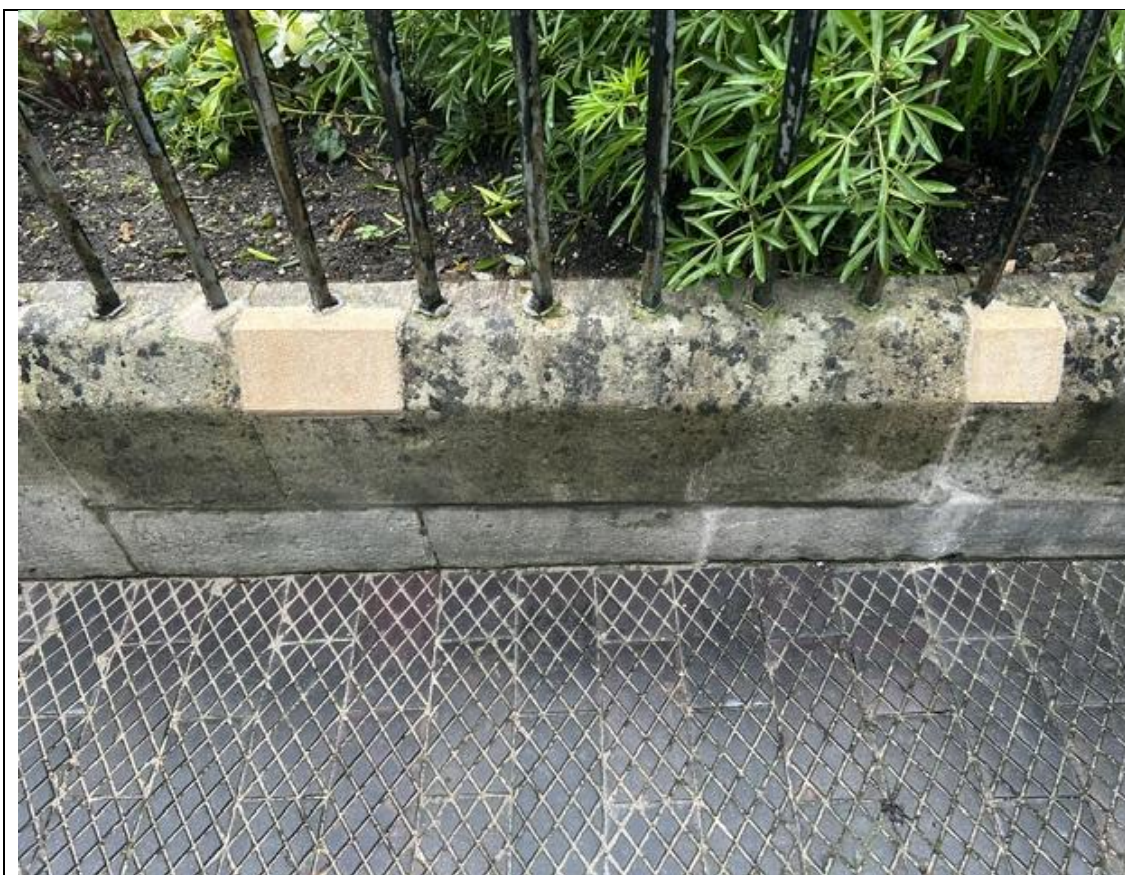
Fig 4. Photo of small indent repairs to side railing plinths using matching stone and lime mortar.

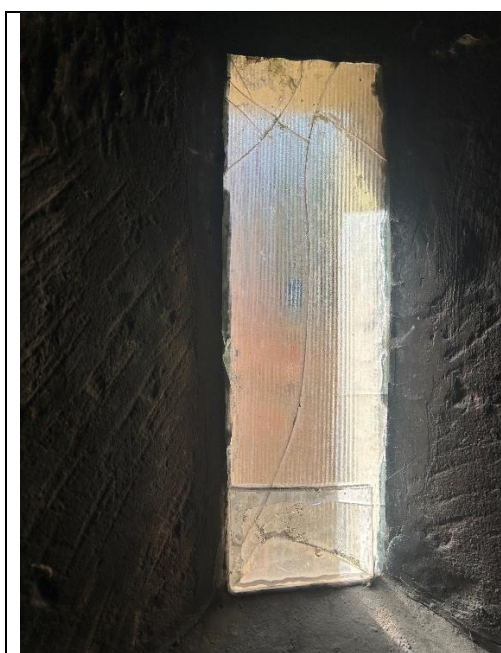
Fig 5. Photo of the broken modern glass to the tower access turret stairs.

- **Repairs to the tower windows.** Windows to the Tower were inspected by Salisbury Cathedral Stained Glass during 2025. Their recommendations were to replace two pieces of broken glass on the spiral staircase and to fully re-lead the north window to the clock room: see fig 5 & 6 below. All the works are to be done by Salisbury Cathedral Stained Glass and is detailed in their attached quotation dated 21<sup>st</sup> July 2026: refer to Appendix D

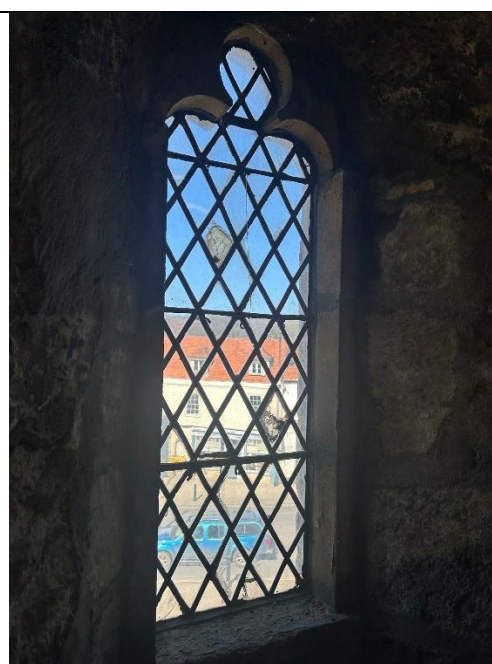
Fig 6. Photo of the north elevation window to be repaired and re-leaded.

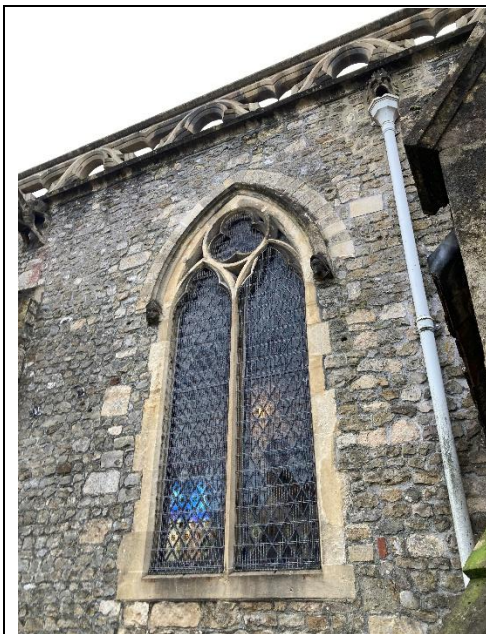
Fig 7. Photo of existing mesh guarding to north nave windows.

- **External Window Guarding.** Proposed installation of new stainless steel, black powder-coated wire guards to both south nave windows and the west tower window. This is due to ongoing issues of vandalism to the Chapel windows, which has resulted in damage to the East Windows in the recent past. The mesh is to be similar to that already installed at the Chapel and will be shaped to follow the individual window openings using stainless steel screw fixings into the joints of the stonework where possible: see fig 7 below. The guarding is also to be fitted by Salisbury Cathedral Stained Glass and is included in their quotation. The guarding will safeguard and protect the windows and stained glass of the Chapel from further damage/vandalism.

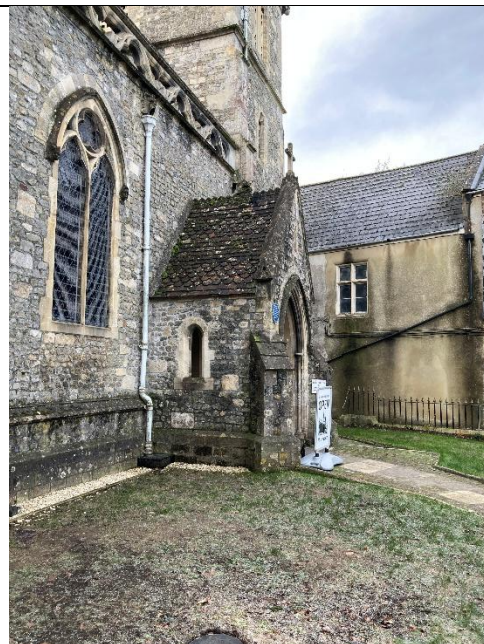
Fig 8. Photo of the north porch which it is proposed be fitted with cast metal gutter and downpipe.

- **New guttering and downpipes to north porch.** Painted cast metal gutter and downpipes to be fitted to north porch roof eaves to prevent ongoing water run off on to masonry below: see fig 8 below. All to match existing guttering and downpipes to Chapel.

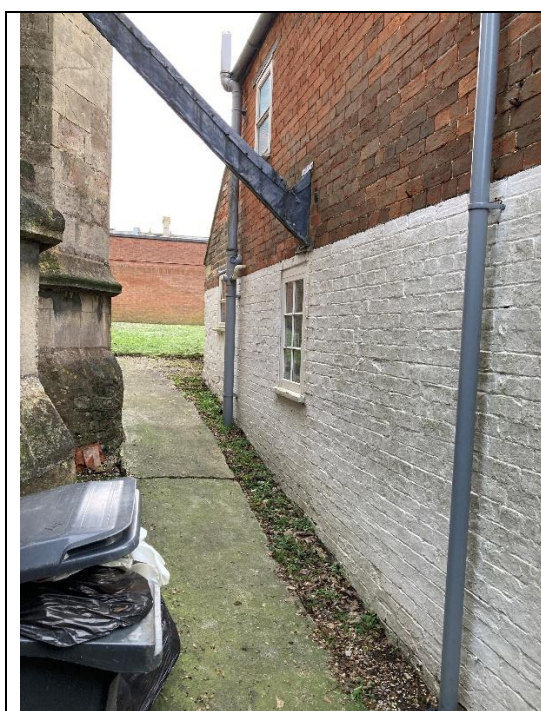
Fig 9. Photo of 'curfew' pipe between Chapel and Cottage which has water ingress into the Cottage.

- **Curfew Pipe Repair.** Drainage/ventilation detail to be fitted to bottom section of lead covered curfew pipe between Chapel and Curfew Cottage: see fig 9 below. This is due to water ingress into the cottage. The exact details are to be agreed onsite with specialist lead workers but is to provide drainage and ventilation to the piping by placement of a carefully set of holes to the bottom of the pipe at its junction with the Cottage. To include stainless steel insect mesh.
- **Tower roof overflow.** The west side of the tower lead roof runs to a single parapet gutter sump outlet which is connected directly to a

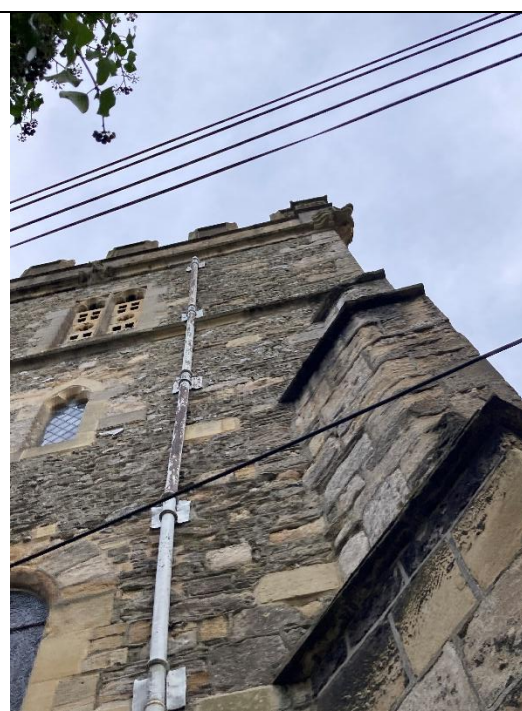
lead downpipe located on the west side of the tower: see fig10 below. The outlet and pipe are sealed with no intermediate hopper. There is, as such, a danger of the roof flooding to this side if the outlet or pipe is blocked. The proposal is therefore to fit an overflow to the roof along the west side of the tower. This detail is to be agreed on site with a specialist lead worker, but is assumed to be a small 50mm dia lead overflow pipe fitted at an appropriate height within the sump and routed through the parapet wall at this location. This will help prevent flooding and damage to the fabric of the tower if the sump or downpipe becomes blocked.

Fig 10. West outlet and down pipe from tower roof. Note: lack of hopper.

- 3.3 Improvement works are mainly focused on detailing to the roofs of the tower and north porch. The lead roof to the tower is divided in two parts by a low pitch. The gutter to the west side of the roof has a direct connection to the external lead downpipe with no hopper. If the sump outlet or the downpipe blocks, there

is a danger of flooding within the tower. As such it is proposed to fit a lead overflow pipe to the sump of the gutter. The north porch roof has no guttering and the condition report recommended the fitting of guttering and downpipes. The proposal is to fit painted cast metal guttering and downpipes similar to those already fitted to the Chapel.

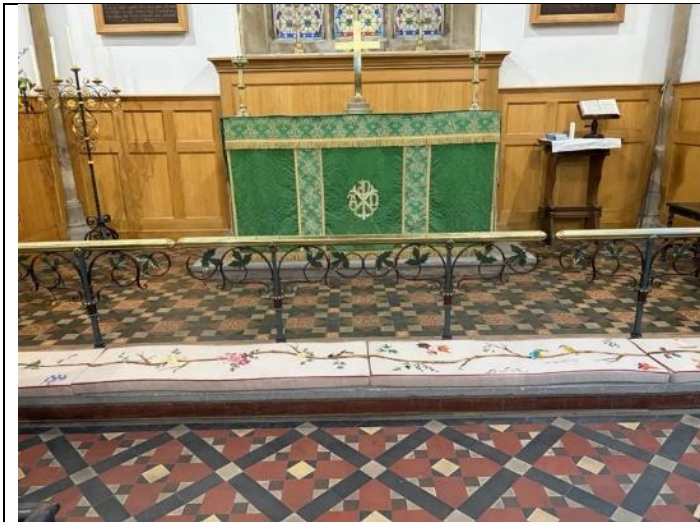
Fig 10. Photo of Victorian tiling to sanctuary floor.

- **Cleaning to Victorian encaustic floor tiles.** Proposed 'conservation' clean of decorative Victorian encaustic glazed floor tiles to Chapel sanctuary: see fig 11 below. The focus is to remove dirt, stains, candle wax, polish and previous sealants but avoiding removing glazing, or damage to the fireskin of the tiles. Cleaning will avoid using household detergents, scouring powder, caustic soda or acidic cleaners. Trial area of cleaning to be done by specialist cleaners to agree methodology and to be approved by the Conservation Officers before works are undertaken.
- **Inspection and cleaning of roof coverings and associated parapet gutters:** The careful cleaning of roof slopes to nave and north porch roofs of moss and debris: see fig 11. To include associated lead parapet

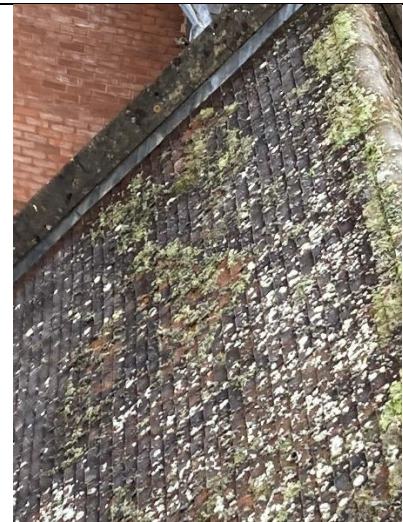
Fig 11. North Nave roof slope showing the extent of moss and lichen growth to it.

gutter to nave roof including sumps and outlets. Fitting of stainless-steel leaf guards where appropriate.
