8332-06-0101

## INSPECTION REPORT

THE RATTLEBONE INN, CHURCH STREET, MALMESBURY, SN16 0LR

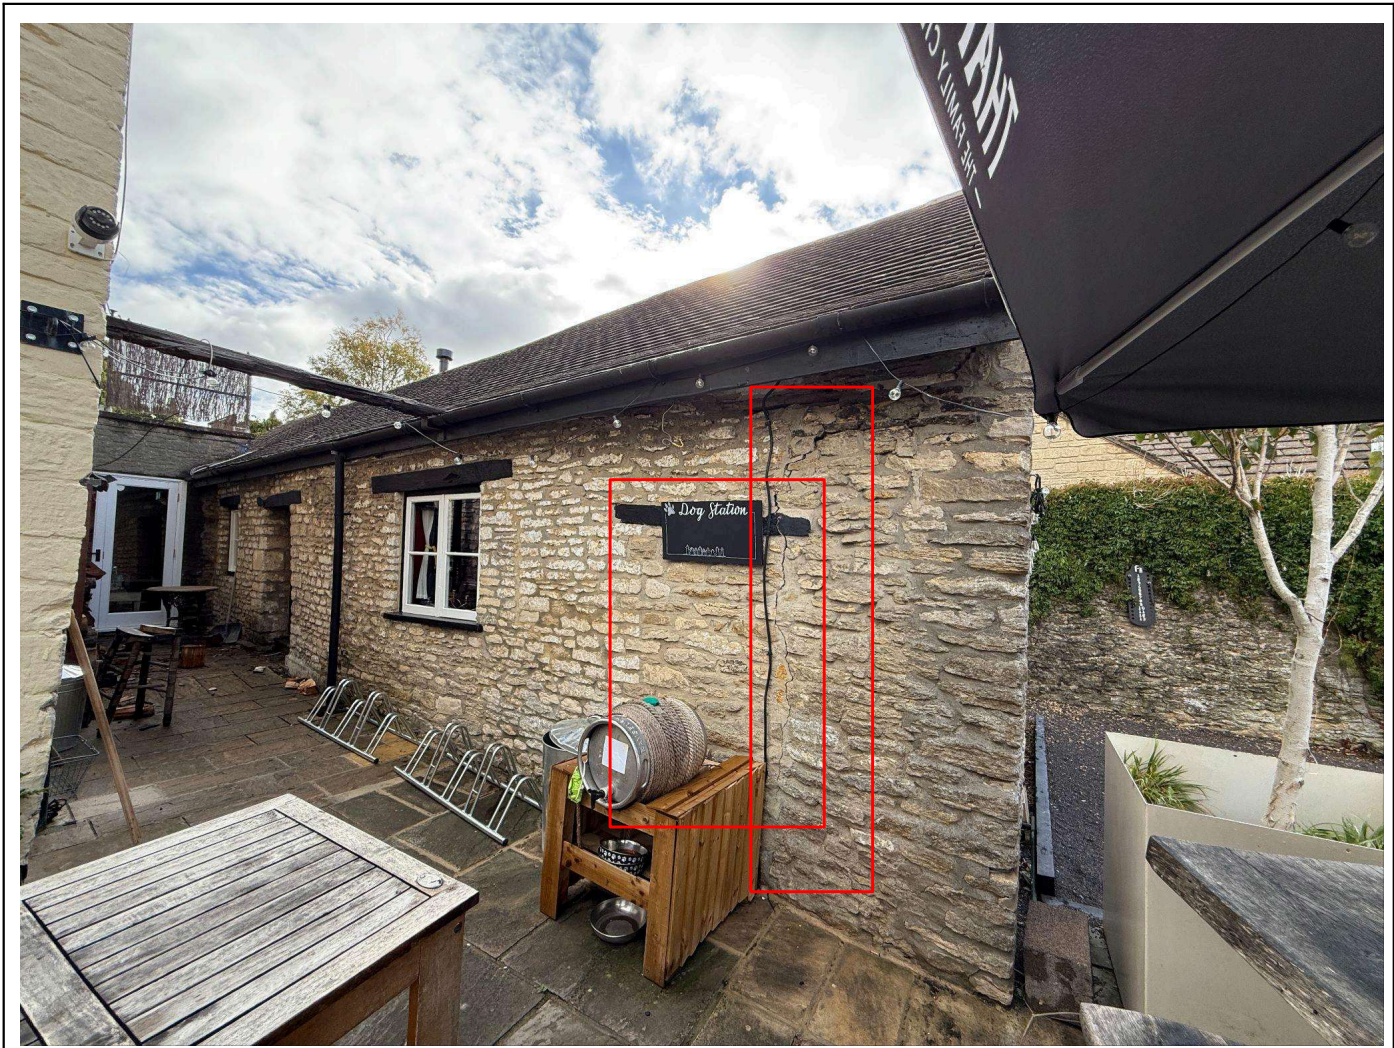
- 4.1. The external defects observed will be referenced according to the areas noted in Figure 1.
- 4.2. Within Area 1; the front elevation of the dining area contained a stepped to vertical crack with a maximum width of 30mm to the top and 1mm towards the bottom of the crack. The crack was located on the south side 1m in from the gable end.

- 4.5. An infilled doorway was located adjacent to the observation above. A timber lintel above the infill was 500mm from the eaves level of the property.

- 6.4. In addition, the cause of the 30mm external crack observed on the south wall 1m from the gable cannot be fully determined based on one visit and a monitoring regime. However, based on the observations possible causes include settlement due to poor soil or a lack of adequate footings. According to BRE Digest a crack exceeding 25mm warrants structural repair.

Picture 1 - Vertical to stepped crack to the south wall and infilled doorway of the Dining Area (Area 1)

- 6.5. Therefore, there are two options. Option 1 is stitching the cracks to the corners internally and the external crack near to the gable end via Helix ties and monitoring the defects for potential future movement. Within this option future underpinning cannot be fully ruled out. Option 2 is conducting three trial holes to assess the conditions of the soil and footings to determine if the movement observed is ongoing, the trial holes will need to be located on the corner where the external crack had been observed and underneath the damp stonework. Following Option 2 it is possible underpinning may be required should condition of the soil and/or footings prove to be inadequate and stitching and repointing to the defects will be required.

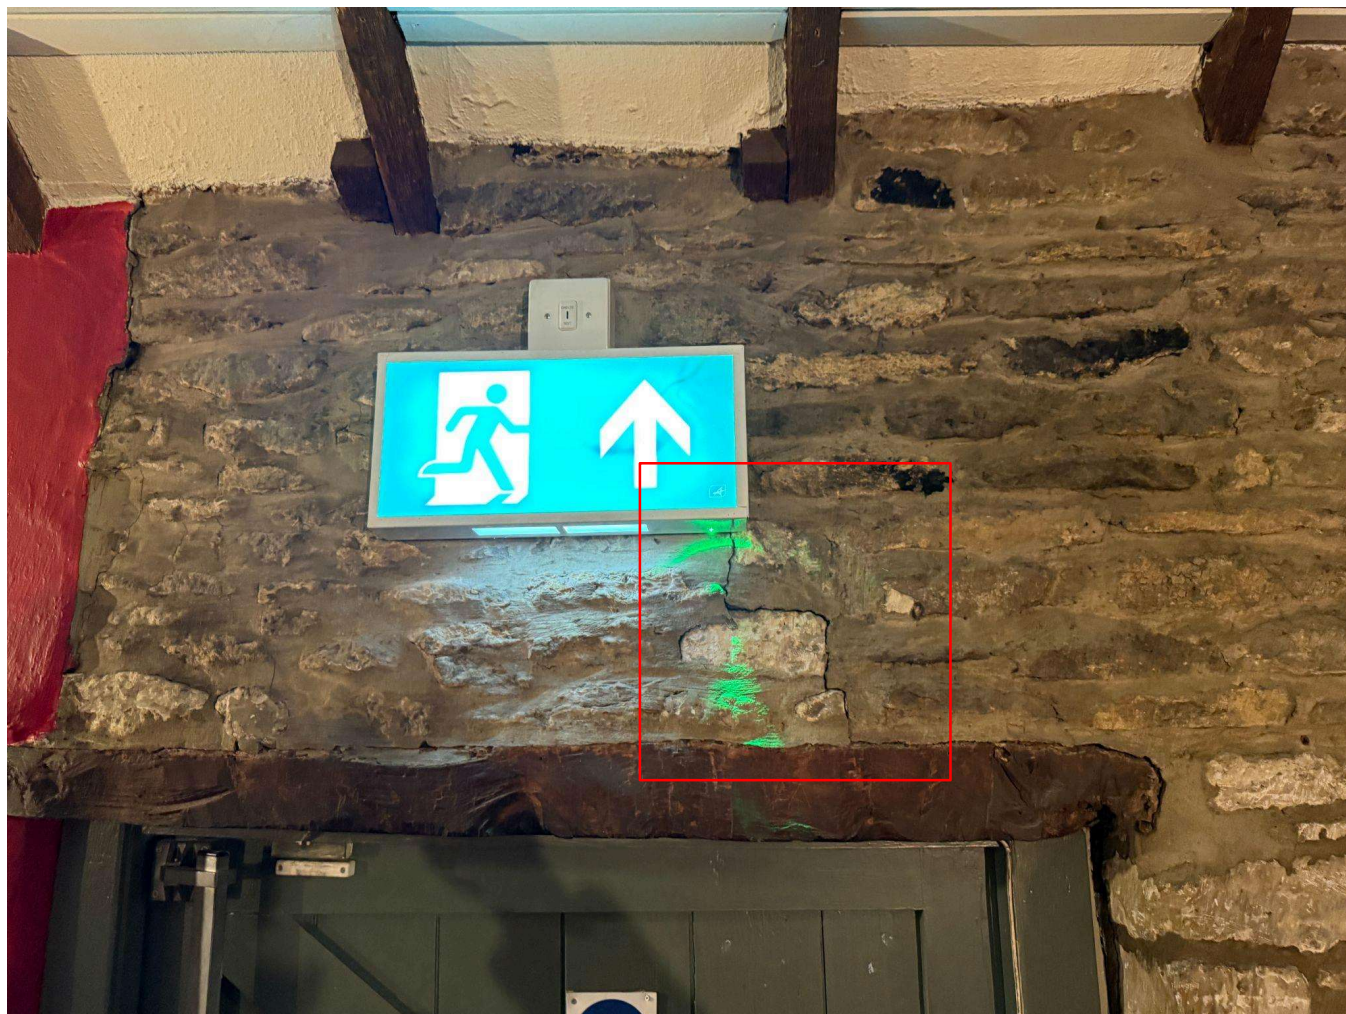
- 5.2. On the same wall below the fire exit sign a 1mm stepped crack was observed from the corner of the sign to the top of the timber lintel.
- 5.3. In both corners of the gable end a vertical crack with a maximum width of 25mm was observed from eaves to the ground floor.

Picture 8 - Stepped crack below the fire exit sign on the south wall of the Dining Area

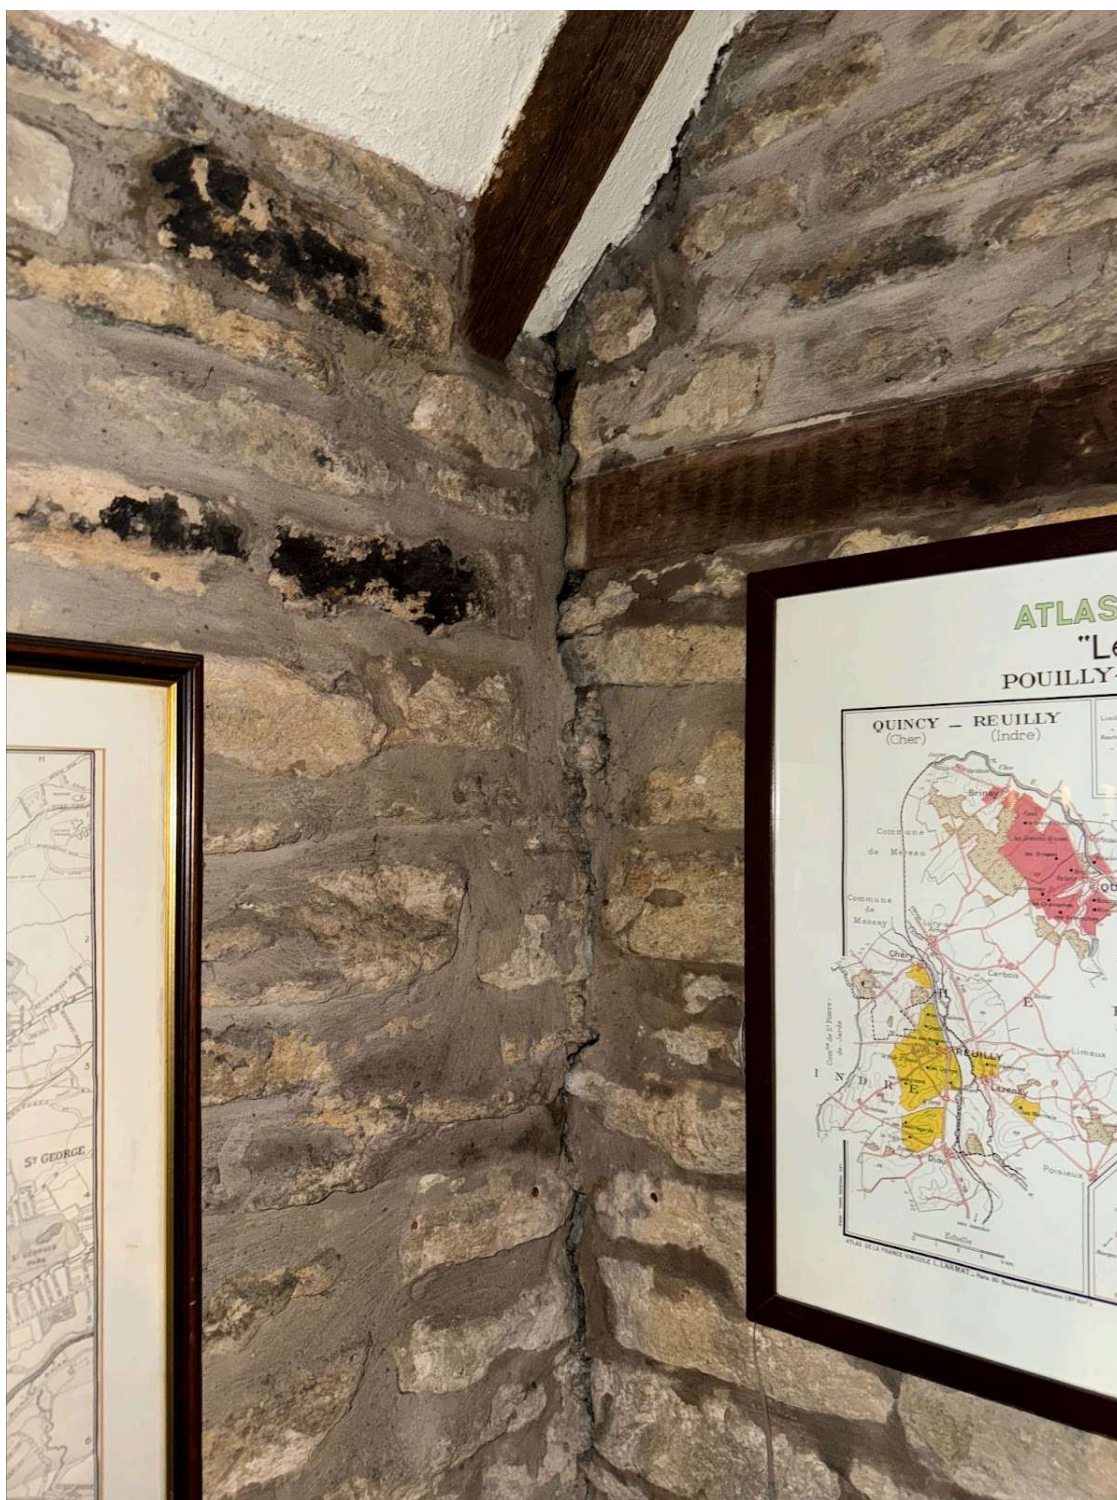
- 6.3. The vertical cracks observed to the corners of the gable wall in the dining area indicate the gable wall was leaning outwards. From the observed roof structure it appeared that the 'A' frames were not connected to the gable through a purlin and no diagonal bracing was observed, this could be a possible cause for the defects observed. However, based on a single visit the cause cannot be fully determine and as a result it is difficult to provide a recommendation for a suitable repair.

Picture 10 - Vertical cracks to the lefthand corner of the gable wall
