# **Historic Building Heritage Assessment**

**Melbourne House, The Nursery,  
Devizes, Wiltshire.**

Reference: 251006A

**Historic Building Heritage Impact Assessment**

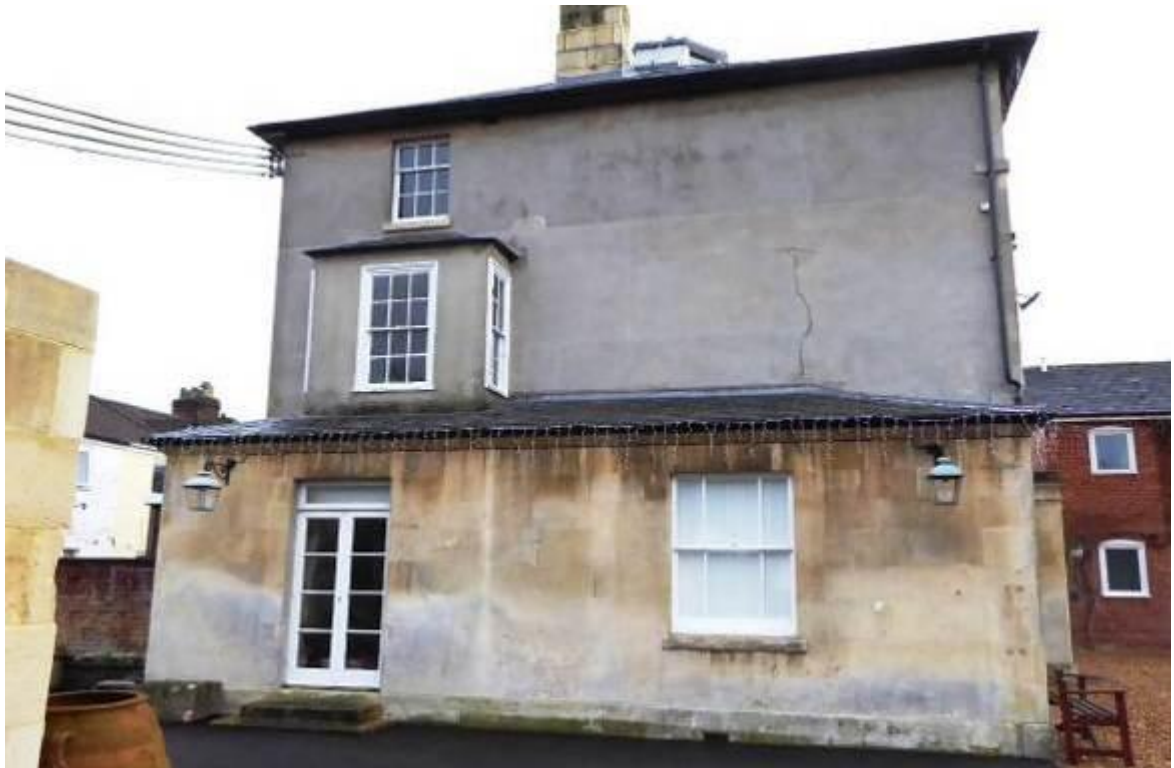
Fig 3.4.6: West side wing

- 3.4.6 The fronts of the side wings, and the exposed west side, are of a slightly different stone to the central front elevation, as can be suggested by the quality and colouring to the material to them. Both side elevations appear to have been butted to the earlier core building as seen by the lack of keying-in, particularly on the west side where there has been some slight movement in the junction. The jointing in the stonework is slightly courser than that to the main elevation and it is also marked out by the greater degree of weathering and disruption of the surfaces that has occurred. At the head of these walls is a cornice below the roof drip, which in style and form is alien to that to the main house, as it is too decorative.

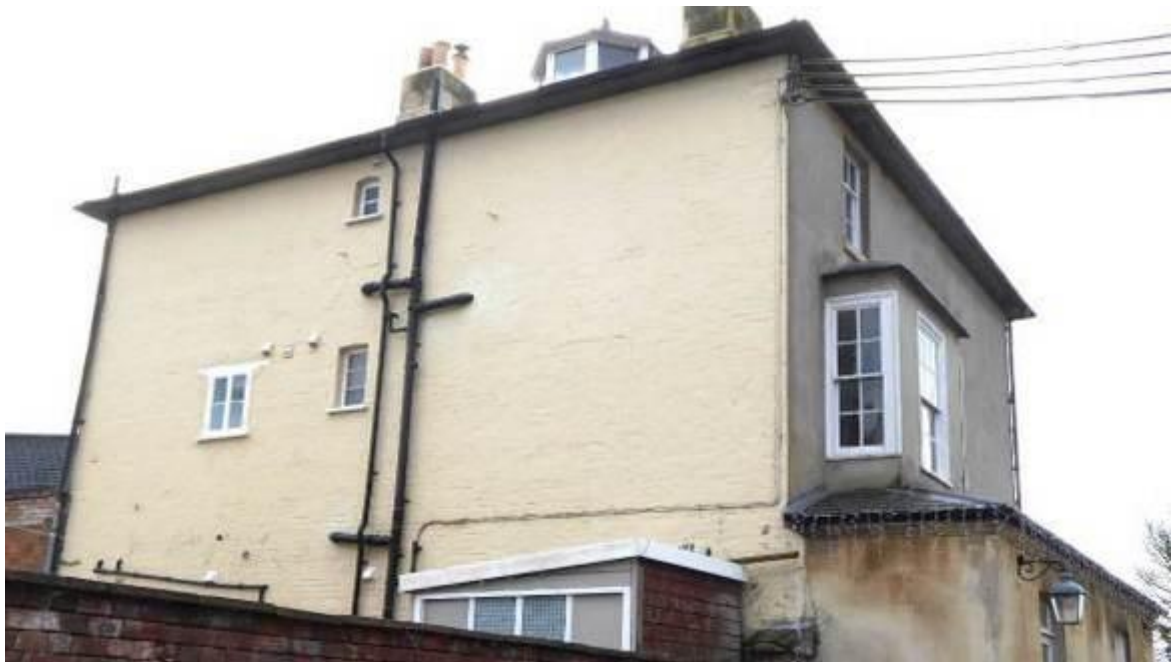
Fig 3.4.9: Rear (north) elevation

- 3.4.9 The rear wall of the main part of the house is of painted brickwork, much as that on the east side, laid in Flemish bond. Within this towards the west side at first floor level, there is a brick arch that would suggest there is a blocked up window in that position. The other windows in this elevation towards the centre and east side wall, all appeared to be later and rather crudely insertions with a mixture of flat and slightly cambered arches or timber lintels over them.

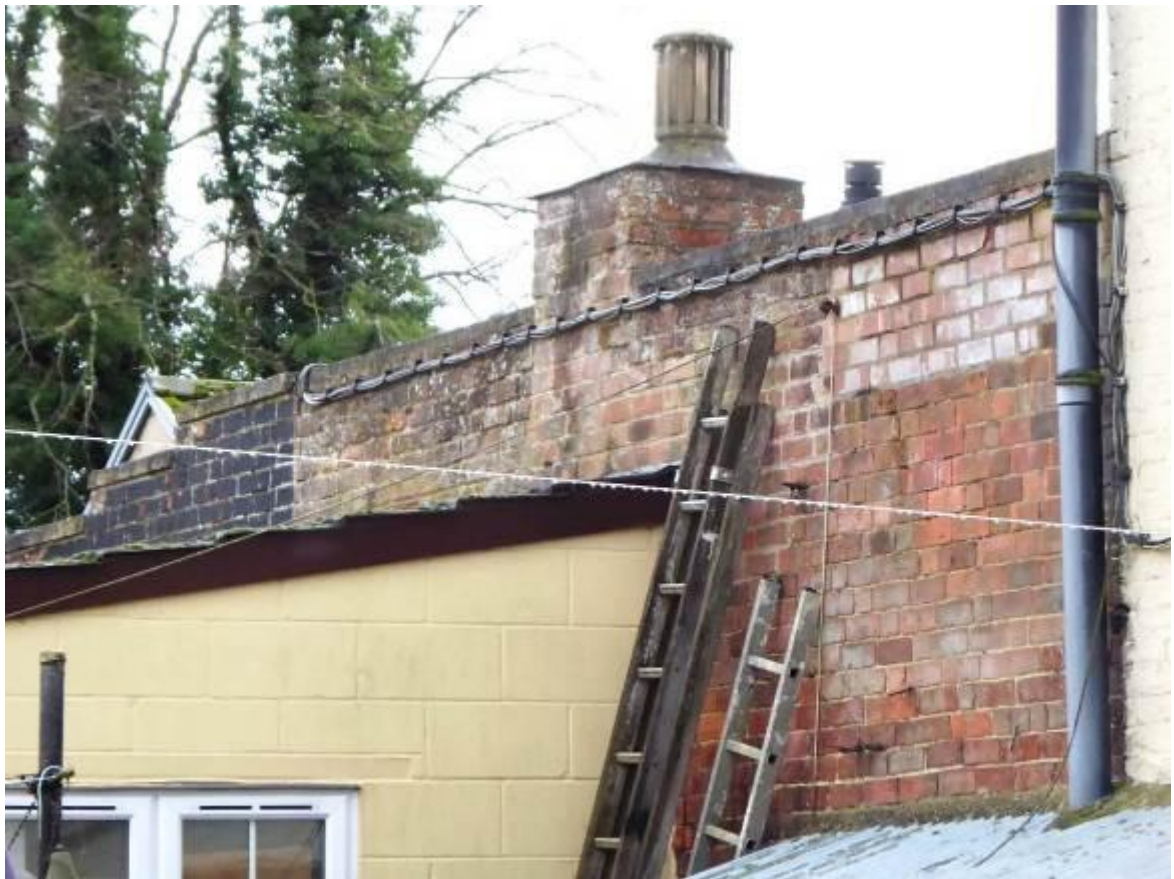
Fig 3.4.10: Rear (north) wall to kitchen

- 3.4.10 From what could be seen of the rear wall to the kitchen, where this extends up above the tops of sheds and outhouses built against it in the back of the properties to Melbourne Place, which faces on to The Nursery, is in brickwork. It has a rendered brick capping and appears to be in Flemish bond built with a mixture of brick types and would suggest that it was a boundary wall that has been much altered and adapted over time.

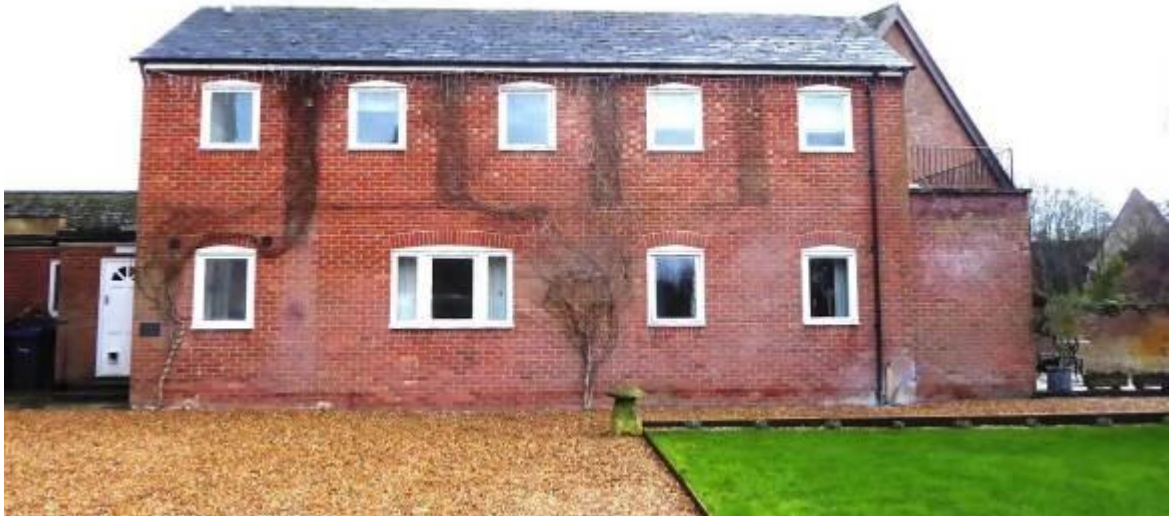
Fig 3.4.11: Two storey rear wing

- 3.4.11 Walls to the two storey rear wing are of cavity construction, built with an orange / red faced clay brick, laid in stretcher bond with roll lock cambered arches over the tops of the window openings formed in a somewhat crude nature. There is a damp proof course (DPC) built in at approximately internal ground floor level. On

the south end of this, is a single storey extension in the same brick, although the upper section appears to have been raised, possibly to form a parapet wall supporting metal railings to the balcony at that level.

- 7.2.5 The windows to the two storey rear extension are standard joinery storm proof large pane tilt and turn units, which in style and appearance are greatly at odds with the main house. The replacement windows will be vertical sliding sashes of a two over pattern so as to be more appropriate to this location and obviate the large areas of reflection experienced from the present form.

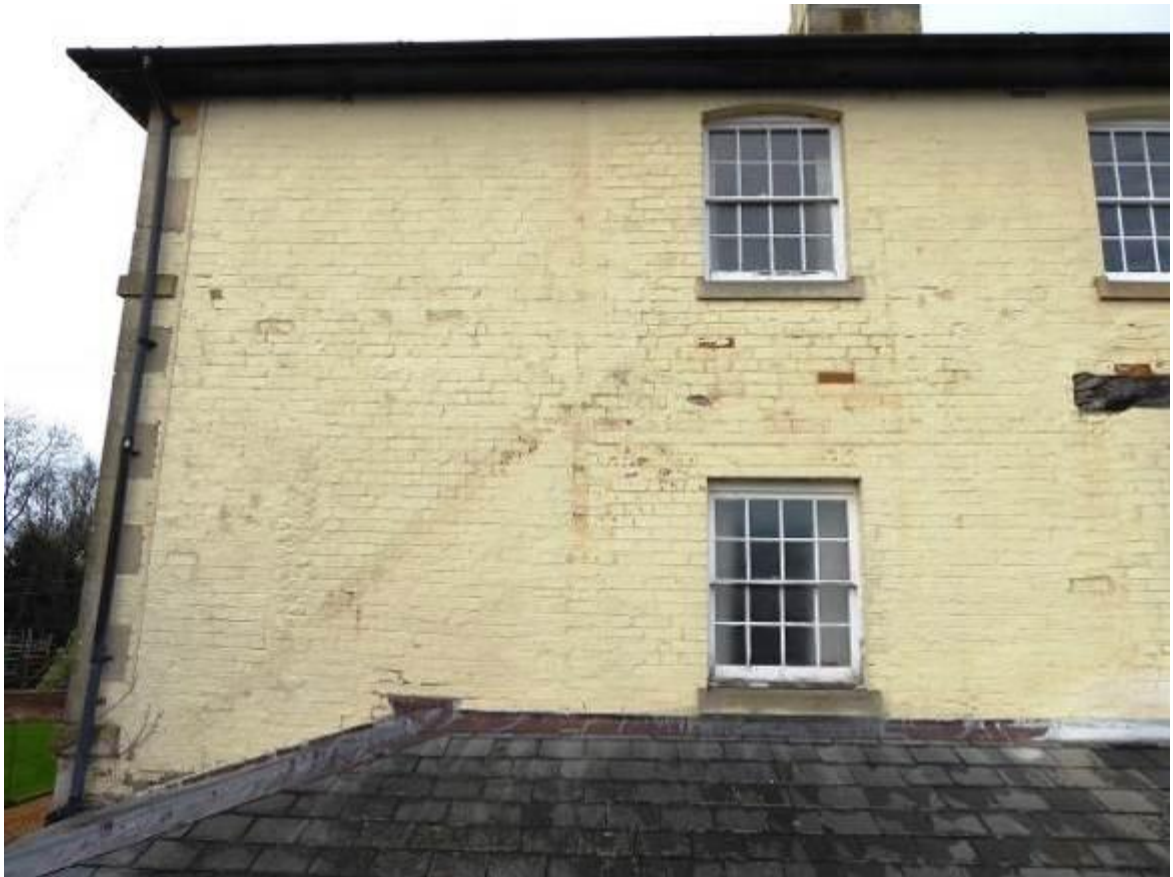
- 8.1.6 At some time, possibly in the mid 20<sup>th</sup>, when this property was used as an hotel, an external metal fire escape and landings was added on to the east side of the building from a doorway in an enlarged window opening on the second floor. Evidence for this can still be seen as a scars and fixing positions on the wall face as well as differences in the brickwork used. It can also be seen where the first floor east side south window has also had its opening adjusted and may have also been some form of escape door. All this ironwork and adaption was probably removed in the early 21<sup>st</sup> century when the east side yard was roofed over and the south wing added.

Fig 8.1.6: Scar of removed fire escape stairs and top landing
