## Retrospective Arboricultural Statement

For recent construction activity at 54 Lower Road in Salisbury

**Report Reference:** NB-2026-057-RAS-RevA

**Report Date:** 30<sup>th</sup> July 2026

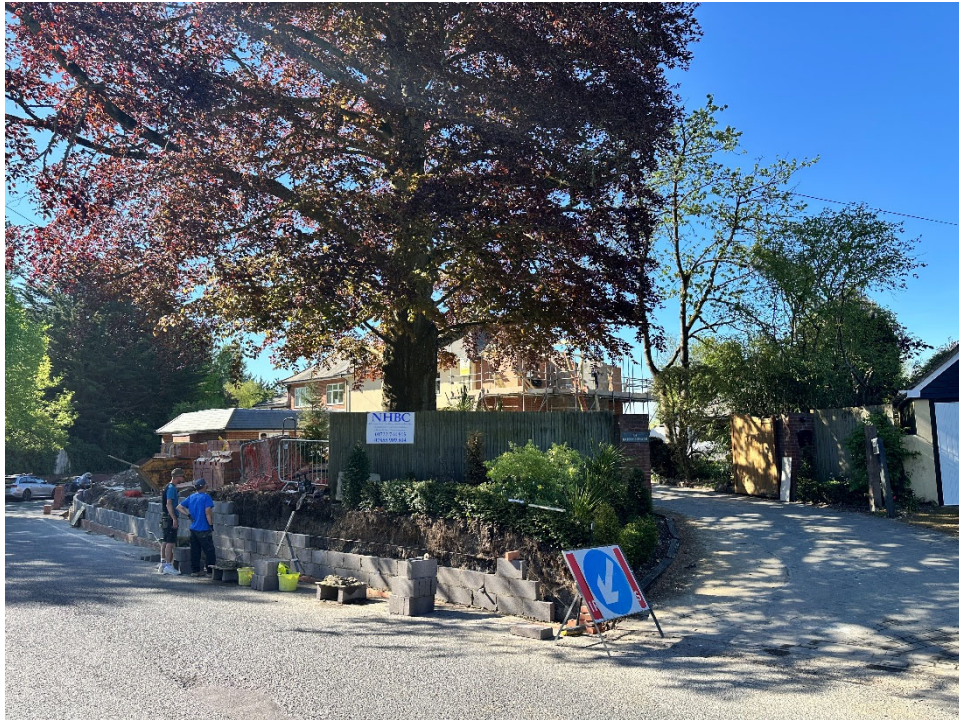
Figure 1: Inner blockwork being laid.

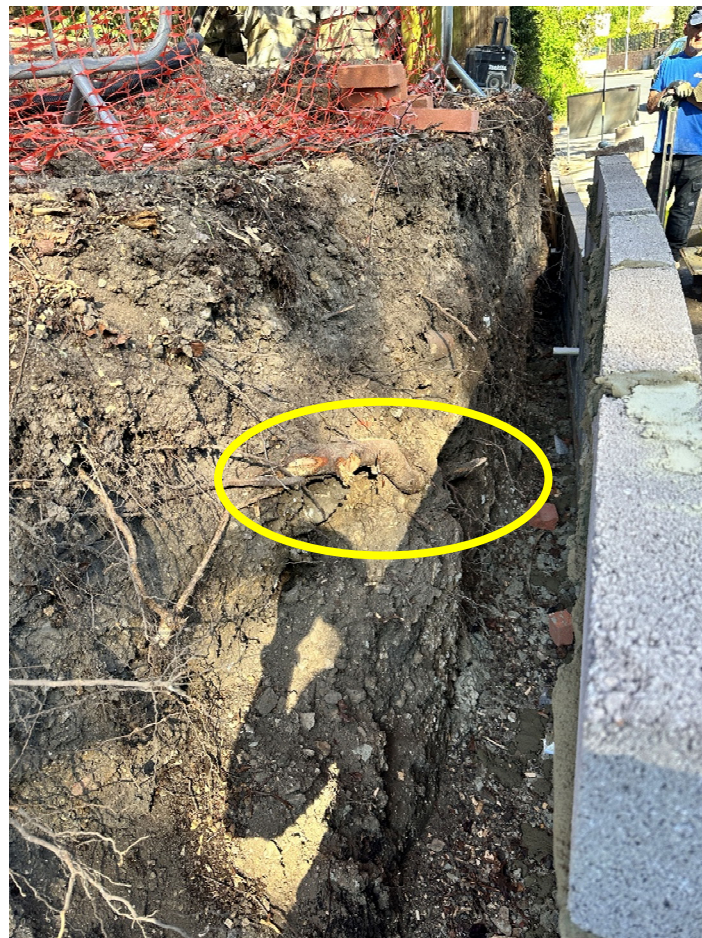
1. Only one root exceeding the standard 25mm diameter was observed; this was approximately 30mm in diameter. This root was located at a point approximately 1.0m above the road level and 350mm below the tree's ground level. The root had a slightly shattered end as seen in Figure 2.
2. All other roots that I noticed were well below the 25mm threshold.
3. The inner block wall was constructed approximately 200mm further out from the soil bank, but the backfill was not seen.
4. Some lightweight tree protection fencing had been installed beneath the canopy of the tree, but materials were being stored and mixed beneath the dripline. At the time I recommended that these were removed and stored elsewhere and the soil beneath aerated to rectify any compaction that had been caused.

Figure 2: One root 30mm in diameter exposed.

Based on the evidence recorded at the time, the root loss associated with the wall's construction was limited. A single root of approximately 30mm diameter was damaged with a slightly shattered end, and numerous fine, non-structural roots had been partly exposed. I would not expect that root damage of this scale to typically cause significant long-term physiological or structural detriment to a mature tree of this species and size. This directly addresses the concern raised in the Arboricultural Officer's comment on the application, and on this evidence I would not expect the works as constructed to have caused lasting harm to the tree.

As a constructive alternative, and to help offset any disturbance already caused, I would suggest that the council consider imposing a condition de-compaction of the root zone beneath the canopy using an air-spade, followed by an application of mulch. This would improve soil aeration and moisture retention to encourage healthy new root growth.

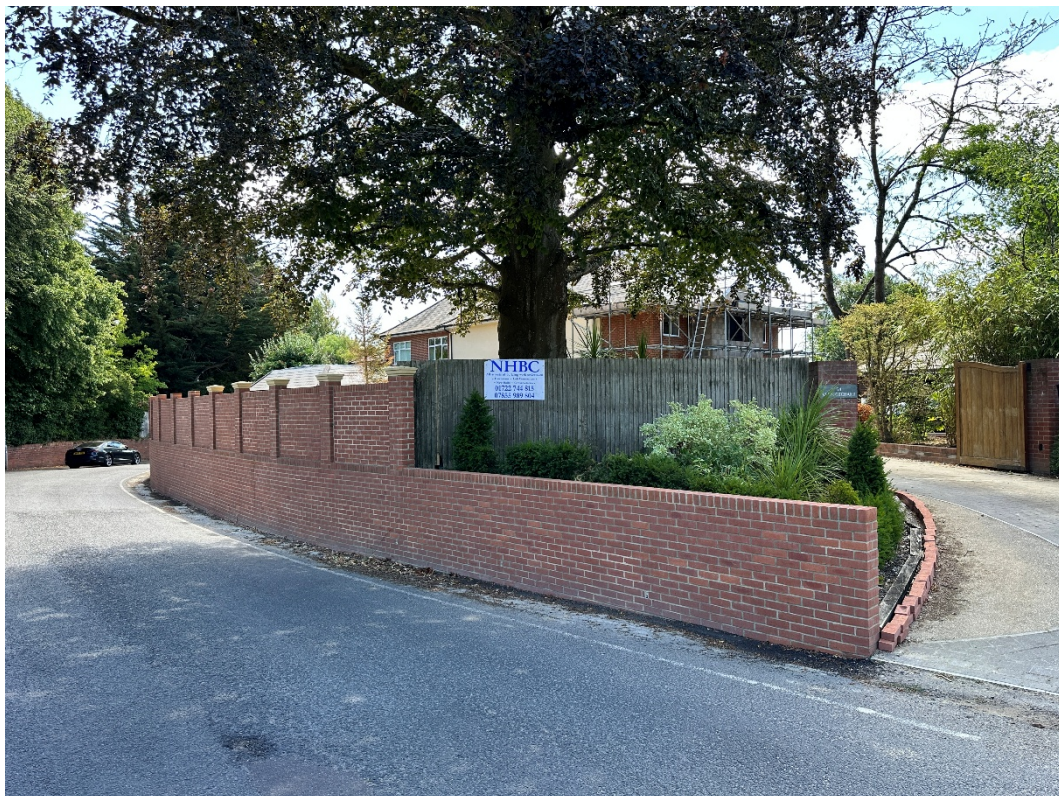
I later revisited 27<sup>th</sup> July 2026 to photograph the finished wall; no obvious further damage was found. Furthermore, all building materials had since been removed from beneath the canopy and were stored elsewhere.

Figure 3: New wall.
