# THE PLANNING WORKS

September 2026

Heritage Statement and Existing Joinery Condition  
Listed Building Consent Application - No 20 Kingsbury Street, Marlborough, SN8 1JA  
Replacement of Windows and Sashes

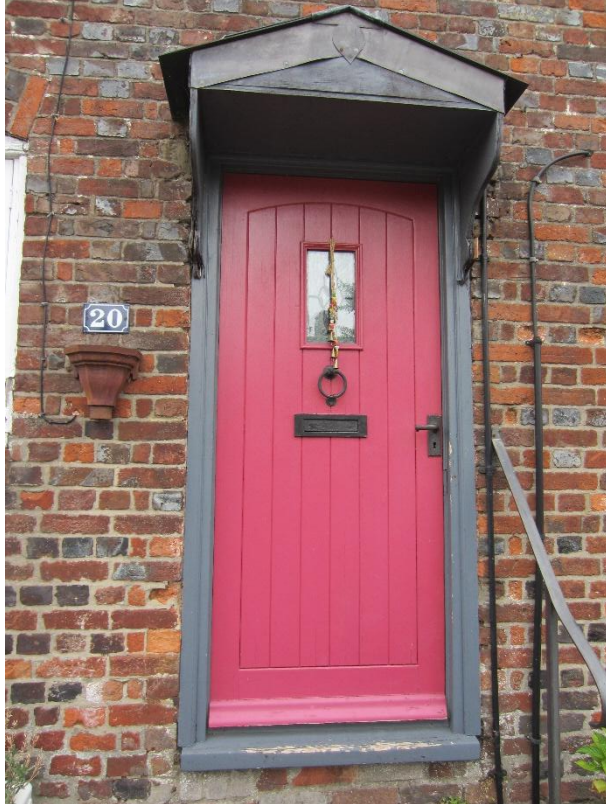
Front Door D1

Fabricated in a combination of soft wood and a composite material, the existing modern front door leaf has an external frame enclosing a section of 'planking' with a shallow arched head. The section of planking is a moulded material rather than traditional individual tongue-and-groove staves. There is a rectangular glazed light in the upper section of the door. This has a moulded beaded surround and stained-glass double-glazing. The door furniture is a modern copy of an old style pattern.

The door leaf has deteriorated and been overpainted to maintain its appearance.

The proposed replacement door and windows will be faithful copies of the profiles and dimensions of the existing joinery. The proposal seeks to change the material used from softwood to hardwood in order to improve both the functionality and longevity of the external joinery. The proposal will maintain the historical significance of the property. The front elevation's contribution to the Conservation Area street scene is not impacted. Harm to the fabric of the building is insubstantial.

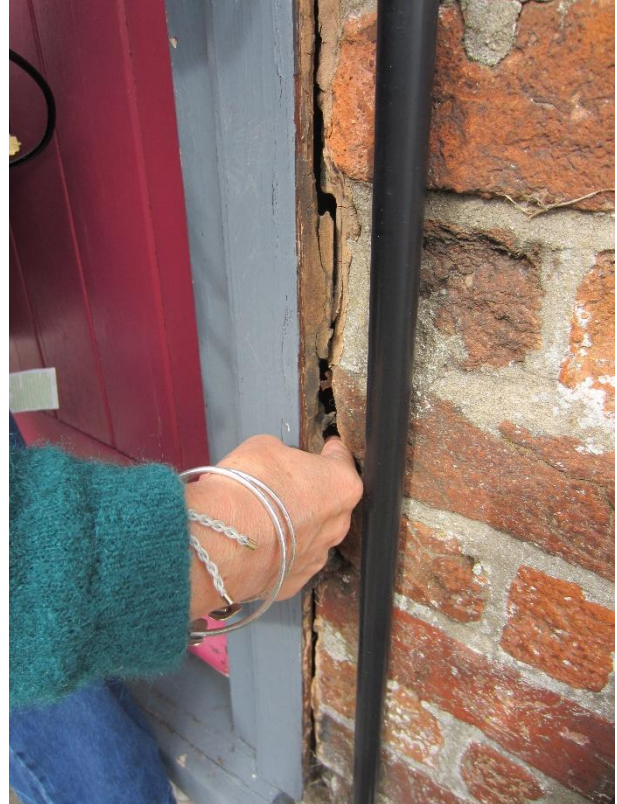
Front Door D1 – Frame

The door frame pre-dates the door and is similar in pattern to those in three of the four neighbouring properties. This may suggest that the frame is of some age.

The frame has not been well-maintained and is now rotten. Gaps between the frame and surrounding brickwork have opened up as the timber has deteriorated beyond repair.

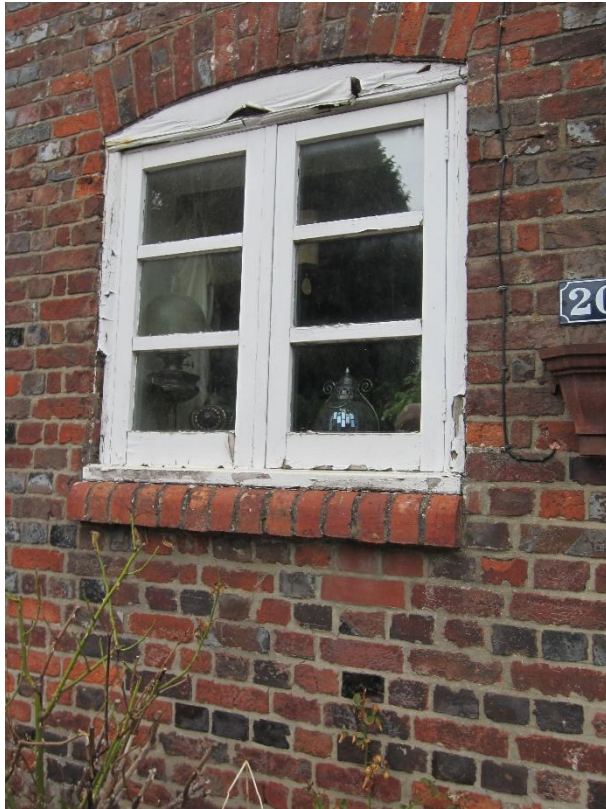
Window G1

All six external windows are formed from exactly the same frame profiles and sections. The windows differ in size but the method of construction is uniform throughout. The Living Room Ground Floor window on the front elevation (G1) has two plant-on vertical beads fixed to the outer frame elements.

The windows are now in poor condition.
