# ARBORICULTURAL REPORT

## HOMEBUYERS TREE REPORT

THE OLD RECTORY  
LYDIARD MILLICENT  
SWINDON  
SN5 3LS

SEPTEMBER 2025  
Ref: SCD 06827 / 2025

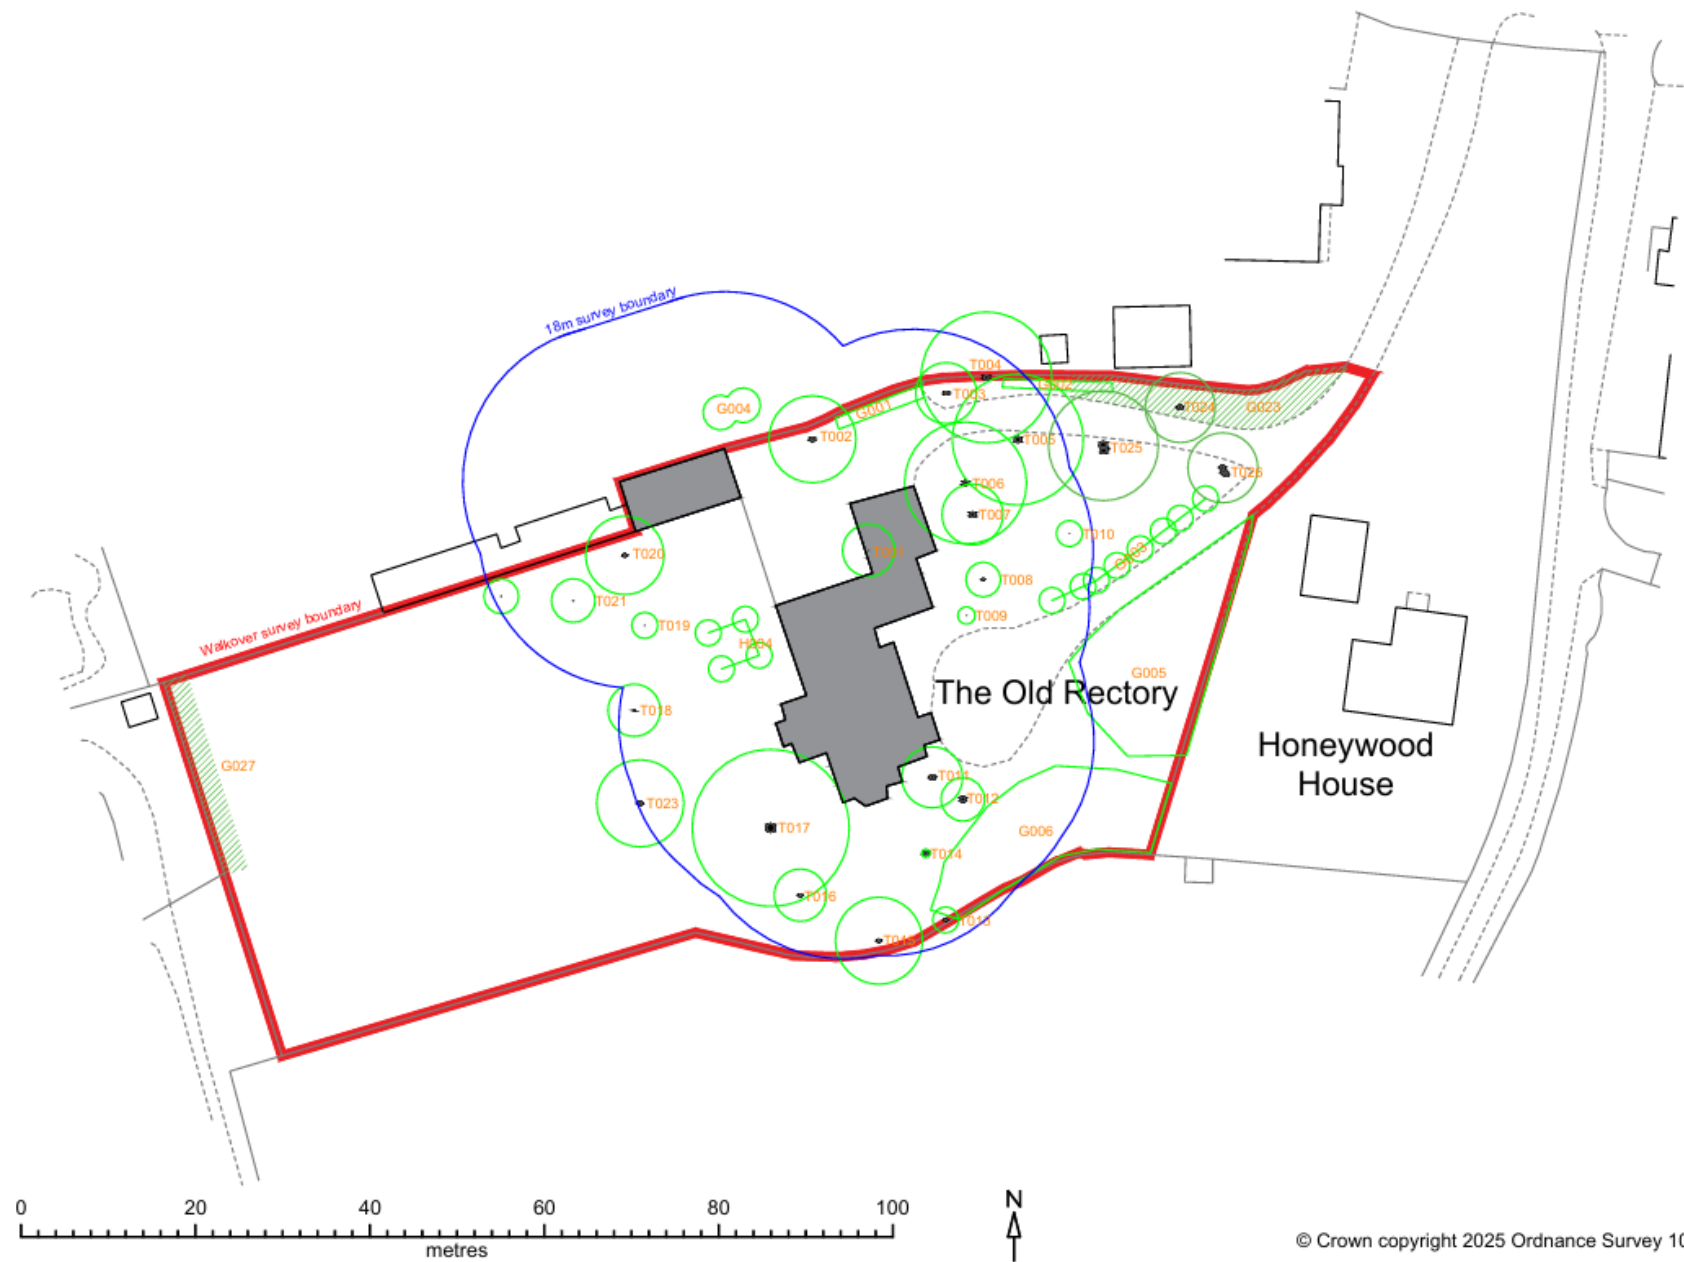
APPENDIX E - SITE PLAN

The position of the trees and shrubs within 18m of The Old Rectory and those requiring works and which are over 18m from the property but still within the formal gardens of the property are shown on the Site Plan which is included in [APPENDIX E - SITE PLAN](#) of this report.
