Three Bears Cottage – RM2 Dining Room

| Three Bears Cottage – RM5 Living Room & RM6 Study | | |
|---|---|---|
| <p><b>CHEDBURN • CODD</b><br/>CONSERVATION ARCHITECTS<br/><i>Historic Building Consultants</i></p> | | <p>Three Bears Cottage<br/>Blackland, Calne</p> |

### Three Bears Cottage – Existing Kitchen External Views

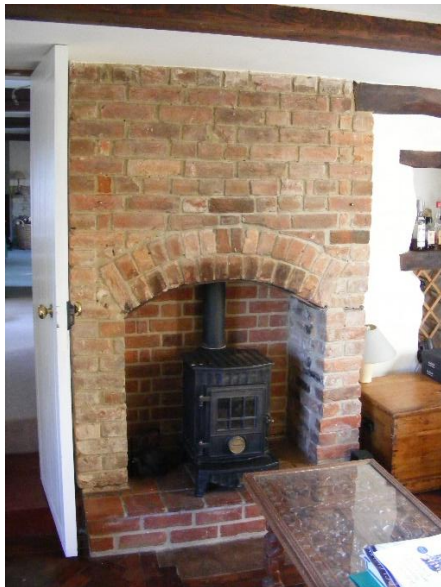
Fig 1 – RM2 Dining Room – view before showing brick fireplace with brick hearth and plastic beams on ceiling

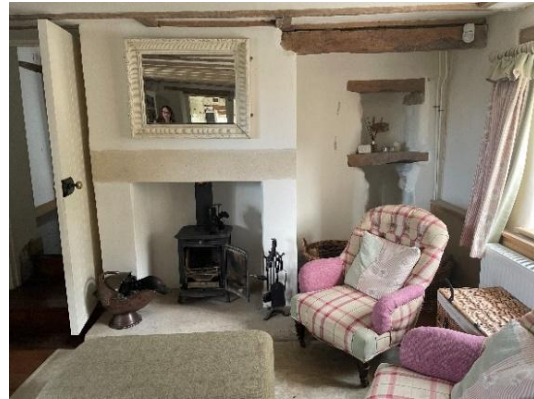
Fig 2 – RM2 dining room – view after new stone lintel and hearth fitted to fireplace finished and finished with lime plaster

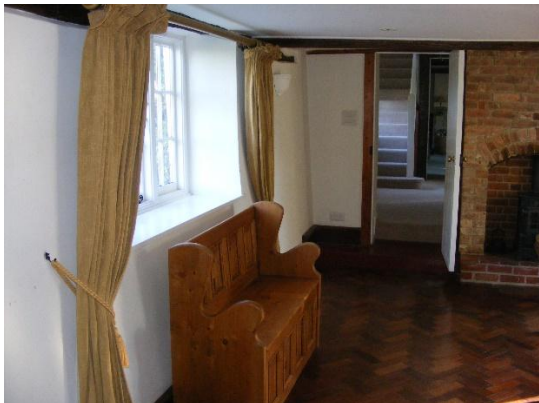
Fig 3 – RM2 dining room – view showing modern plasterboard to ceiling before removal, wood block floor and painted window sill.

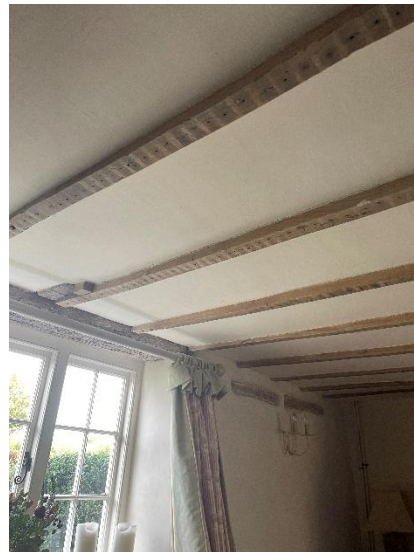
Fig 4 – RM2 dining room -view after plasterboard removed to leave joists exposed

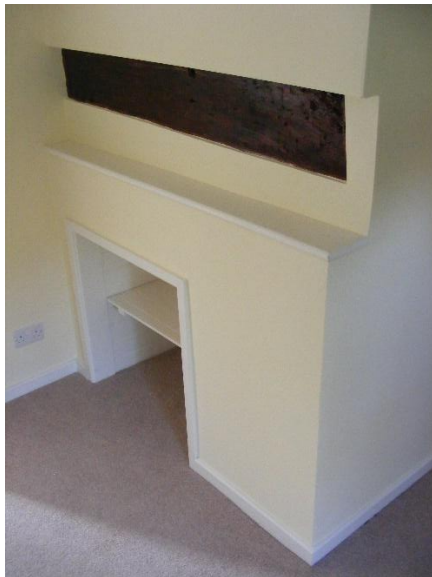
Fig 5 – RM3 Hall – view before alterations showing plastered fireplace alcove, boarding and trim and carpet floor finish

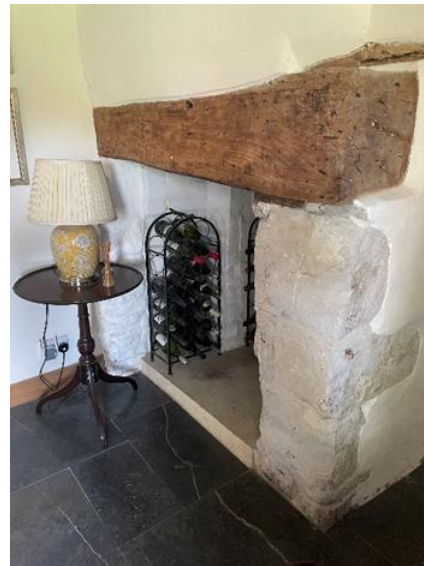
Fig 6 – RM3 Hall – view after alterations exposing original timber lintel, fireplace opened up, plaster removed at low level, stone exposed, new stone hearth and new blue lias stone flooring.

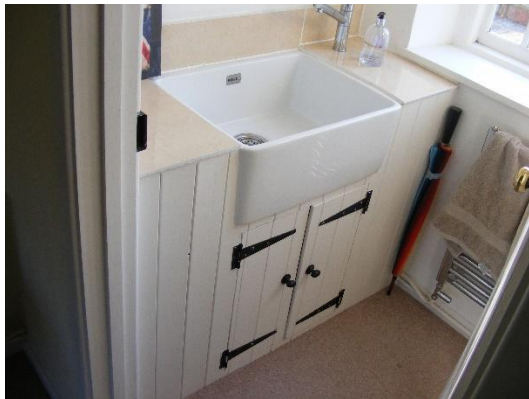
Fig 7 – RM4 WC – view before renewal of basin and replacement floor finish.

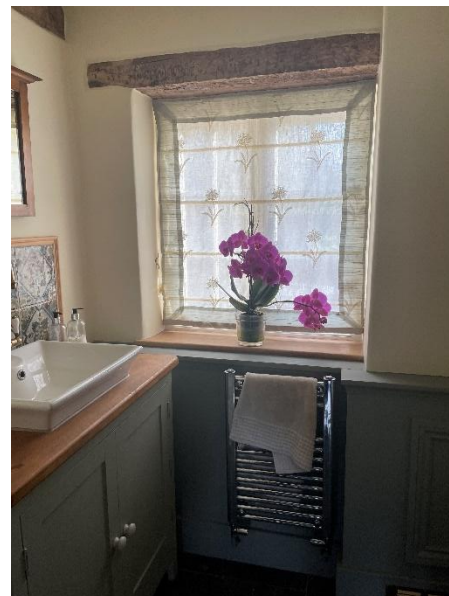
Fig 8 – RM4 WC – view after renewal of WC fittings, new dado panelling, new oak window board and original lintel exposed

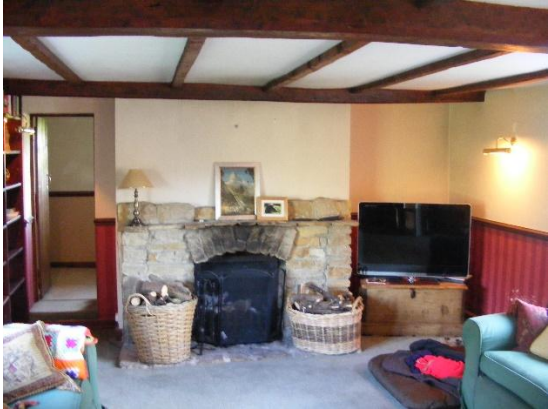
| Three Bears Cottage – RM5 Living Room & RM6 Study | | |
|---|---|---|
| <p>Fig 9 – RM5 Living Room – view before alterations showing stone fireplace surround, carpet floor finish and plastic beams running at right angles to fireplace</p> | <p>Fig 10 – RM5 Living Room – view after alterations showing fireplace opened up with new stone hearth and stone lintel inserted. Plastic beams removed, ceiling joists exposed and repaired area to ceiling above.</p> | |

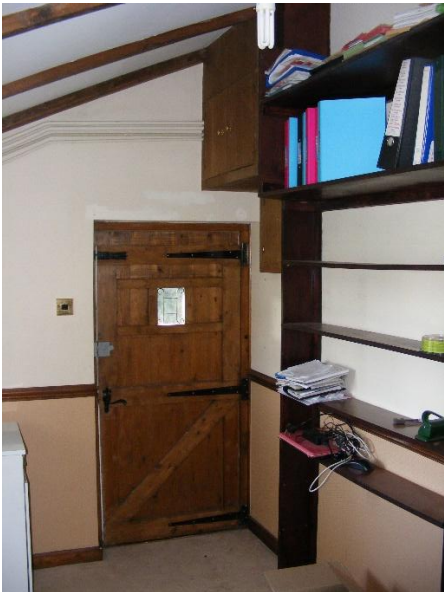
| Three Bears Cottage – RM5 Living Room & RM6 Study | | |
|---|---|---|
| <p>Fig 11 – RM6 Study – view before alterations showing high level meter cupboard and previous door.</p> | <p>Fig 12 – RM6 – Study – view after alterations showing new meter cupboard at low level, door with glazed panel, and new stone floor finish</p> | |

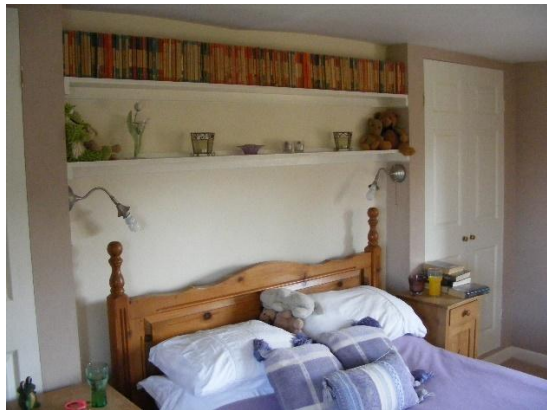
| Three Bears Cottage – RM8 Bedroom 4 and RM10 Bedroom 4 | | |
|---|---|---|
| <p>Fig 13 – RM8 Bedroom 3 – view before alterations showing East wall with alcove cupboards either side of chimney breast. And textured plaster ceiling.</p> | <p>Fig 14 – RM8 Bedroom 3 – view after alterations showing fireplace opened up with new stone lintel and stone hearth inserted.</p> | |

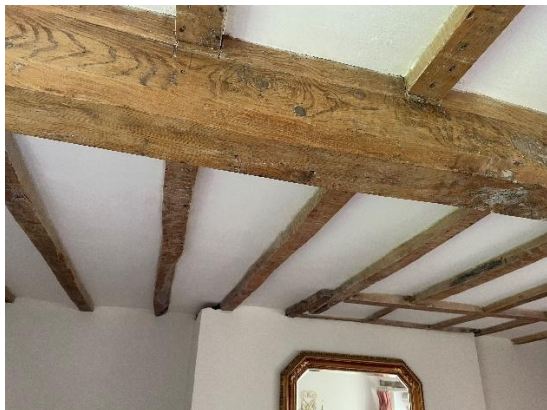
| Three Bears Cottage – RM8 Bedroom 4 and RM10 Bedroom 4 | | |
|---|---|---|
| <p>Fig 15 – RM8 Bedroom 3 – view after alterations showing chimney breast and alcoves, and textured plaster to ceiling removed and joists and beams exposed.</p> | <p>Fig 16 – RM10 Bedroom 4 showing replacement timber collar to roof truss.</p> | |

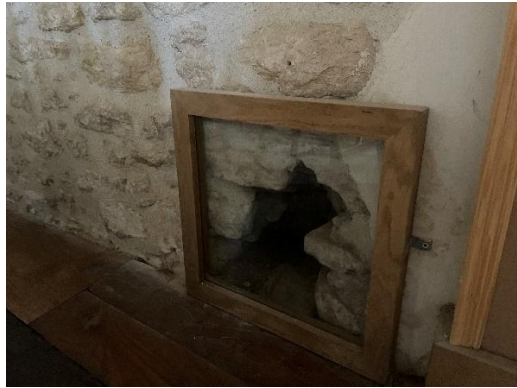
| Three Bears Cottage – RM2 Dining Room and RM9 Bathroom | | |
|---|---|---|
| Fig 17 – RM2 Dining Room – Hollow within wall adjacent to kitchen left exposed and protected with glass in frame | Fig 18 RM2 Dining Room - new MDF dado panelling with ventilation gap behind and ventilation grille at skirting, with profiled trim and ledge | |

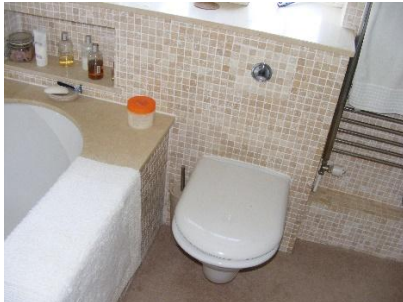
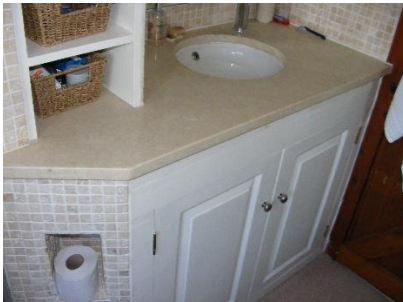
| Three Bears Cottage – RM2 Dining Room and RM9 Bathroom | | |
|---|---|---|
| Fig 19 - RM9 Bathroom– Old bathroom fittings now removed | Fig 20 – RM9 Bathroom – current situation with old fittings stripped out awaiting new fit-out. | |

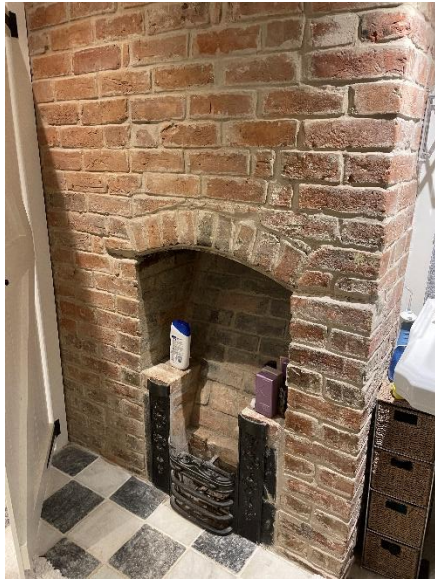
Fig 21 – R11 Ensuite – brick fireplace revealed and repointed, and stone tiles visible

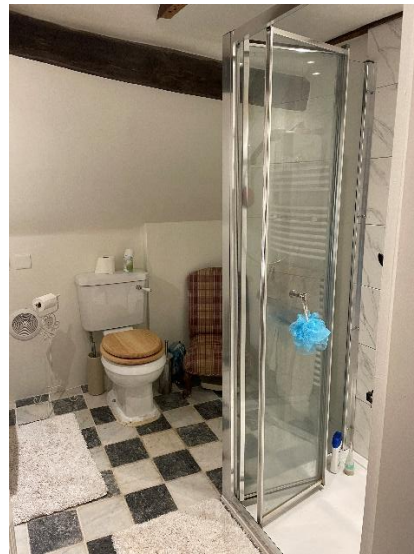
Fig 22 – RM11 Ensuite – shower relocated from against fireplace.

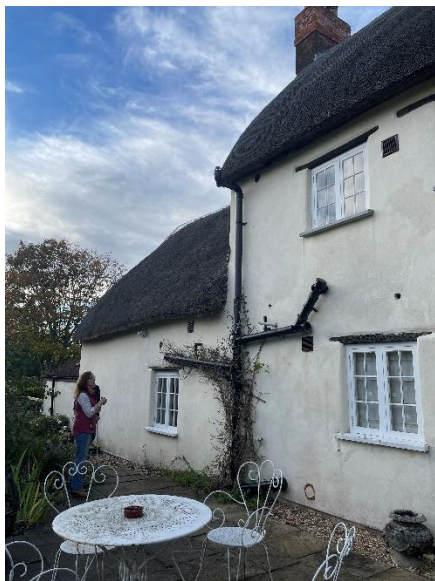
Fig 23 – Exterior from south showing ventilator terminals from bathroom and ensuite

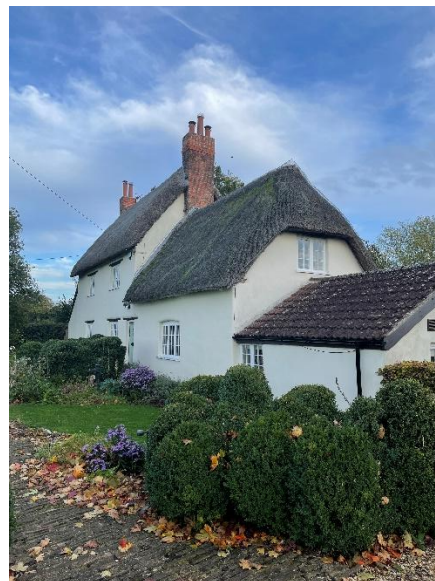
Fig 24 – Exterior from north west showing ventilator terminal in gable wall of kitchen extension, and raised chimneys

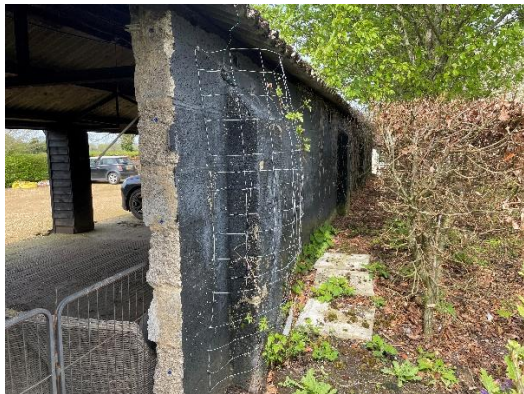
| Three Bears Cottage – Existing Outbuilding Internal and External Views | | |
|---|---|---|
| Fig 11 – View east wall of outbuildings towards south end of garden, with no cladding and in need of stabilising repairs. | Fig 12 – View of outbuilding roof to south end with link from garden to poolside and parking area. Blockwork walls showing signs of deterioration. | |

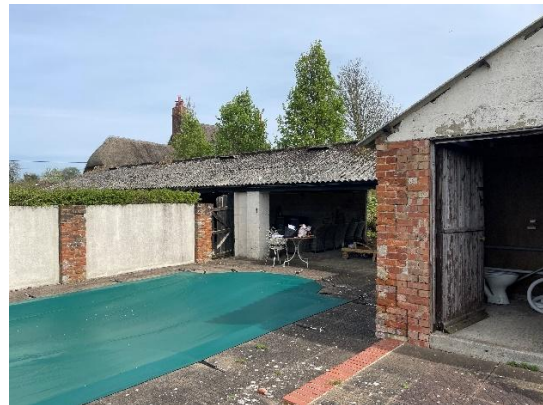
Fig 14 – View from poolside showing WC within storage barn, and garage outbuilding running north to south behind. Garden just visible beyond. Deteriorating concrete and brick patio paving visible.

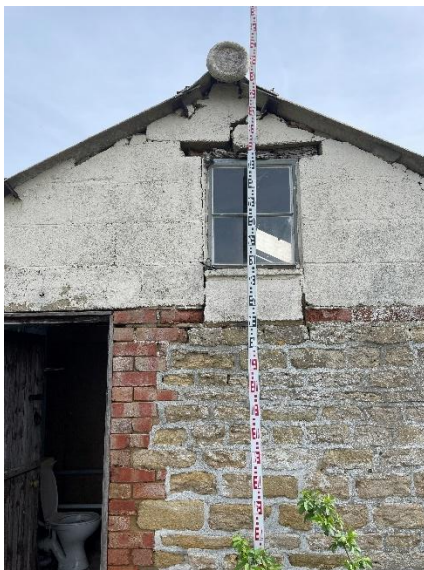
Fig 15 – View of west gable of storage barn with cracks visible over window and deteriorating lintel and masonry.
