**LAINGLY CHASE  
TREE RISK REPORT  
APRIL 2026**

**FORD TREESCAPES**

## **SUMMARY**

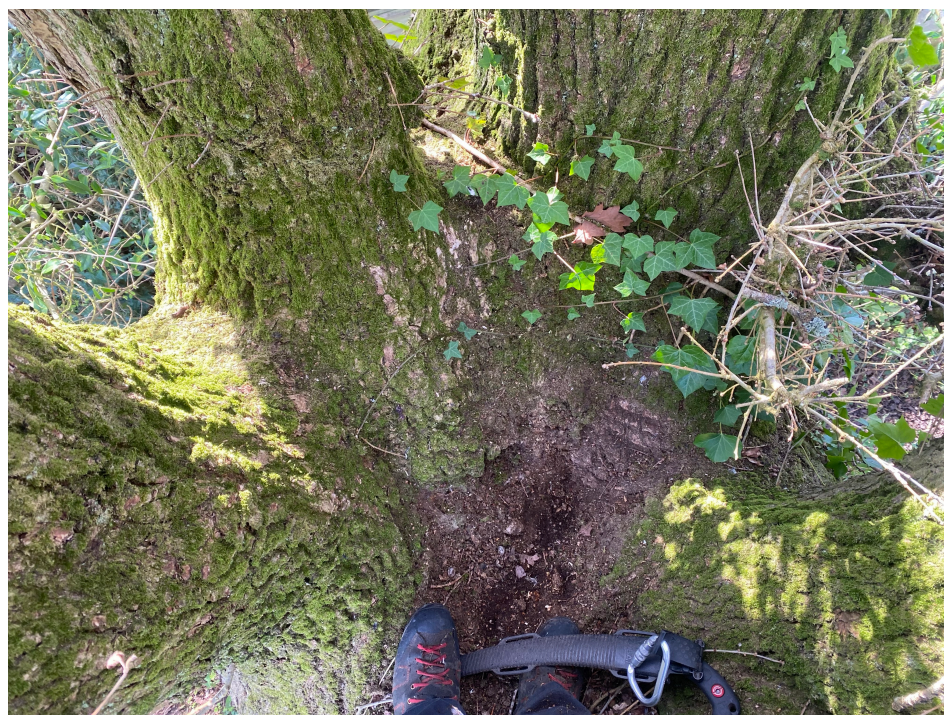
| TREE SURVEY DATA | | | | | | | | | | | | |
|---|---|---|---|---|---|---|---|---|---|---|---|---|
| T1 | English oak<br><i>Quercus robur</i> | 12 | 126 | M | Good | Good | Large stem diameter to height ratio. Mature tree with veteran potential. Historically pollarded at 4m. No significant visibly or audibly detected decay. Attachment points of re-growth from pollard head appear in good condition from within tree (see <i>figure 1</i> ). Tree growing over garden shed. Neighbour has complained about overhang of tree. So QTRA assessment carried out. | 3 | Proper ty | 6 | <1/1M Broadly acceptable | No management needed at present but if pressure from neighbours to prune persists then a crown reduction by drop crotch pruning of one stem to south recommended. Reducing lateral benches by 1.5 m in length and in height by 1m only to the single stem to south. (See <i>figure 2</i> )<br><br>Monitor tree health. |

*Figure 1* T1: stem unions at crown break.

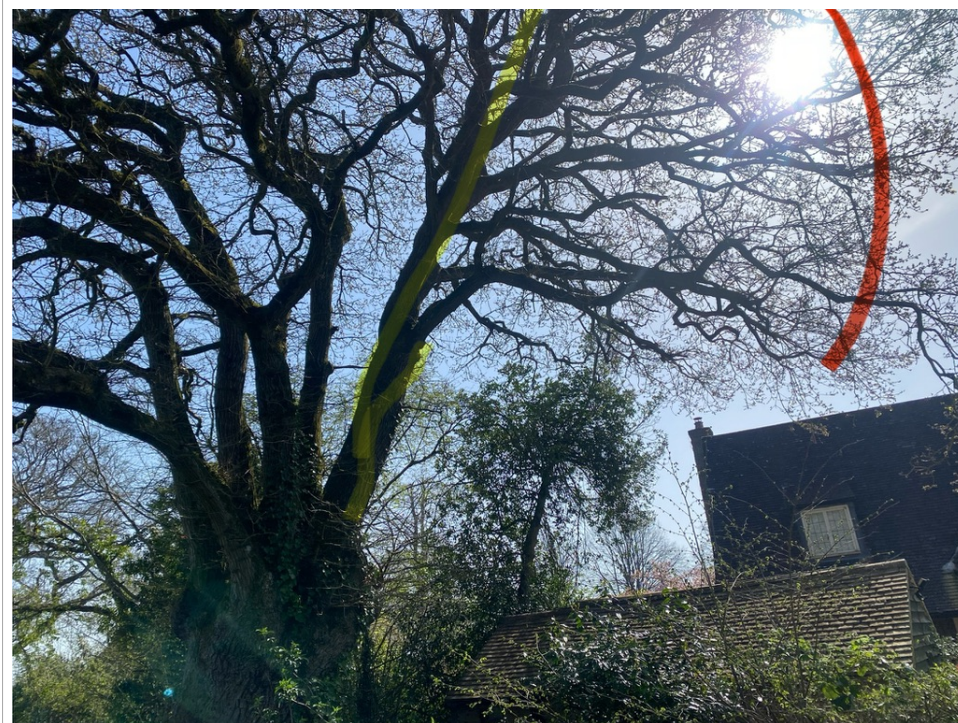
*Figure 2* T1: yellow highlighted stem with red pruning line if pruning is to be carried out.

All the trees on site that I was asked to look at had an acceptable risk rating when calculated using the QTRA method. This being said although currently not necessary for risk reduction, partial crown reduction works to T1 could be carried out which would plicate neighbours and would ultimately help in the long term longevity of the tree as It is an old pollard with substantial re-growth. One holly stem has still been recommended for removal on a maintenance basis. Pruning works are recommended to T4-T8 also on a maintenance basis so they are not obstructing overhead wires. Crown lifting works are recommended to T11 also on a maintenance basis. Although G1 presents broadly acceptable risk, if lower risk is desired from snapped branches, reducing lower lateral branches has been recommended. Please look at the management recommendations section in the tree data table above for detailed recommendations.

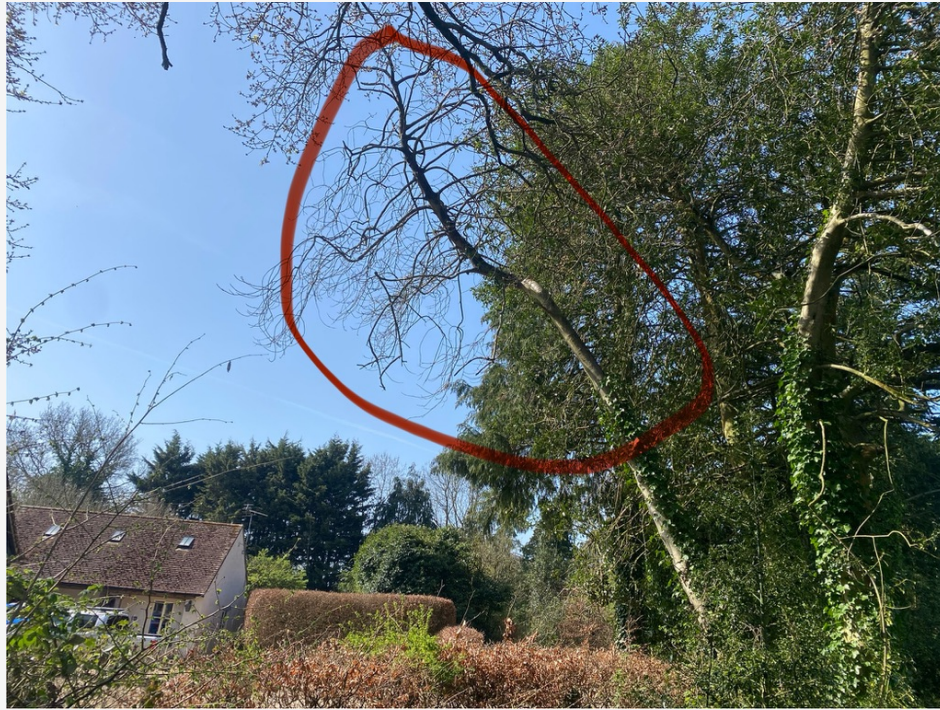
| TREE SURVEY DATA | | | | | | | | | | | | |
|---|---|---|---|---|---|---|---|---|---|---|---|---|
| T2 | Holly<br><i>Ilex Aquifolium</i> | 8 | 24* | SM | Poor | Poor | Dead holly stem likely to fall onto neighbours driveway. Not risk related but maintenance issue. | 3 | Proper ty | 5 | <1/1M Broadly acceptable | Remove holly stem. (See <i>figure 3</i> ) |

*Figure 3 T2: Dead holly stem to remove for maintenance reasons.*

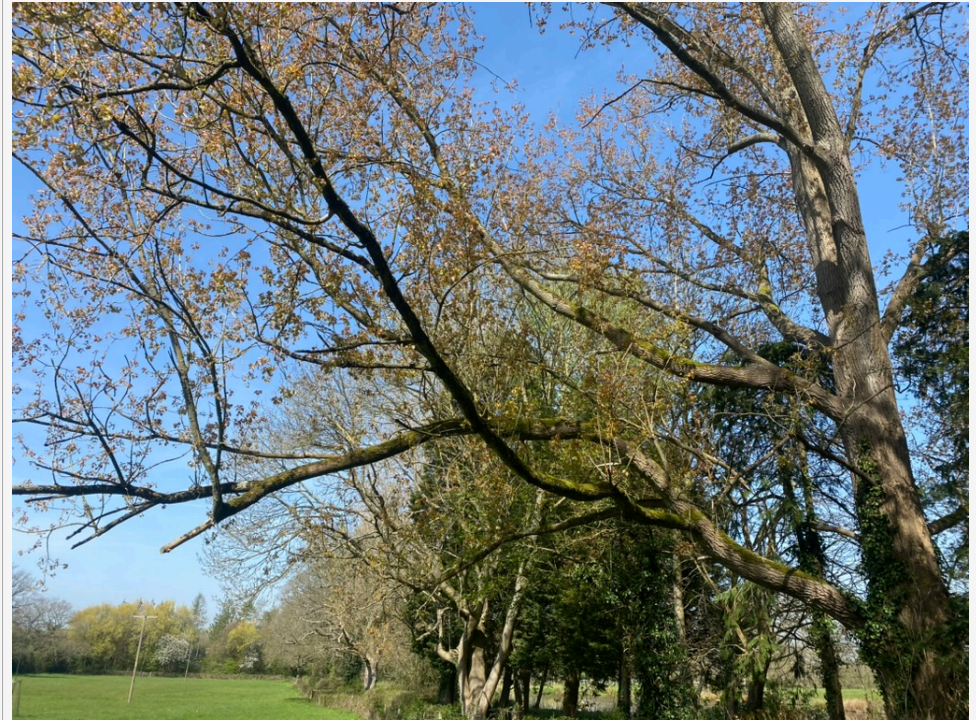
| TREE SURVEY DATA | | | | | | | | | | | | |
|---|---|---|---|---|---|---|---|---|---|---|---|---|
| G1 | Poplar (Hybrid black)<br><i>Populus x canadensis</i> | 20 | 90 | EM | Good | Good | 3 Large trees with some long lateral branches. Client expressed concerns due to brittle nature of timber, no significant issues observed QTRA assessment carried out for branch failure. Risk is broadly acceptable. | 3 | 2 | 5 | 1/1M Broadly acceptable | No action required for risk reduction. If risk is desired to be even lower it would not be detrimental to reduce two lower lateral branches by 3m.(see figures 4&5) If so the chances of them failing would be reduced but they would still act as a barrier from branches that may fall from above. |

*Figure 4 G1: lower lateral branch that may be desired to be reduced by 3-4 m in length to a suitable growth point.*

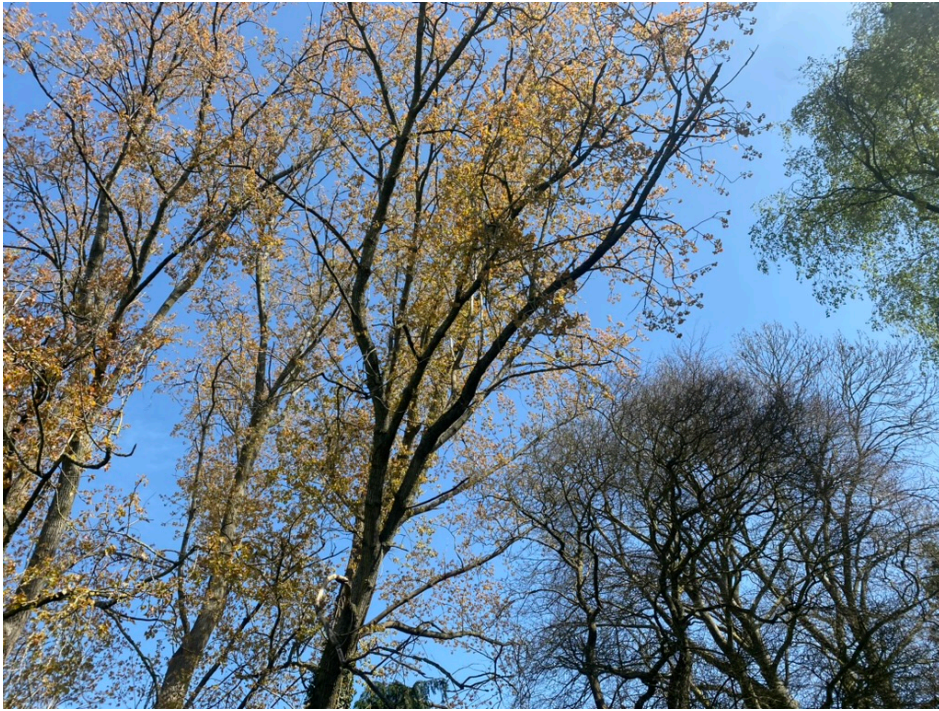
*Figure 5 G1:* another lower lateral branch that may be desired to be reduced by 3-4 m in length to a suitable growth point.

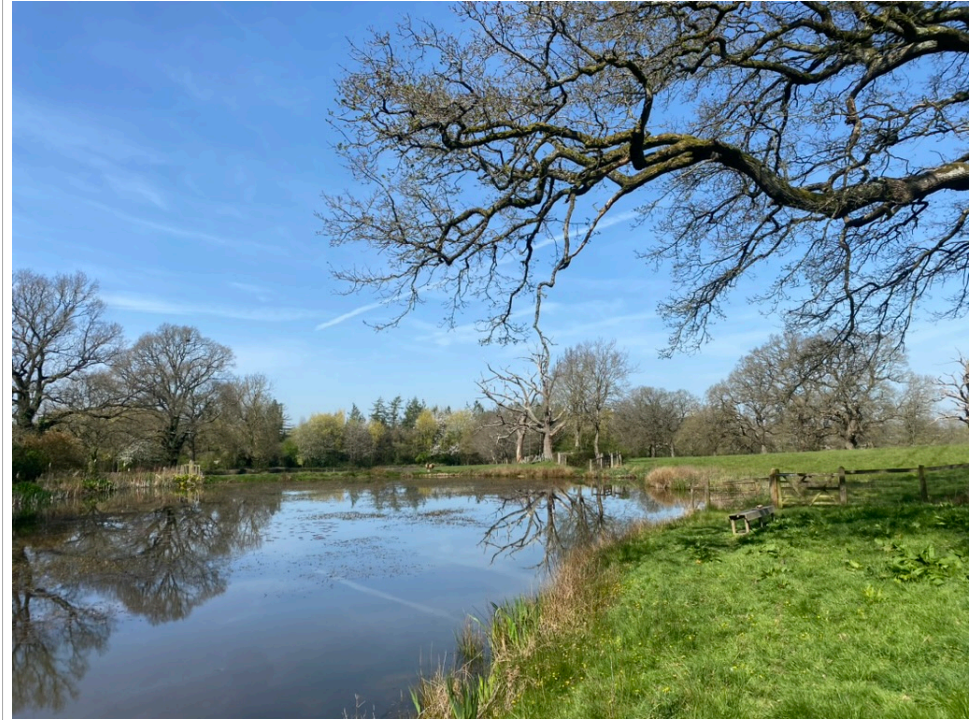
One speculation as to why the oak trees could be dying in the field north of the pond is that the pond is capturing water that would have flowed down hill, therefore reducing the available water for these trees, this coupled with changing climate and other factors such as disease like oak decline could be contributing to the mortality of these trees. It is recommended that these dead trees are retained as they hold high biodiversity and habitat value in standing deadwood. If it is becoming tiresome to keep moving befalling branches out of the way of tractors, the trees could have the limbs shortened so they are more stable standing trunks. Bill had asked whether crown lifting some of the live trees would be possible this time of year, The main issue here would be then allowing tractors in closer proximity to these trees which would be of fr higher detriment to the crown lifting of smaller branches. Crown lifting to allow tractors underneath the canopy would increase compaction below ground and increase risk of physical damage to the tree from tractors. Compaction damages the rooting environment limiting the trees ability to uptake water and nutrients and will likely accelerate tree mortality and decline in these fields.

*Figure 6:* view downhill over pond toward dead oak trees.
