## 98 The Street Tree Risk Assessment 2026

**Mr & Mrs Goodwill**

98 The Street  
Holt  
BA14 6QH

5<sup>th</sup> October 2026

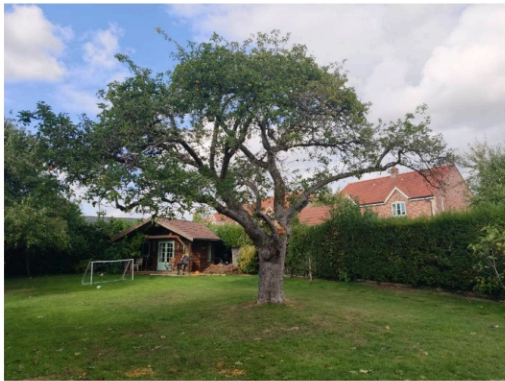
Common Apple (T1)

- 3.1.1 Use of a sounding hammer indicates that the trunk is hollow. Bees are nesting in a trunk cavity at 1.2m. Scar at 2m where major limb was shed in September 2026; this reveals extensive decay at the point of failure. The tree has long and end-loaded limbs. There is recent shoot growth in the mid-crown. Minor deadwood throughout the crown.

The tree has long and end-loaded limbs.

Extensive trunk and limb decay.

The highest risk is a limb being shed onto a garden user.

*Apple (T1) - Reduce the crown by 2m in all directions. Also, remove all deadwood from the crown.*
