## Arboricultural Appraisal Report

### Subsidence Damage Investigation at:

Glebe House  
Hilmarton  
Calne  
SN11 8SB

| MWA REF: | SUB260512-18715 |

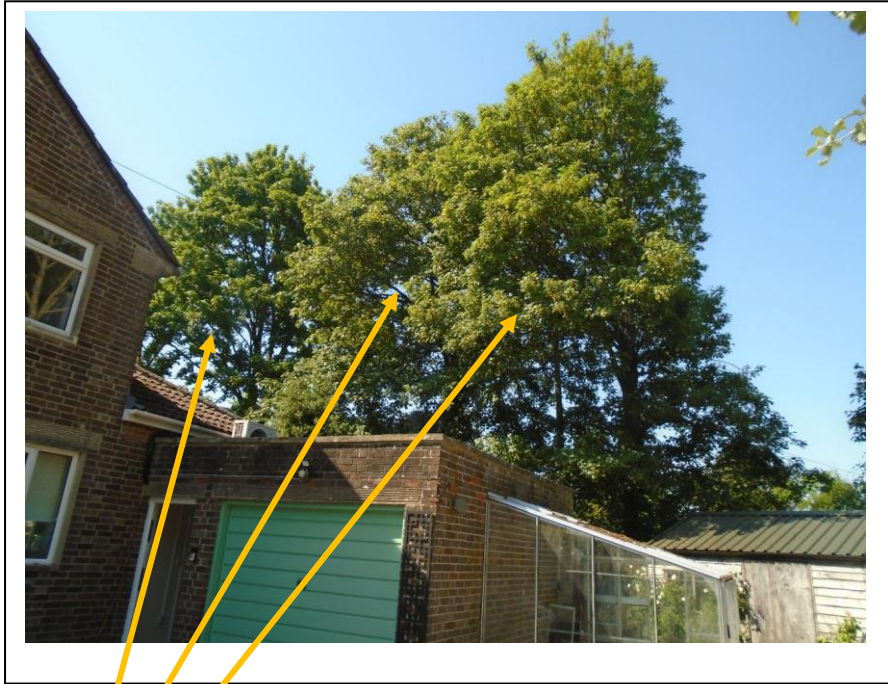
| Tree No. | Species | Height (m) | Dia (mm) | Crown Spread (m) | Dist. to building (m) | Age Classification | Ownership |
|---|---|---|---|---|---|---|---|
| T2 | Sycamore | 16 * | 650 * | 11 * | 6.75 * | Potentially older than extension | Third Party<br>The Old Vicarage<br>SN11 8SB |
| T3 | Sycamore | 15 * | 450 * | 13 * | 8 * | Potentially older than extension | Third Party<br>The Old Vicarage<br>SN11 8SB |

| Tree No. | Species | Height (m) | Dia (mm) | Crown Spread (m) | Dist. to building (m) | Age Classification | Ownership |
|---|---|---|---|---|---|---|---|
| T4 | Sycamore | 16 * | 500 * | 14 * | 16 * | Potentially older than extension | Third Party<br>The Old Vicarage<br>SN11 8SB |

View of T4, T3 & T2

| Tree No. | Species | Height (m) | Dia (mm) | Crown Spread (m) | Dist. to building (m) | Age Classification | Ownership |
|---|---|---|---|---|---|---|---|
| Recommendation | | Remove (fell) to near ground level. Owner to physically remove any regrowth (no chemical treatment due to translocation risk). | | | | | |

| Tree No. | Species | Height (m) | Dia (mm) | Crown Spread (m) | Dist. to building (m) | Age Classification | Ownership |
|---|---|---|---|---|---|---|---|
| Recommendation | | Reduce height by 3m and crown radius by 1m leaving balanced crown. Prune on a biennial cycle to maintain at broadly reduced dimensions. | | | | | |

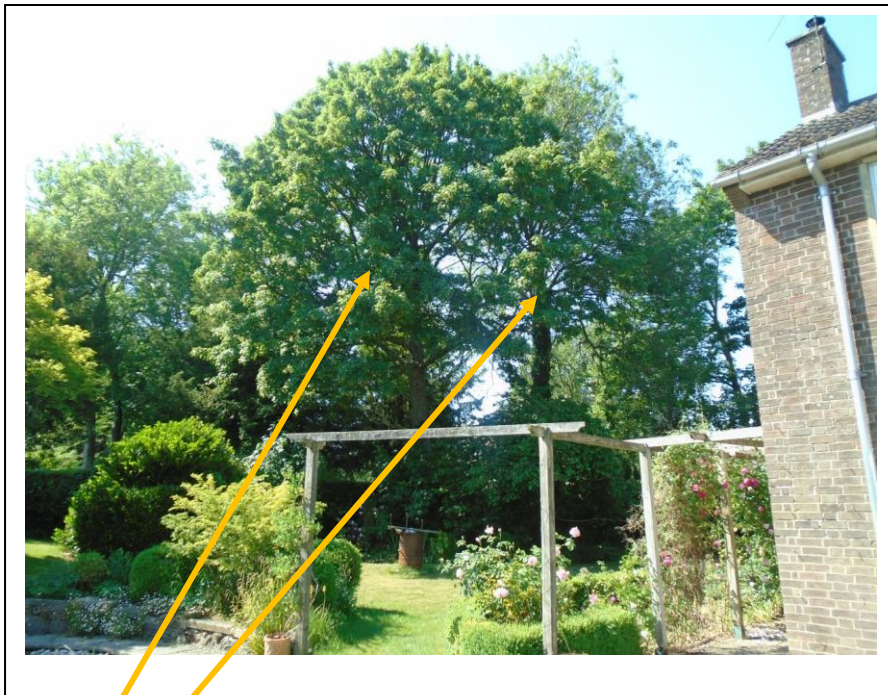
| Tree No. | Species | Height (m) | Dia (mm) | Crown Spread (m) | Dist. to building (m) | Age Classification | Ownership |
|---|---|---|---|---|---|---|---|
| T5 | Ash | 17 * | 600 * | 16 * | 16 * | Potentially older than extension | Policy Holder |
| T6 | Sycamore | 17 * | 600 * | 14 * | 17.5 * | Potentially older than extension | Policy Holder |

View of T6 & T5

| Tree No. | Species | Height (m) | Dia (mm) | Crown Spread (m) | Dist. to building (m) | Age Classification | Ownership |
|---|---|---|---|---|---|---|---|
| Recommendation | | Reduce height by 3m and crown radius by 1m leaving balanced crown. Prune on a biennial cycle to maintain at broadly reduced dimensions. | | | | | |
| Recommendation | | Remove (fell) to near ground level. Owner to physically remove any regrowth (no chemical treatment due to translocation risk). | | | | | |

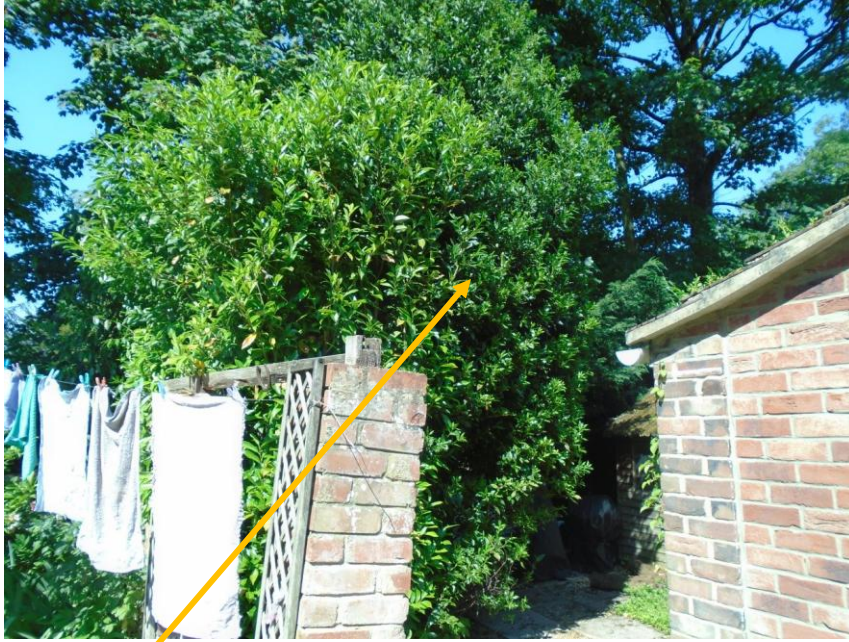
| Tree No. | Species | Height (m) | Dia (mm) | Crown Spread (m) | Dist. to building (m) | Age Classification | Ownership |
|---|---|---|---|---|---|---|---|
| SG1 | Laurel | 4 - 6 | Ms | 4 * | 2.5 | Younger than Property | Policy Holder |

View of one section of SG1

| Tree No. | Species | Height (m) | Dia (mm) | Crown Spread (m) | Dist. to building (m) | Age Classification | Ownership |
|---|---|---|---|---|---|---|---|
| Recommendation | | Remove (fell) to near ground level and treat stump to inhibit regrowth. | | | | | |

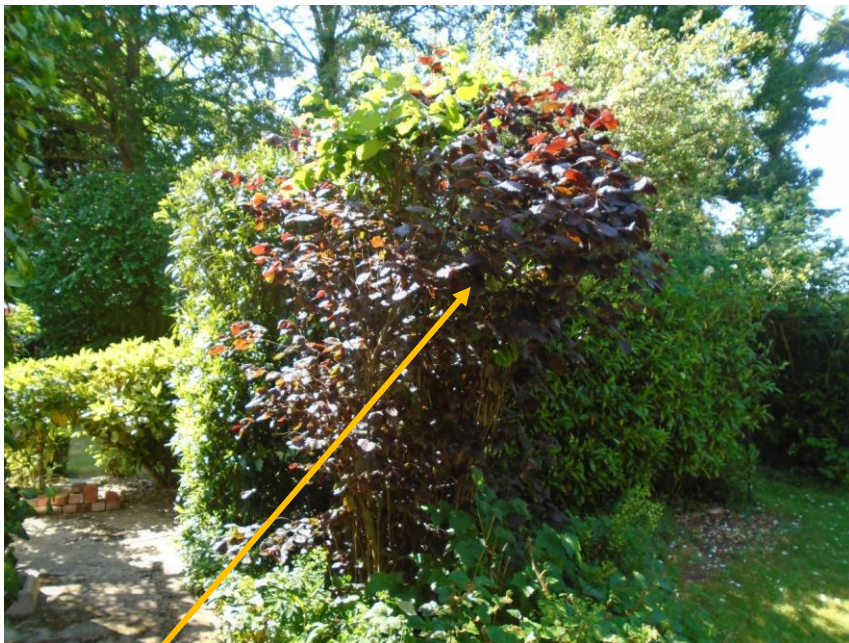
| Tree No. | Species | Height (m) | Dia (mm) | Crown Spread (m) | Dist. to building (m) | Age Classification | Ownership |
|---|---|---|---|---|---|---|---|
| SG2 | Mixed species shrubs including Laurel and Hazel | 3 | Ms | 5 | 2 | Younger than Property | Policy Holder |

View of SG2

| Tree No. | Species | Height (m) | Dia (mm) | Crown Spread (m) | Dist. to building (m) | Age Classification | Ownership |
|---|---|---|---|---|---|---|---|
| Recommendation | | Remove (fell) to near ground level all stems within 4m of the property. Owner to physically remove any regrowth (no chemical treatment due to translocation risk). Maintain remaining broadly at no more than current dimensions by periodic pruning. | | | | | |
