**ATWORTH ARBORICULTURE LTD**

**VISUAL TREE INSPECTION OF AN OAK TREE AT 64,  
SUTHERLAND CRESCENT, CHIPPENHAM.**

**Prepared for:  
Mr. Vincent Brown,  
64, Sutherland Crescent,  
Chippenham,  
SN14 6RS**

**4<sup>th</sup> of August 2024**

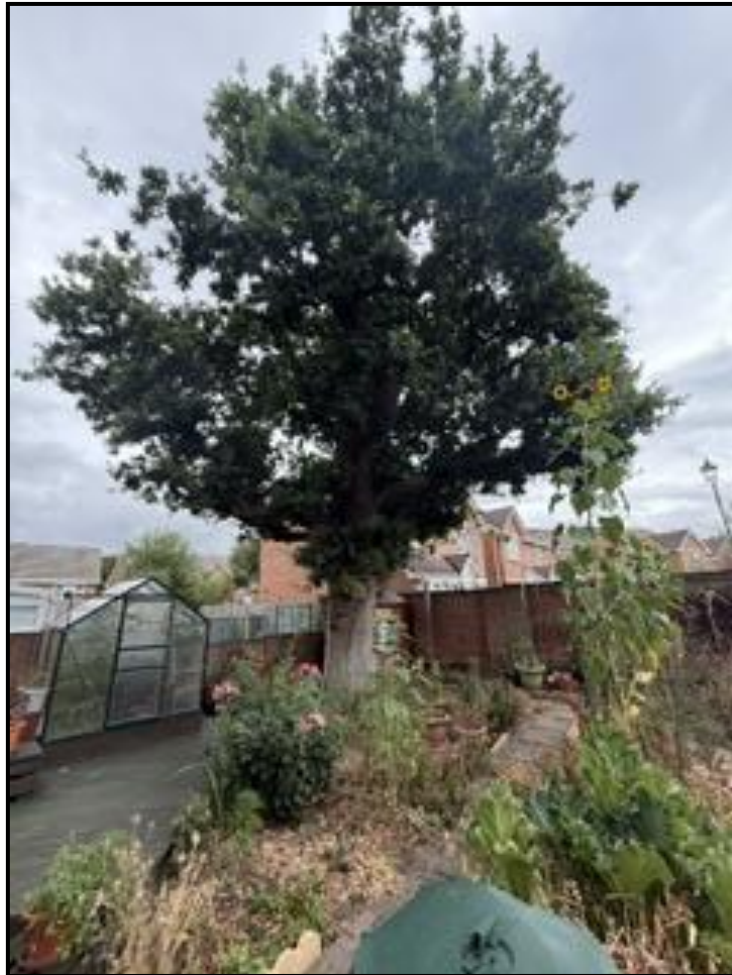
The tree is in the rear garden of the property, 8m east of the property. A wooden shed is 1.3m east and neighbouring properties, 65 Sutherland Crescent, 6m northeast and 63, Sutherland Crescent, 10m northwest. The garden of the neighbours is 3m north and a greenhouse, 2m northwest. No faults were observed at the base of the tree. Tap tests were carried out with a mallet. This tap test showed some bark de-lamination at the base of the stem to the south. The crown breaks away from the stem at 3m above ground level (agl). Around the crown break, numerous limbs have been removed historically, to the northwest, northeast, southeast and 2 to the south. None of the remaining branch stubs appears decayed. Historically the crown has been reduced. Mr. Brown told me the tree had been reduced several times since he has lived there. The last time the tree was reduced was in 2023. Branches are growing over the neighbour's garden to the north and over the neighbours drive to the east and close to No 64 in the west. The crown appears normal with good vigour. Mr Brown told me there had been lots of ants on the most westerly branch. Below the most westerly branch was lots of detritus and aphid waste. It is most likely that the ants have been feeding on the aphids.

Overall, the tree is in good, safe condition.

The tree is probably over 100 years old and precedes the surrounding houses by many years. If any damage was done to the tree during construction, it is not showing signs now. This mature tree looks healthy and normal with many more years potential.

Although the tree is healthy, it is very close to 3 properties. Historically, the tree has been periodically reduced, and it would be prudent to continue this. Reducing the crown reduces the area of the crown which decreases the effects of the wind on the tree. Smaller, more frequent reductions are less harmful than less frequent larger reductions.

The crown should be reduced all around back to previous pruning points. This work to be carried out within 6 months by a fully qualified and insured tree surgeon working to BS3998 (2010), Tree work.

The tree should be re-inspected in 3 years or sooner if the tree shows signs of decline.
