**STRUCTURAL INSPECTION OF  
TWIN SPAN BARN AT  
WILSFORD DOWN COTTAGE  
WILSFORD, PEWSEY**

Visual Structural Inspection of steel portal framed barn for Full Plans Planning application

| Property Address | Barn at Wilsford Down Cottage, Wilsford,<br>Pewsey SN9 6HB |
| Shire Ref number (our ref) | S-24-292 |

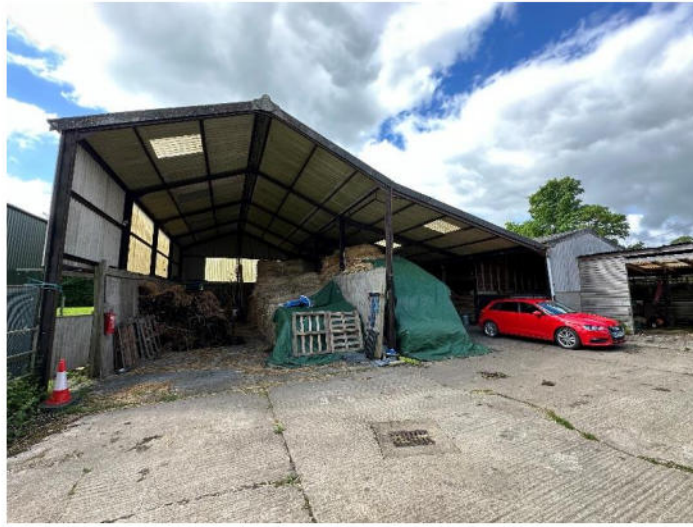
- 2.1. The North elevation of the building is the primary access to the barn. The elevation is fully open and the steel portal frame is exposed to view. The steel frame has a light surface corrosion. All elements are in a satisfactory structural condition.

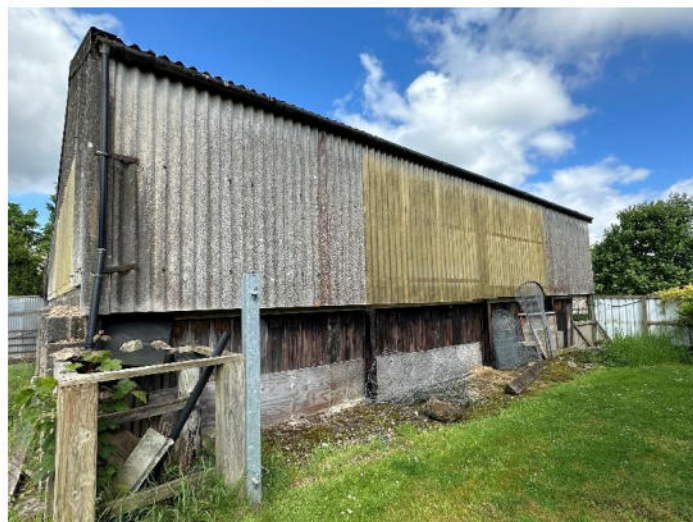
- 2.2. The East elevation of the barn is clad full height in asbestos cement cladding. The lower part of the elevation comprises timber boarding. The boarding will need to be replaced. Where exposed to view all steel elements are in an acceptable structural condition.

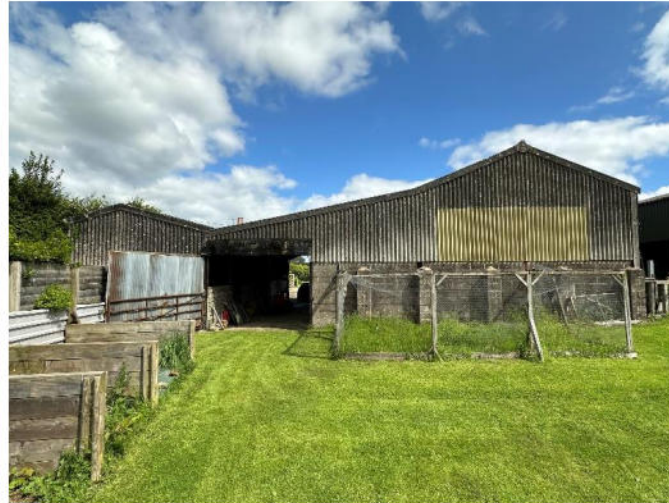
- 2.3. The South elevation faces out to open fields. The elevation is clad half height in asbestos cement corrugated sheeting, with single skin blockwork walling below. All elements are in a satisfactory structural condition.

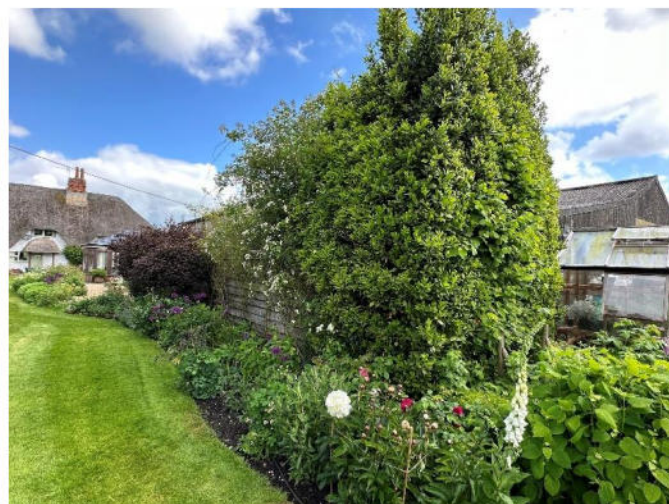
- 2.4. The West elevation faces towards the Cottage Garden and is obscured by fencing and vegetation. This is also the section of the building which is proposed to be demolished.

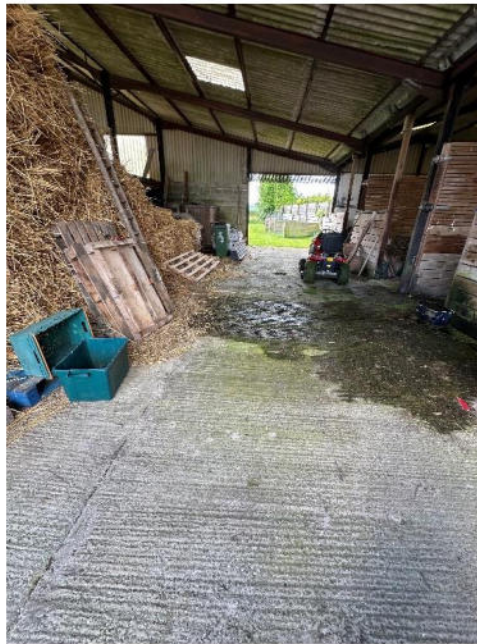
- 3.1. The floor slabs within the building comprise of in-situ concrete. They are suitable to be overlain with a damp-proof membrane, insulation, and screed. The floor slab has been subjected to loading significantly higher than domestic loading and is suitable to be retained.

- 4.2.2 The floor slab will need to be cleaned suitable to receive a damp-proof membrane and insulation. In areas with no floor slab, a new slab will need to be provided.

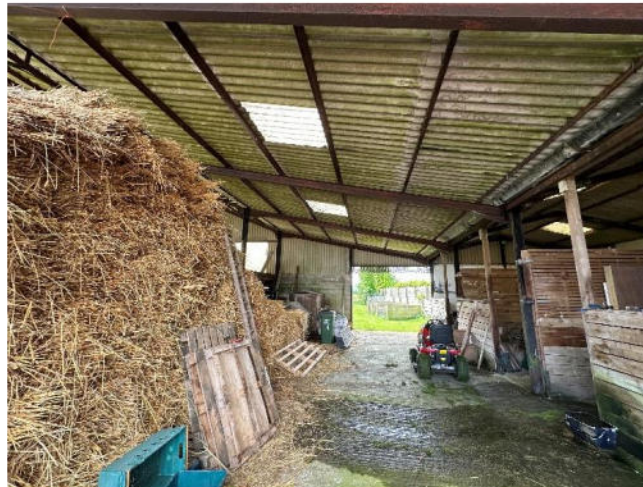
- 3.2. The purlins are of hot rolled angle steel sections. These have a light surface corrosion with no loss of section. The side rails are in timber. All elements are in a satisfactory structural condition.

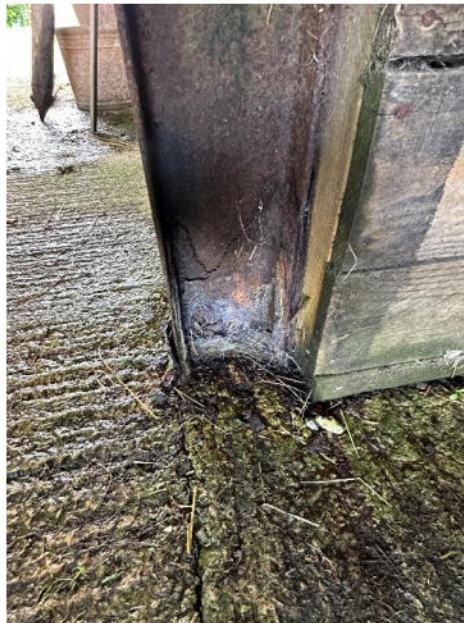
- 3.3. The primary steel frame has a light surface corrosion with no significant loss of section. The frame will need to be painted as part of the conversion. However, a small number of columns will require repairs at the base where corrosion has taken place as shown in the photograph below.

- 4.2.3 The steel frame will be retained and requires some small remedial works to the bases of a few columns, and it will require repainting to prevent any further corrosion.
