**STRUCTURAL INSPECTION OF  
THE GREEN BARN AT  
WILSFORD DOWN COTTAGE  
WILSFORD, PEWSEY**

Visual Structural Inspection of steel portal framed barn for Full Plans Planning application

| Property Address | Barn at Wilsford Down Cottage, Wilsford,<br>Pewsey SN9 6HB |
| Shire Ref number (our ref) | S-24-292 |

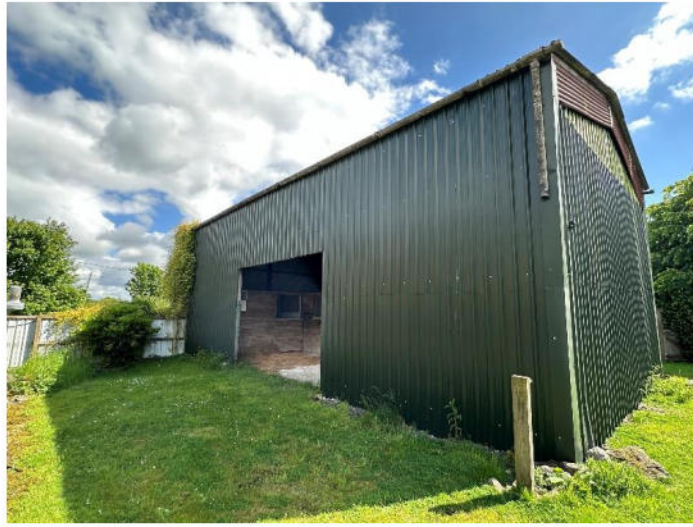
- 2.1. The West elevation of the building contains the access door to the barn. The elevation comprises single skin corrugated sheeting. All elements are in good structural condition.

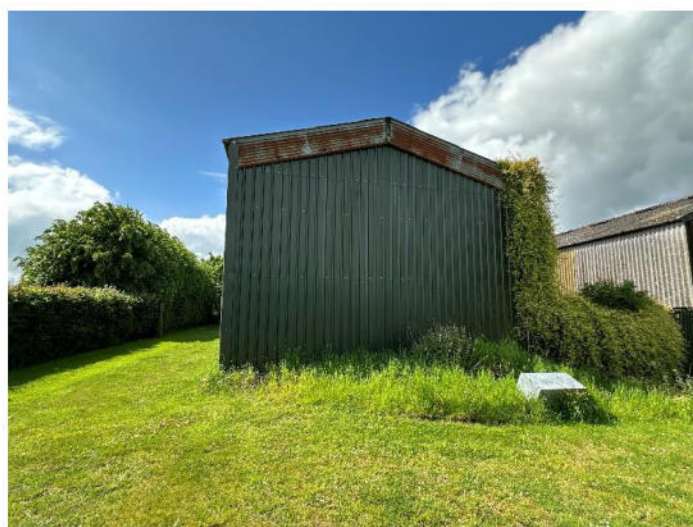
- 2.2. The North elevation of the barn is clad full height in profiled steel cladding. The elevation contains vegetation growing on the cladding and this will need to be removed. Where exposed to view all elements are in good condition.

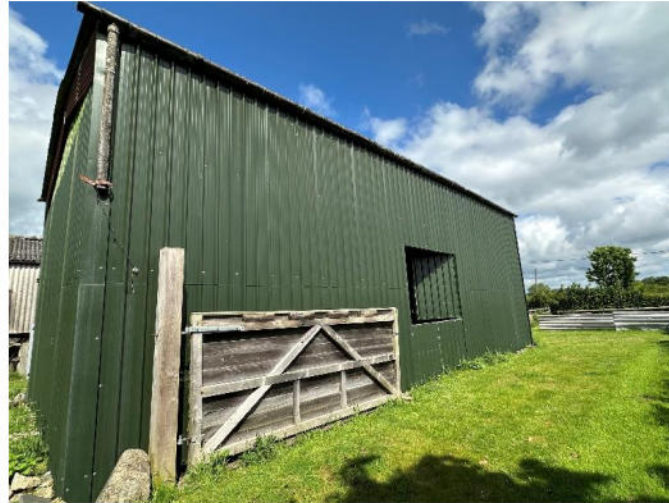
- 2.3. The East elevation faces out to open fields. The elevation is clad in full height corrugated metal sheeting. All elements are in a satisfactory structural condition.

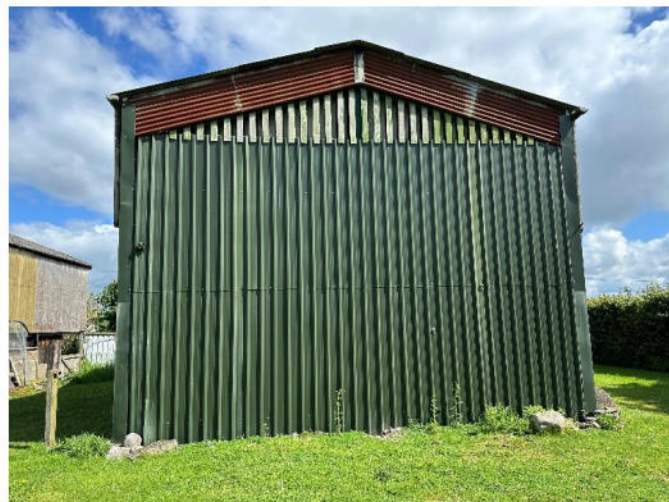
- 2.4. The South elevation comprises corrugated steel cladding with a small section of Yorkshire boarding at the high level gable peak. All structural elements are in a satisfactory condition.

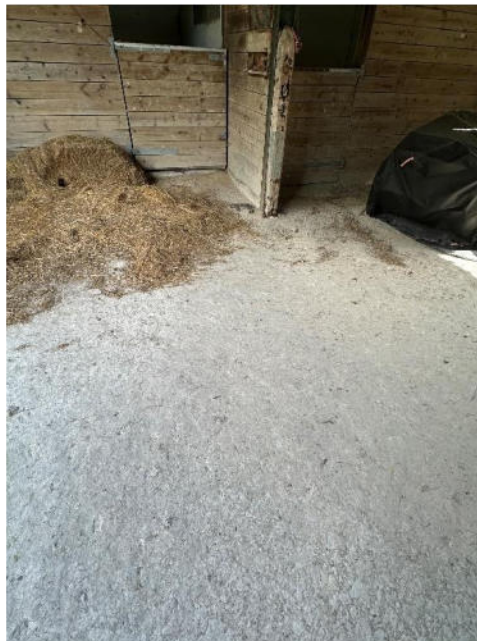
- 3.1. The floor slabs within the building comprise of in-situ concrete. They are suitable to be overlain with a damp-proof membrane, insulation, and screed. The floor slab has been subjected to loading significantly higher than domestic loading and is suitable to be retained.

- 4.2 The proposed works will require the following.
  - 4.2.1 The roof cladding will be tested for asbestos and replaced if necessary.
  - 4.2.2 The floor slab will need to be cleaned suitable to receive a damp-proof membrane and insulation. In areas with no floor slab, a new slab will need to be provided.

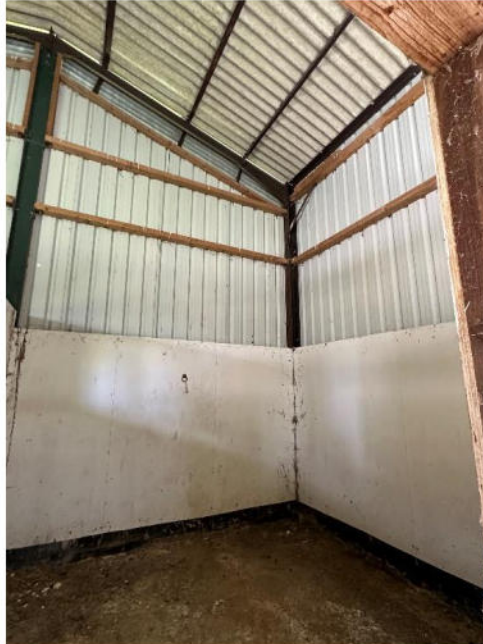
- 3.2. The purlins are of hot rolled angle steel sections. The side rails are in timber. All elements are in good structural condition.

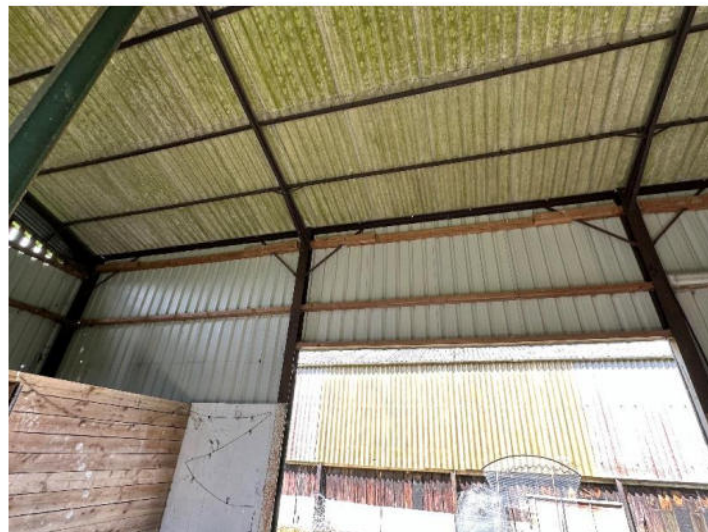
- 3.3. The primary steel frame has a light surface corrosion with no loss of section. The frame will need to be painted as part of the conversion.

- 4.2.3 The steel frame will be retained and requires no remedial works, but it will require repainting to prevent corrosion taking hold.
  - 4.2.4 A new perimeter inner wall will be constructed in timber studwork to comply with Building Regulations Parts A and L.
