# DESIGN, ACCESS & HERITAGE STATEMENT

Rainwater Disposal Improvements at:

## The Yelde Hall, Chippenham, SN15 3HL

For: Chippenham Town Council  
Date: Tuesday, 13 October 2026  
Ref: 24-04-RS3

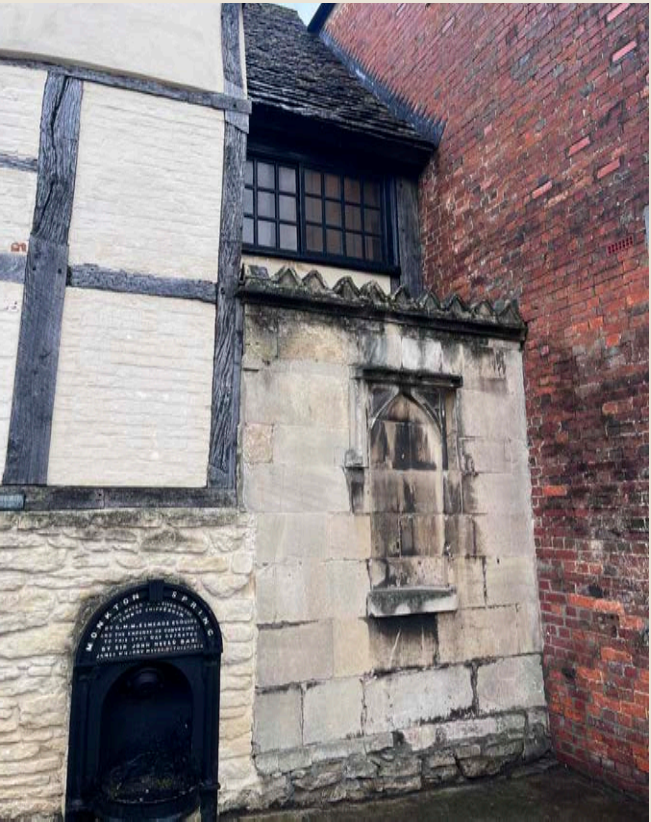
Figure 4: North elevation. Single storey section with metal roof, dog-toothed parapet stone wall, blank niche

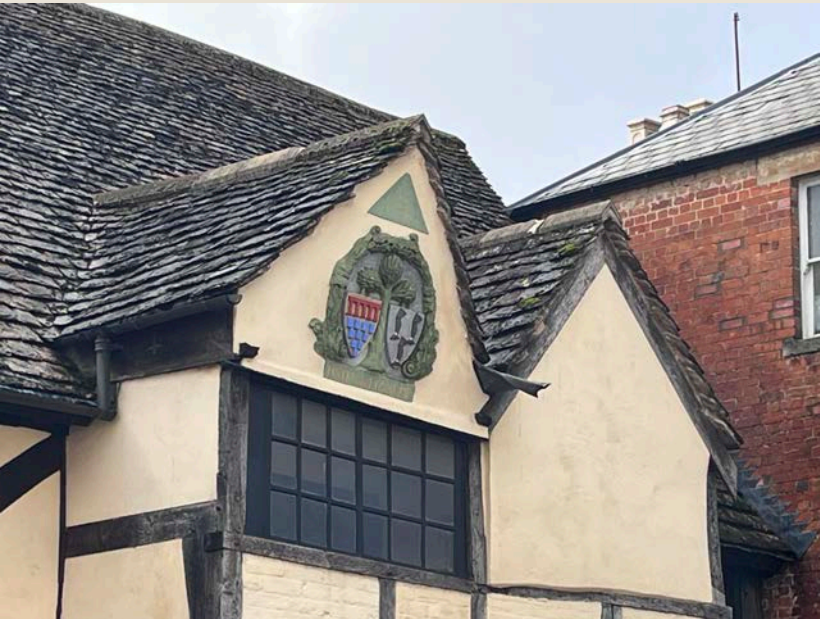
Figure 6: North elevation, lead-lined valley gutter (G4) discharging onto pavement below

A decorative cast iron or lead work hopper will be installed on the North elevation to serve the lead lined valley gutter (G4). The hopper will be sensitively designed to reflect the character and time period of the hall, and will discharge into a cast iron circular downpipe (RWP6) to match existing. This aims to address the current issue of rainwater striking the pavement and splashing back onto the walls, helping to prevent further damp issues to this section.
- 10.4.

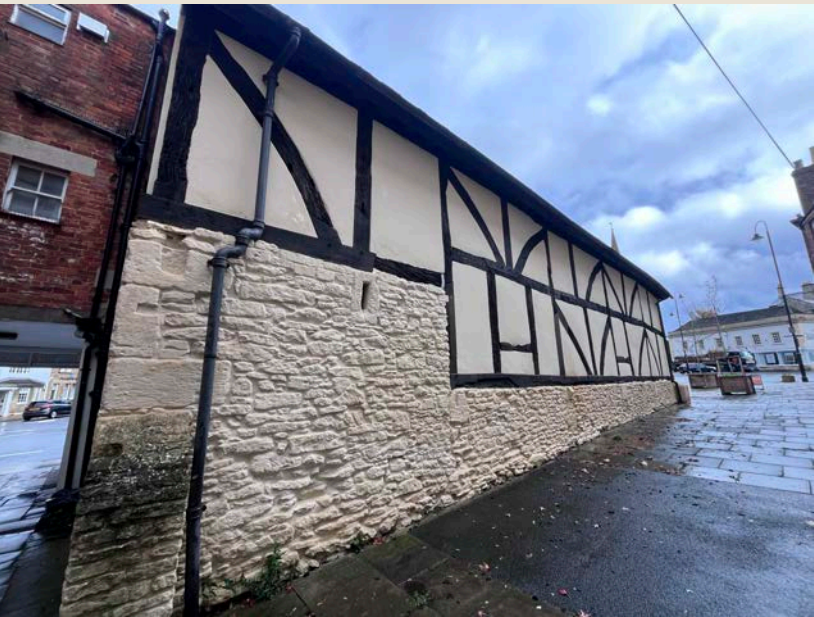
- 6.5. Down-pipe at the southwest corner is poorly routed and stained, suggesting blockage with vegetation at the base of the wall (see fig. 7 & 9). The downpipes discharge to open gullies both of which were congested with leaves at the time of the inspection.
- 6.6. Defects in the gutter joints are causing rainwater splash back and staining to the lime plaster infill panels and the stone plinth at the base (see fig. 7 & 13).
- 6.7. The stone-based plinth abuts a hard-paved, sloping pavement, which is not water permeable retaining water at the base of the walls

Figure 7: South elevation. Algae staining and rising damp to stone plinth. Southwest downpipe (RWP1) with multiple defective junctions and blocked gully

The complex (double 'S') downpipe (RWP1) at the southwest corner will be rerouted with less junctions to prevent risk of future blockages or defects.
- 10.5.

The gullies will be unblocked and refitted with silt traps and grate inserts to reduce the risk of future blockages, allowing downpipes to discharge effectively and aiding surface water runoff of the surrounding paving, preventing further rising damp to the stone plinth. A regular maintenance schedule will be implemented to monitor the gullies and avoid long term blockages.
- 10.10.

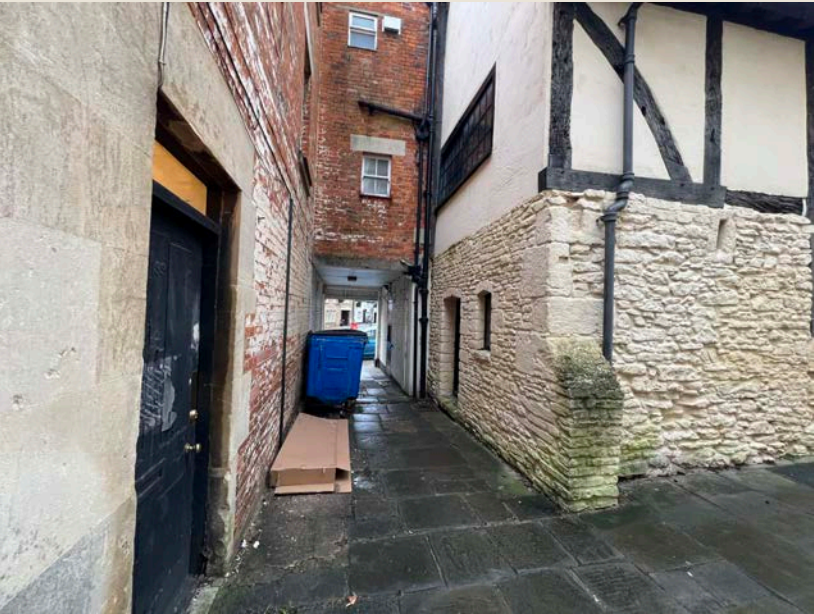
Figure 8: Yelde Hall, West elevation

- 6.8. The brick wall appears damp at the vertical abutment with the adjoining property at first floor level
- 6.9. The elevation is marbled due to water runoff from the roof verge above (see fig 8).

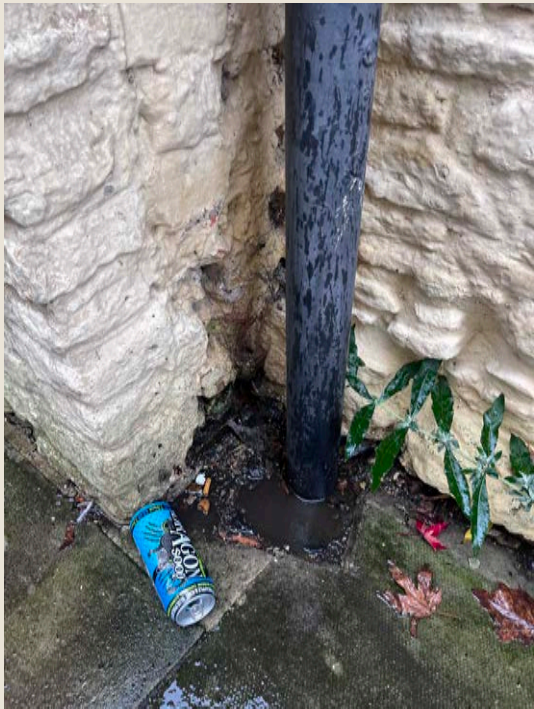
Figure 9: Southwest corner downpipe (RWP1) and hard paving around blocked gully

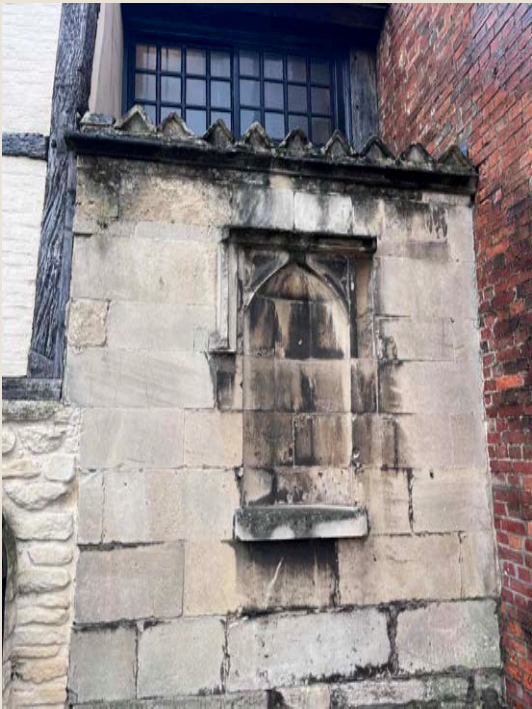
- 6.10. Absence of guttering at the west end over single storey metal roof causing water damage to wall coverings (see fig. 11).
- 6.11. There is a heavy moss covering over the full section of the roof with significant vegetation growth coming from the hidden parapet gutter which is undersized and poorly maintained, possibly leading to the degradation of the stonework to the parapet (see fig. 4 & 12).
- 6.12. There is a blank niche with sulphate crusting (limestone). The right-hand label stop is entirely missing, as is part of the central hood mould and the left-hand label stop return (see fig. 10).

- 6.13. At the top of the ashlar wall there is a dog-toothed stone parapet with a moulded drip profile. This is in very poor condition and requires urgent attention. The stone is inherently damp due to defects with the lead parapet gutter behind (see fig. 4 & 10)
- 6.14. Set back from the ashlar elevation over a flat lead roof is an elevation containing timber framed windows in an oak frame. The glazing is in fair condition and in good decorative order. The wall beneath the window is defective with a significant loss of covering most likely due to the splash back from the lack of guttering on the roof over.

Figure 10: North elevation, damaged stone work to dog-toothed parapet and blank niche with missing right-hand stop

The dog-toothed stone parapet will be repaired to match existing. The left stop to the stone blank niche will also be replaced to match existing and restore the historic facade.
- 10.8.

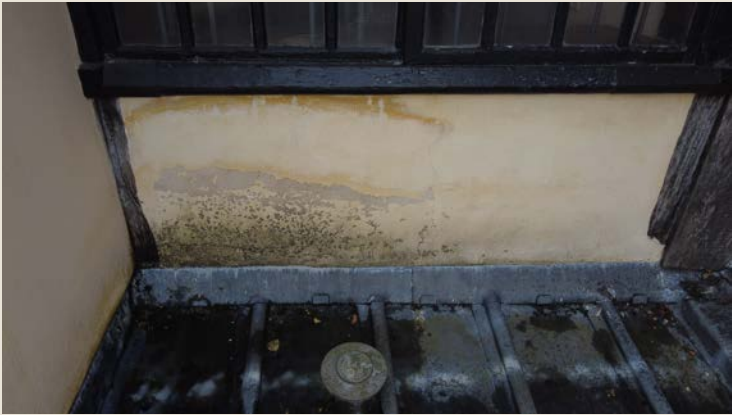
Figure 11: Water damage to wall above single storey metal roof, North elevation

A gutter (G6) will be installed to the roof above the parapet, with a downpipe (RWP5) discharging onto the roof to control the rainfall over the single storey section and prevent further water damage to the walls that surround it.
- 10.9.

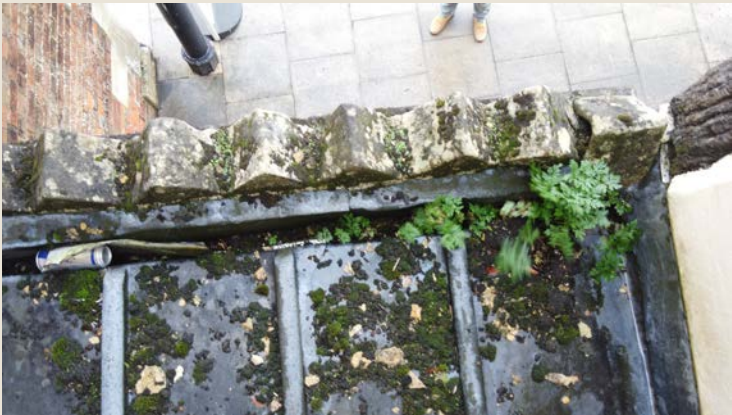
Figure 12: Metal roof with undersized parapet gutter (G7), significant vegetation and moss causing blockages. Damp and damaged dog-toothed stone parapet wall.

The parapet gutter (G7) to the metal flat roof will be increased in size, with the aim of preventing future overflow or damp to the stone parapet. All debris, rubbish and moss to be removed from the roof; regular monitoring and maintenance will be implemented.
- 10.7.

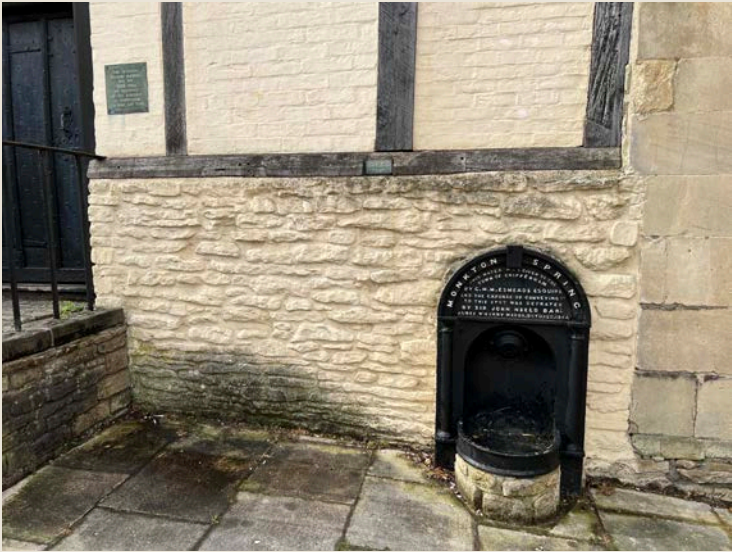
Figure 13: North elevation, significant damp due to lead valley discharging onto paving, with no rainwater runoff, and splashing back onto stone plinth
